Heritage Committee
Monday February 5, 2017
7:00 p.m.
Council Chambers, Aberfoyle

Heritage Impact Assessment

66 Brock Road South,
Morriston, ON

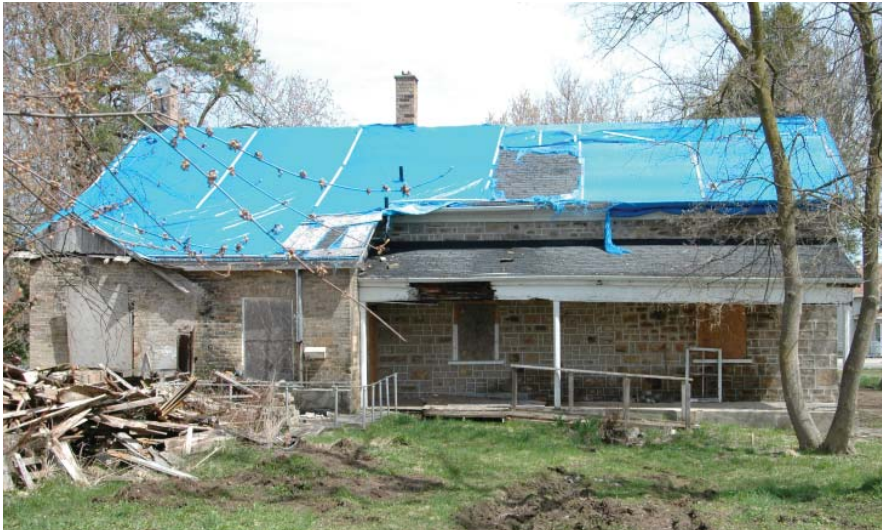
Figure 21 - Rear View of brick addition and deteriorating porch and roof. Note partial removal of yellow brick addition. Photos from site visit, January 2017.

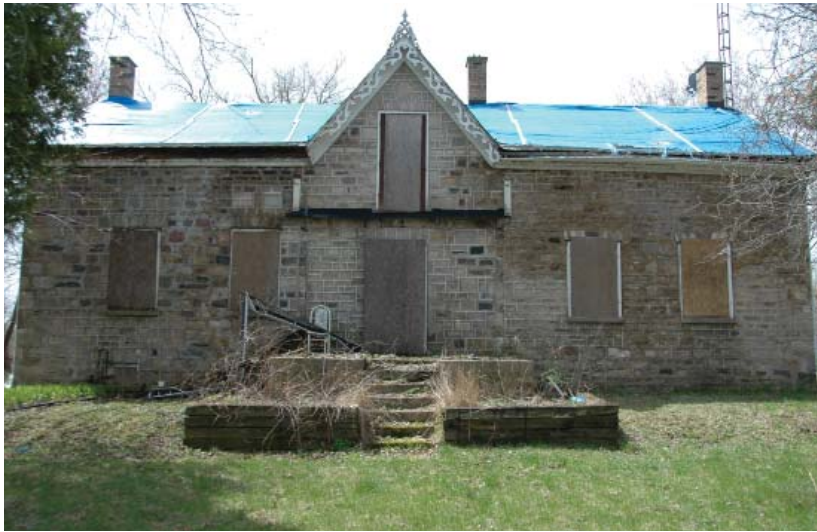
Figure 23 - Front View of house. Note Front porch has been removed. Photos from site visit, January 2017.

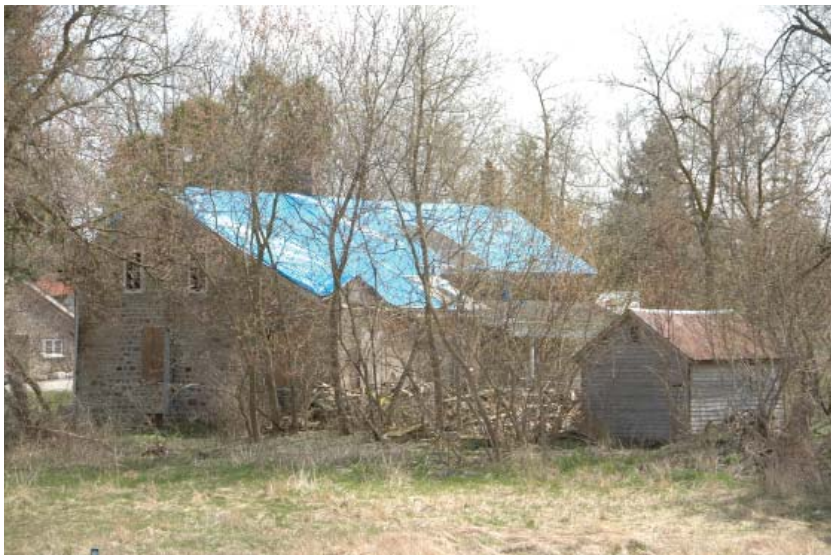
Figure 27 - View facing side of house. Note partial removal of Brick Addition, with wood framed Ice House still standing. Photos from site visit, January 2017.

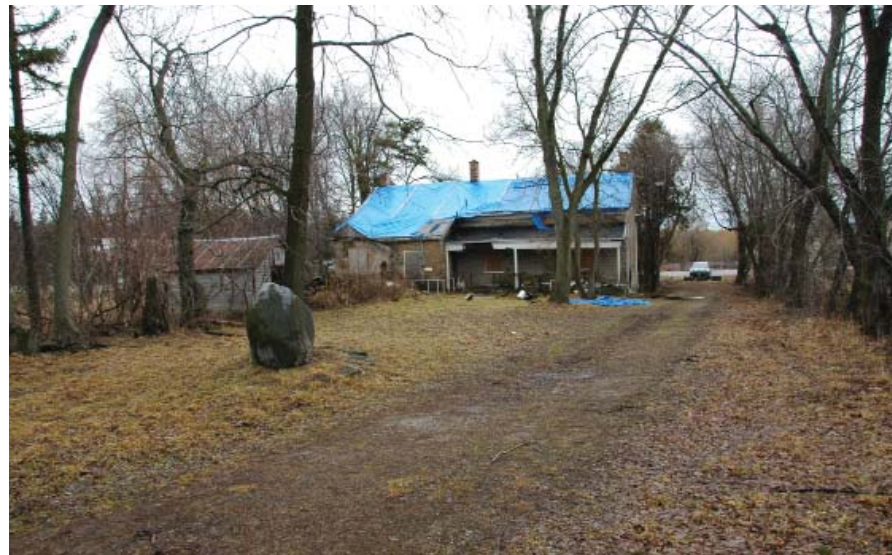
Figure 28 - View facing rear of house. Note partial removal of Brick Addition, with wood framed Ice House still standing. Photos from site visit, January 2017.

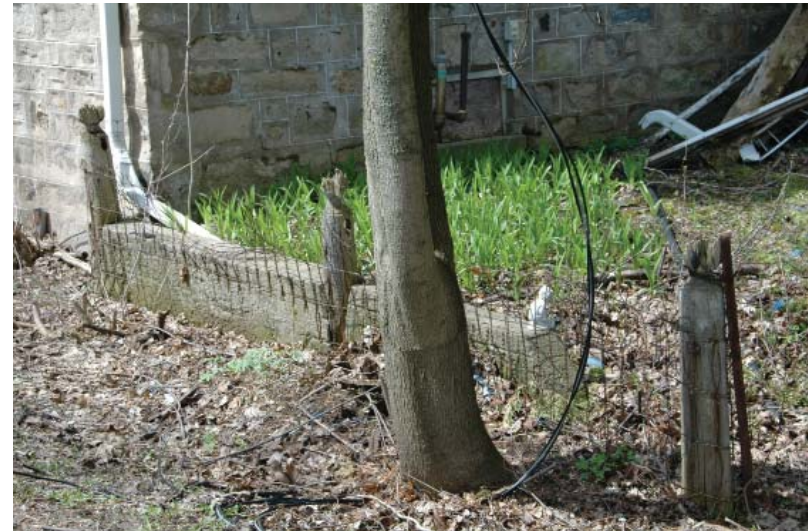
Figure 40 - Historic dilapidated fence. Photos from site visit, January 2017.

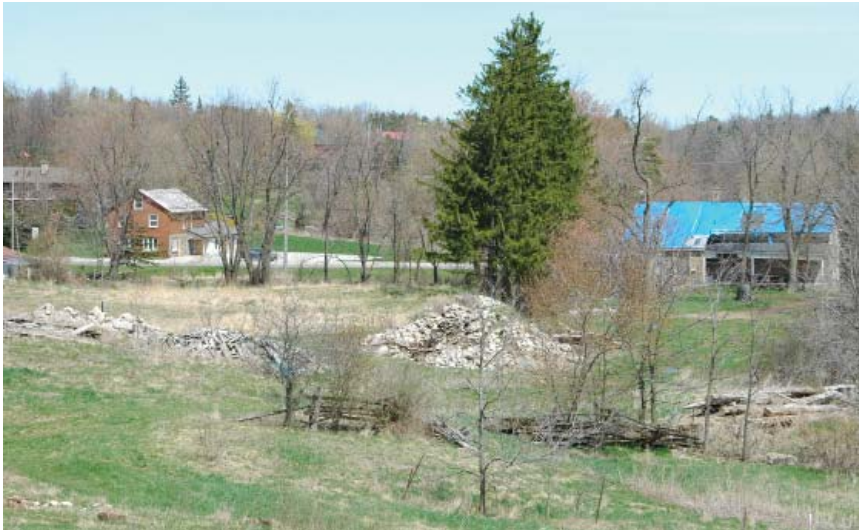
Figure 43 - View of property facing North. Note the rubble piles, where Barn/ Outbuildings used to be located. Photos from site visit, January 2017.

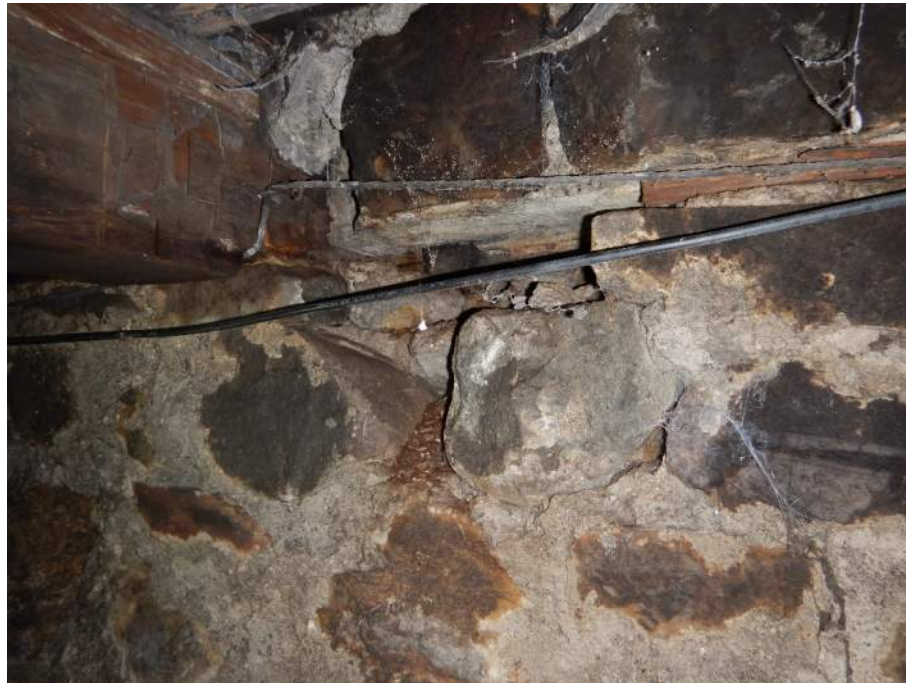
Figure 2 – Interior Mortar Deterioration

- The mortar was in good condition. Some stones were noted to be missing in the basement. Refer to Figure 2.

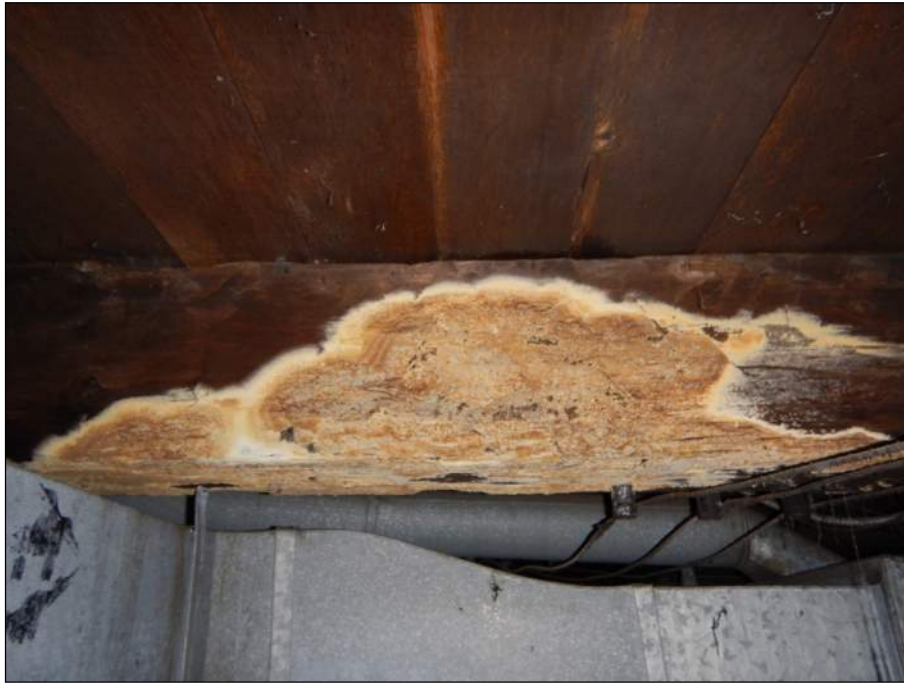
Figure 3 – Mold on Floor Beam

- The original main floor framing showed many signs of rot and mold. Refer to Figure 3 and Figure 4. The damage to the wood members compromises their load carrying ability.

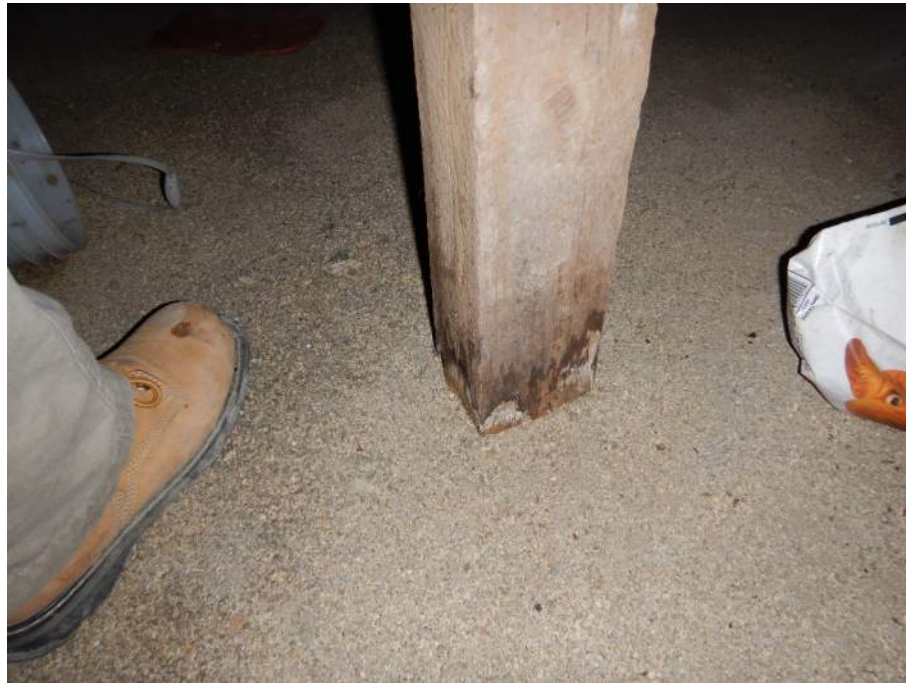
Figure 5 - Joist Reinforcing

- Some load carrying posts showed signs of rot and deterioration due to moisture at the floor level. Refer to Figure 5.

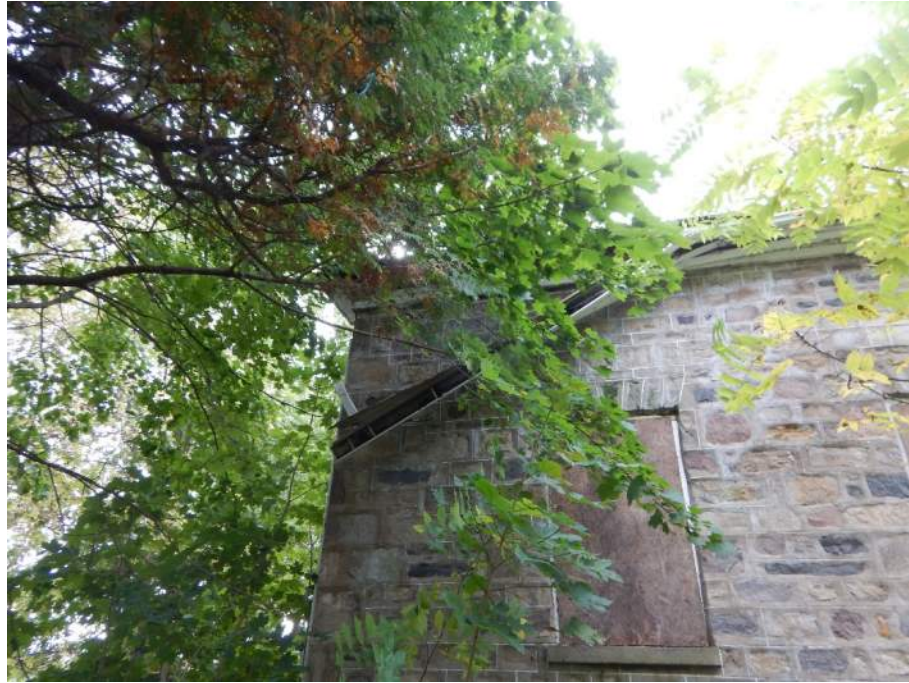
Figure 6 – Gable End Elevation

- The eaves trough was detached from the roof. Refer to Figure 6. Lime based mortar, commonly used at the era of the home's construction, is highly susceptible to moisture. The lime breaks down in the presence of moisture, compromising the stability of the wall. Damaged eaves trough and downspouts will accelerate deterioration of the mortar.

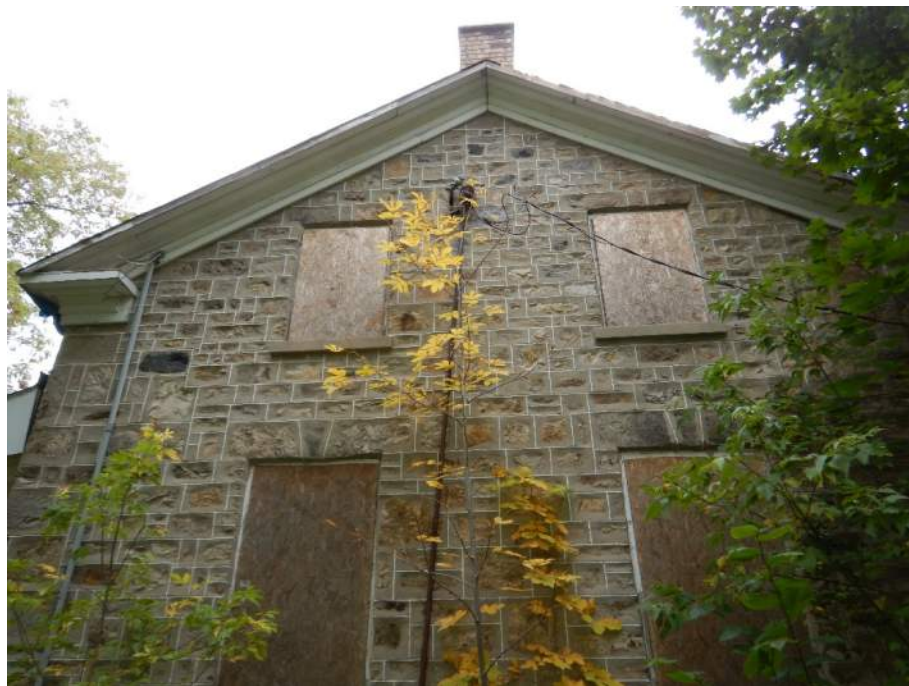
Figure 7 – Gable End Elevation

- The stone and mortar was generally in good condition. Small trees were noted close to the wall. Refer to Figure 7. The presents of many trees limits the drying potential of the stone walls and may lead to accelerated rates of deterioration.

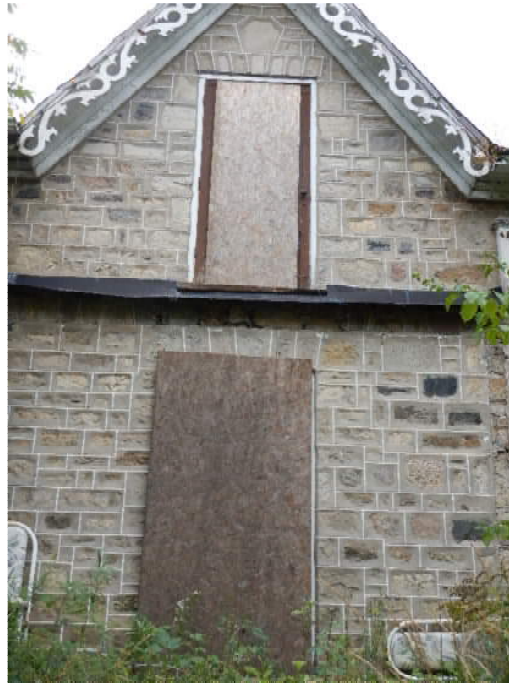
Figure 8 – Front Gable Elevation

- The stone and mortar was generally in good condition. An original front porch has been removed. Refer to Figure 8.

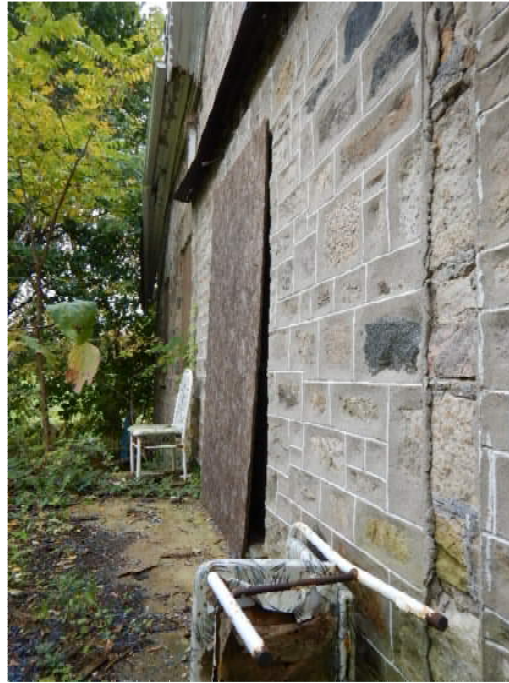
Figure 9 – Front Door Boarding Loose

- The plywood covering the front door was loose. Loose boarding may allow rodents and trespassing humans to enter the house. Refer to Figure 9.

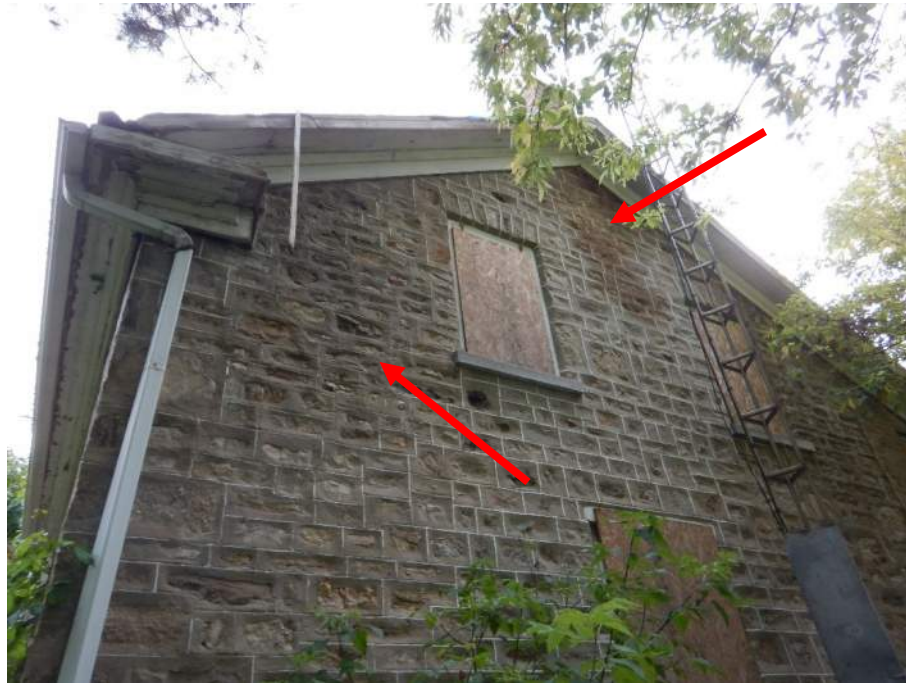
Figure 10 – Moisture on Stone Wall near Chimney

- Moisture likely due to a leaking chimney and roof was noted. The presents of moisture accelerates the deterioration of the lime based mortar. Refer to Figure 10.

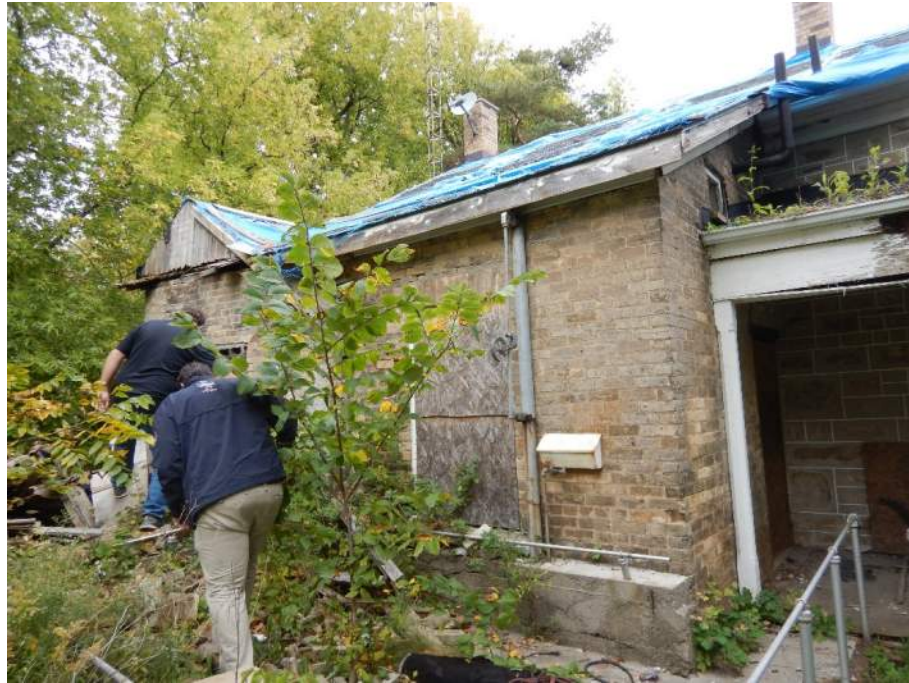
Figure 11 – Brick Addition Roof

- The tarp on the roof has been compromised. Refer to Figure 11.

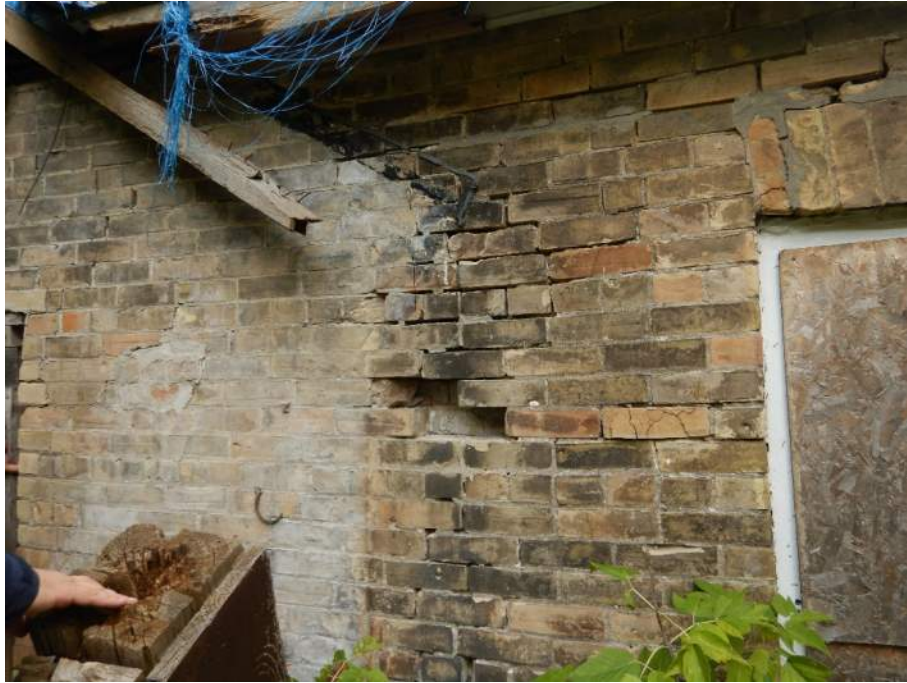
Figure 12 – Deteriorated Bricks and Mortar

- The brick and mortar was in very poor condition. Refer to Figure 12. The bricks and the mortar were missing in many locations.

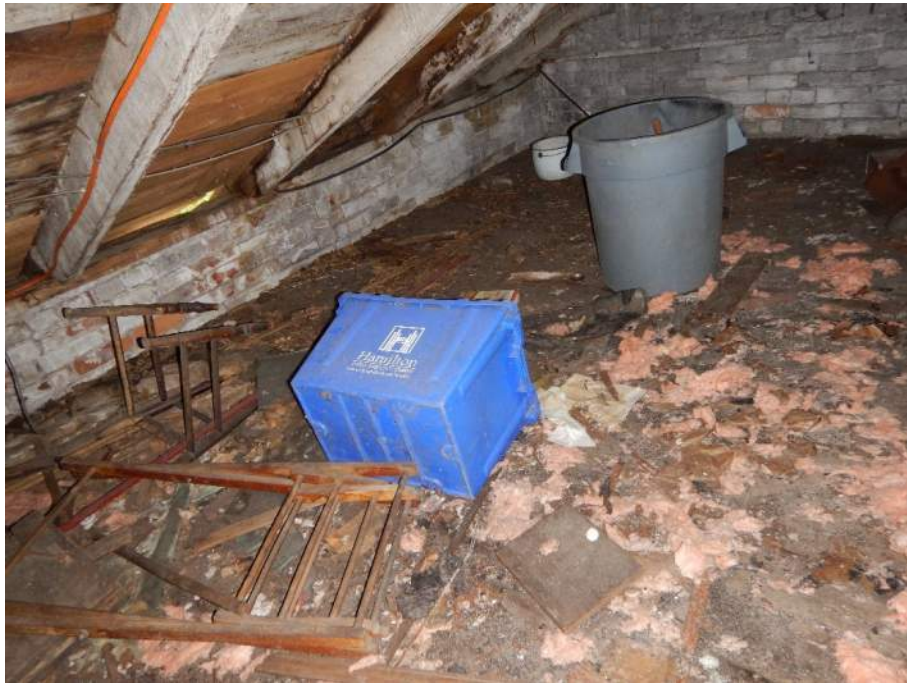
Figure 13 – Deteriorated Bricks and Mortar

- The rafters of the addition were deteriorated due to moisture. Refer to Figure 13. The damage to the wood members compromise their load carrying ability.

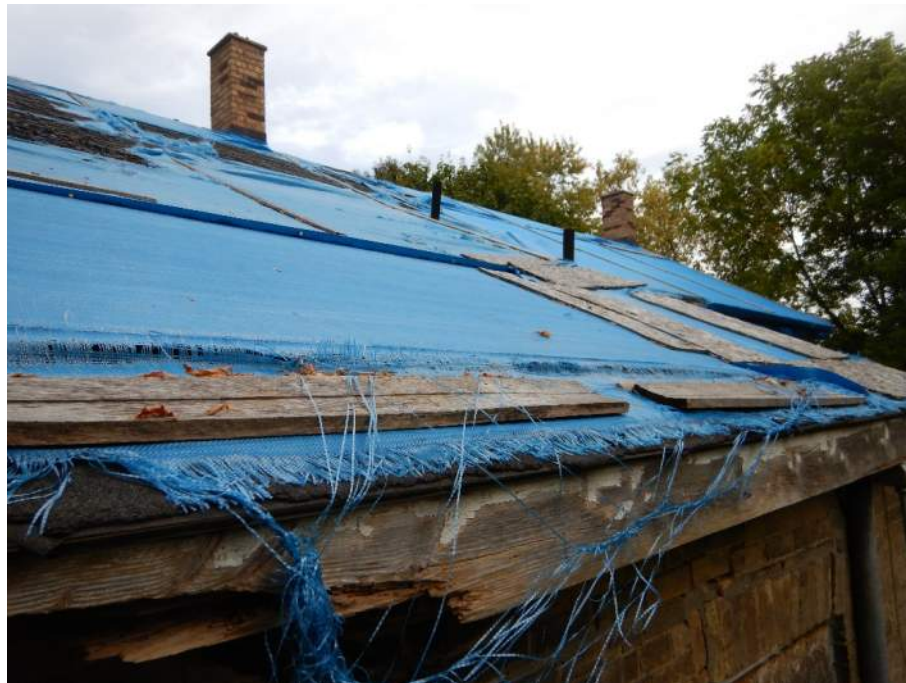
Figure 14 – Ripped Tarp on the Roof

- A tarp has been installed on the roof to protect the building. The tarp has exceeded its useful life. Refer to Figure 14. Houses are very susceptible to elevated levels of moisture. Roofs are required to keep the structure free from elevated moisture levels.

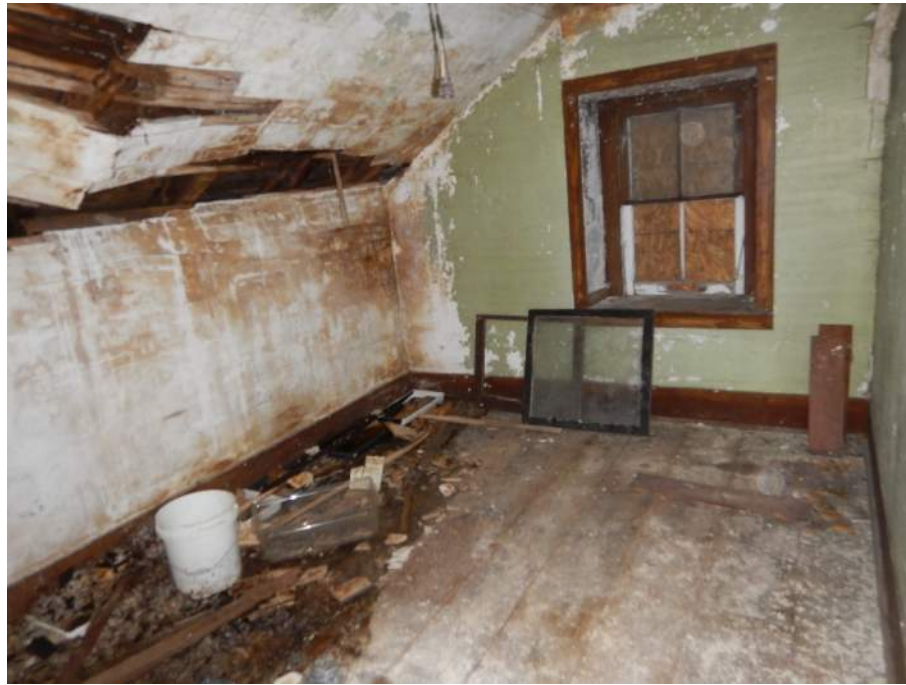
Figure 15 – Deteriorated Rafters

- The roof structure has deteriorated in at least one location due to a roof leak. Refer to Figure 15.
