Special Heritage Committee Meeting
Tuesday August 17, 2021 @ 3:00 PM
Via Electronic Participation

Register at:

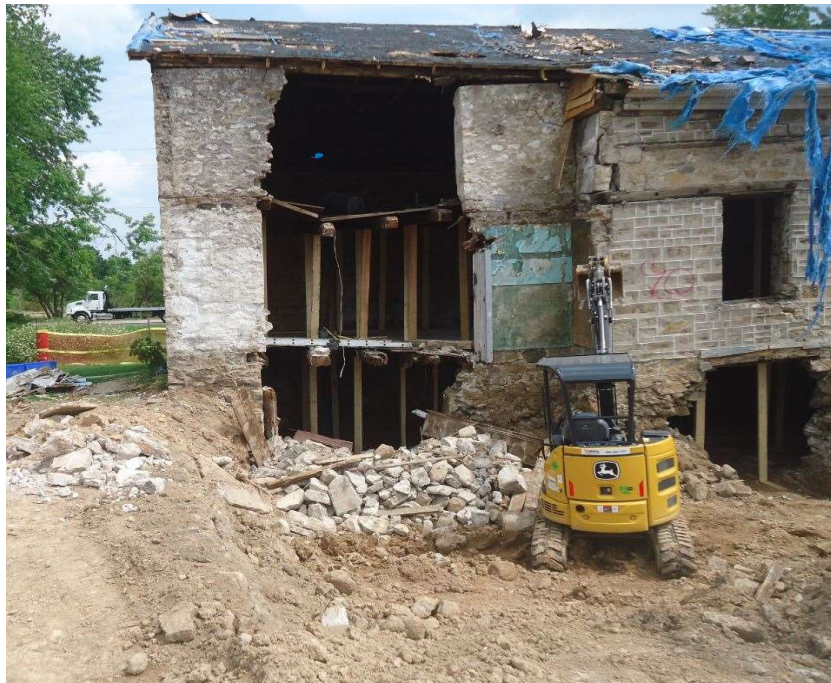
Photo 2: Rear elevation. Location of previous brick addition

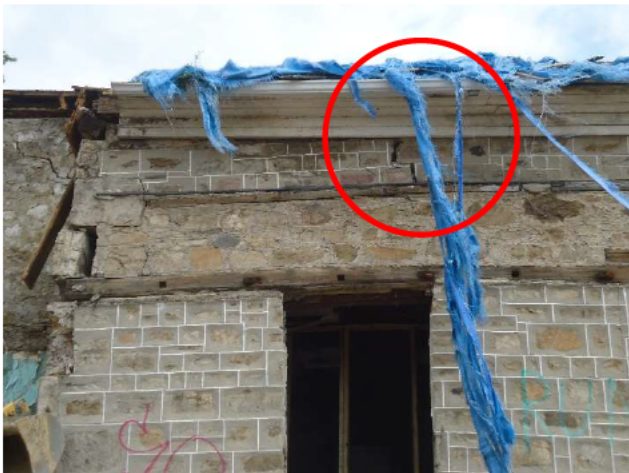
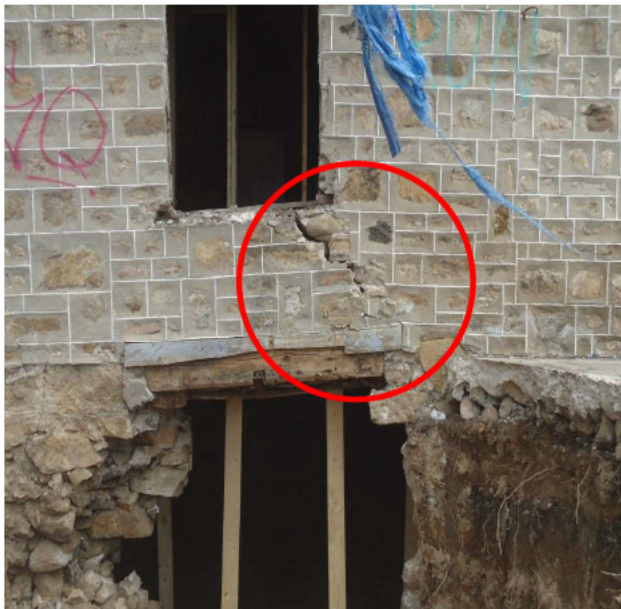
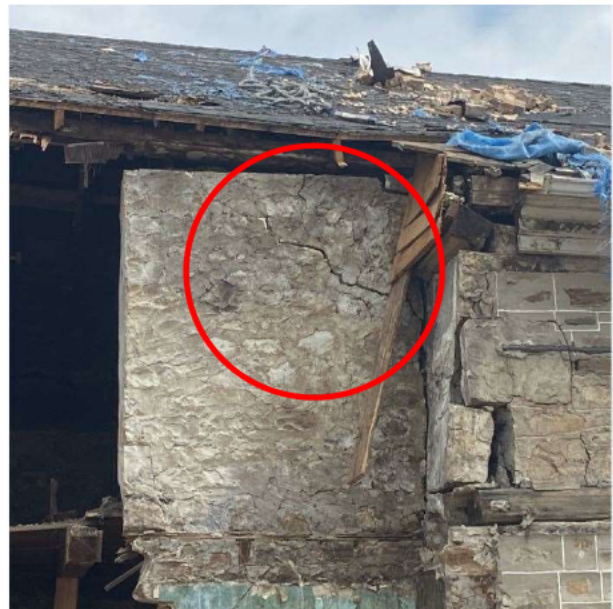
Photo 3: Shear cracks noted in exterior stone walls.
Note the large gap between the top of the stone wall and the underside of the wood roof framing (bottom right).

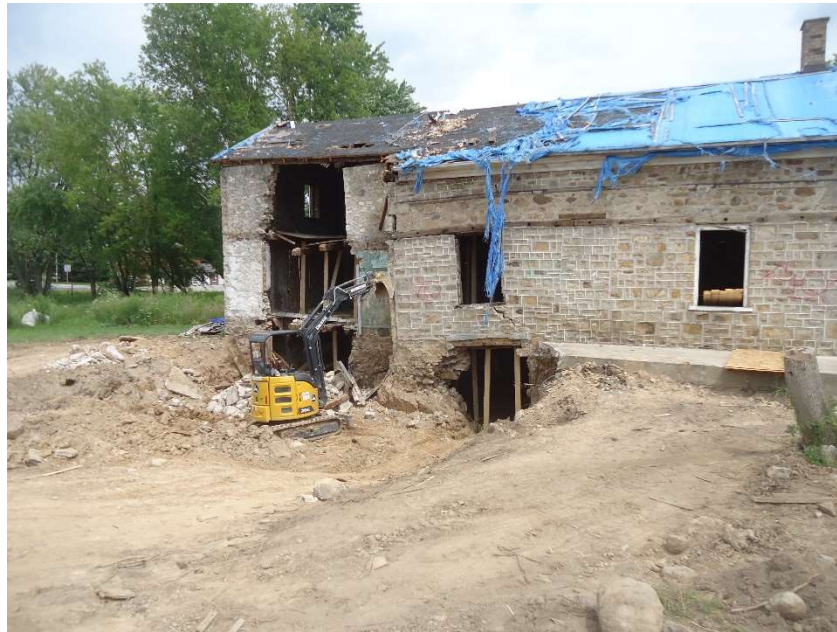
Photo 4: Wall appears to have a significant lean to the left of the second floor window opening. The foundation wall below this section appears unstable. Also note holes in the roof and no windows will allow moisture to continue to enter the building and damage the structural framing.
