REPORT HER-2021-002

SUBJECT: 880 Victoria Road S – Caulfield-Carter Farm

1.0 Heritage Building Protection Plan

CARTER FARM ASSESSMENT

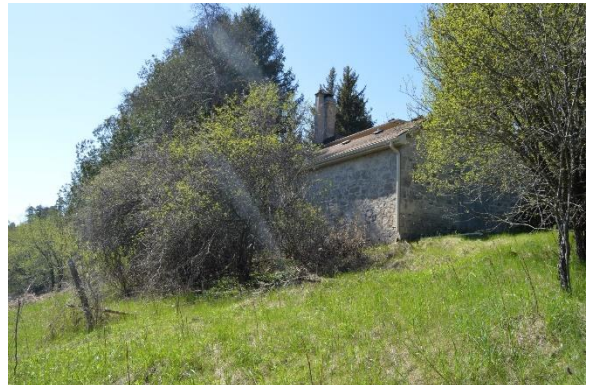
Back of the building (showing overgrown vegetation and drop in grade.)

There is a significant drop in grade at the back of the building. Before the drop, there is a row of overgrown vegetation making it difficult to review the building's elevation. From the base of that drop the terrain slopes gently down towards a creek which connects to Eramosa River.

Use hand tools to remove all other vegetation along the farmhouse's walls and against its foundations to halt further damage. Provide a 12 inch wide strip of gravel 3 to 6 inches deep along the entire perimeter of the building to stop any new growth and increase proper drainage. During this work regrading will be required creating a slope away from the house.

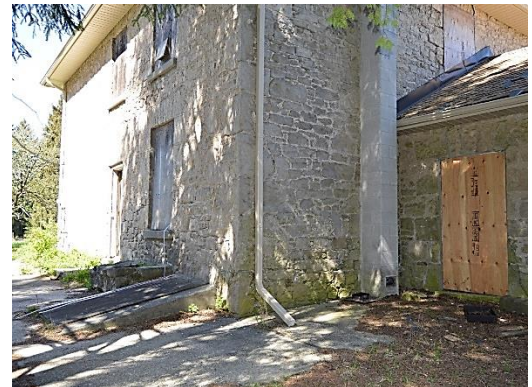
There are two points of access to the cellar – an interior staircase below the main staircase and an exterior access on the south elevation adjacent to the back wing. The outdoor areaway is composed of a concrete foundation wall with a plywood cover. The cover has a very shallow slope and should be monitored regularly to detect any leaking or other deterioration.

Access hatch to Cellar

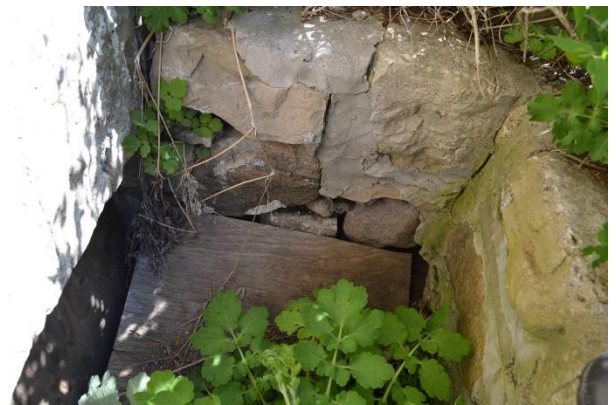
Two cellar windows at the west side of the farmhouse are located within window wells which are of a rubble stone construction similar to the foundations. At these locations' plywood sheets are resting in the bottom of the wells and in front of the windows. Heavy vegetation was observed both within and adjacent to the window wells.

Window well

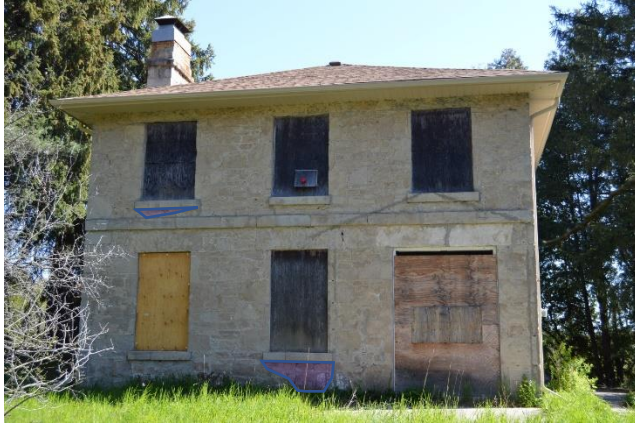
West Elevation – Front of house

On the west elevation there once was an exterior vestibule. This vestibule may have been seen as an improvement to the lifestyle of the farming family in the early twentieth century, who wished to control drafts of cold west wind into the farmhouse. Wooden ledgers and reglets where the addition would have been fastened are still visible and concrete slabs mark the floors of the missing porch.

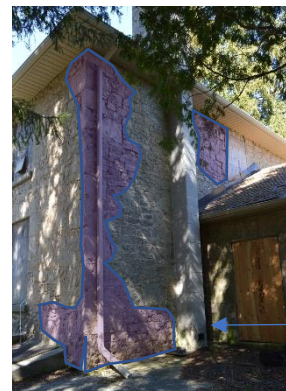
East Elevation

Mould and moss to be reviewed and removed. See figure below.

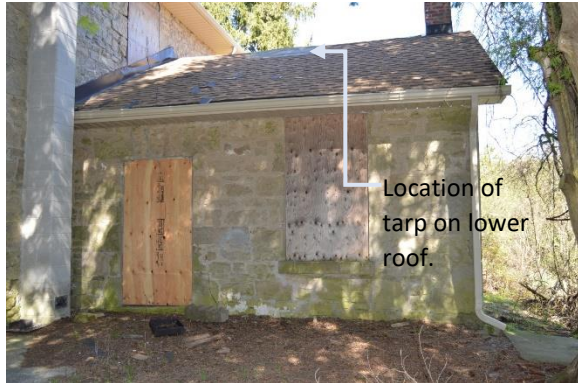
Back Wing's South Elevation

Several areas of deterioration were noted at the time of review. Organic growth (moss) was visible on the stones and mortar of the south and west elevations. Such growth is a sign that water has been infiltrating the structure with such regularity that the structure is unable to fully dry out. At the west wall a large diagonal crack was noted. The crack has been filled with cement, which is an inappropriate material to use in the repair of a historic masonry wall. At the back wing's east and north walls significant mortar loss was noted at the base of the walls and under the larger stones there is significant mortar erosion. The condition of the walls in this area may be related to adjacent grade changes.

Replace deteriorated mortar and perform targeted repointing and crack-filling within the next 1-2 years. Include the portions of exterior wall at grade and at downspout locations. The exact extent of the work will only be known once work commences. This work must be performed by skilled masons with heritage experience and be overseen by a qualified heritage consultant.

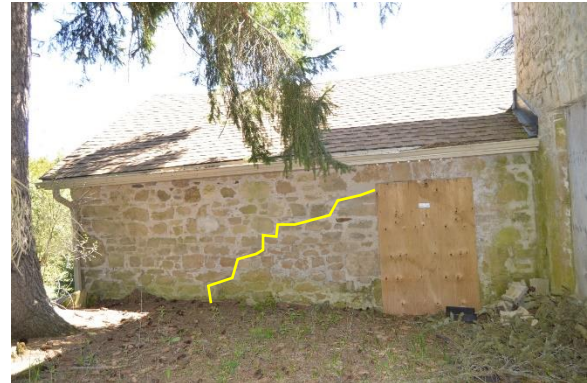
Back Wing's West Elevation (the crack is filled with cement)

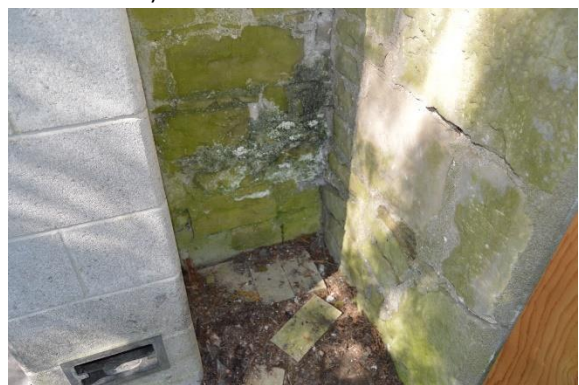
Intersection at Back wing's South Elevation and 2 Storey addition (showing the level of moss growth)

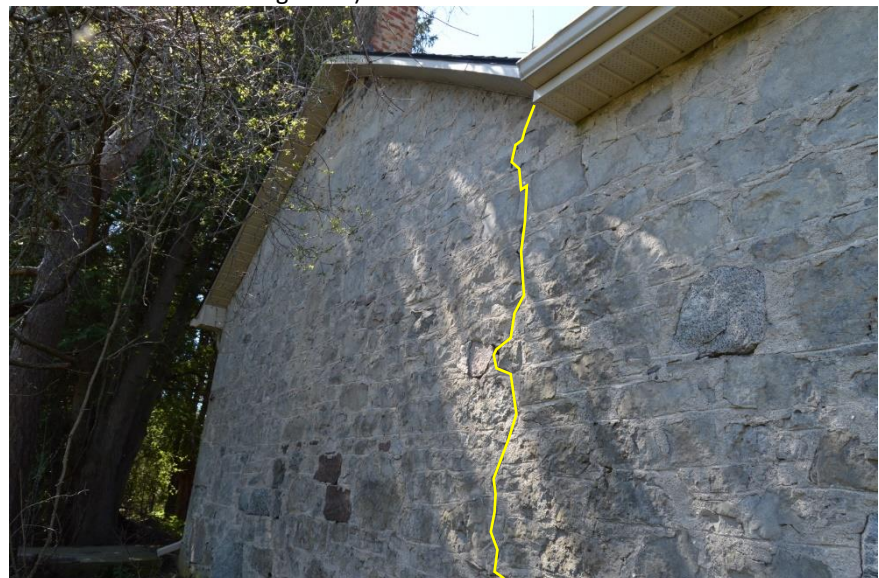
Back Wing's East Elevation – at south end showing an old vertical crack

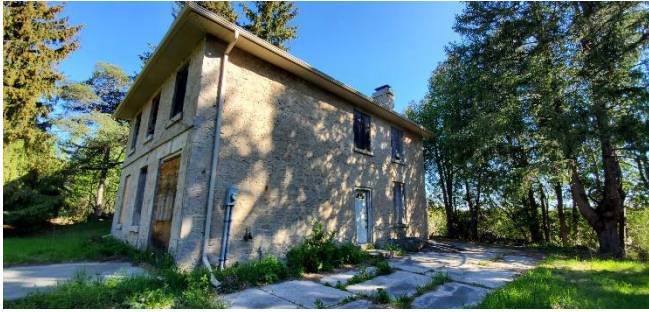
Incoming Electrical – South Corner

The house has an underground 200A, single phase electrical service to the South corner of the house where the meter is located. It enters the house to a 200A electrical panel on the East wall of the basement. The 120/240V, 1-Phase, 3-wire, 40 circuit panel has a 200A main breaker and mini breakers that feed the remainder of the house. The panel directory accuracy has not been confirmed, this would require testing.

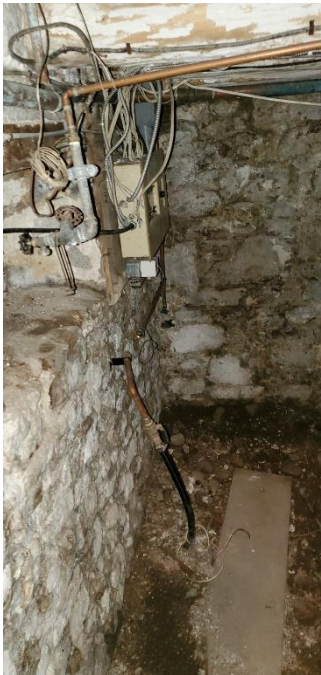
The building does not have a source of potable water. The water connection to the building has been shutoff and the water meter has been removed. The domestic water heater appears to be past its life expectancy. It is possible that the lack of domestic water uses and air infiltration from the open-ended piping has caused premature aging of the copper water lines.

*Missing Water Meter, open
end pipe*

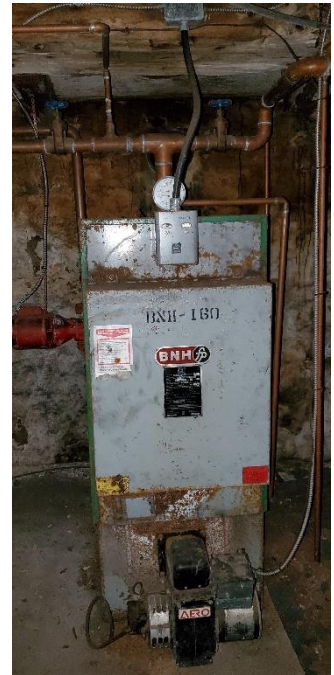
Oil-Fired Boiler

The building is not currently heated. It was previously heated using a hydronic system consisting of an oil-fired boiler supplying hydronic radiators throughout the house. The boiler in the cellar below the house is in very poor condition and well past the end of its useful life. The hydronic system has not been in operation or maintained for several years previous to the time of this report. The pumps and motors are presumably seized; rust and corrosion are visible. The hydronic copper pipes show signs of corrosion and likely require large scale replacement. The expansion tank was completely corroded.
