Harden Environmental Services Ltd.
4622 Nassagaweya-Puslinch Townline Road
Moffat, Ontario, L0P 1J0
Phone: (519) 826-0099 Fax: (519) 826-9099

August 9, 2023

**Re: Mill Creek Aggregates Pit –Review of 2022 Monitoring Data
Part Lot 24, Concession 1, and
Part Lots 21, 22, 23, and 24, Concession 2**

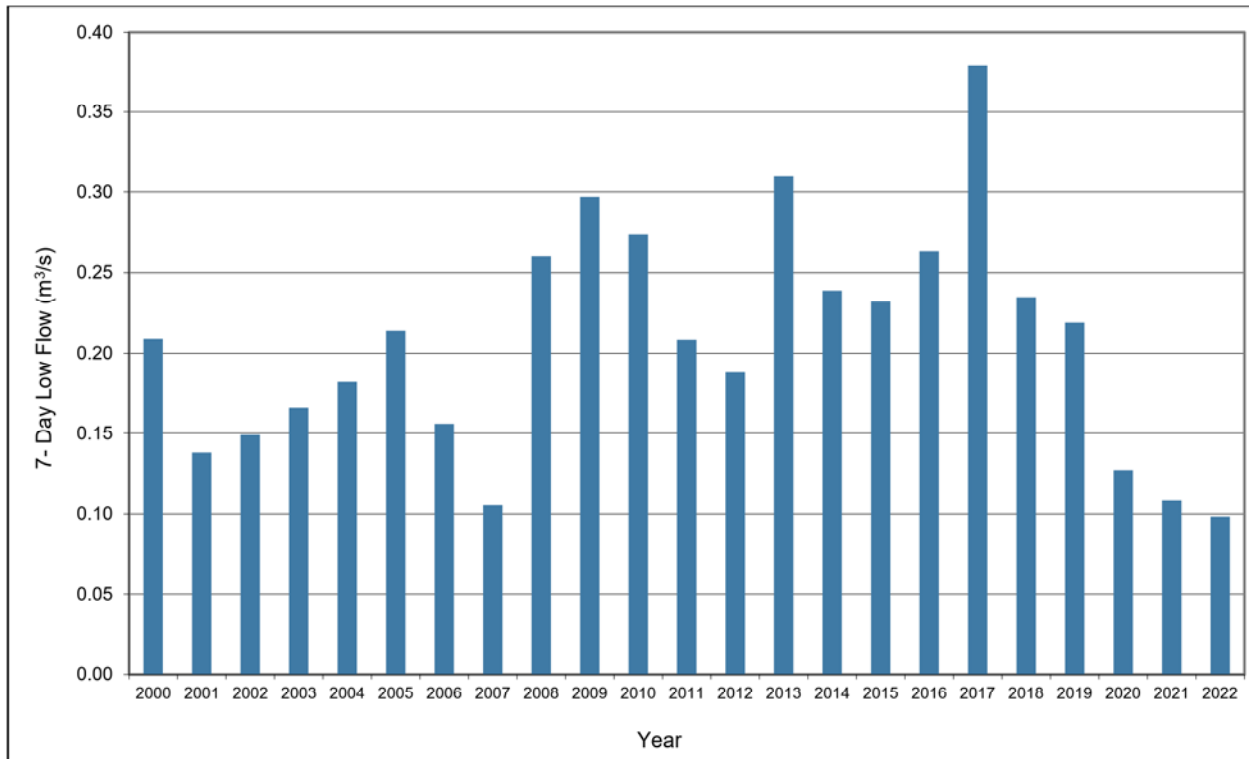
Figure 2-9 Seven Day Annual Low Flow Values at SWM2, 2000 through 2022

The 2022 7-day low flow at SWM2 is slightly lower than the 7-day low flow value from 2021 and 2007 and is the lowest value recorded since 2000. The average of the SWM2 7-day low flow values from 2000 to 2021 is 0.212 m³/s. The 2022 7-day low flow of 0.098 m³/s is considerably lower than the historic average. The lower 7-day low flow values recorded in 2020 and 2021 were attributed to the lower-than-normal amount of precipitation received in 2020 and the first five months of 2021. The low 7-day low flow value recorded in 2022 is attributed to the appreciably dry climatic conditions observed in 2022 and likely also reflects a cumulative impact from dry conditions in 2020 and 2021.

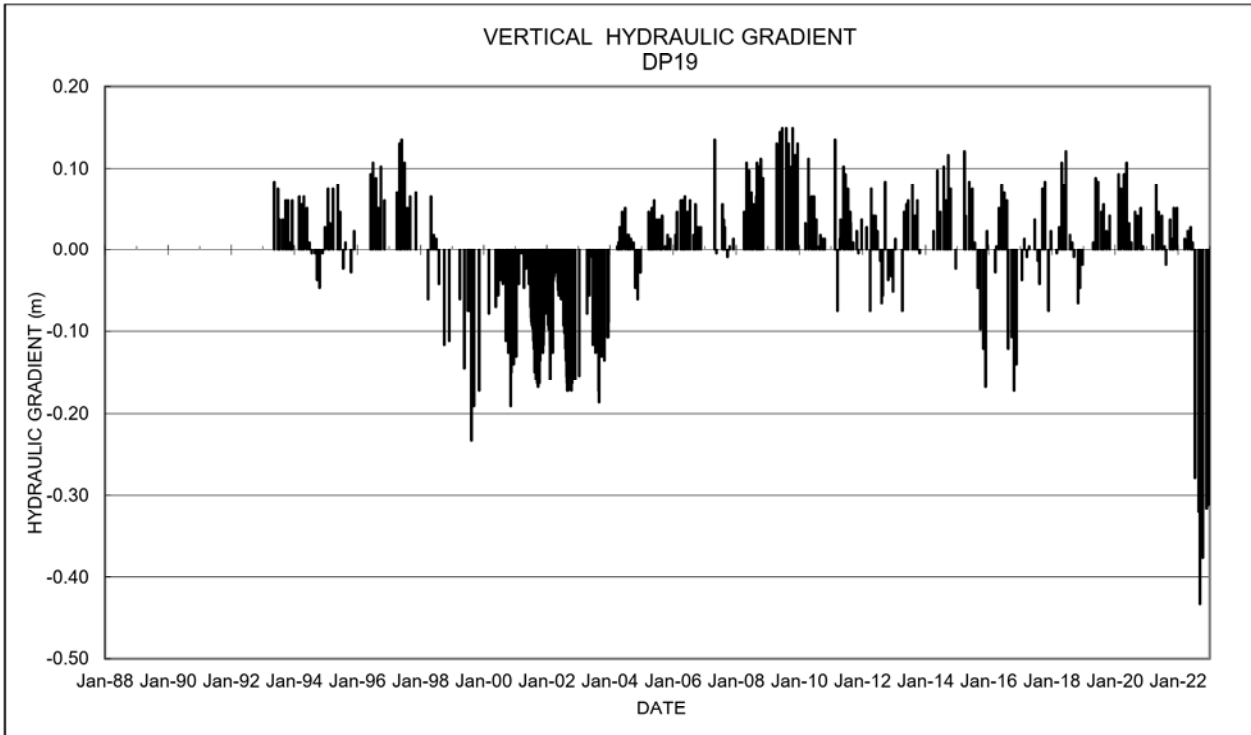
Figure 3-10 Hydraulic Gradient at Stream Drive Point Station DP19

- 4) Wetland monitoring stations DP6, DP7 and DP8 are within historical range in 2022. This area of the site is influenced by water levels in Pond 3.
- 5) A review of the Mill Creek drive point monitors shows that there are significant changes in hydraulic gradients within Mill Creek occurring in 2022. These drive point monitors have been valuable in showing the potential for groundwater discharge to Mill Creek. In 2022 it is observed that historically significant downward gradients occurred in Mill Creek between the Hanlon Expressway off

- ramp from Hwy 401 to Concession Road 7. The report states that the “sudden change in gradient is due to upgradient activities”.
- 6) The temperature plots of groundwater and surface water (thermographs) do not indicate changing conditions compared to the previous five years. The development of open water bodies at the site has increased groundwater temperature immediately adjacent to the ponds and temperatures have increased in groundwater between Mill Creek and the ponds. The temperature does trend toward background groundwater temperatures as distance from the ponds increases. The coordinated report states that the cold-water fishery has not been affected by observed temperature changes.

The Township in collaboration with the aggregate industry and other water users in the area should identify the root cause for the reversal of groundwater flow to Mill Creek as indicated by monitors DP18, DP19 and DP20 between Hwy 401 and Concession Road 7.

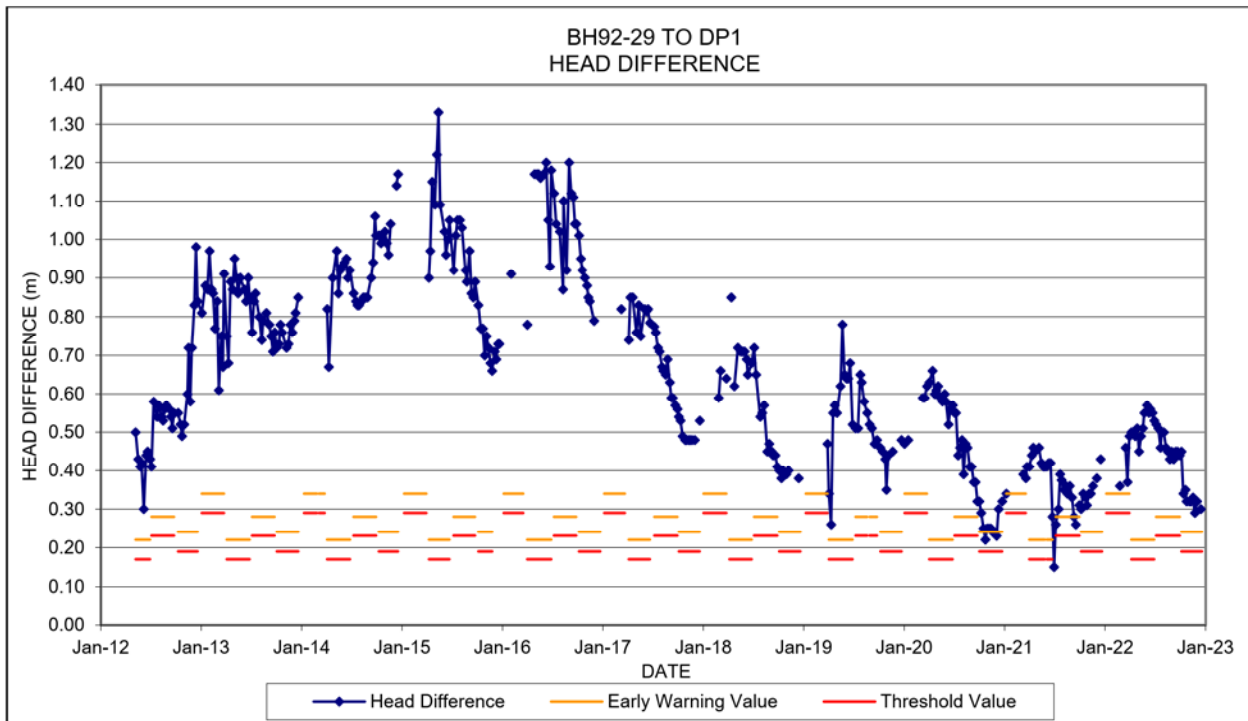
Figure 3-13 Hydraulic Head Difference for Monitoring Pair BH92-29/DP1; May 2012 to December 2022

The threshold breaches in monitoring pairs BH92-29/DP1 and OW5-84/DP5CR are concerning insofar as the artificial water level in Phase 3 pond strongly influences the hydraulic gradient between these monitoring pairs. Temporary responses to storm events that trigger the observed breaches and Figures G7, G9 and G11 show that the hydraulic gradient is riding close to the threshold. These breaches did not occur with a higher Phase 3 Pond water level. Continued monitoring during active and post extraction phase will be necessary to confirm that water levels have stabilized at an elevation favourable for continued groundwater discharge to Mill Creek.

This monitor pair replaced the BH92-30 to BH92-28 threshold pair in May 2012, as BH92-30 was removed during extraction activities in April 2012. This pair is located in the northwest corner of the site, south of the confluence between the Pond Creek tributary and Mill Creek. DP1 is an in-creek drive point located in Mill Creek near the western property boundary. There were no exceedances of the threshold values or the early warning values at this pair in 2022.

The lower Pond 3 water level is influencing groundwater flow to Mill Creek west of Pond 3. Groundwater flow is hovering around the minimum allowable. We recommend a review of Pond 3 levels and the factors that influence the Pond level in hopes of identifying methods to stabilize the Pond level with more favourable groundwater flow to Mill Creek in an important fishery area.

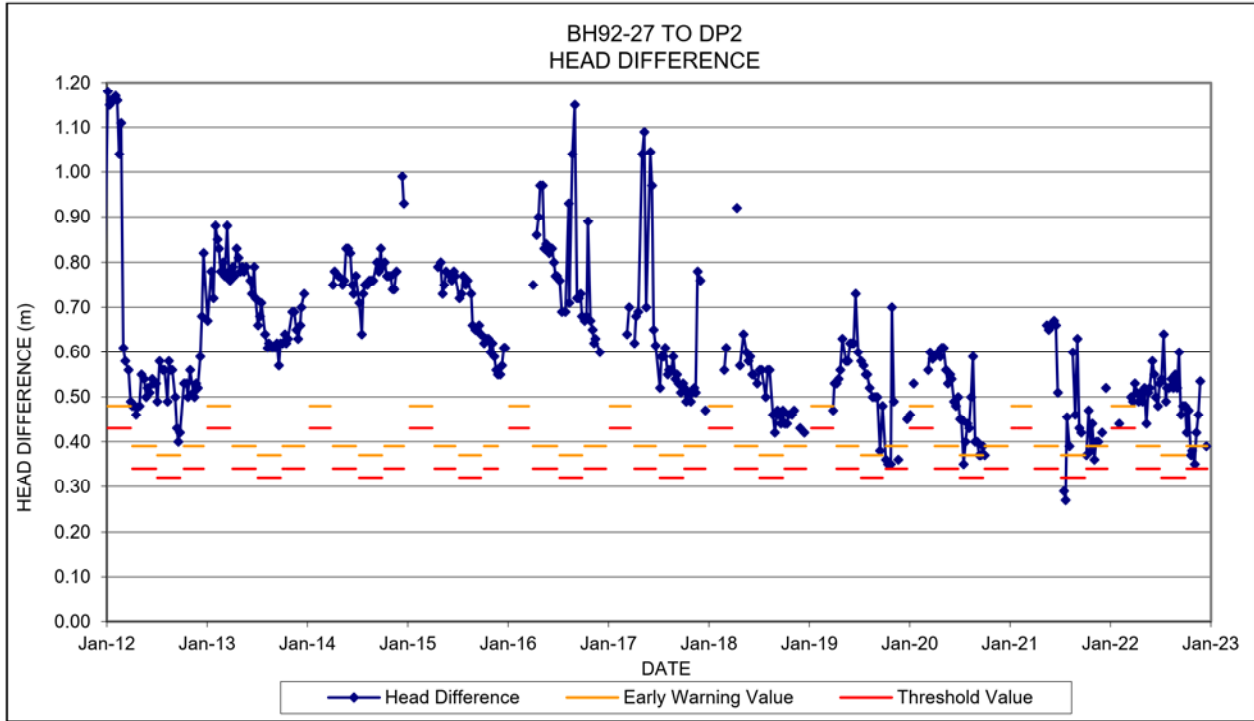
Figure 3-14 Hydraulic Head Difference for Monitoring Pair BH92-27/DP2; December 2011 to December 2022.

such, the February 2 exceedance was likely caused by a lag in groundwater level response following snowmelt conditions. Early warning threshold exceedance have occurred at this well pair during the fall in 2019, 2020, 2021 and 2022. The early warning value exceedances are generally attributed to the lag in groundwater level response following an increase in precipitation that typically occurs in the fall. In 2022, a total of 51 mm of precipitation was recorded between October 13 and November 1.

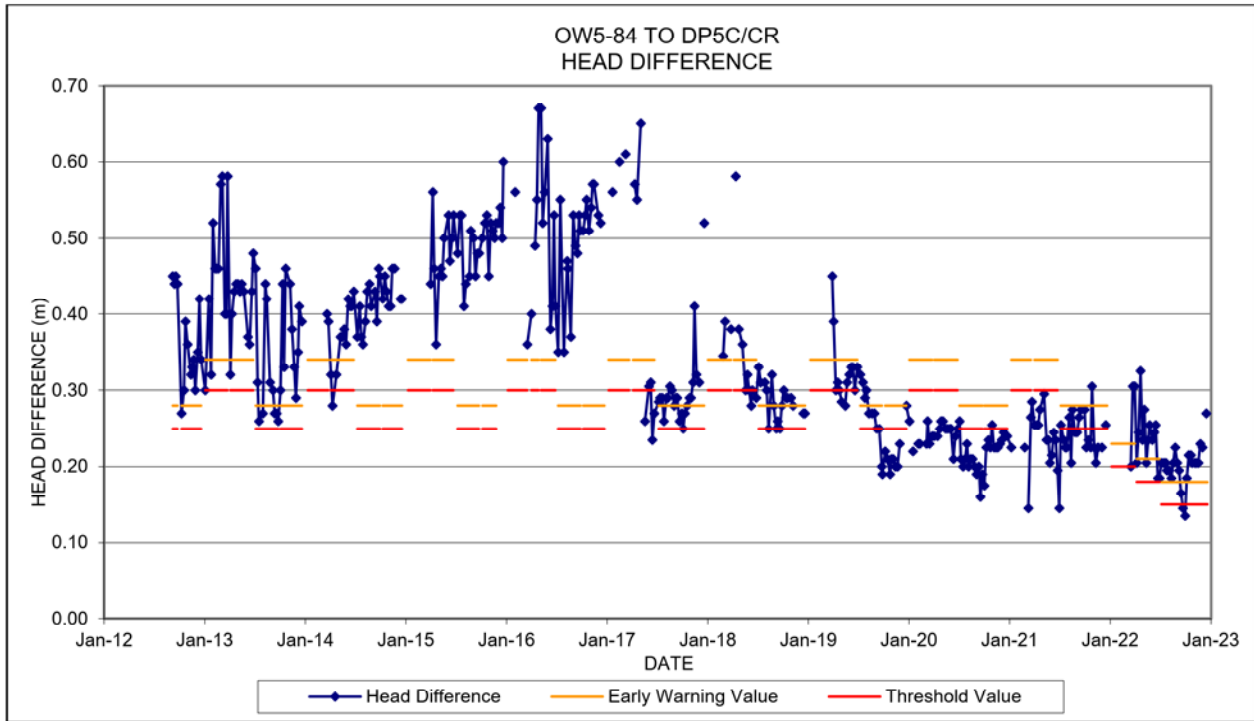
Figure 3-15 Hydraulic Head Difference for Monitoring Pair OW5-84/DP5C/CR; September 2012 to December 2022

The head difference at the OW5-84 to DP5CR pair exceeded the revised early warning value on four occasions in 2022 (March 17, September 15, September 22 and September 30) and exceeded the revised threshold value on one occasion (September 30, 2022). Based on a review of the 2022 daily climate data, melting conditions were present on March 17. As such, the lower head difference measured on March 17 is attributed to the lag in groundwater level response to snowmelt conditions. The head difference increased by 0.11 m between March 17 and 24. In September 2022, rainfall events ranging from 5 to 15 mm occurred in the days prior to each of the September 15, 22 and 30 monitoring events. It is interpreted that a more rapid groundwater level increase occurred at DP5CR following the precipitation events than at OW5-84, which temporarily reduced the head difference at this well pair. The head difference returned to a value greater than the early warning and threshold values in October 2022.

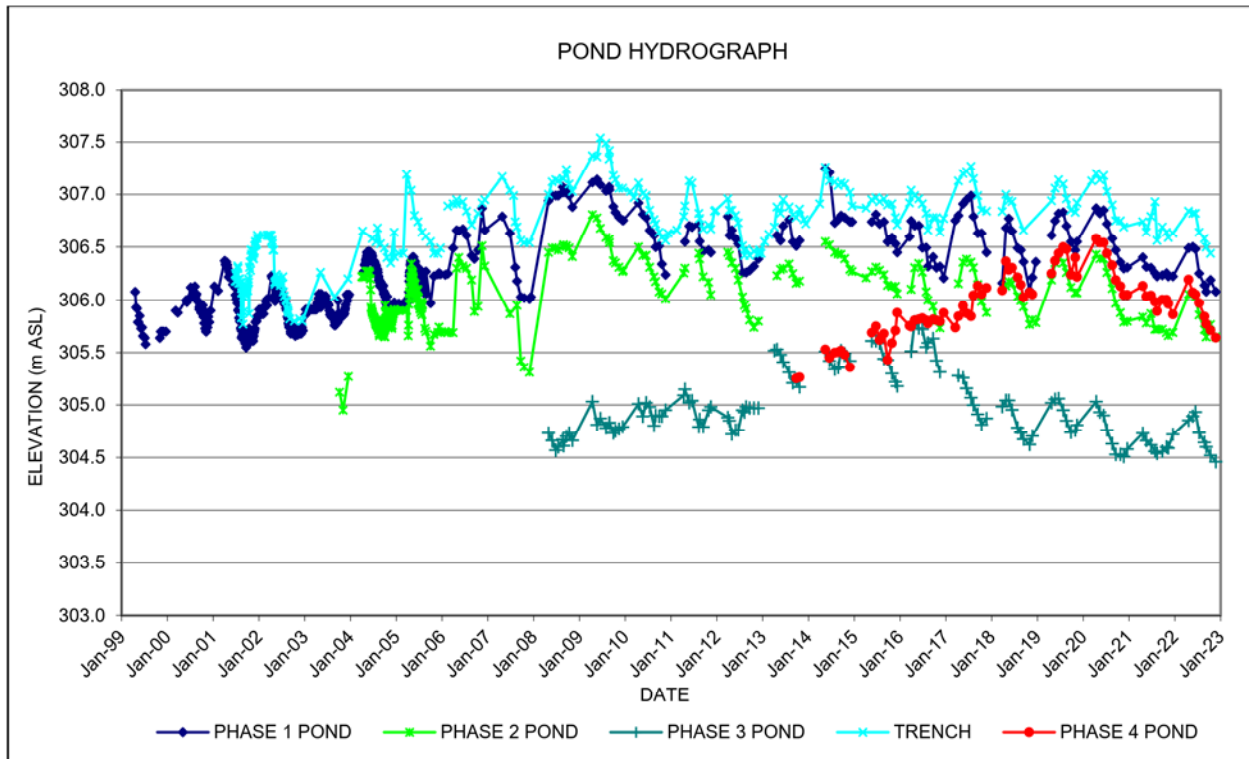
Figure 3-19 Pond Hydrograph; January 1999 to December 2022

The early warning and threshold values established for the Phase 1, 2, 3 and 4 ponds were not exceeded in 2022. The pond water levels typically decreased in 2020, 2021 and 2022, which reflects the lower precipitation amounts observed during that period. In 2022, the pond levels remained within their respective historic range.
