File:3301  
By: Email & Hand

November 15, 2013

**Re: Puslinch Community Centre – Parkland Trail**

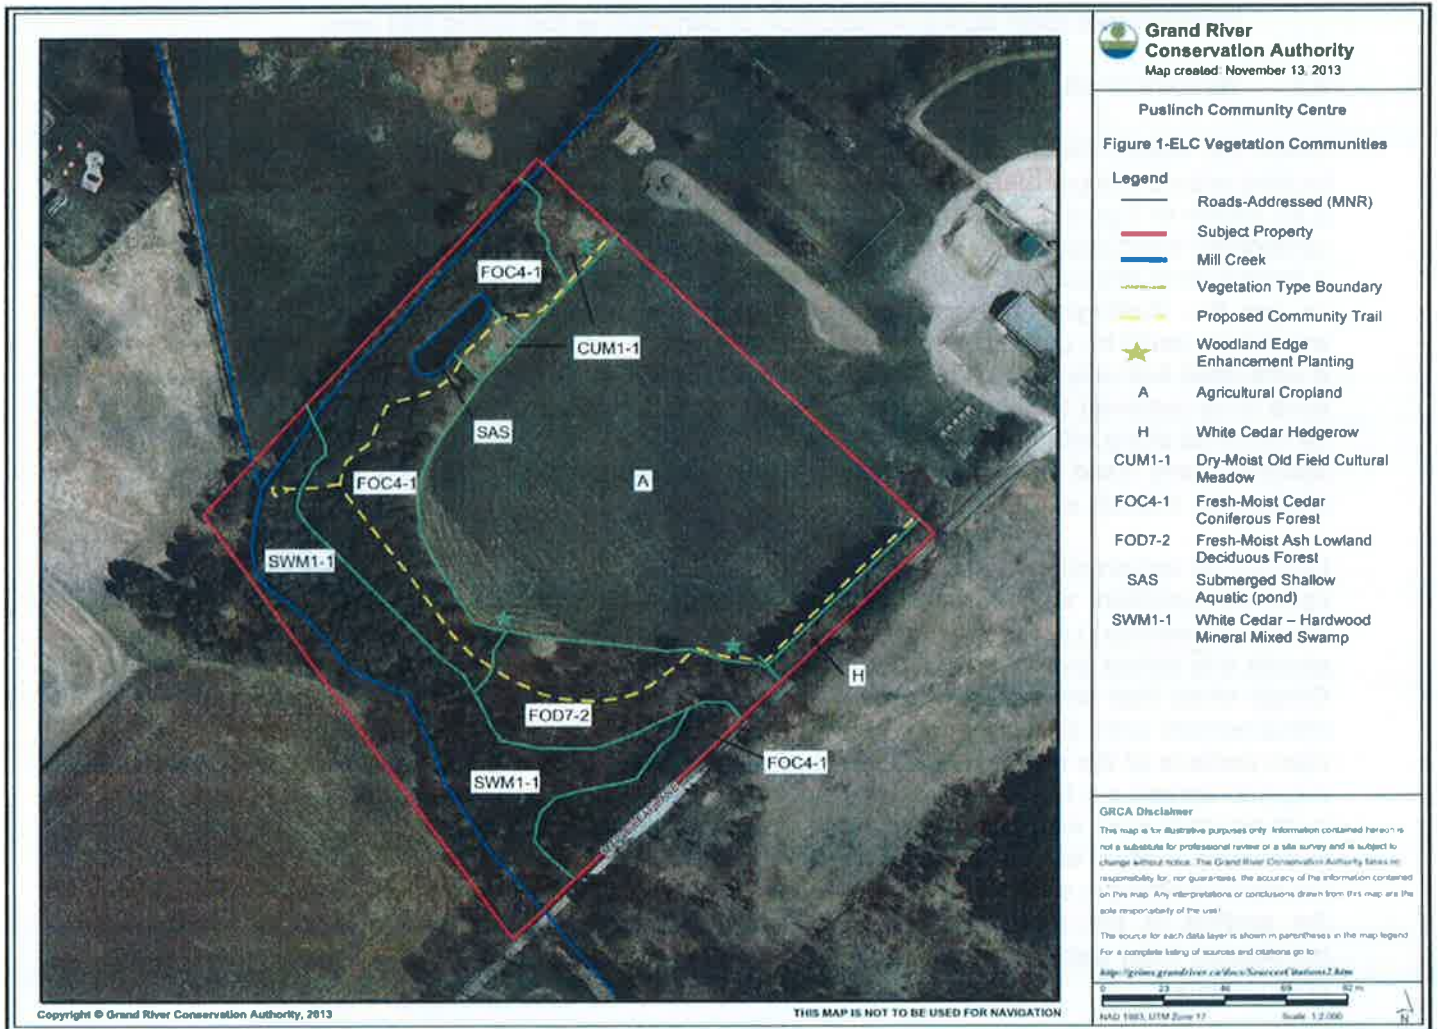
Vegetation communities on the subject lands were initially identified through interpretation of aerial photography available on the GRCA website. Vegetation mapping was done in accordance with the Ecological Land Classification (ELC) system for southern Ontario. Fieldwork confirmed the presence of three naturally established vegetation communities, as well as an old field meadow, a coniferous hedgerow and a dug pond. Figure 1 illustrates the spatial distribution of these vegetation communities.

Given the above mentioned constraints, it is recommended that a recreational trail should be located around the perimeter of the woodland within vegetation units CUM1-1, FOC4-1 and FOD7-2 as shown in Figure 1. In this constrained woodland environment a trail width of 8 feet (2.4m) is considered most appropriate in order to minimize tree loss and impacts to other vegetation. Either a stonedust or stonedust over compacted granular surface treatment could be used in this setting as per the Wellington County Active Transportation Master Plan (May, 2012). Alternatively, woodchips could be utilized in some sections of the trail. Based on these trail design parameters it is estimated that only about 10 living trees ranging in size from 4 to 10 inches dbh (10-26cm) would have to be removed to accommodate trail construction. However, 7 dead trees would also have to be removed along with cedar and hardwood regeneration (i.e. young trees 1 to 3 inches dbh). This assumes only hand held equipment and small machines are used in trail construction (e.g. chainsaws, bobcats etc.).
