August 13, 2021 SBMW-21-0274

Re: 47 Whitcombe Way (66 Queen Street), Morriston, ON

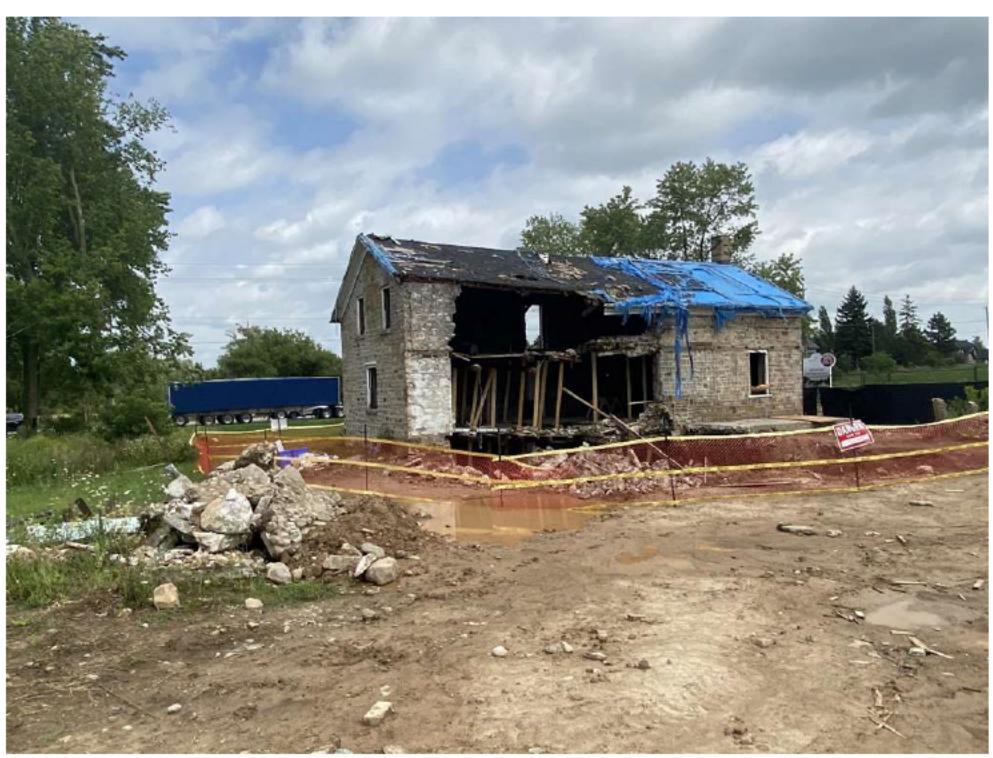
- 1. Additional temporary construction fencing and signage has been installed around the perimeter of the building (see photo 1).
- 2. An additional section of the rear (west) exterior field stone wall has failed and fallen away from the structure. At the time of review approximately 50 percent of the west stone wall and foundation are missing leaving a larger section of the main floor, second floor, and roof framing further unsupported (*see photo 2*). The mini-excavator bracing the wall has been removed.

Photo 1: Additional construction fencing and signage is installed.

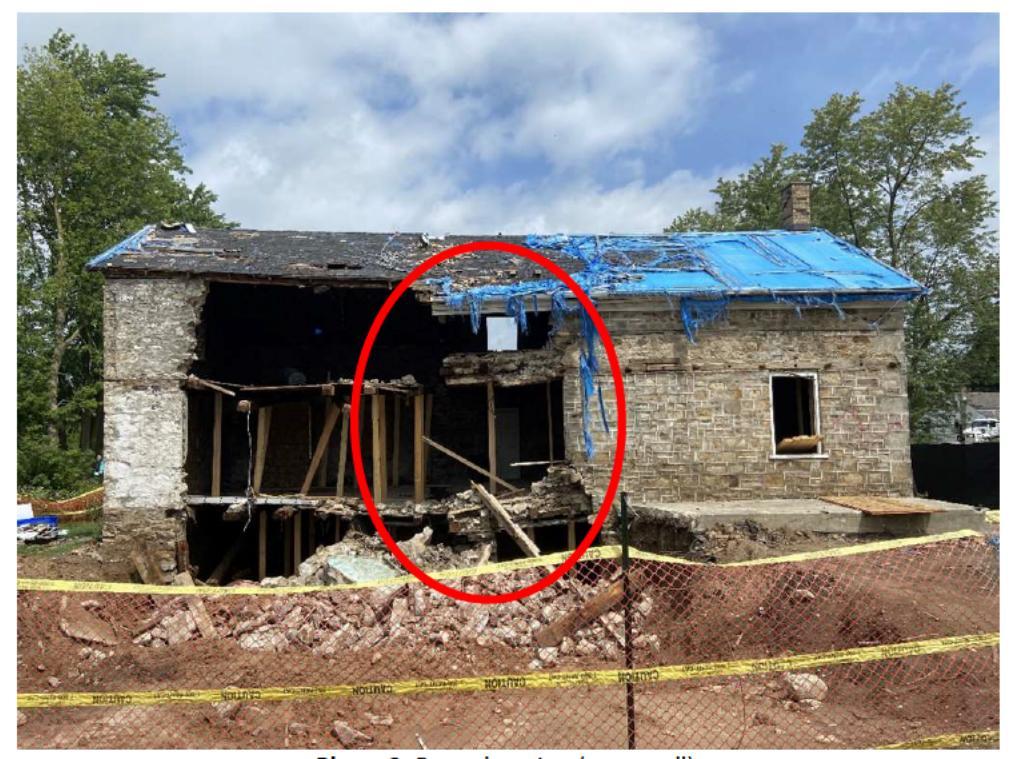
Photo 2: Rear elevation (west wall).

<u>Note:</u> Large sections of the existing foundation and above grade stone wall are missing.

Large piles of field stone on the ground below the opening. The roof and second floor framing are unsupported.

Circled area shows additional wall section that has failed and fallen away.

It is our recommendation that demolition proceed under a valid demolition permit under the supervision of a structural engineer to ensure that:

- a. Demolition is completed in a safe sequence.
- b. only areas requiring demolition due to public safety concerns be demolished.
- c. Adequate shoring is installed to the remaining structure (if any).

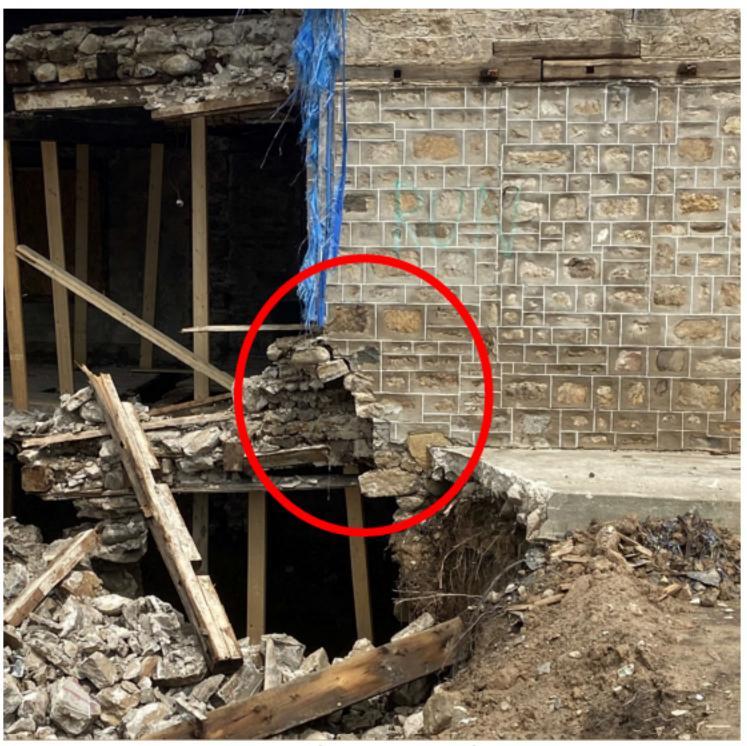
- 3. Where the additional wall sections have fallen, a portion of the remaining wall does not provide constant full height bearing to the founding soil (*see photo 3*).

Photo 3: Rear Elevation. <u>Note:</u> The foundation wall is not adequately providing bearing to the stone wall above.

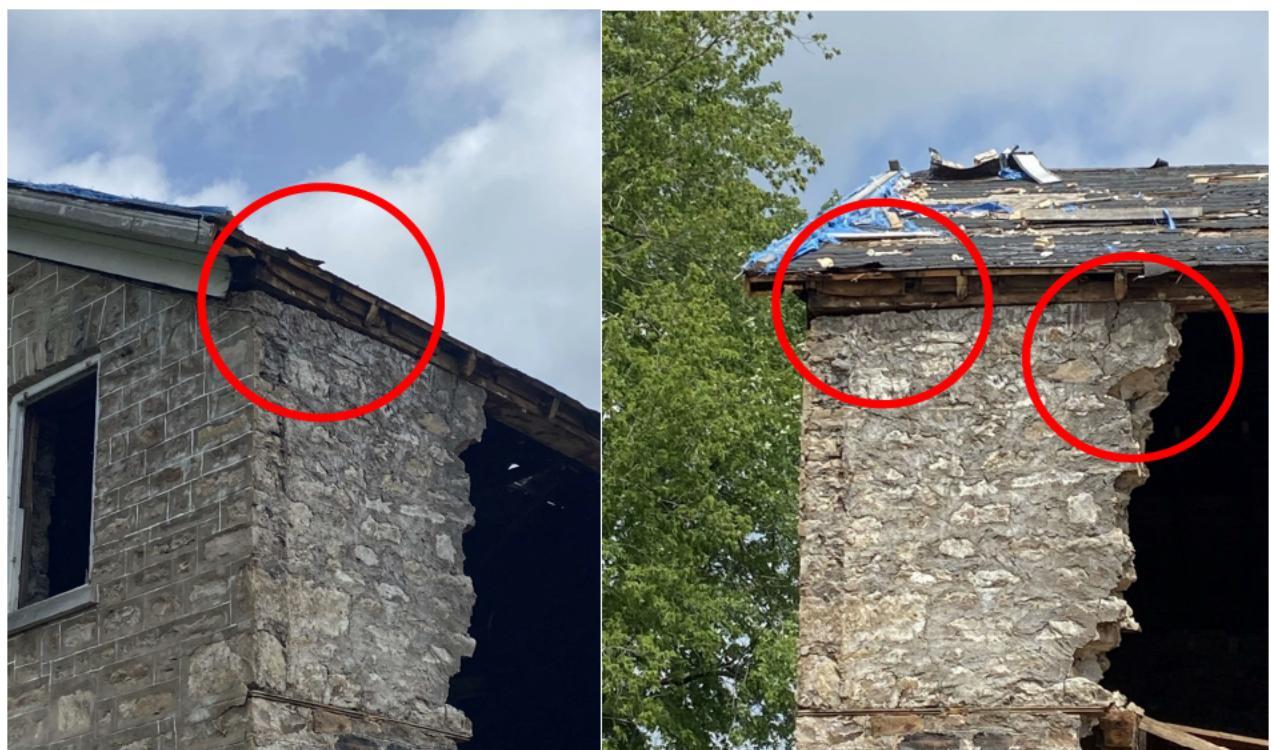
- 4. Due to the larger section of unsupported roof framing, the roof structure has lifted from the top of the stone wall at the north west corner of the building, leaving the wall unsupported (*see photo 4*).

Photo 4: Photo of north west building corner. <u>Note:</u> The roof framing has separated from the top of the wall, indicating the wall is not adequately braced. Note also the additional shear cracks in the field stone wall.

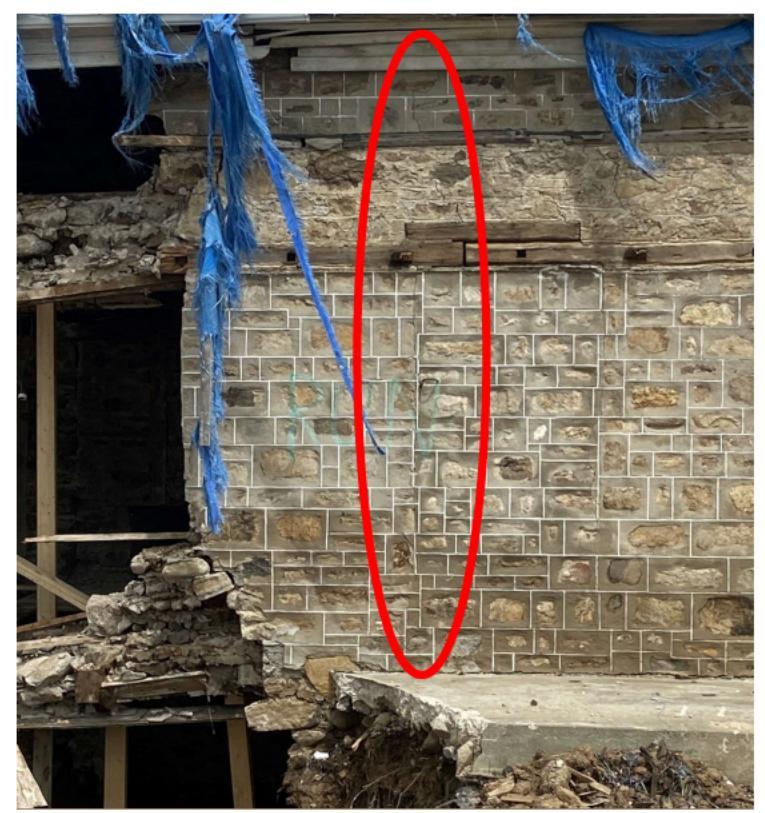
- 5. Where the roof structure is unsupported, it appears to be have sag/deflecting and is out-of-plumb.
- 6. At the face of the existing exterior concrete slab-on-grade at the west wall, there appears to be a near vertical crack extending for approximately the full height of the exterior stone wall (*see photo 5*).

Photo 5: Rear elevation (west wall). Photo of near vertical hairline crack extending approximately full height of stone wall.

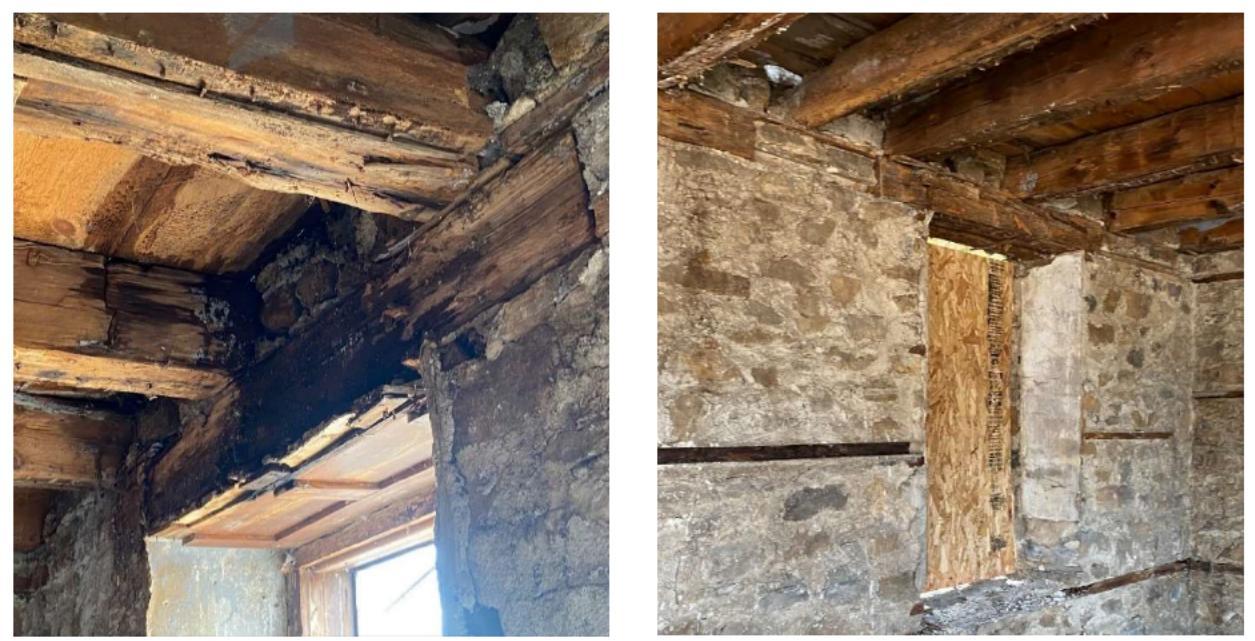
- 7. Additional photos of the wood framing were provided by the owner and show severe moisture damage to the wood framing throughout, including the south end of the building (*see photo 6*). These photos support the conclusion of the poor framing described in the structural condition assessment from Tacoma Engineers.

Photo 6: Photos of interior wood framing at south end of building (*photos provided by owner*). <u>Note:</u> Severe moisture damage on wood floor joists and window headers.
