Heritage Committee
Monday, November 20, 2017
7:00 p.m.
Council Chambers, Aberfoyle

Heritage Impact Assessment

66 Brock Road South,
Morrison

June 2017

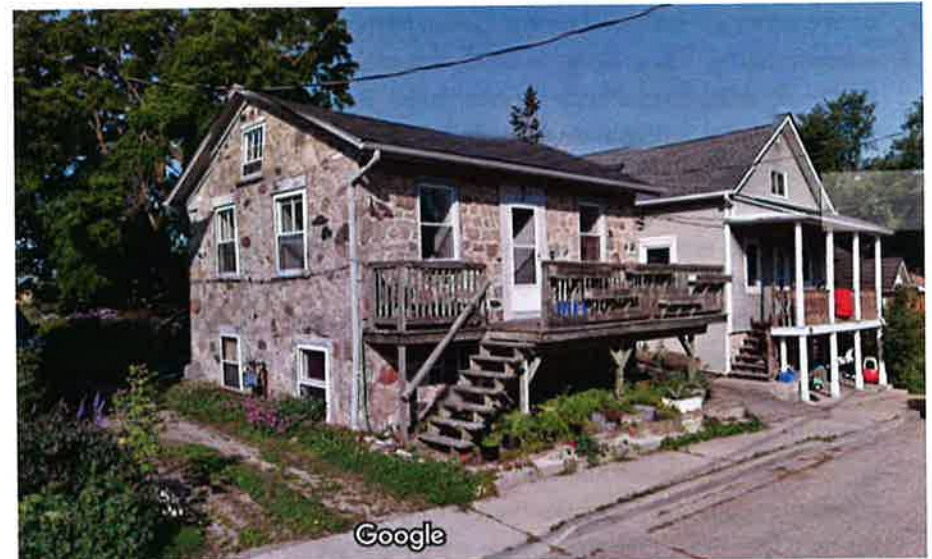
Figure 11 - Farm Labourer's Cottage

This stone cottage on Victoria Street, once belonged to the Calfas Homestead. It was built circa 1860, and was the farm Labourer's cottage. It was modest and simply designed using fieldstone for the exterior structure and walls.

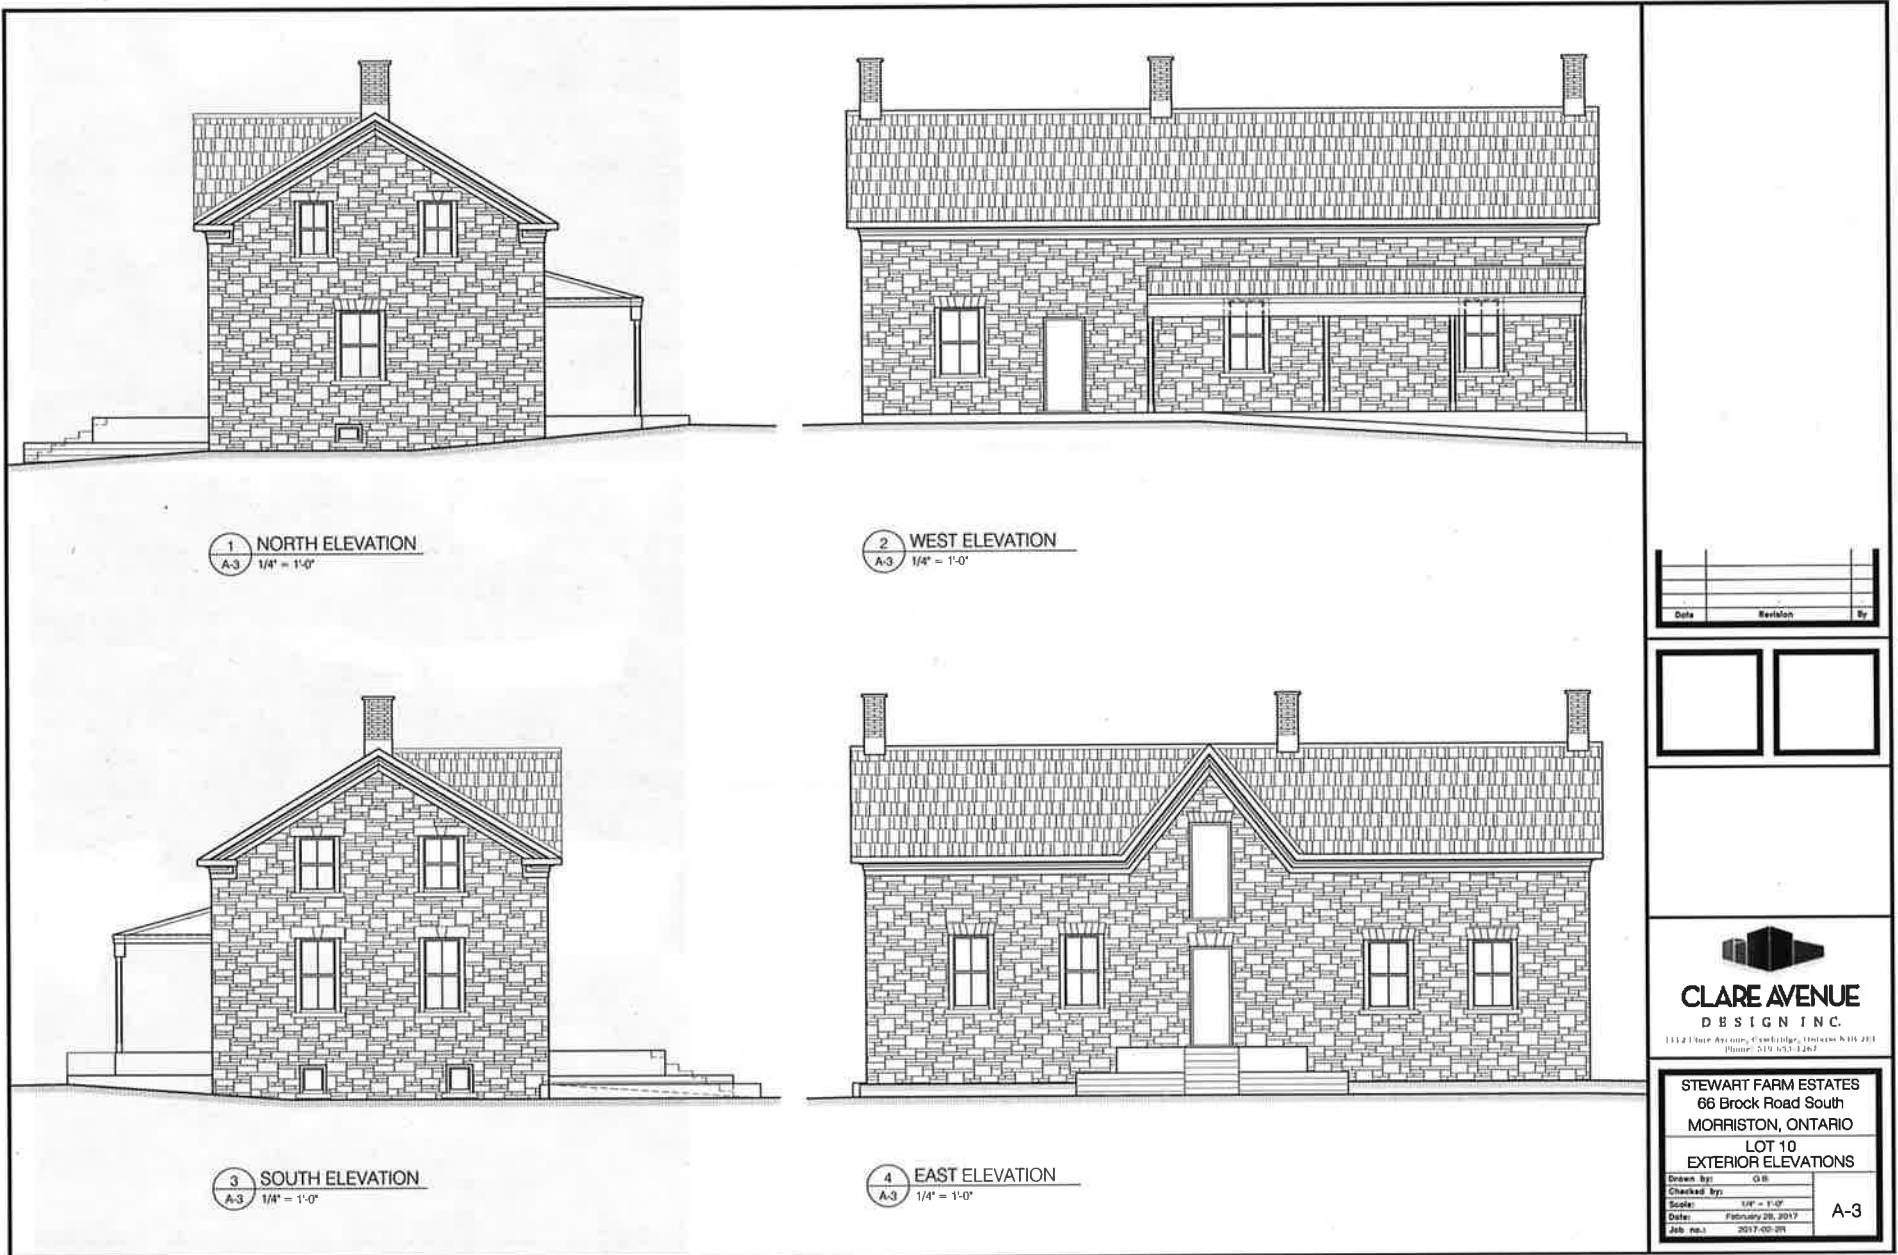
elevations of existing

This two-storey house is characterized by stone rubble, typical of the region, with white painted wood detailing at the gable, eaves and window openings. The building form with its singular gable roof and symmetrical openings are characteristic, however the front porch as since been removed and never replaced. A yellow brick addition with a covered porch was added at the rear.
