**2012
Ecological and Aquatic
Monitoring Report
Roszell Pit,
Puslinch Township.
ARA Licence No. 625189.**

December 12, 2012.
DE-382

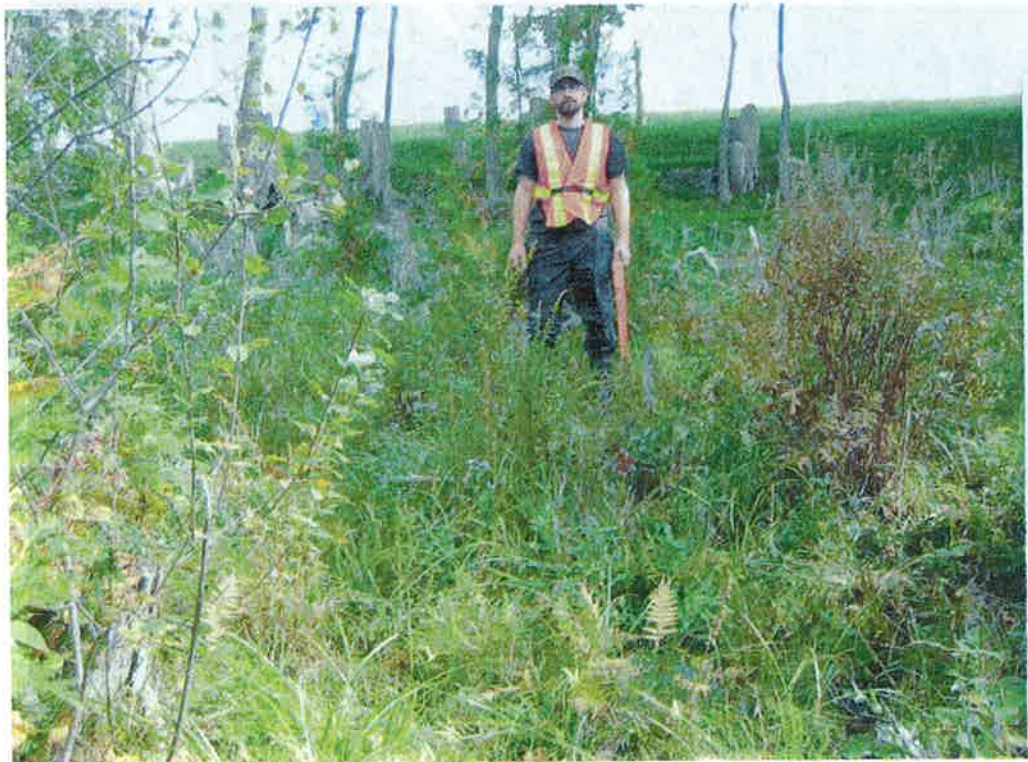
Photo 2. Vegetation Plot B, facing E from Steel T-bar.

A total of 4 tree and shrub species were located within the area sampled along the north-south and east-west transects including: Eastern White Cedar, Glossy Buckthorn, Yellow Birch, and Alternate-leaved Dogwood. Within vegetation Plot B a maximum of 21 trees or shrubs in total per transect were found, with all occurring in the understory (<10cm DBH).

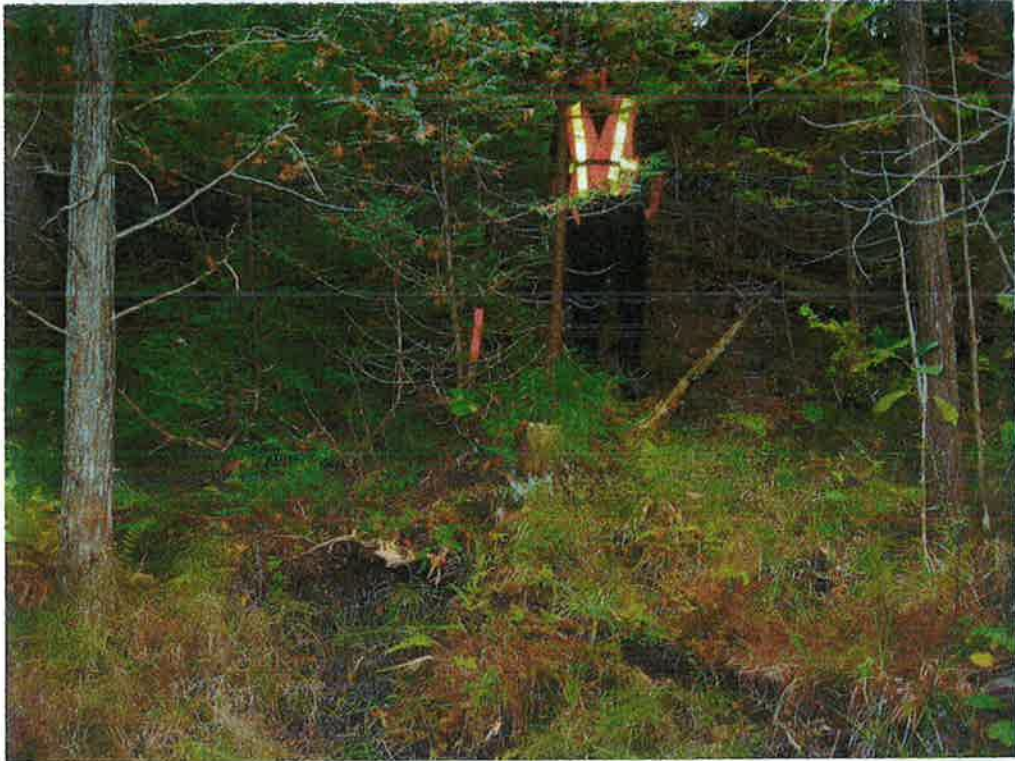
Photo 3. Vegetation Plot C, facing E from Steel T-bar.

The vegetation Plot C was located in fresh-moist cedar swamp. Vegetation Plot C was located in the upstream seepage area of Tributary #7 and near drive point piezometer DP8, see Figure 1. The dominant taxa, their percent cover, and total number of species for each sub-plot are shown in Appendix 3. Within the 4 vegetation quadrats sampled in Plot C, water depths were a maximum of 1mm and the soils were saturated indicating where there was no surface water, there was water near the surface.

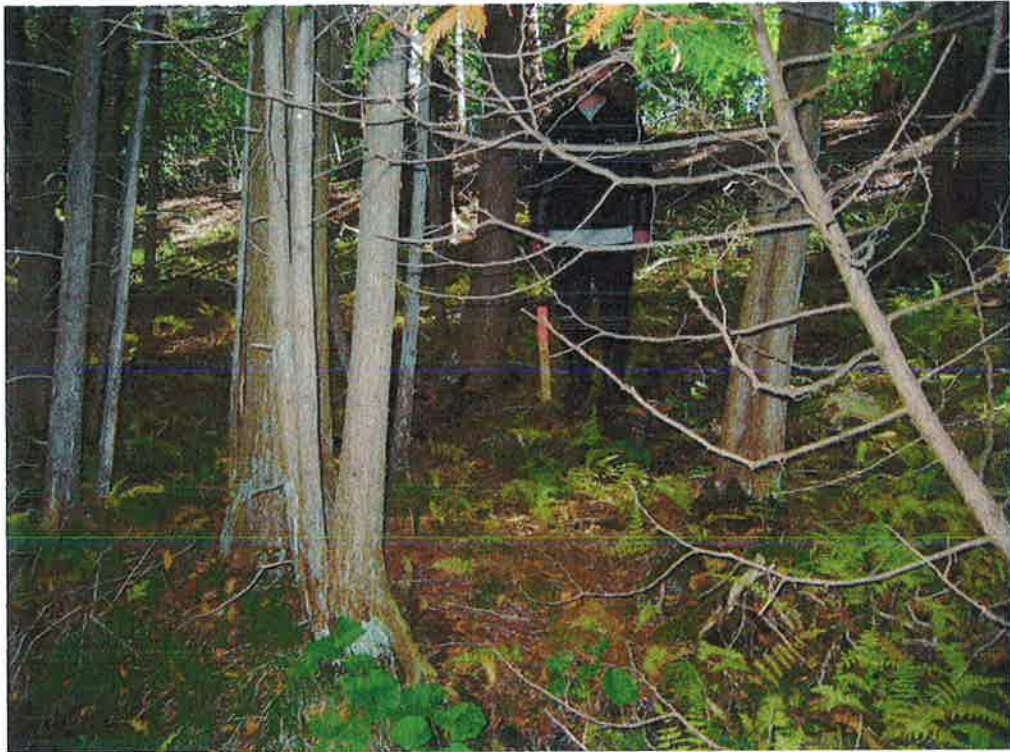
Photo 4. Vegetation Plot D, facing E from Steel T-bar.

Within vegetation Plot D two tree species were encountered along the north-south and east-west transects: Eastern White Cedar and Yellow Birch. This vegetation plot is located within cedar swamp, with Eastern White Cedar and Yellow Birch noted as canopy species along the transects conducted for Plot D. Within the north-south and east-west transects combined a total of 10 dead Eastern White Cedar were noted within the understory.

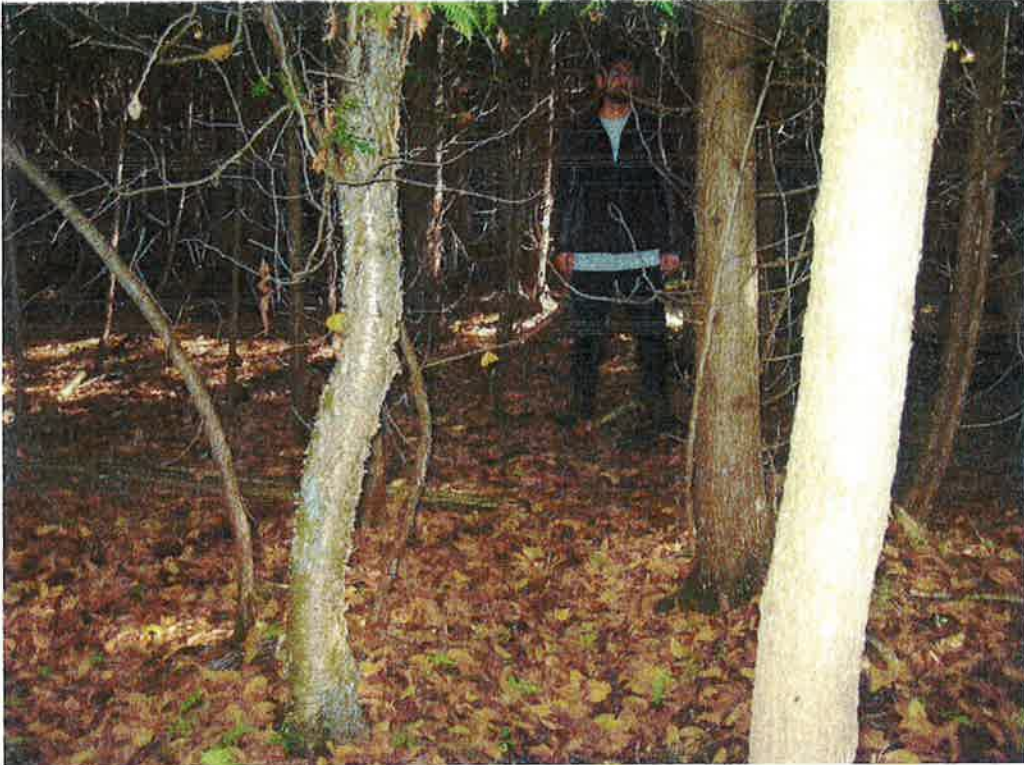
Photo 5. Vegetation Plot E, facing E from Steel T-bar.

The vegetation Plot E was located in fresh-moist cedar swamp. Vegetation Plot E was located in a seepage area approximately 30m downslope of the trail along the Speed River. The seepage area in which vegetation plot E was located is part of Tributary #9 and is located downslope of drive point piezometer DP7, see Figure 1. The dominant taxa, their percent cover, and total number of species for each sub-plot are shown in Appendix 3.

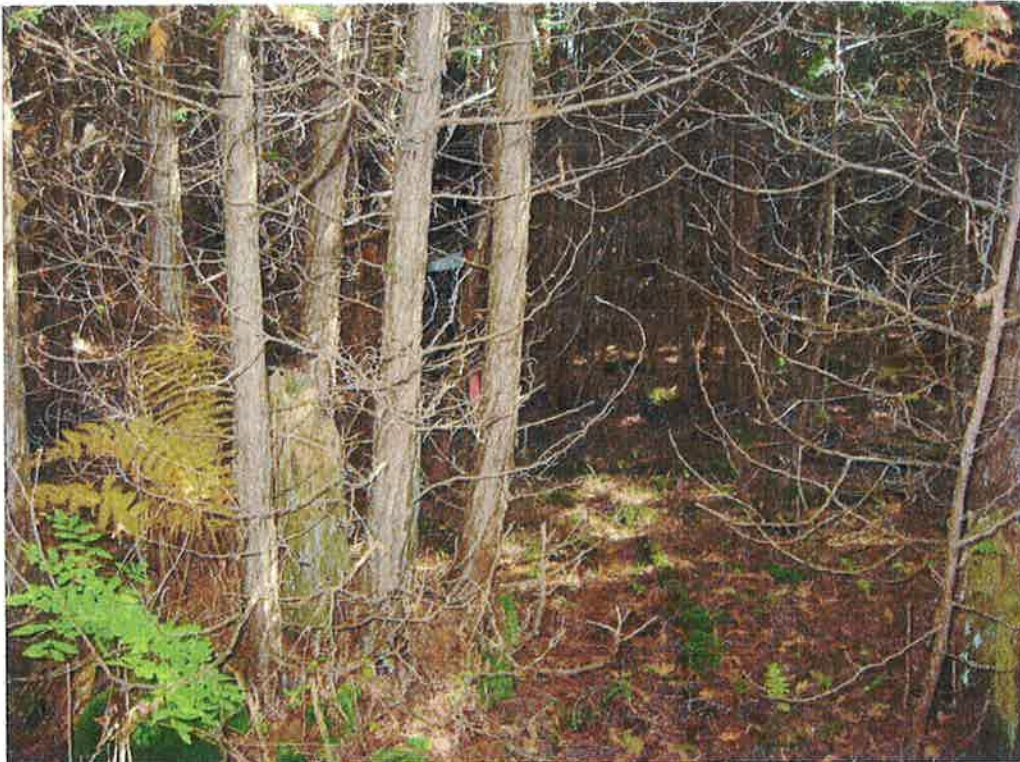
Photo 6. Vegetation Plot F, facing E from Steel T-bar.

The vegetation Plot F was located in a fresh-moist cedar swamp, dense with Eastern White Cedar. Vegetation Plot F was located in a seepage area downslope of the trail along the Speed River, to the west of the southeastern corner of the extraction area of the Roszell Pit. The closest drive point piezometer is DP7, to the northeast. Vegetation plot F is not in a seepage area with contributes to a tributary through surface water flow, Tributary #9 is the closest tributary to this vegetation plot and is located to the west of it.

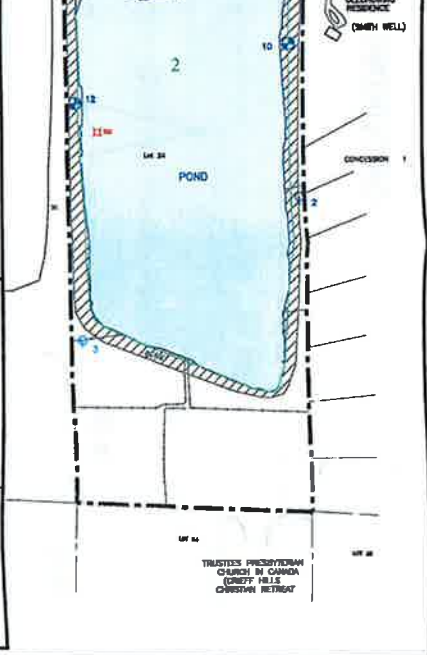
Figure 2

Figures 2 to 4, which follow, show the magnitude of the annual groundwater flux, or annual fluctuation (being the difference between the seasonal high elevation and the seasonal low) for the last twenty years, for the above-noted monitors. The figures also provide bar plots depicting the annual precipitation for each year. Groundwater hydrographs for the monitors over the same

GROUNDWATER FLUCTUATION AND YEARLY PRECIPITATION

The hydrographs indicate that over the last several years, there has been a general increase in the elevation of the groundwater table in the granular aquifer beneath the western part of the property relative to historic values as was predicted at the time the approvals were granted. Several of the monitors (e.g. BH8-1, located adjacent to the extraction pond in Phase 3) exhibit a more-pronounced increase starting about 2009, relative to other monitors. The hydrographs also illustrate that the seasonal variation is more muted relative to historic trends. This muting effect is also illustrated in Figures 2 to 4 that show the reduction in the magnitude of the difference between the seasonal high elevation and the seasonal low elevation of the water table that has occurred over the last few years, but most noticeably in 2009 and 2010. There appears to have been at least a partial reversal of this trend in 2011 in several of the monitors in question.

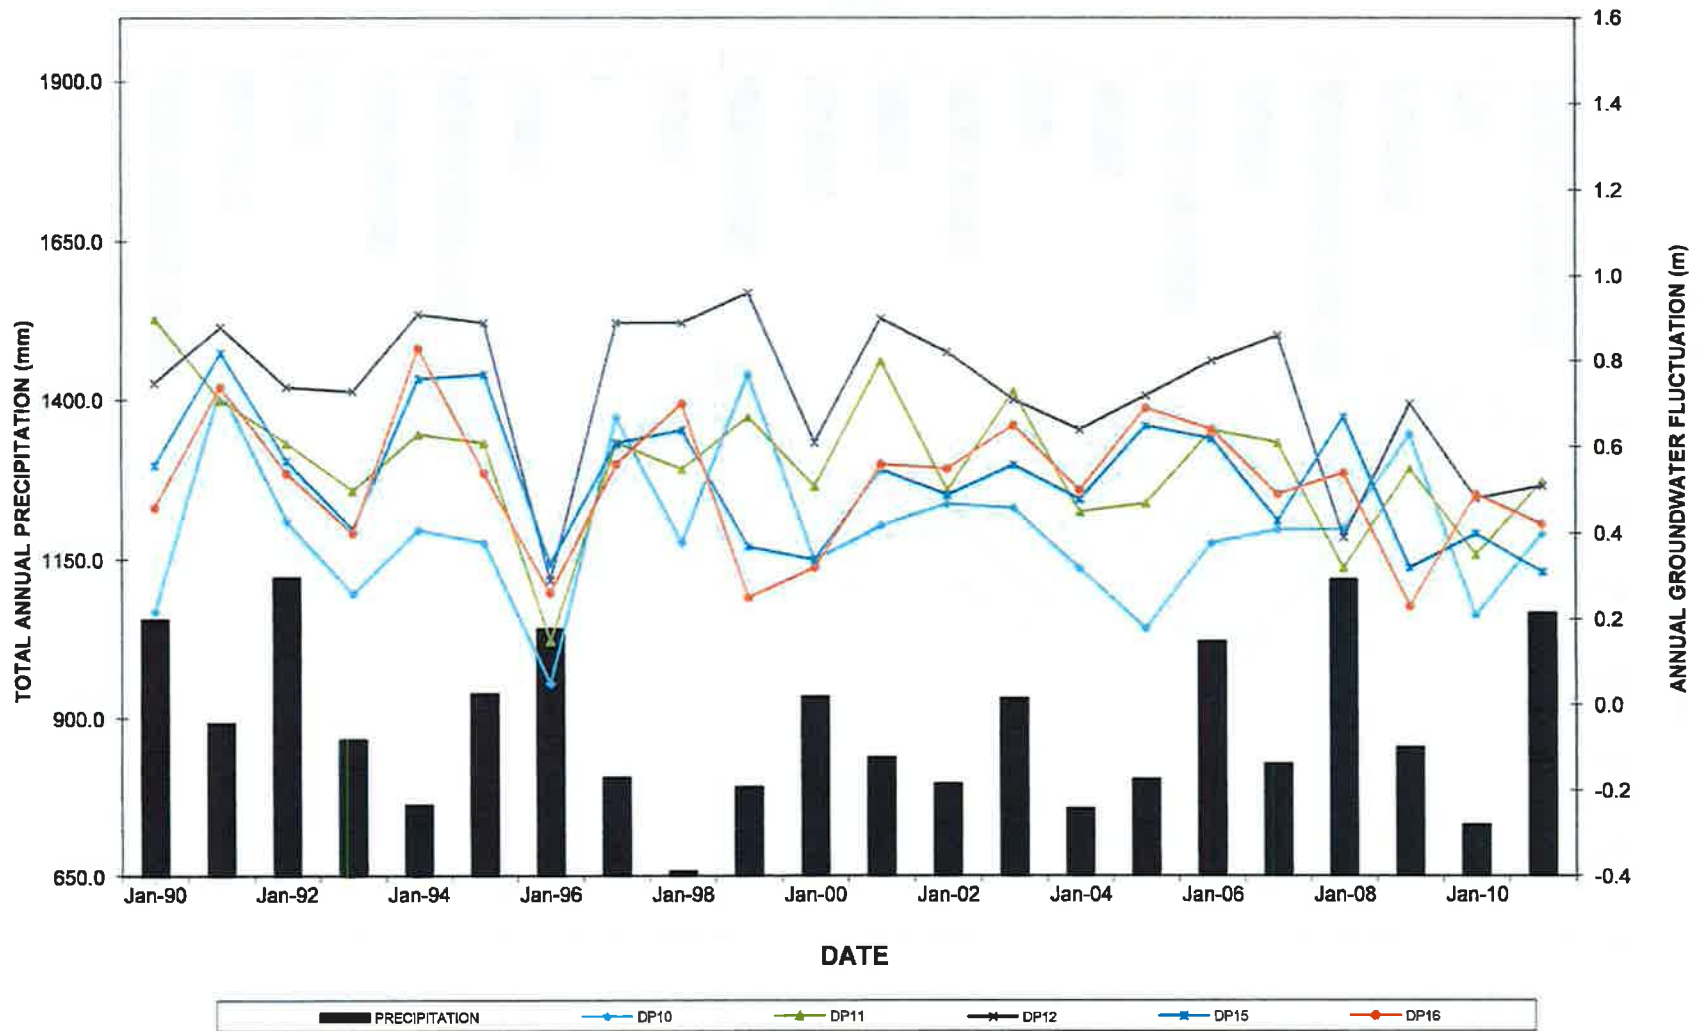
Figure 4

GROUNDWATER FLUCTUATION AND YEARLY PRECIPITATION
