**Attention:** Ms. Karen Landry, CAO/Clerk  
**RE:** 2013 Groundwater Monitoring Report  
Capital Paving Inc., Wellington Pit, Licence No. 20085  
Part Lots 7 and 8, Concession 3, Township of Puslinch

RE: Monitoring Report CBM - St Mary's Cement McMillan Pit (License#5737)

Attn: Mr. Colin Evans  
Re: CBM Lanci Pit  
Part of Lot 25, Concession 1, Township of Puslinch

Project Name:  
**Lanci Pit 2014 Acoustical Audit**

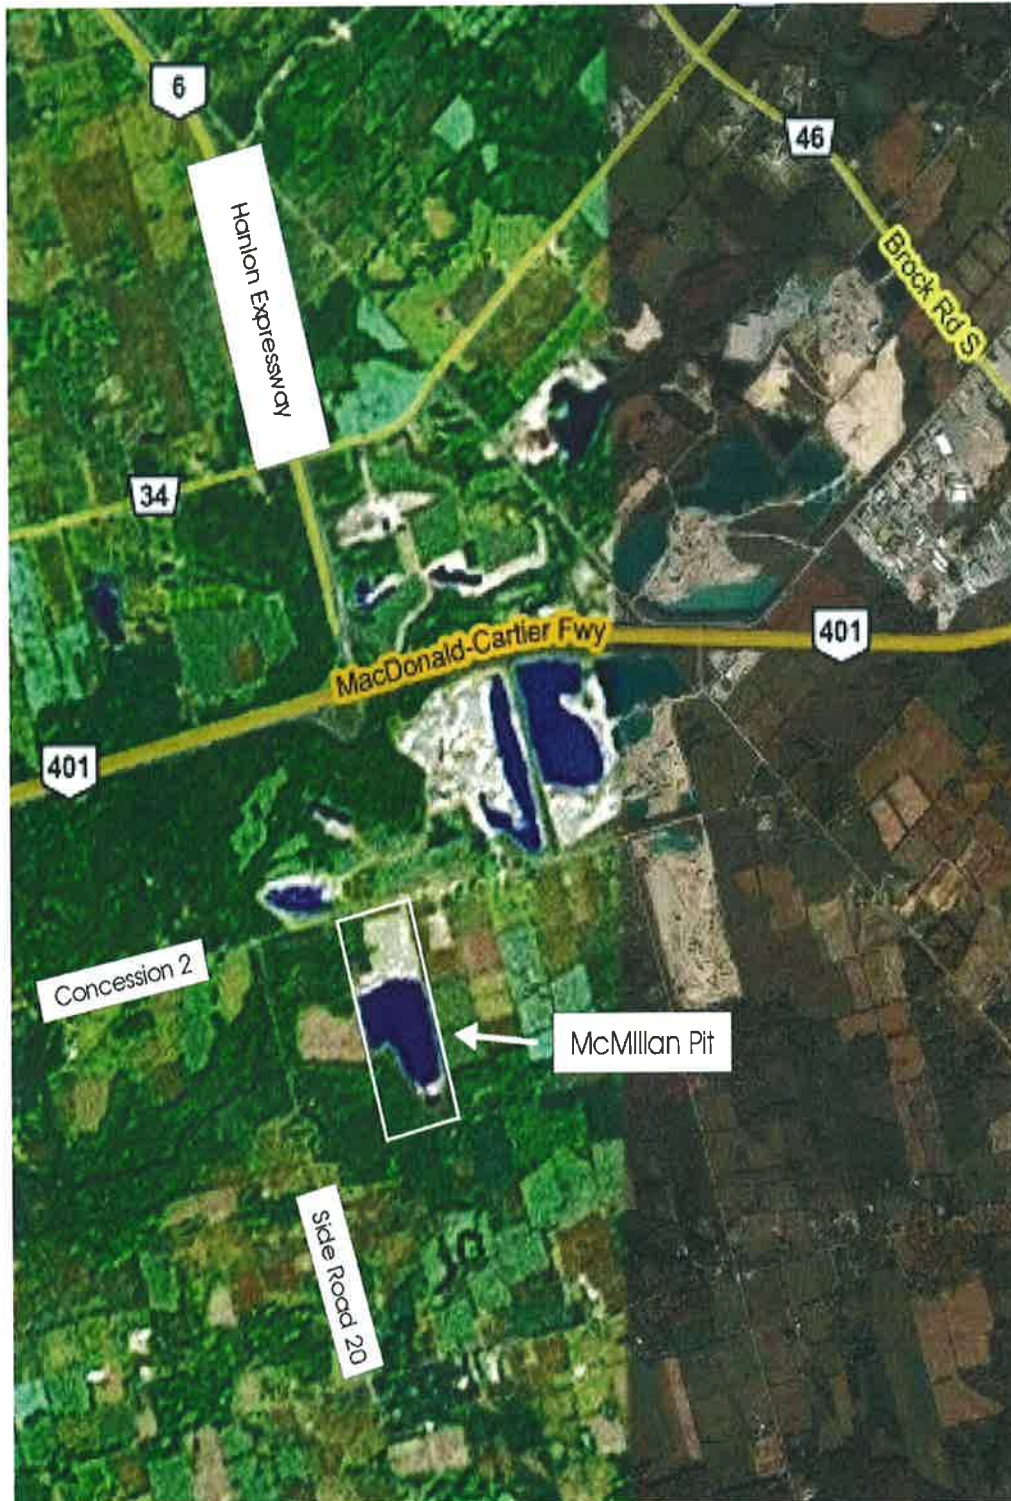
Figure 1: McMillan Pit Location.

Tributary 3 of Mill Creek is the nearest discharge point of groundwater crossing the pit site, and reflects the quality of groundwater discharging from the McMillan Pit (Figure 1). Water quality monitoring is based on an assessment of the benthic biota that Tributary 3 supports. The community of benthic biota is subject to the full rigor of the environment through the annual or biannual life cycles of the species. The community therefore represents the integrated temporal effects of all pollutants and environmental conditions through the year and not only those conditions at the time of sampling.

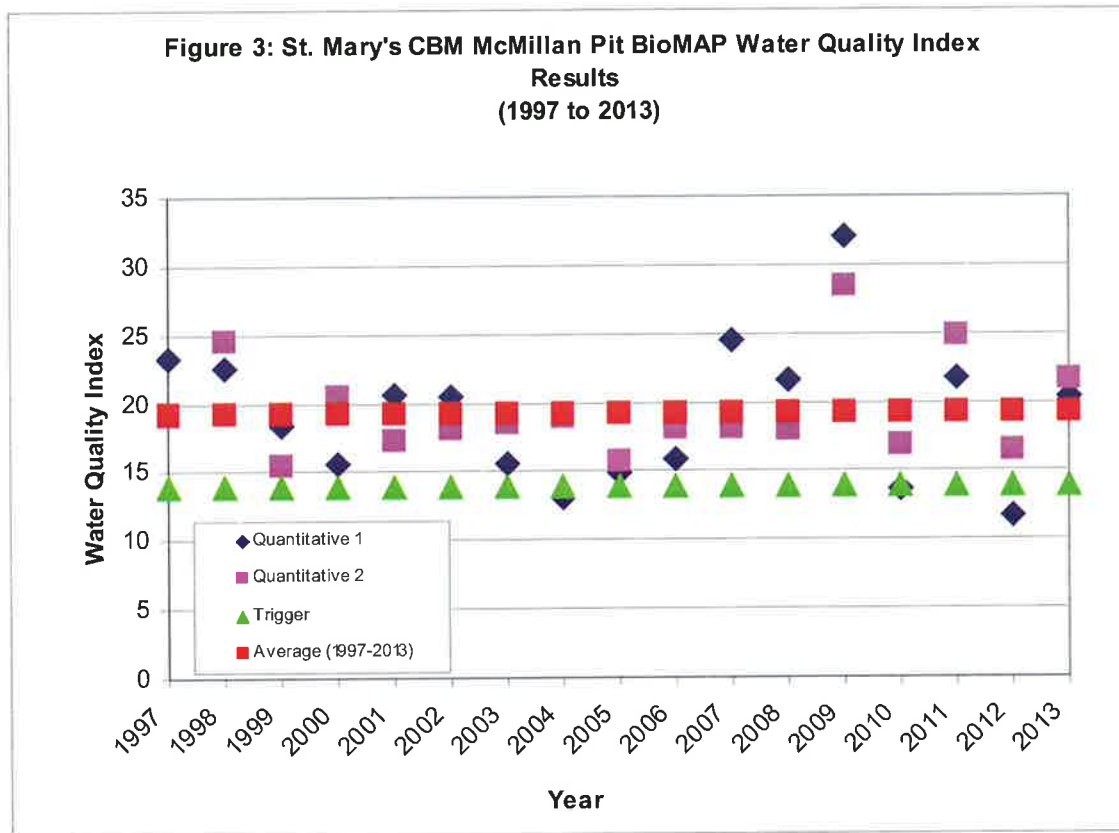
Results of the BioMAP analysis from 1997 – 2013 are tabulated in Table 1 and shown graphically in Figure 3. Results show the average WQI for 2013 is 21.0, well above the trigger of 14. The T1 value is 20.4 and the T2 sample value is 21.6. The species composition represents an unimpaired creek and is similar to previous years. For the first time in 2011, a third sample(T3) was collected in Tributary T3 closer to Mill Creek in the hopes of expanding the area available for sampling since the number of individuals per sample remains extremely low due to high sand contents of the bed material that limits available niches for benthic invertebrate production. However, the lower water quality index at that location suggested it is more typical of the much larger Mill Creek waterway and that the sampling location selected is likely under the influence of Mill Creek flooding and is not representative of the tributary water quality. Therefore, no expansion of historical sampling is justified, and sampling in 2013 continued with just the original 2 locations only.

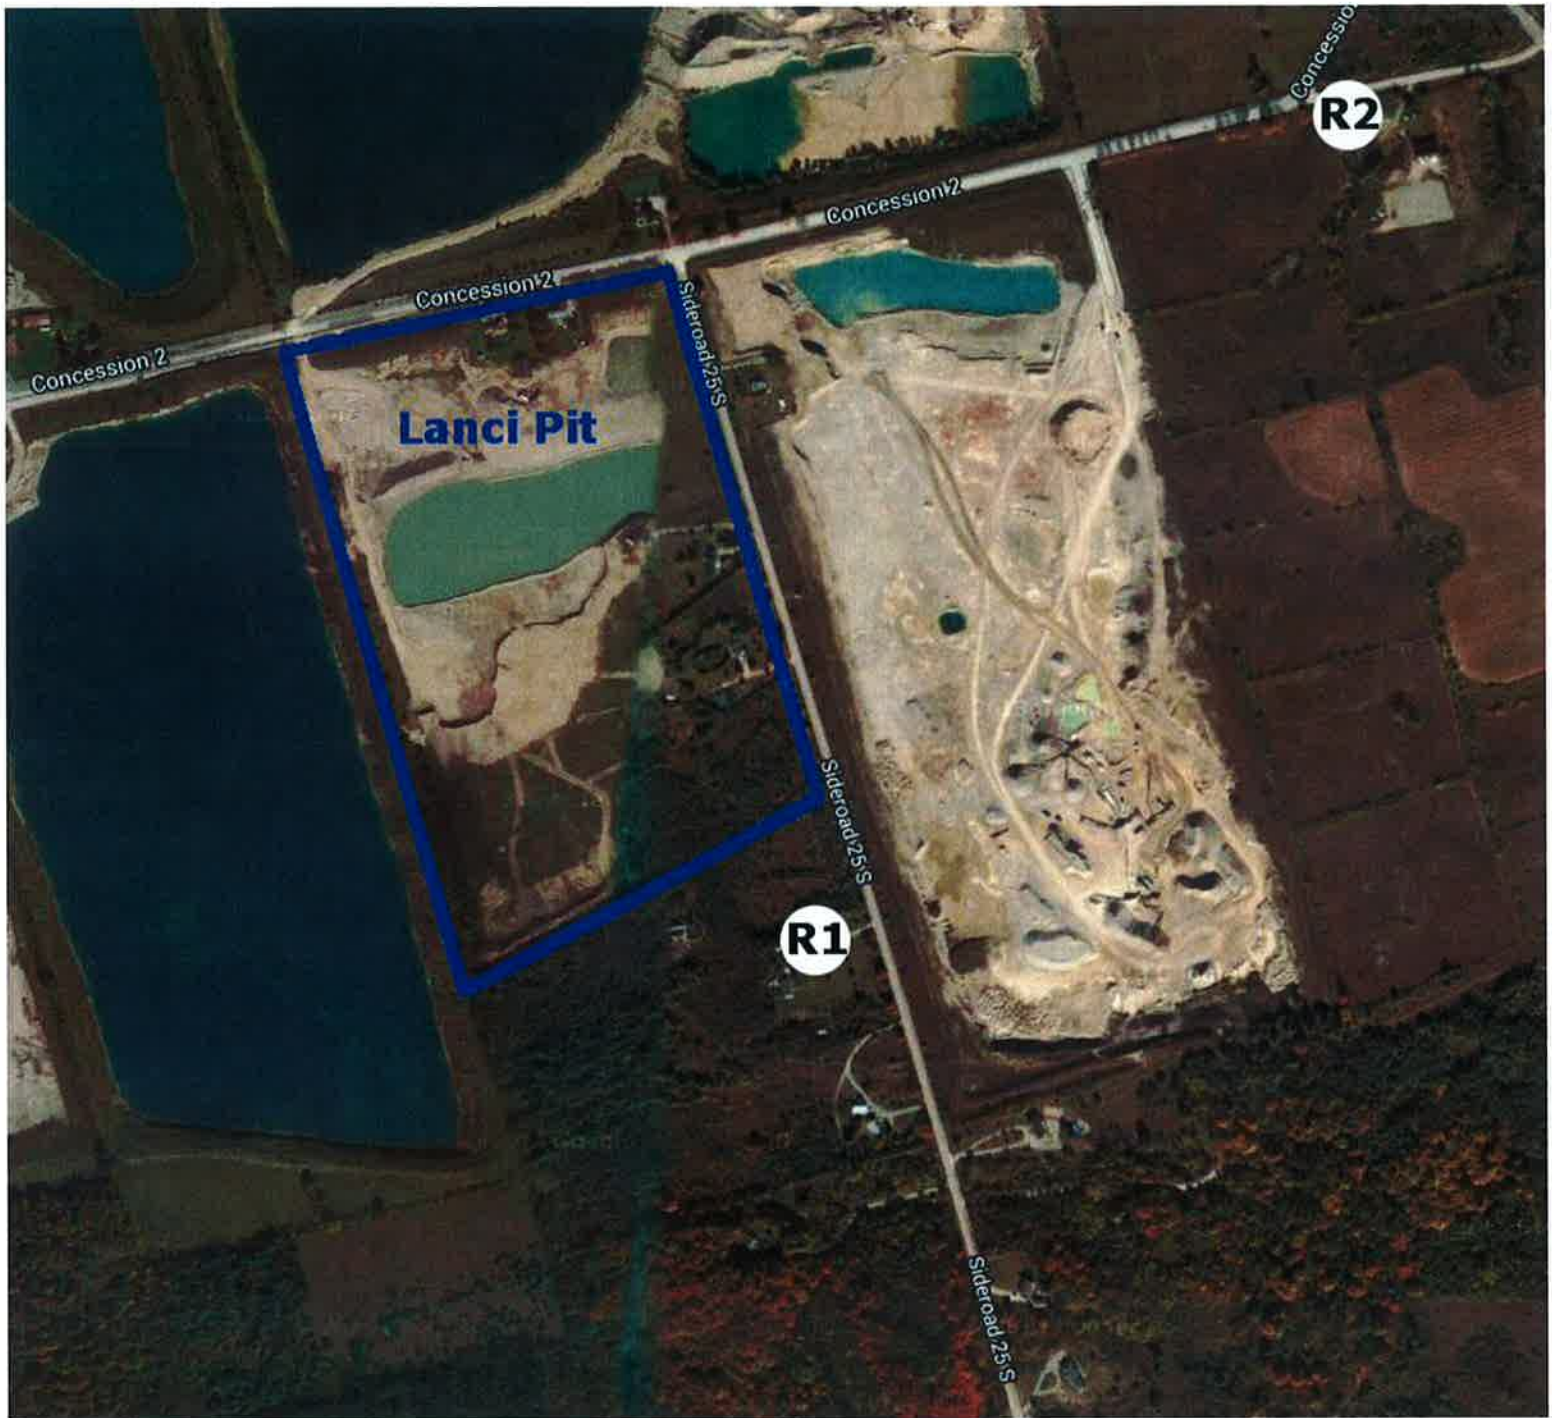
Figure 1

The surrounding sensitive receptors are illustrated in Figure 1. The noise from a stationary source should not in any hour exceed the limits outlined in Table 2. The extraction and processing operations in the pit are restricted to the daytime hours (07:00-19:00).

During the site visit on July 24, 2014, sound level measurements were conducted at locations representative of the worst-case receptors surrounding the pit (refer to Figure 1). The measurement results are summarized in the following table. It should be noted that during the measurements, the sound level meter was paused to minimize the contribution from airplane flyovers and vehicle pass-bys on the local roads.

Drawing Title:  
 Key Plan Showing Site Location and Receptors
