## Licensees Compliance Assessment Report - Aggregate Resources Act

<b>Background Information</b>			<b>Year: 2013</b>
Licensee: Cox Construction Ltd.		Licence ID #: 5710	MNR District/Area Office: Guelph
Lot: 9 to 13	Conc.: 4	Geographic Twp.: Puslinch	Municipality: Wellington

Licensee: Cox Construction Ltd.      Licence ID #: 20212      MNR District/Area Office: Guelph  
 Lot: 8 to 10      Conc.: 4      Geographic Twp.: Puslinch      Municipality: Wellington

Licensee: Cox Construction Ltd.		Licence ID #: 20749 (Nigro)	MNR District/Area Office: Guelph
Lot: 11 & 12	Conc.: 4	Geographic Twp.: Puslinch	Municipality: Puslinch (County of Wellington)

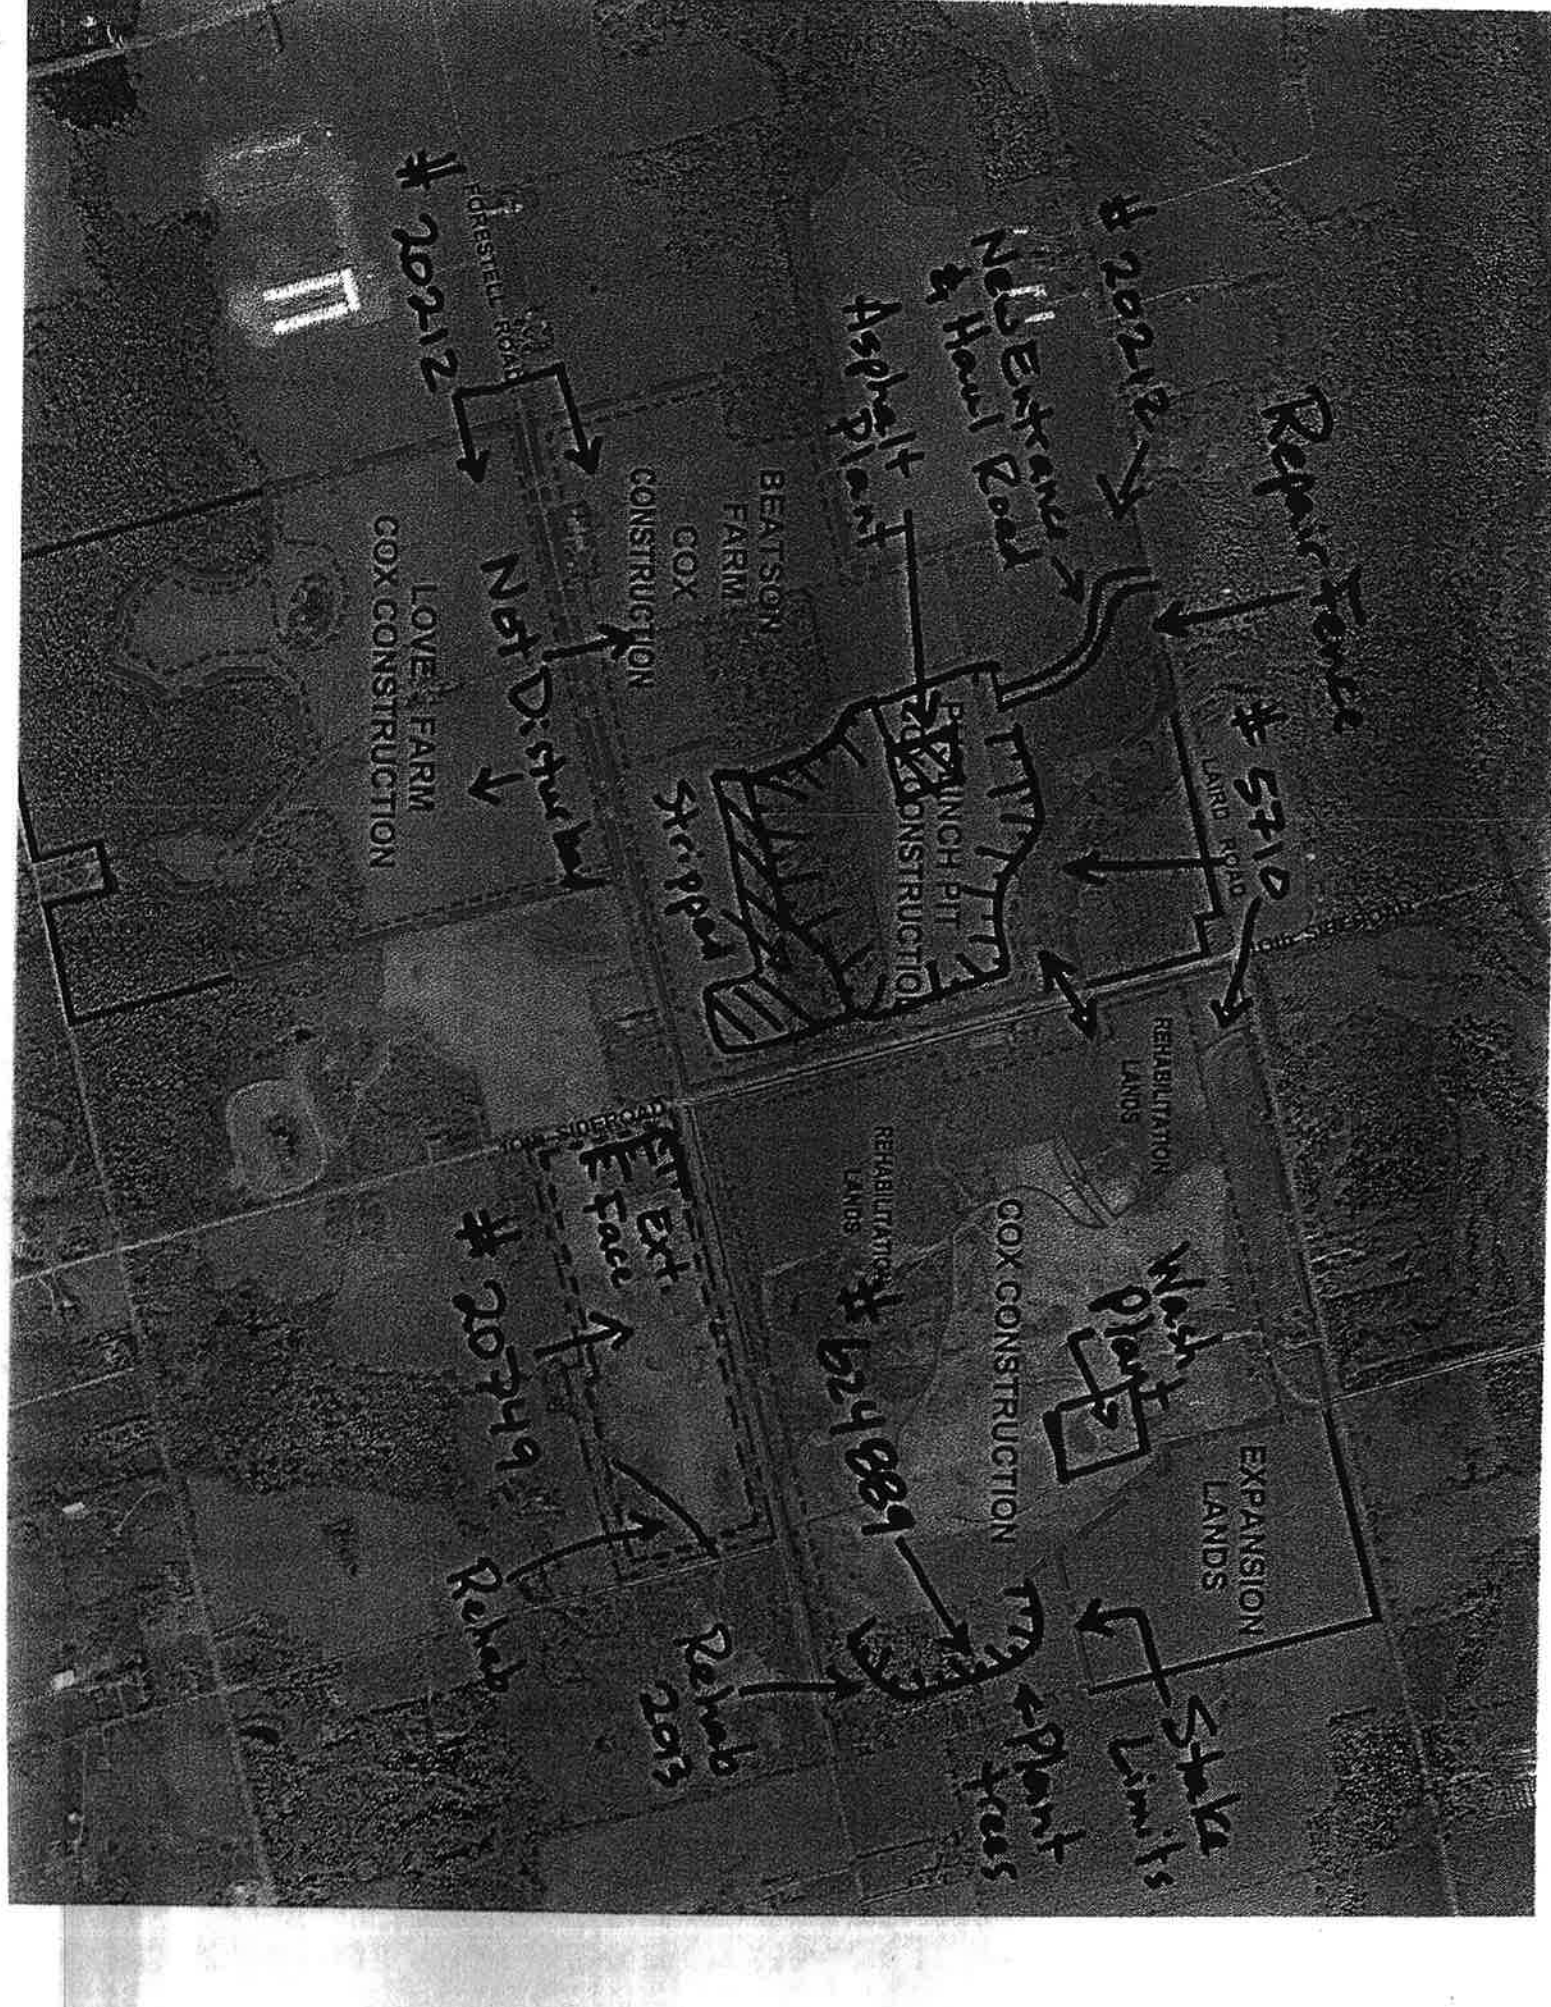
Cox has opened a pit west of Sideroad 10. Cox has re-established the asphalt plant to the lands west of SR 10.

Cox has rehabilitated the lands east of SR 10. The attached drawing shows the extent of agricultural rehabilitation.

Berms are established along SR 10 and Forestell Road.

Repairs Fence

Stake  
Limits

It is recommended that setbacks be staked (although not required) in NE and SE corners of Lot 10 prior to operation next season.

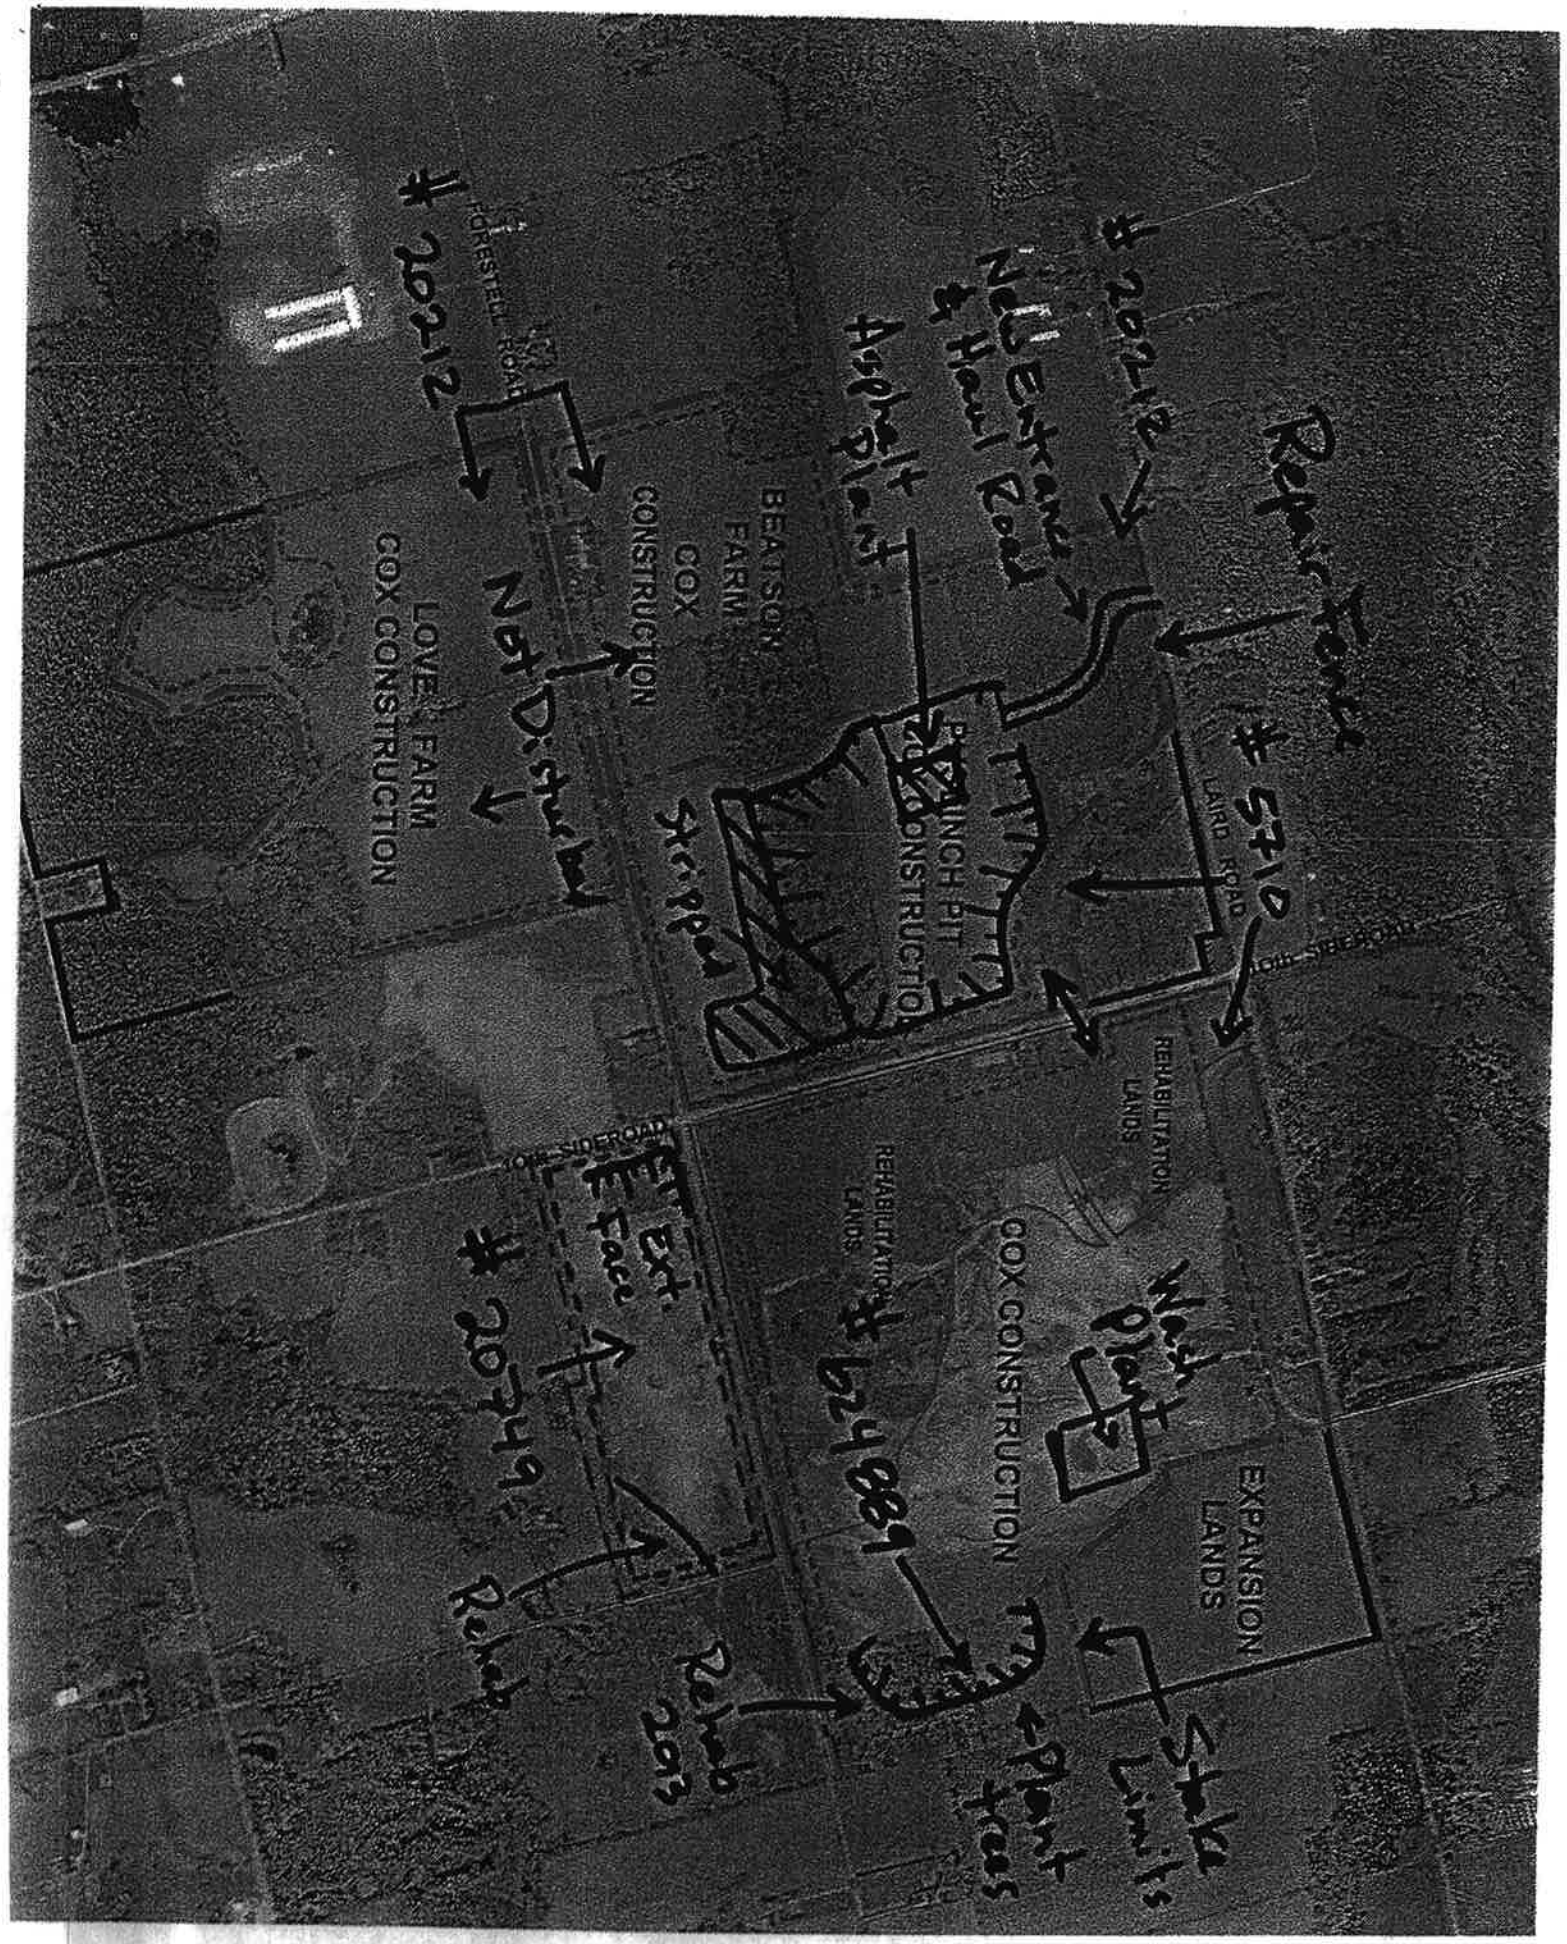
OPERATING STANDARDS	IN COMPLIANCE?			COMMENTS	Remedial Action?
	Yes	No	N/A		
<b>D – Rehabilitation</b>					<b>Y</b>
D29 Disturbed Hectarage	√		Current year - # of hectares	0	Total # of hectares +/- 14.0
D30 Progressive rehabilitation	√		Current year - # of hectares	0	Total # of hectares 2.0
D31 Sloping of Faces	√				
D32 Grades/Contours/Elevations	√				
D33 Importation of Material (Inert)	√				
D34 Vegetation	√				
D35 Final Rehabilitation	√				
<b>E - Prescribed Conditions (For Licences issued after June 27, 1997)</b>					
E36 Other Monitoring Reports			√		
E37 Requirements of C of A's			√		
E38 Noise Mitigation			√		
E39 Fuel Storage Tanks			√		
E40 Spills Plan			√		
E41 Permit to Take Water			√		
E42 Dust Suppression Measures Req'd. (Haul routes, equip, etc.)			√		
<b>F - Other Conditions (As indicated on either Site Plan or Licence)</b>					
F43 tonnage					
F44					
F45					
<b>General Comments:</b>					
Site is essentially extracted with only material along the westerly limits. Test holes indicate that there is very little recoverable aggregate below the water table.

Site was largely inactive in 2013.					
Licence ID#: 20749

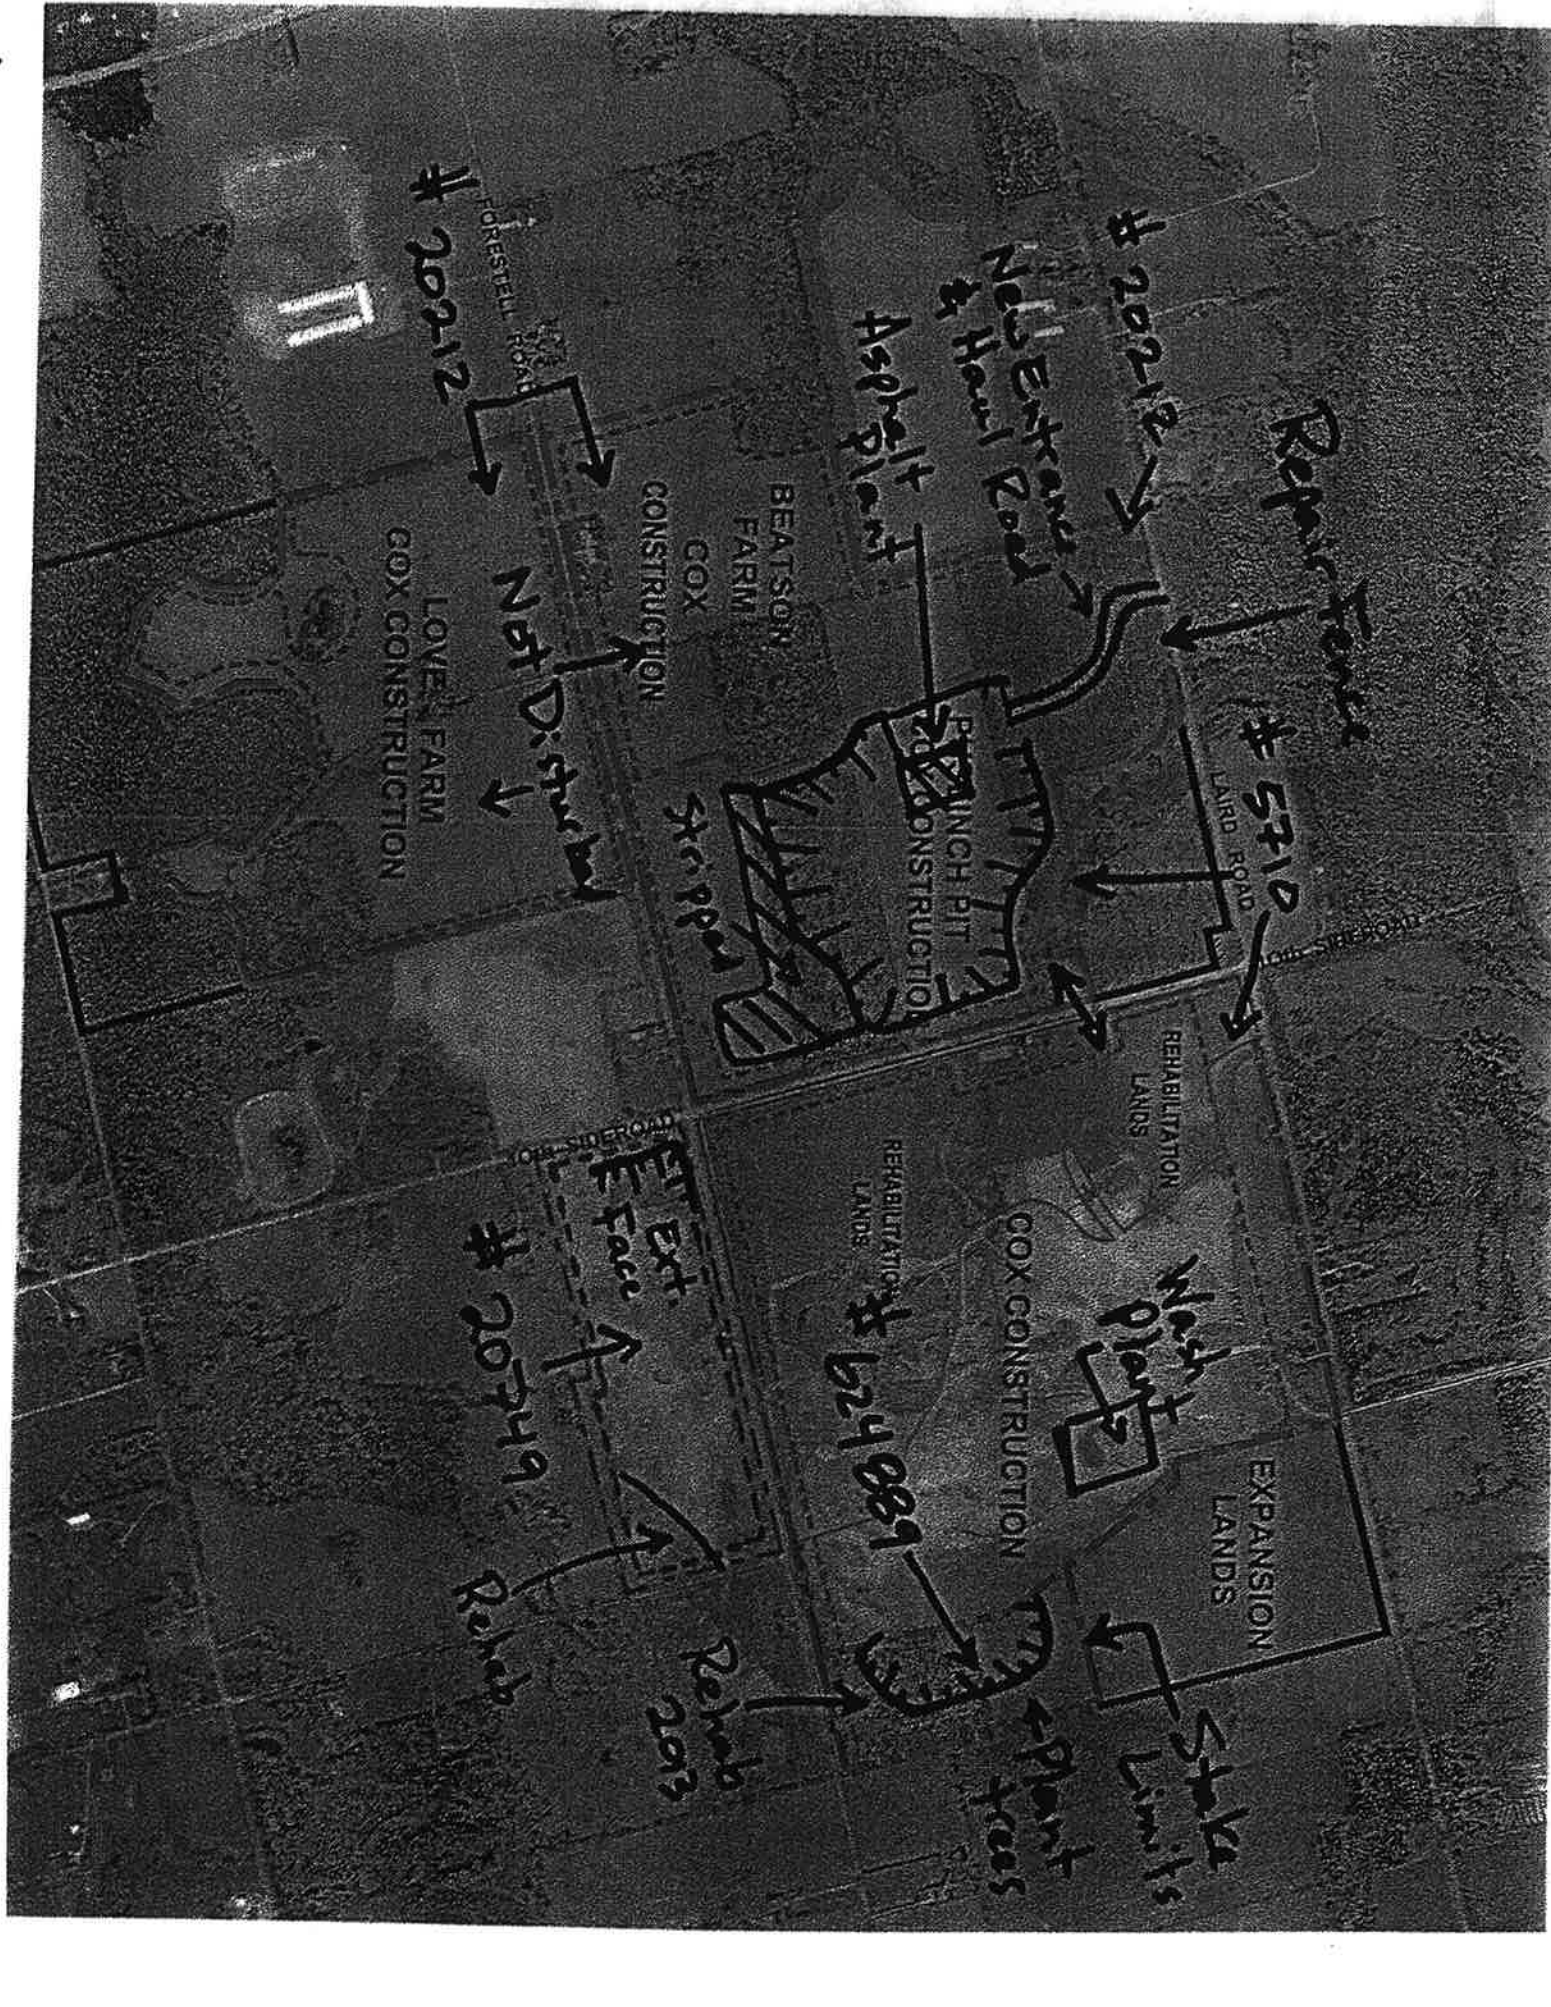
OPERATING STANDARDS	IN COMPLIANCE?			COMMENTS	Remedial Action?
	Yes	No	N/A		
<b>A - Site Access</b>					
A1	Boundaries (clearly marked)		x	Northern boundary to be re-staked	Y
A2	Entrance and Exits (location/closed)	√			
A3	Lease/Ownership/Extraction Agreement			Owner Operated	
<b>B - Site Protection</b>					
B4	Fencing	√			
B5	Fencing (site plan variation or temporary relief granted)	√			
B6	Screening (trees/berms)	√			
B7	Setbacks (15m / 30m or other)	√			
<b>C - Operational Details</b>					
C8	Operating Sequence	√			
C9	Stripping (overburden)	√			
C10	Overburden Seeded	√			
C11	Extraction Depth	√			Lowest floor elevation +/- 328 m
C12	Buildings/Scales (location)	√		No buildings or scales	
C13	Equipment (any specific conditions or restrictions)	√			
C14	Plant (location/any specific conditions or restrictions)	√			
C15	Scrap (location/removal)	√			
C16	Stockpiles (location)	√			
C17	Topsoil (location/seeded)	√

Repair Fence

Stake Limits  
Plant trees

A1 - Boundaries	Northern boundary to be re-staked	Dec. 15, 2013
