Licensees Compliance Assessment Report - Aggregate

Licensee: St. Marys Cement Inc. (Canada)	Licence ID #: 17600	MNR District/Area Office: Guelph
Lot: Part 26	Conc.: 1	Geographic Twp.: Puslinch
		Municipality: Township of Puslinch

Licensee: St. Marys Cement Inc. (Canada)		Licence ID #: 48576 (Tikal)	MNR District/Area Office: Guelph
Lot: Part 21	Conc.: 9	Geographic Twp.: Puslinch	Municipality: Township of Puslinch

Licensee: St. Marys Cement Inc. (Canada)		Licence ID #: 129817 (Mast-Snyder)		MNR District/Area Office: Guelph	
Lot: Part 14 and 15	Conc.: 4	Geographic Twp.: Puslinch		Municipality: Township of Puslinch

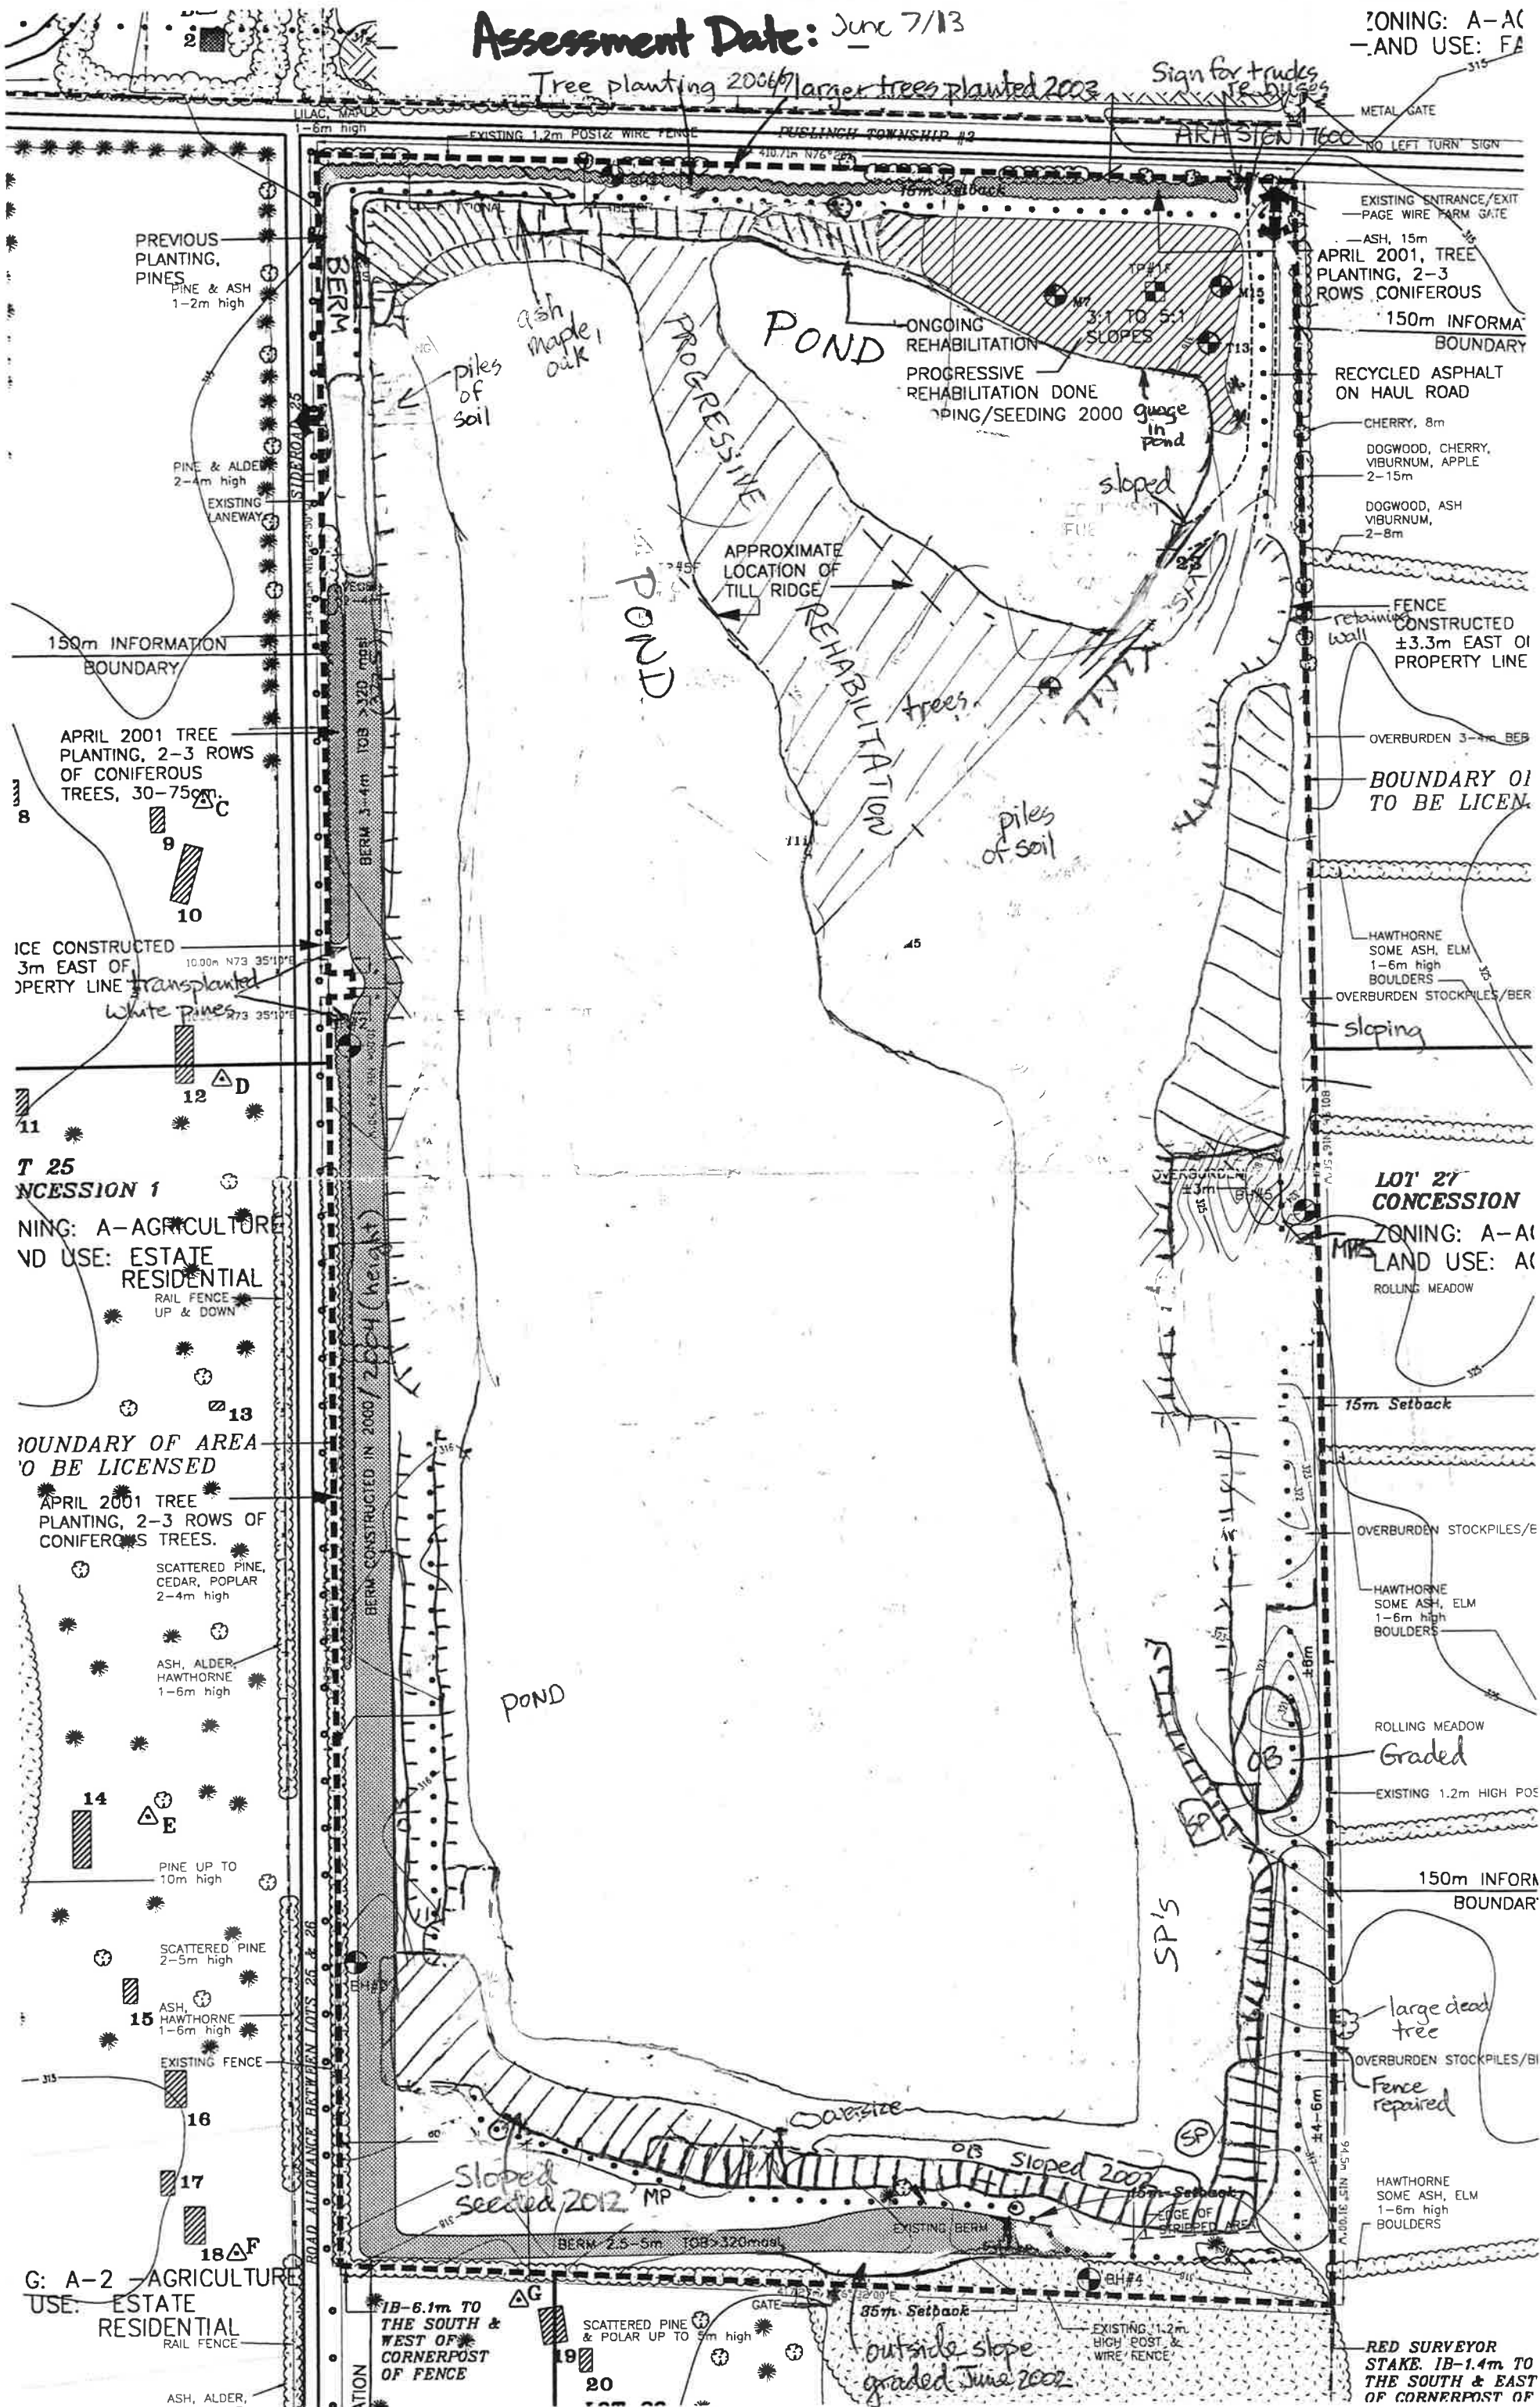
CBM (Puslinch Quality Aggregates) Licence 17600

D29 and D30 – The disturbed and rehabilitated areas were updated in 2012 by the licensee using a GPS.					
D30 & D31 – About 150 metres of the north face was rehabilitated in the 2007. Rehabilitation of the shallow areas in the northern pond has occurred, as shown on plans. Sloping rehabilitation (+/- 0.7 ha) completed in the southwest part of the site in 2012 (see Compliance Assessment report).					
E36 – Refer to letter of August 1/2012 from Aercoustics Engineering regarding noise audit completed.					
Licence ID#: 17600

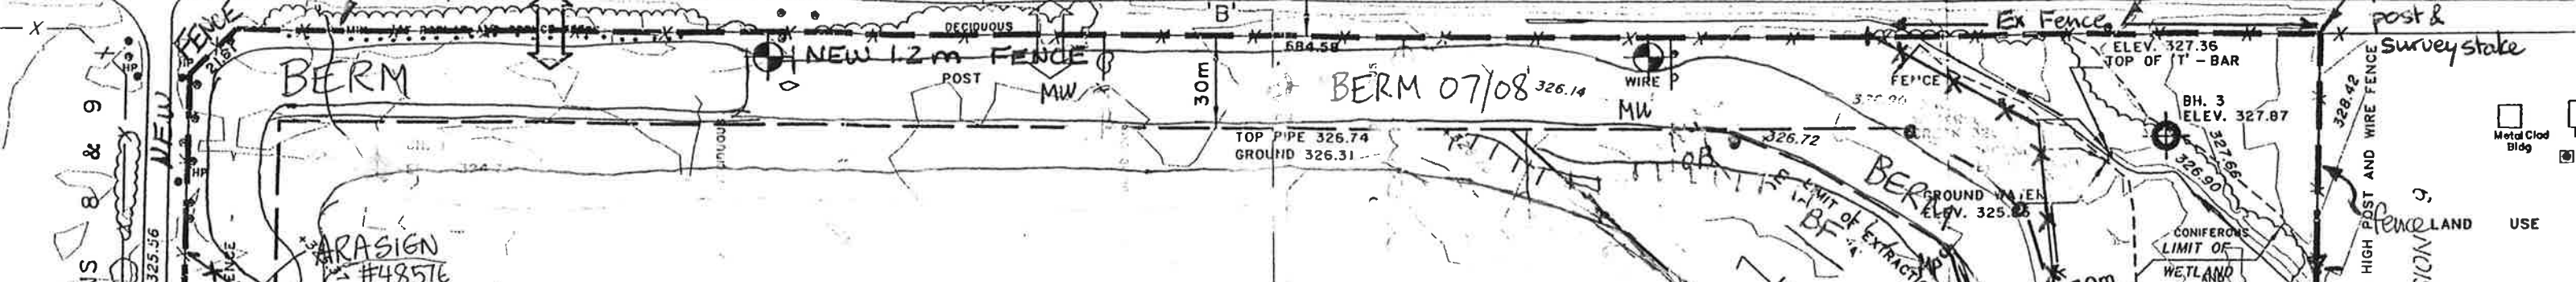
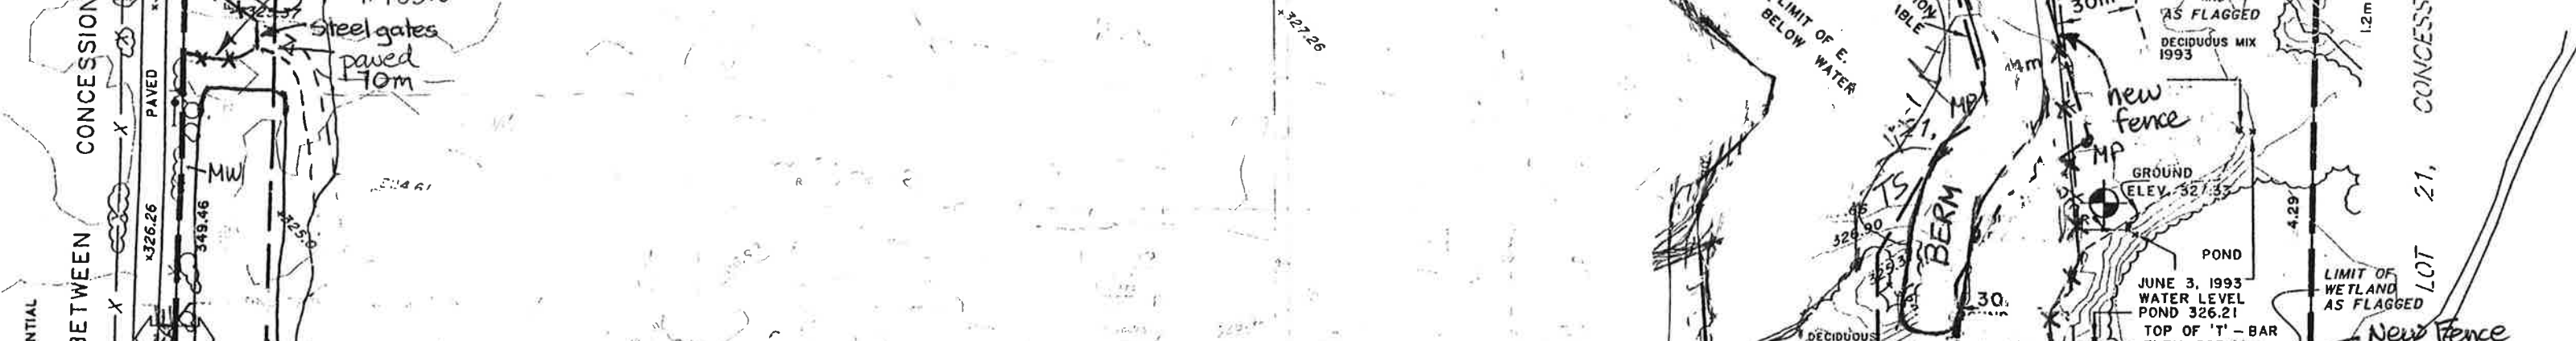
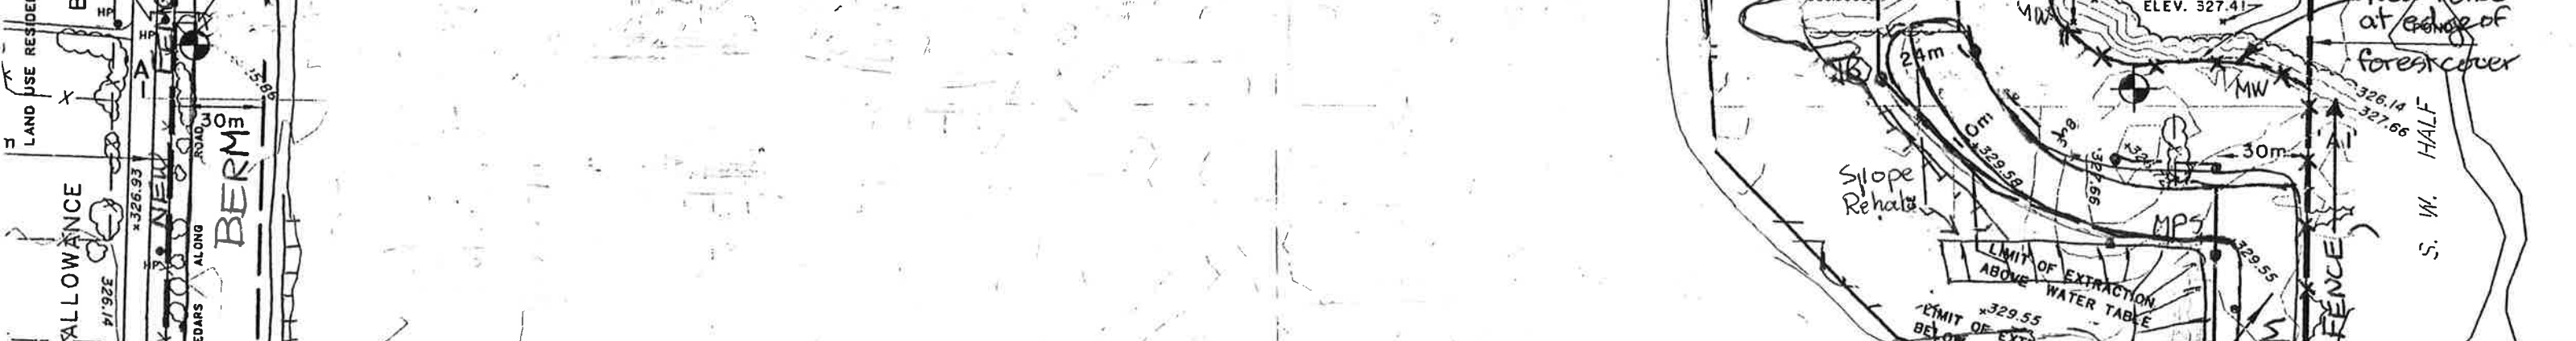
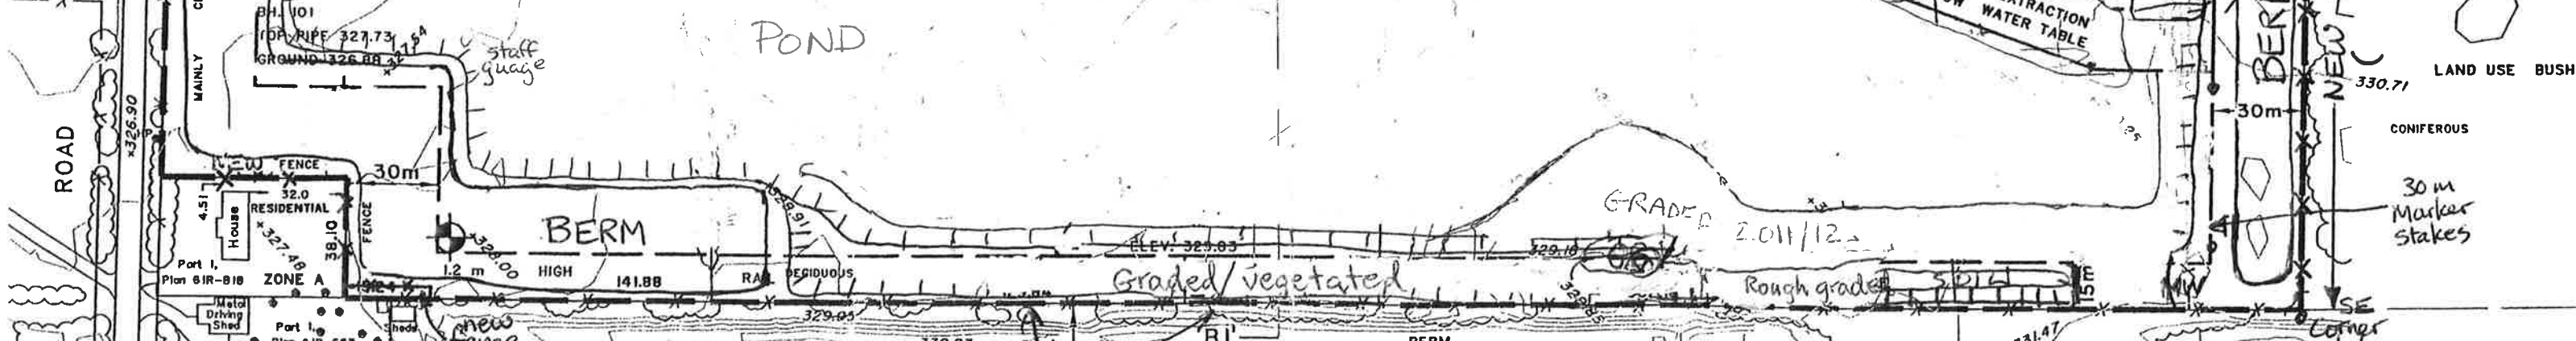
Tikal Pit
Licence no. 48576
Assessment Date: June 11/13
Scale 1:2000

B6	Screening (trees/berms)	X		Berms have been constructed along the portions of the west, south, north and east boundaries (see operational note #4). See site sketch.	
B7	Setbacks (15m / 30m or other)	X		The setback areas along the south and east boundaries were previously staked. The below water extraction limits in Phase 4 have been surveyed.	
C - Operational Details					
C8	Operating Sequence	X		Extraction has been completed, as shown on site plans.	
C9	Stripping (overburden)	X		Stripped topsoil and overburden has been stored in berms. Trees along shared common boundary with Dufferin pit were cleared as per standards. See general comments.	
C10	Overburden Seeded	X		All berms are well vegetated.	
C11	Extraction Depth	X		Maximum depth allowed - +/- 314 m asl Lowest floor elevation +/- 317 m	
C12	Buildings/Scales (location)	X		There are no buildings within the licensed property.	
C13	Equipment (any specific conditions or restrictions)	X		There is no equipment currently operating on site (see page 2, note #7a on site plans).

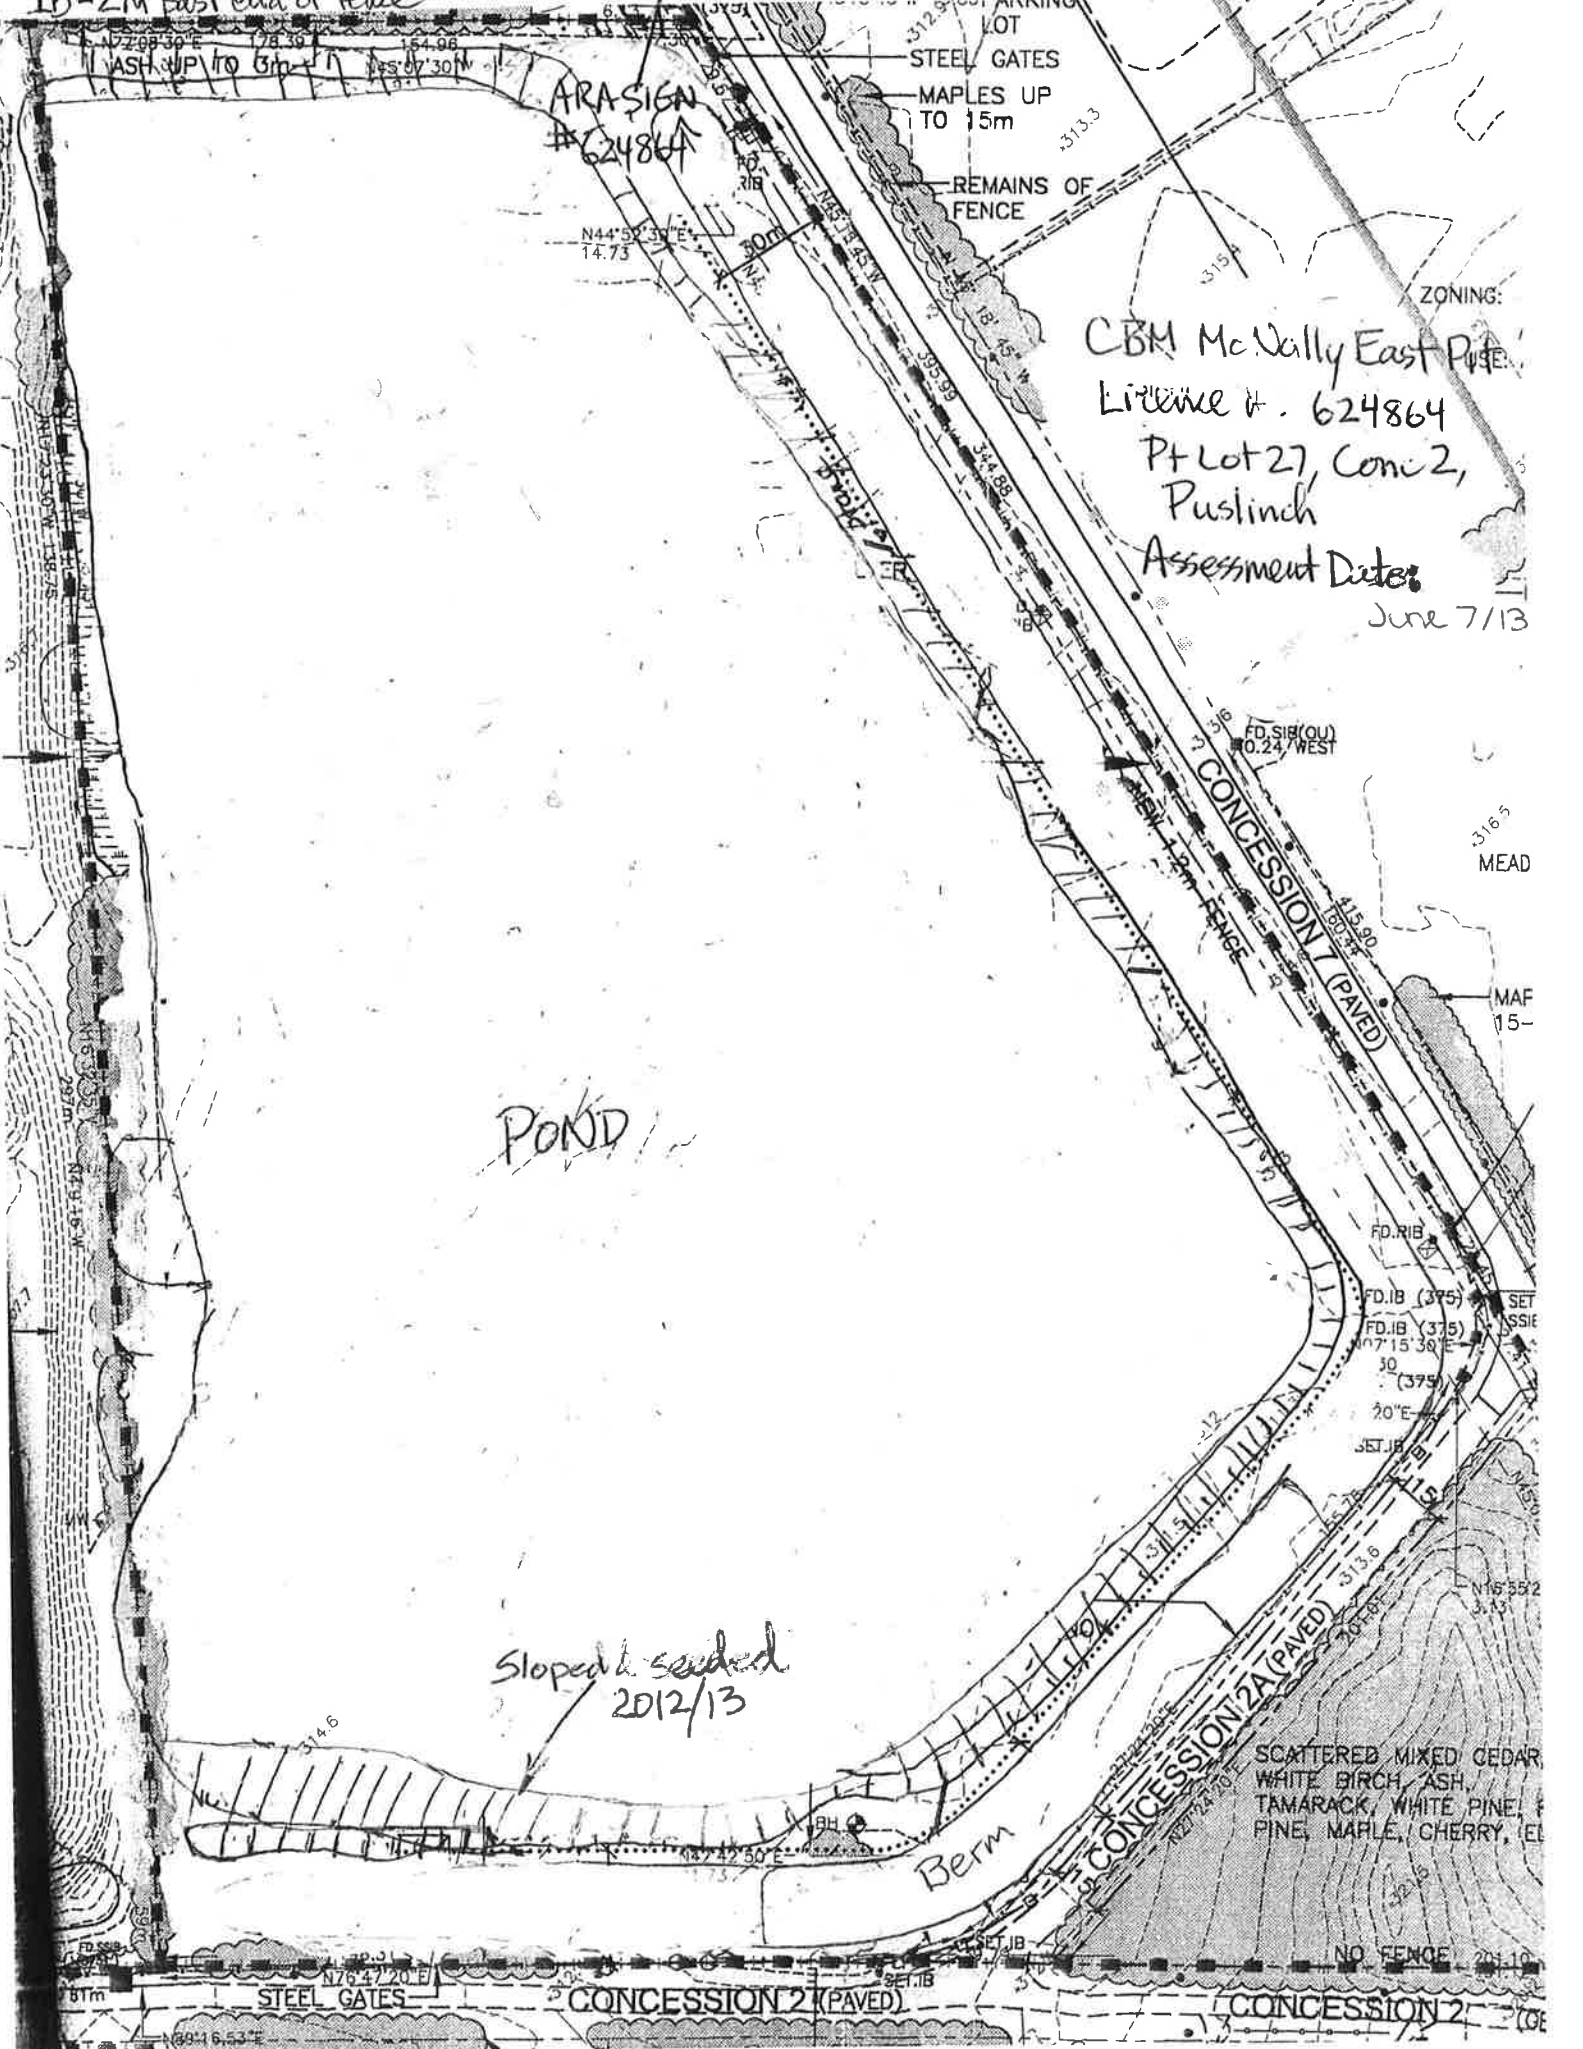
ZONING:
CBM McNally East Pct.
License # 624864
Pt Lot 27, Conc 2,
Puslinch
Assessment Date:
June 7/13

B6	Screening (trees/berms)	X		Berm remains along Concession 2A road boundary of site. The other perimeter berms have been used for rehabilitation of side slopes. See general comments.	
B7	Setbacks (15m / 30m or other)	X		Setbacks maintained as shown on the site plans. Relief granted for the common boundary shared with the adjacent pits to the west and north (site plan override).	
C - Operational Details					
C8	Operating Sequence	X		Above and below water extraction has been completed. See general comments.	
C9	Stripping (overburden)	X		Stripped topsoil and overburden stored in perimeter berm on site and to be used for progressive rehabilitation of the site.	
C10	Overburden Seeded	X		Established berm is well vegetated.	
C11	Extraction Depth	X		Maximum depth allowed - +/- 292 m asl	Lowest floor elevation +/- 292 m
C12	Buildings/Scales (location)	X		There are no buildings within the licensed property as shown on the site plans.

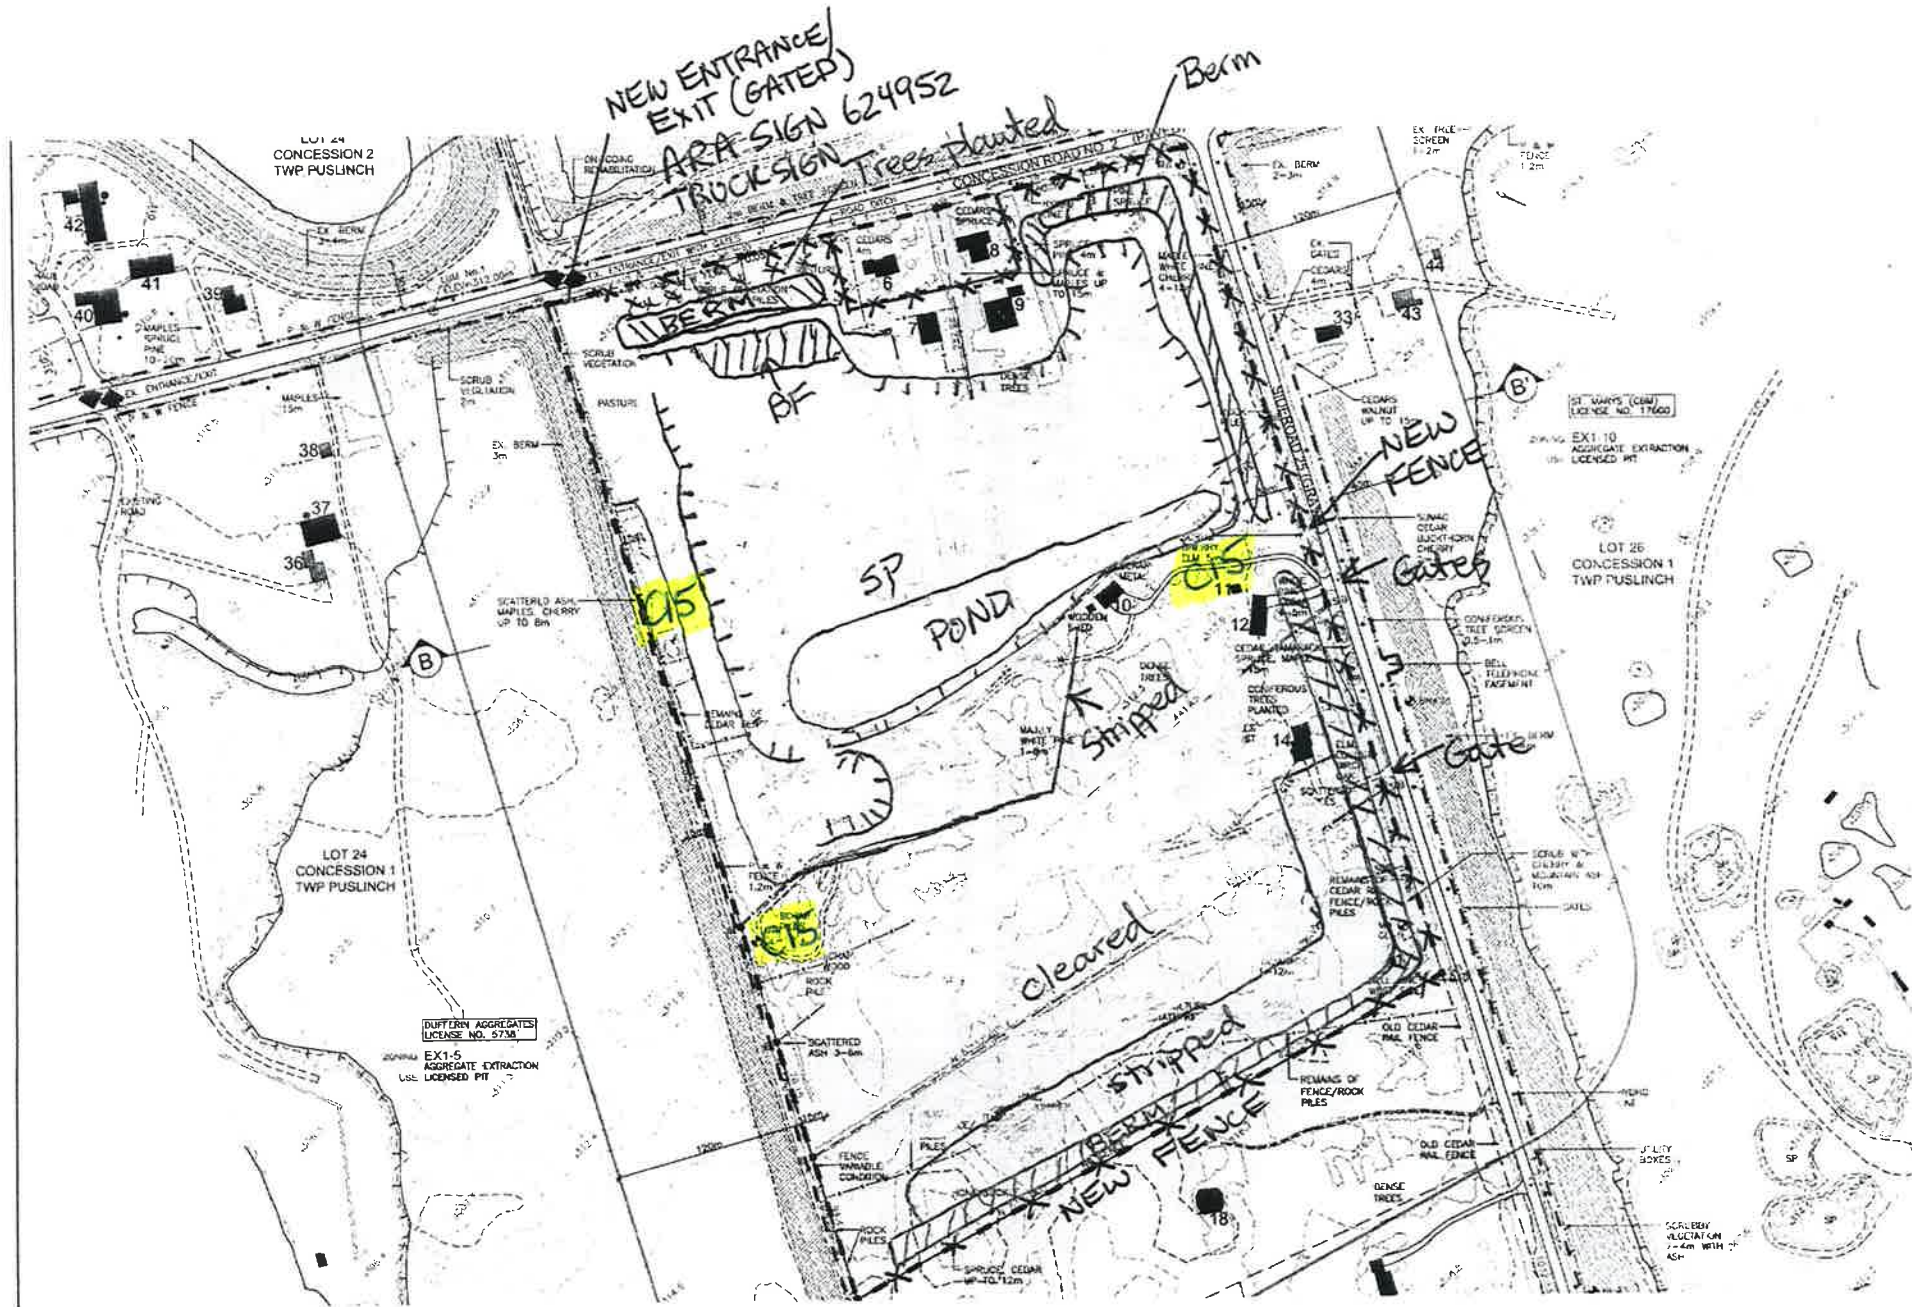
CBM Lanci Pit
 Ref # 624952
 1:4800

B6 Screening (trees/berms)	X			Berms have been constructed adjacent to Concession 2 and are under construction along Sideroad 25 and south boundary. Coniferous trees planted along north setback, west end.	
B7 Setbacks (15m / 30m or other)	X			Northern section of 15 m west setback area has been stripped for haul road into pit as shown on the site plans. See general comments.	
C - Operational Details					
C8 Operating Sequence	X			Above and below water extraction has occurred in Area 1. Trees have been cleared and stripping proceeding south into Area 2	
C9 Stripping (overburden)	X			Stripped topsoil and overburden stored in perimeter berms on site and used for progressive rehabilitation of the northern pit face.	
C10 Overburden Seeded	X			Berms have been seeded. Established berms are well vegetated.	
C11 Extraction Depth	X			Maximum depth allowed - +/- 293.5 m asl Lowest floor elevation +/- 294 m
