RE: Monitoring Report CBM - St Mary's Cement McMillan Pit (License#5737)

# Licensees Compliance Assessment Report - Aggregate Resources Act

# Wellington Pit - Licence I.D. 20085

## Compliance Assessment Report Sketch - 2013

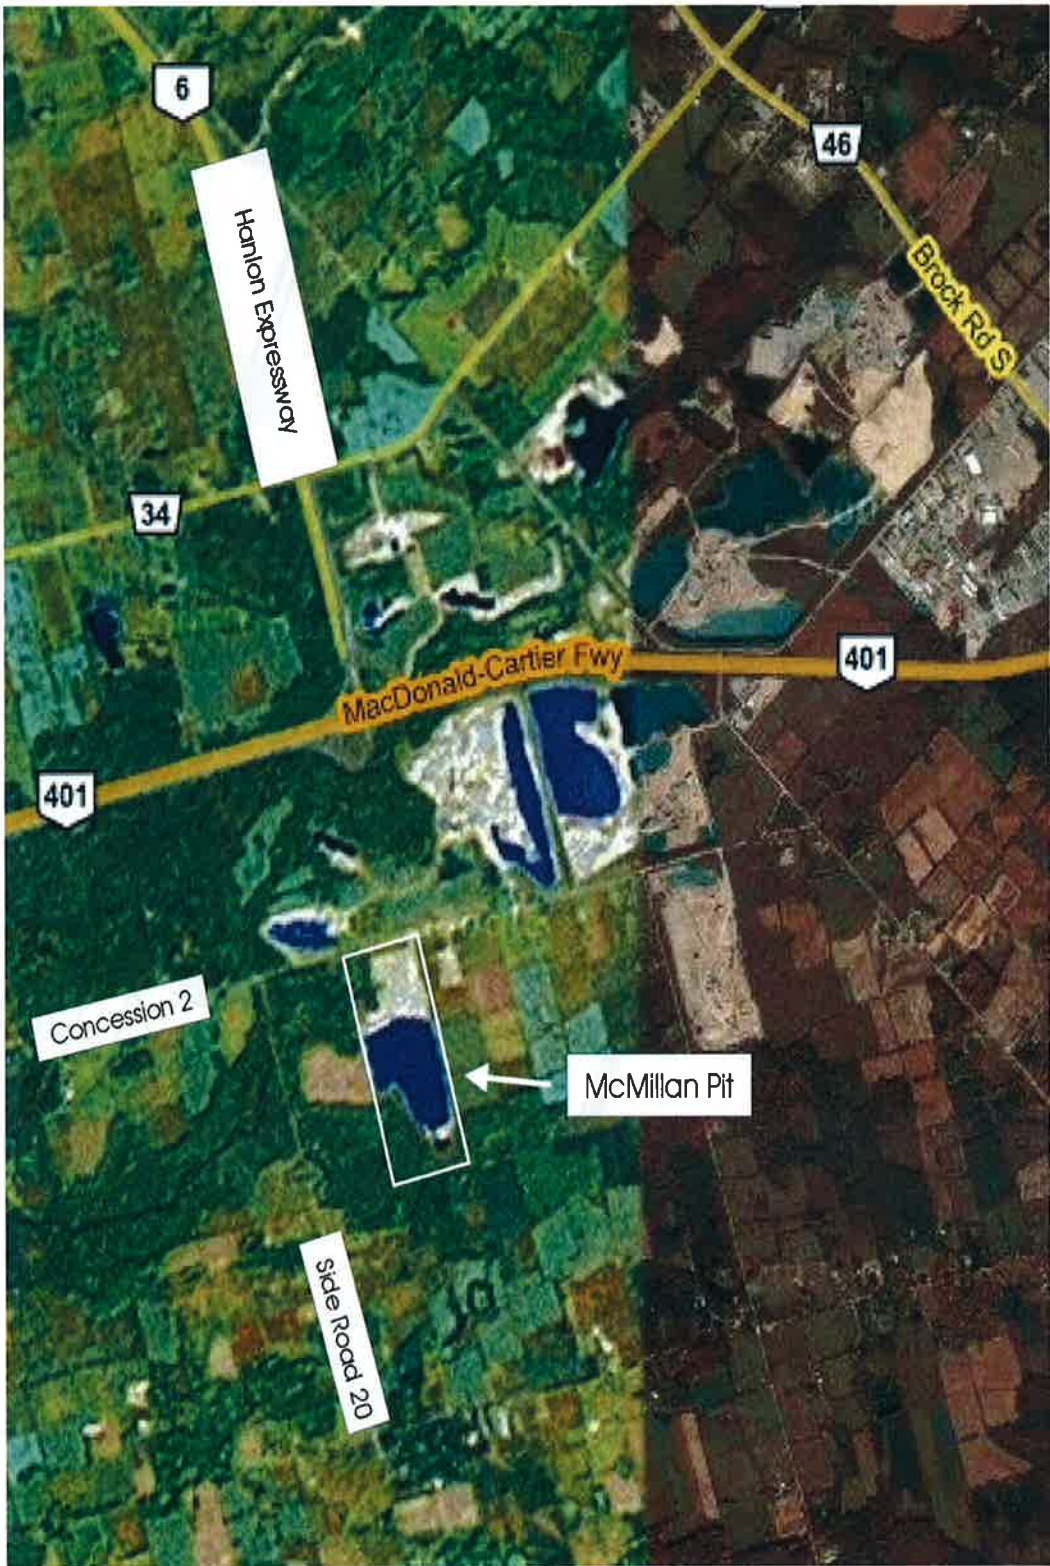
Figure 1: McMillan Pit Location.

Tributary 3 of Mill Creek is the nearest discharge point of groundwater crossing the pit site, and reflects the quality of groundwater discharging from the McMillan Pit (Figure 1). Water quality monitoring is based on an assessment of the benthic biota that Tributary 3 supports. The community of benthic biota is subject to the full rigor of the environment through the annual or biannual life cycles of the species. The community therefore represents the integrated temporal effects of all pollutants and environmental conditions through the year and not only those conditions at the time of sampling.

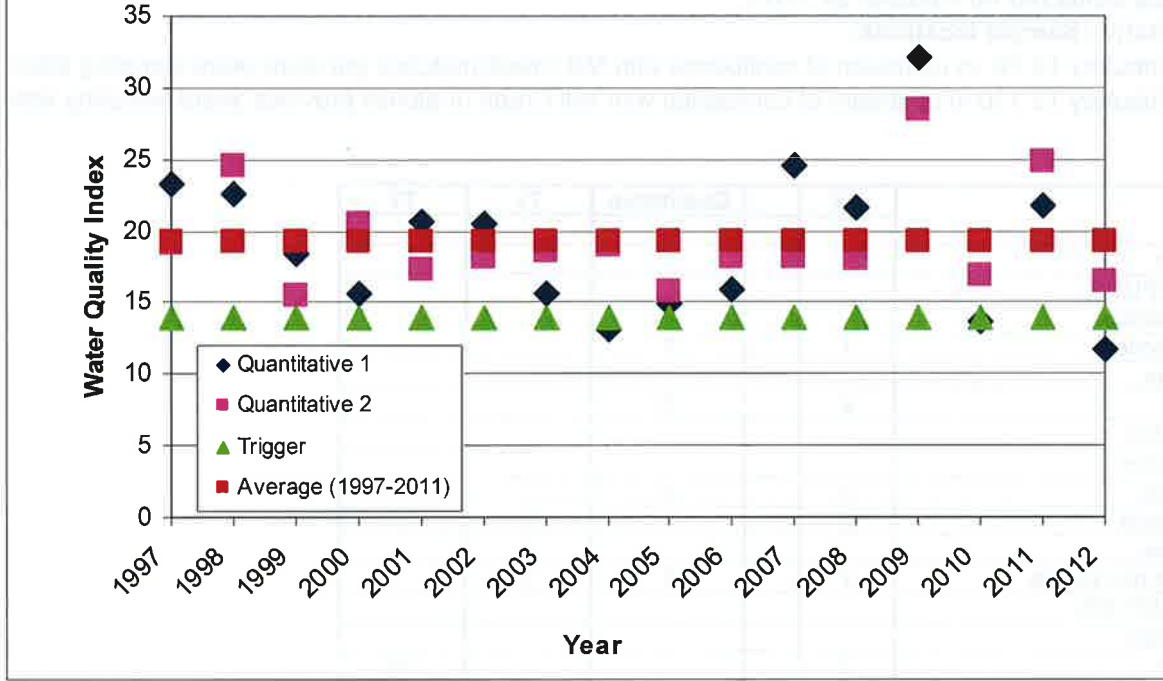
**Figure 3: St. Mary's CBM McMillan Pit BioMAP Water Quality Index Results (1997 to 2012)**

Results of the BioMAP analysis from 1997 – 2012 are tabulated in Table 1 and shown graphically in Figure 3. Results show the average WQI for 2012 is 14.1, just above the trigger of 14. The T1 value is 11.7 and the T2 sample value is 16.5. The species composition represents an unimpaired creek and is similar to previous years. For the first time in 2011, a third sample(T3) was collected in Tributary T3 closer to Mill Creek in the hopes of expanding the area available for sampling since the number of individuals per sample remains extremely low due to high sand contents of the bed material that limits available niches for benthic invertebrate production. However, the lower water quality index at that location suggests that it is more typical of the much larger Mill Creek waterway and that the sampling location selected is likely under the influence of Mill Creek flooding and is not representative of the tributary water quality. Therefore, no expansion of historical sampling is justified, and sampling in 2012 continued with just the original 2 locations only.

For 2012 the average water quality index values remain above the trigger level of 14. While the value at the T2 site is below the previously calculated range of water quality values, the overall species composition continues to reflect the community collections of previous years. The mean sensitivity value for 2012 is 3.25 and the benthic community in Tributary 3 remains representative of a southern Ontario unimpaired creek. No negative impacts to water quality due to extraction activities have been detected in the 2012 sampling.
