**RE: Ecology Peer Review – Dufferin Aggregates Mill Creek Pit Phase 6 2023 Ecological Monitoring Report (GEC, 2024)**

## **2023 Ecological Monitoring Report**

**Dufferin Aggregates Mill Creek Pit - Phase 6**

**June 2024**

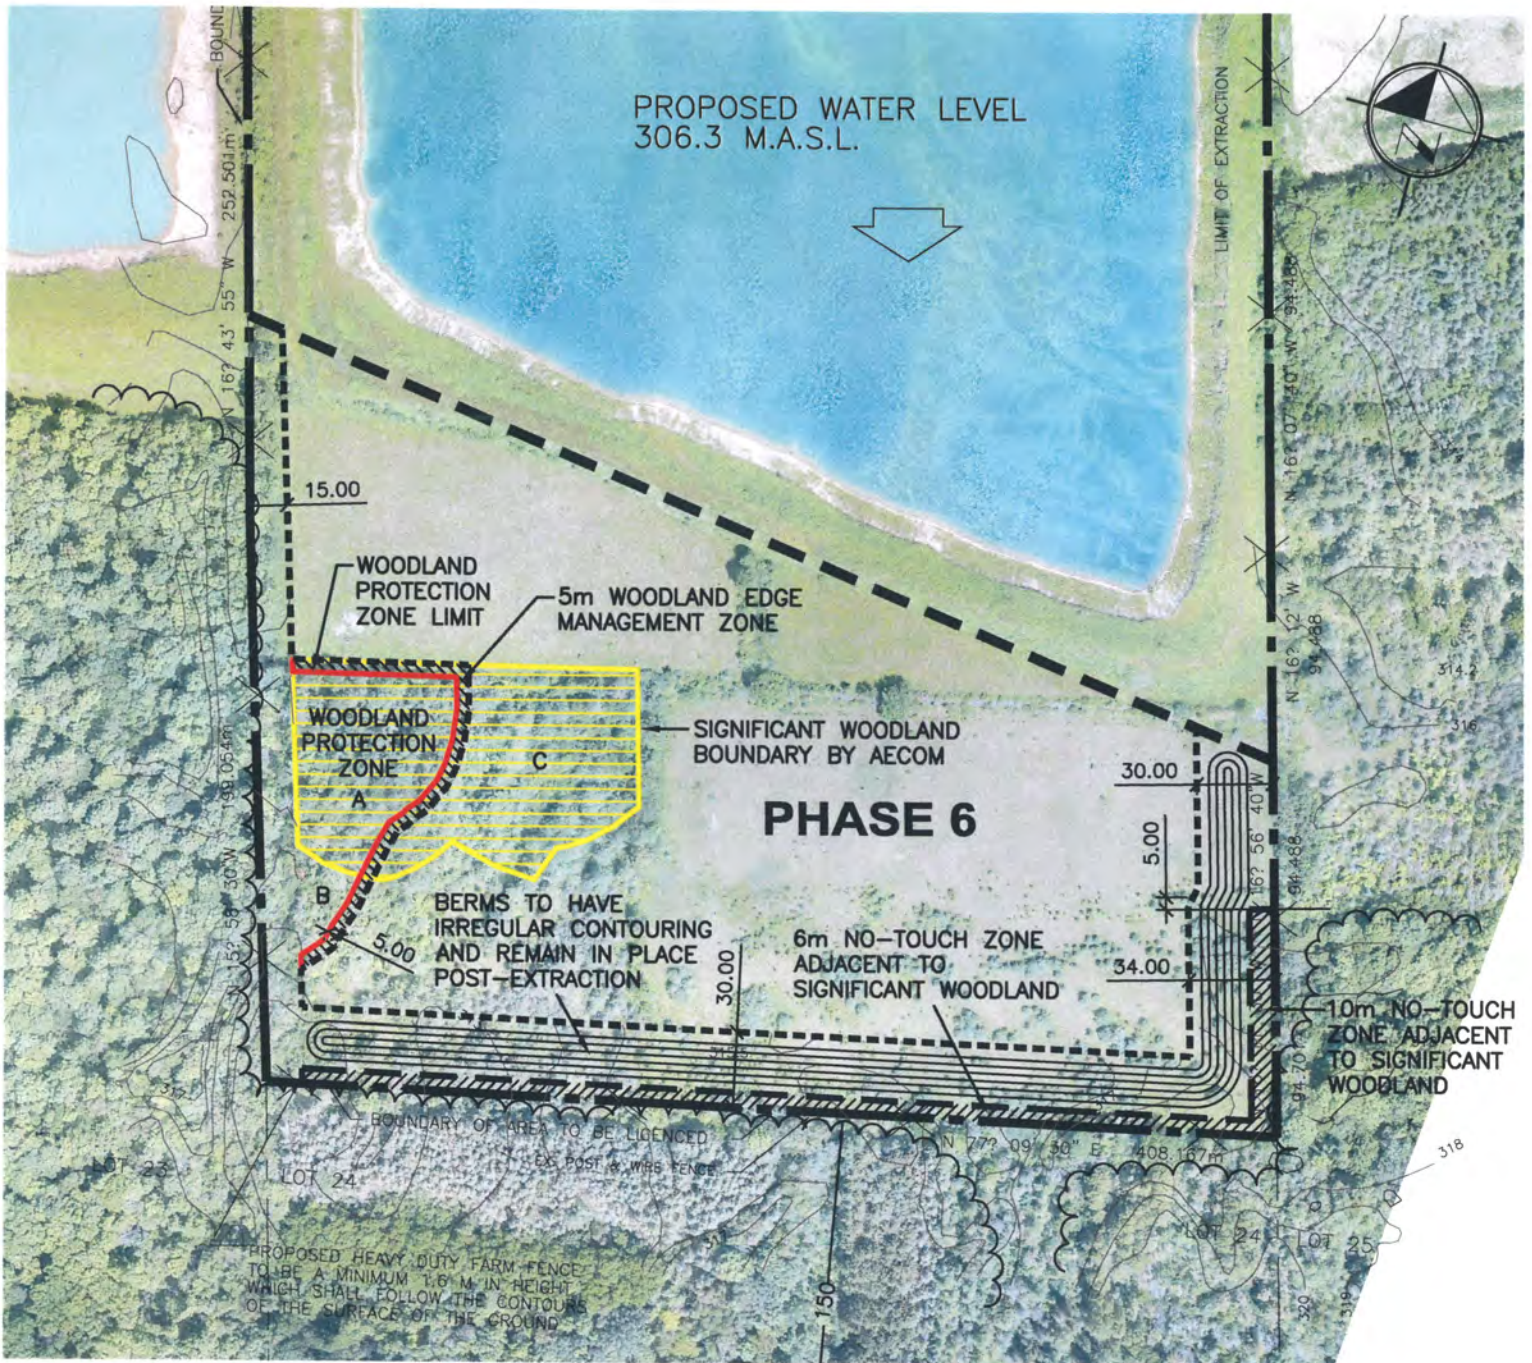
**FIGURE 2**  
**REVISED EXTRACTION FOOTPRINT**  
**MILL CREEK PIT**

Dufferin submitted their Major Site Plan Amendment to the Mill Creek Pit (Licence 5738) in 2015, along with applications for related Official Plan and Zoning By-law Amendments to the Township of Puslinch. The Mill Creek Pit is owned by the University of Guelph and is located on Part Lot 24 Concession 1 and Part Lots 21-24 Concession 2 in the Township of Puslinch, County of Wellington (**Figure 1**). The Mill Creek site is approximately 188.6 ha in size. The 6.53 ha Phase 6 extraction area is a southerly extension, within the licensed boundary, of existing Phase 2 (**Figure 2**).

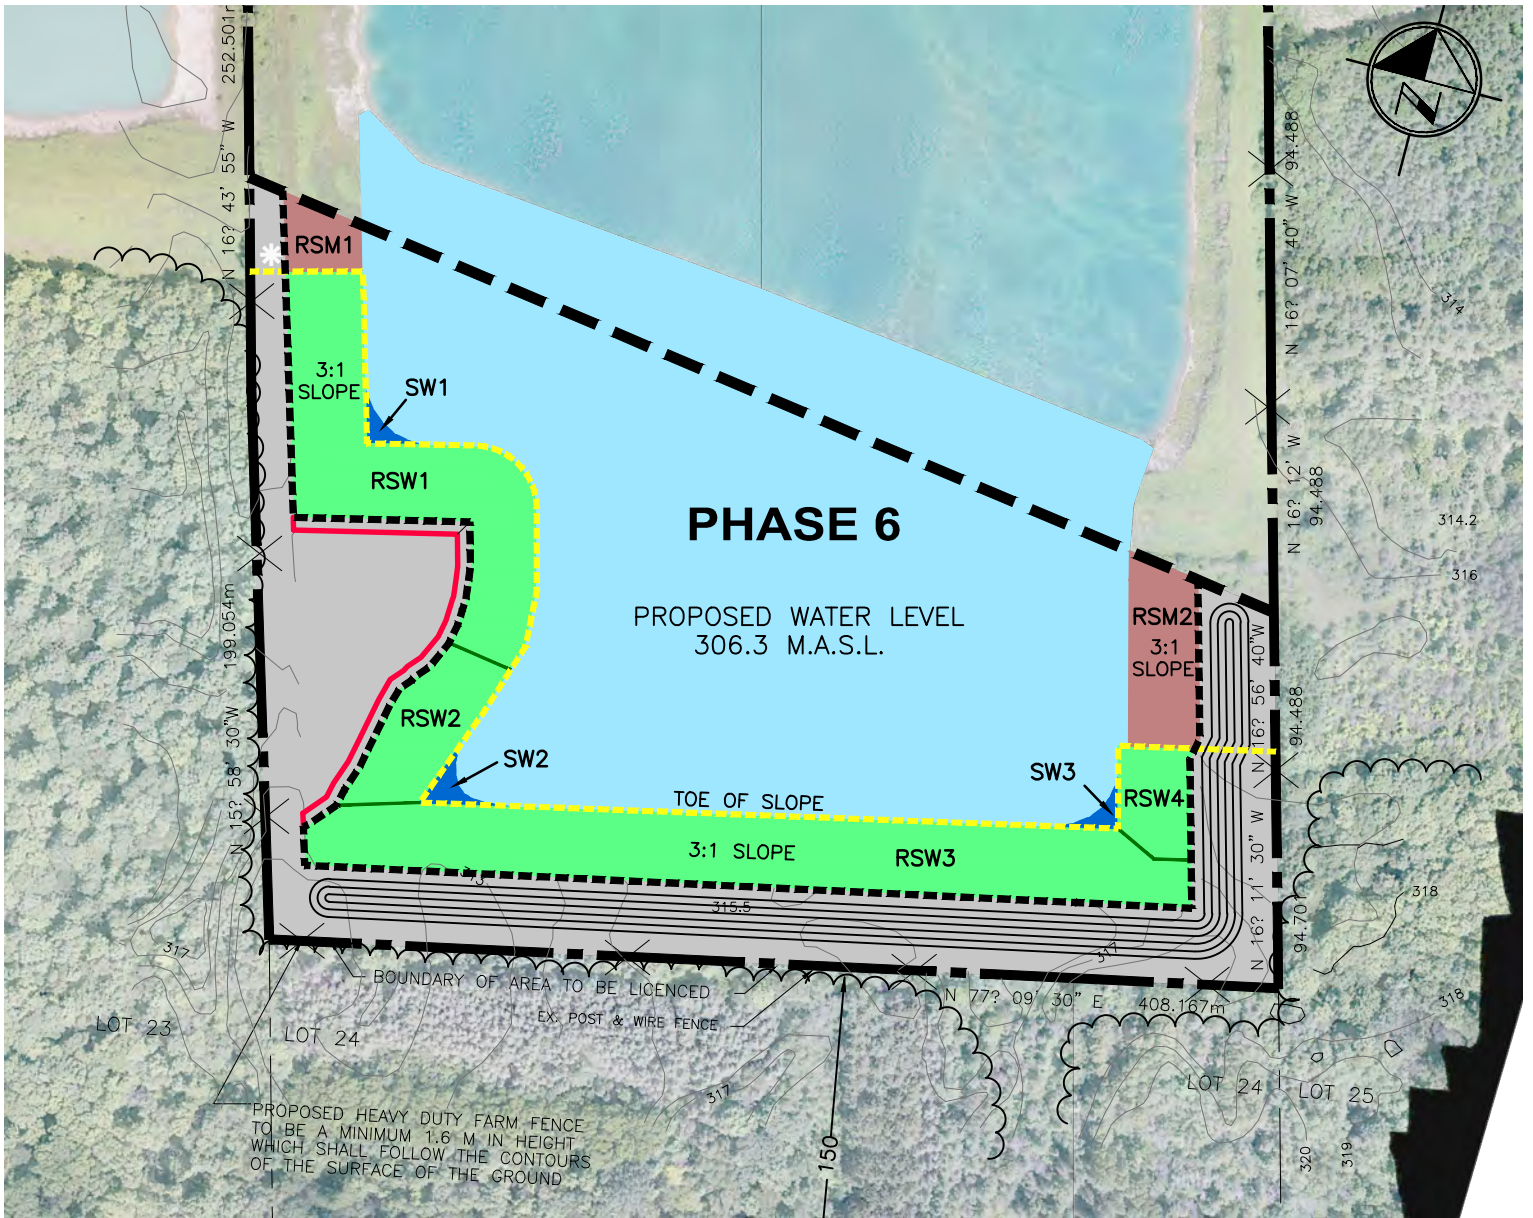
**FIGURE 4**  
**REHABILITATION PLAN**  
**MILL CREEK PIT**

**Figure 4** shows the various rehabilitation units included in the Rehabilitation Plan. The progressive rehabilitation of Phase 6 commenced in November 2020. Pit Rehabilitation Unit RSW2 and the southern portion of Unit RSW1 were created in 2021; this work included the creation of the side slopes, placement of habitat features including boulders, rock piles and woody debris (e.g., stumps root wads, logs, etc.), and seeding with a non-invasive seed mix.

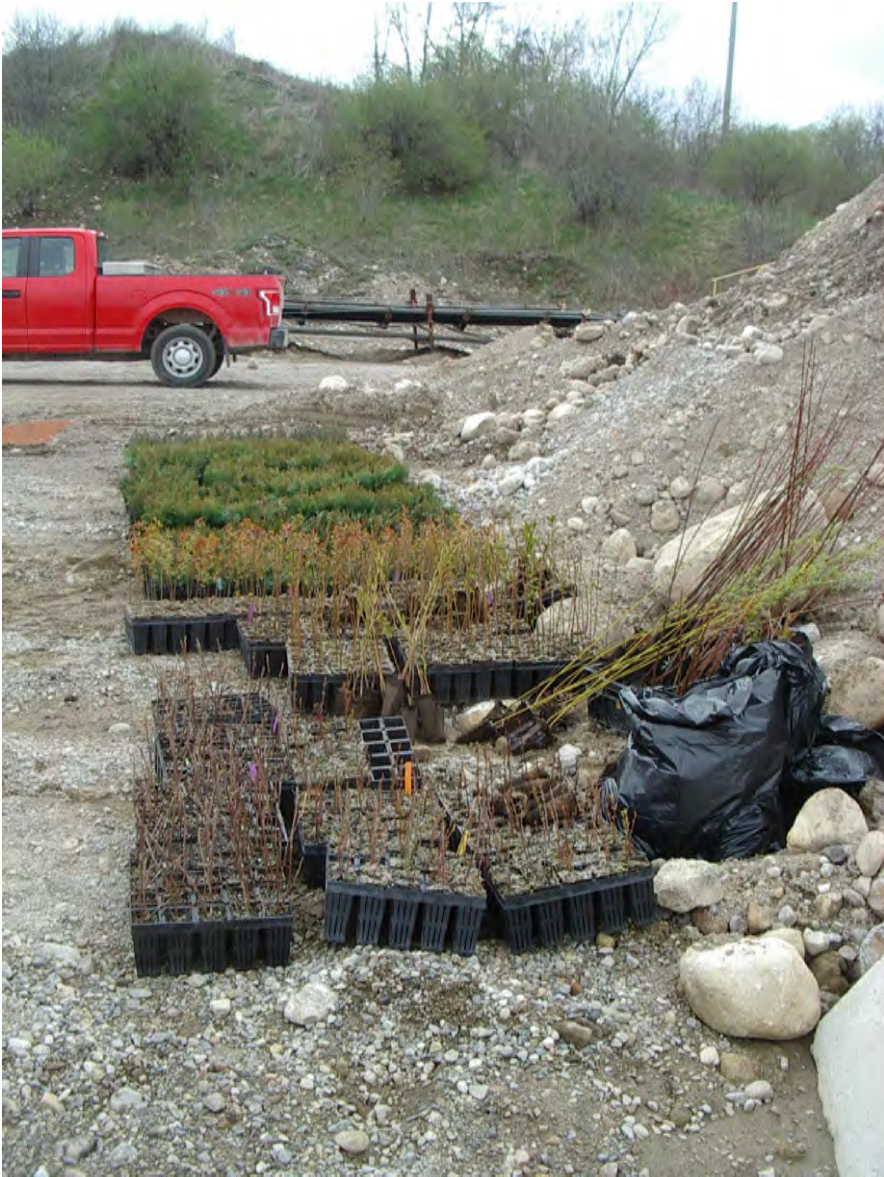
Photo 1: Plugs of native trees and shrubs were planted on the Phase 6 rehabilitation side slopes on April 25-27, 2023.  
GEC 2023-04-25.

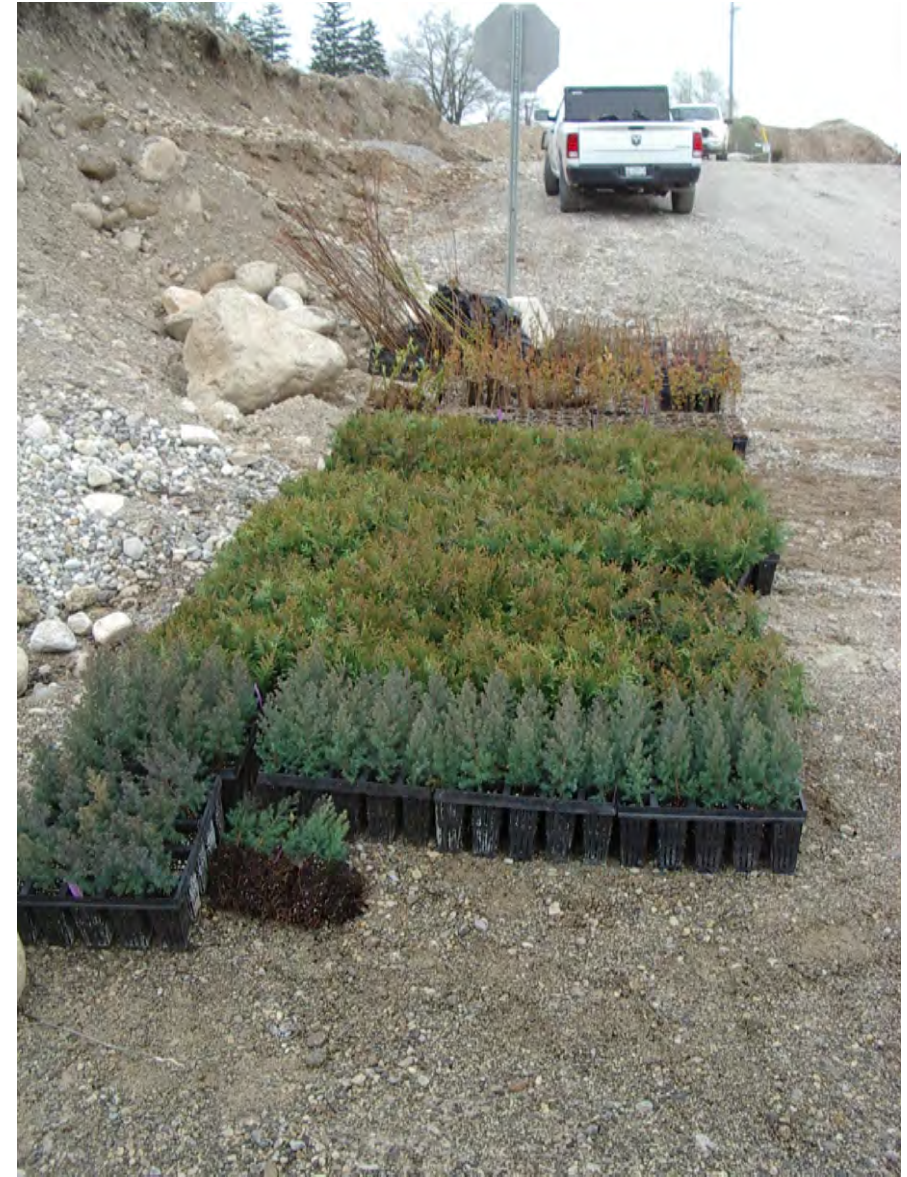
Photo 2: Plugs were selected due to the limited access and difficult terrain in Phase 6. Planting large numbers of container-grown stock was not practical. GEC 2023-04-25

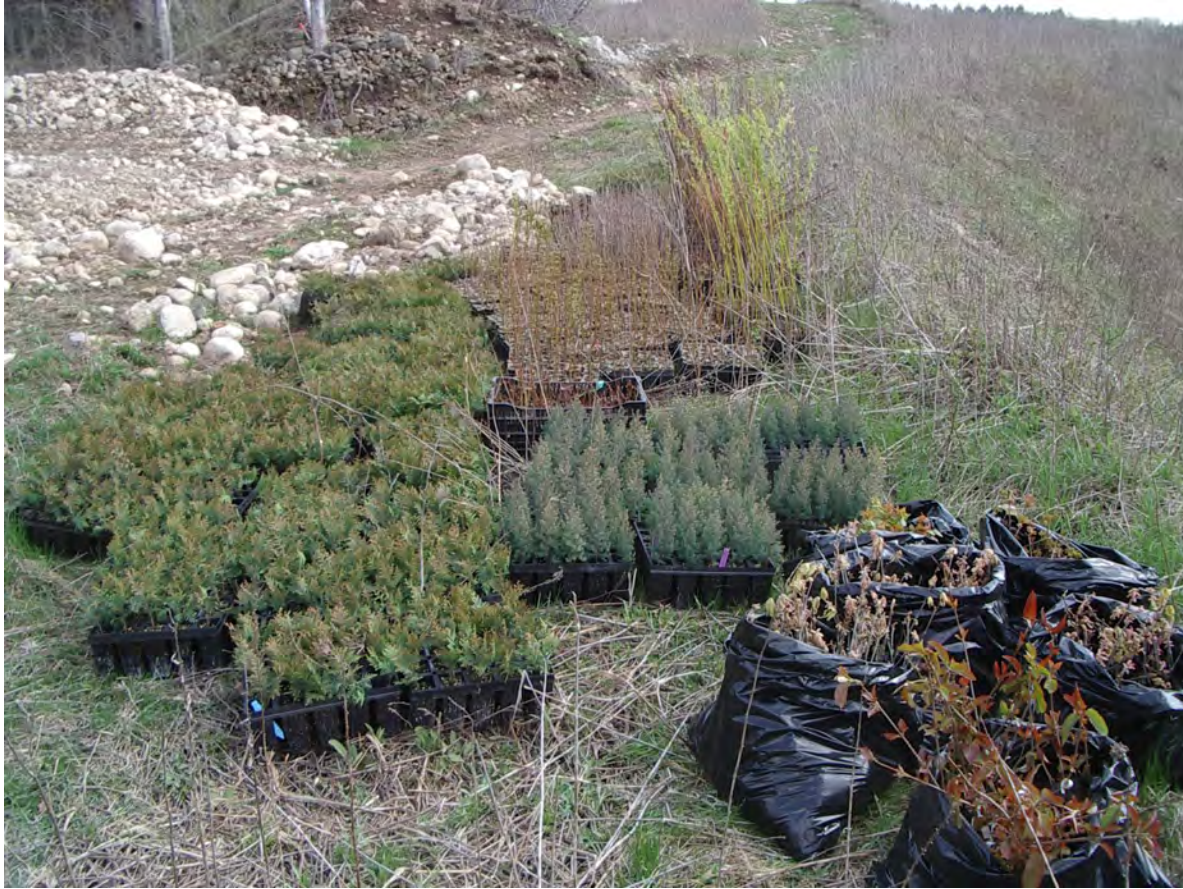
Photo 3: A large proportion of the species selected are early successional pioneering species such as White Cedar, White Birch and Red Cedar. Longer-lived tree species such as White Oak, Bur Oak and Red Maple were also planted in some areas.

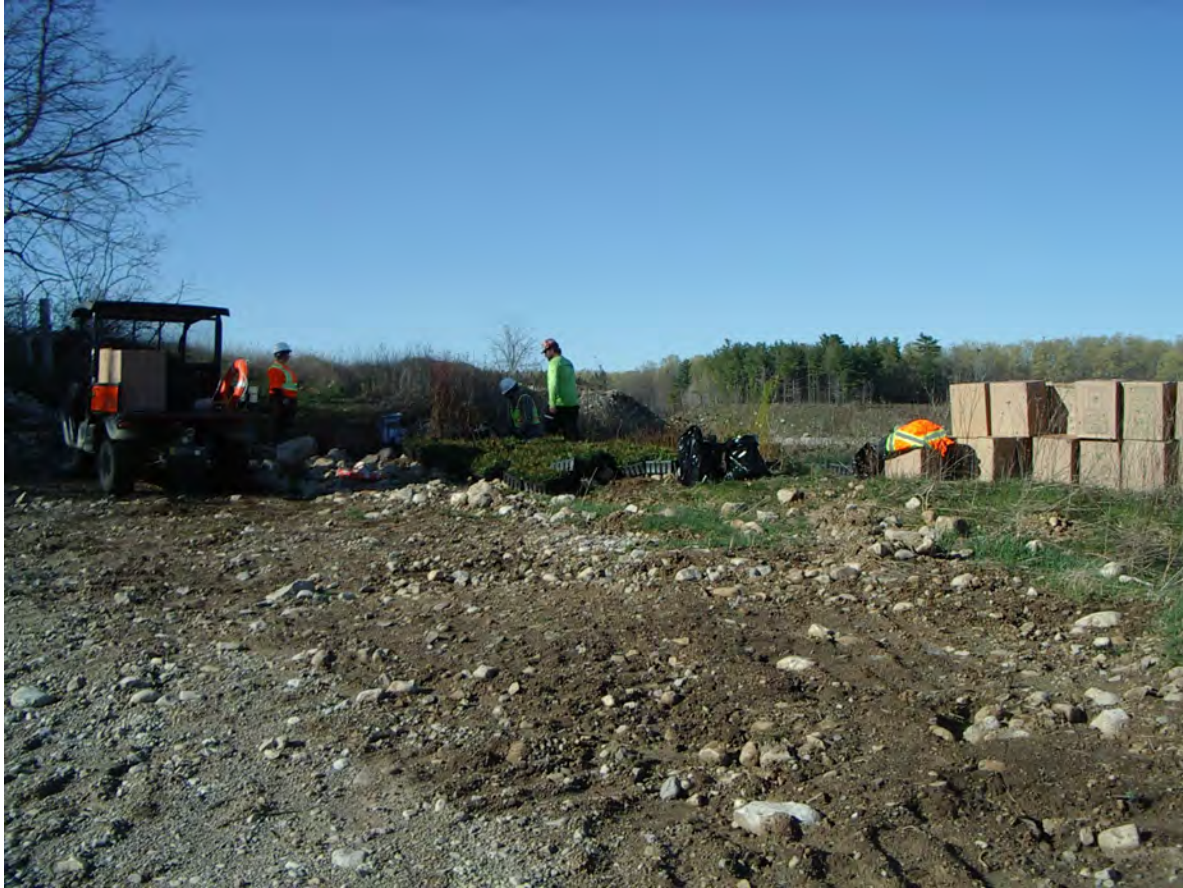
Photo 5: Tamarack Reforestation planted a total of 3844 trees and 1221 shrubs.  
GEC 2023-04-25

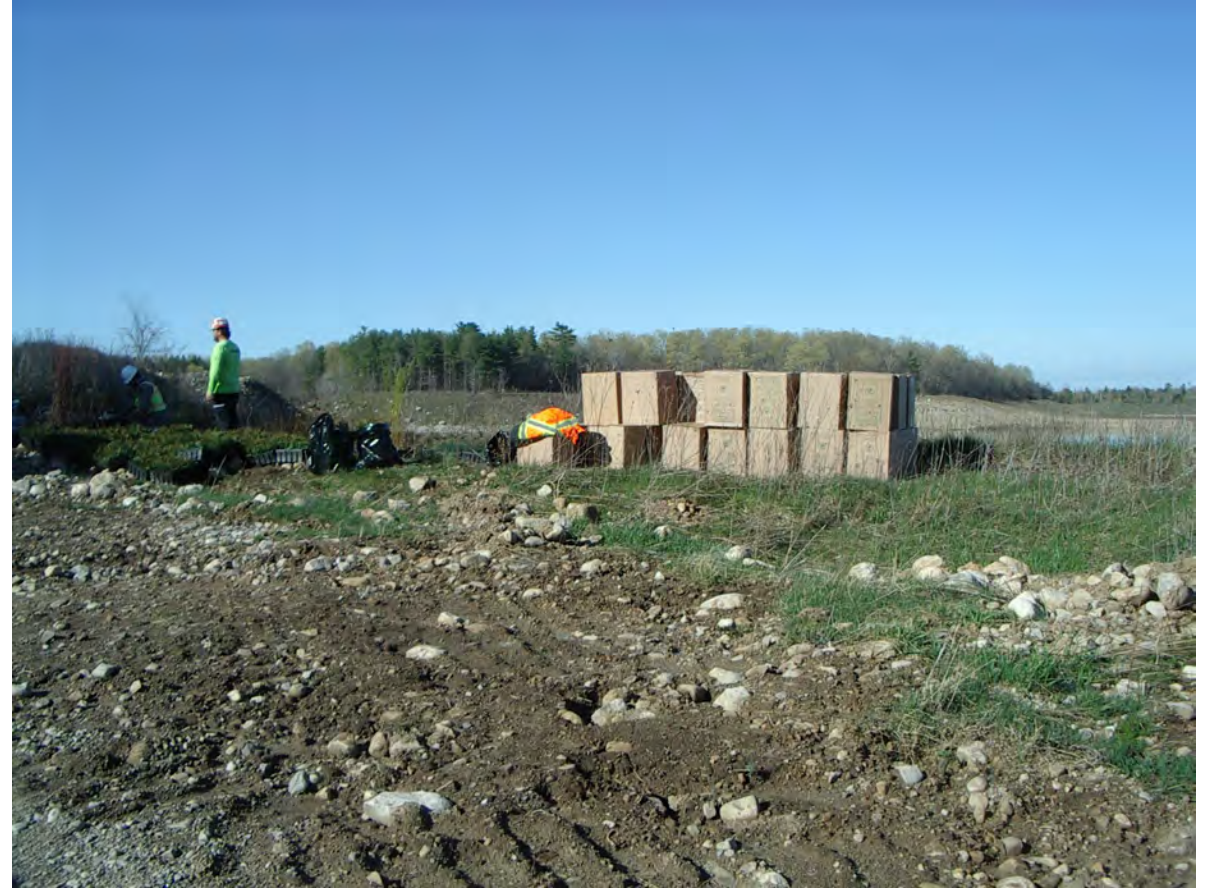
Photo 6: The cardboard boxes contain Cocodisc weed control mats. Each planting had a mat installed, to help control weedy competition and improve soil moisture retention.  
GEC 2023-04-25

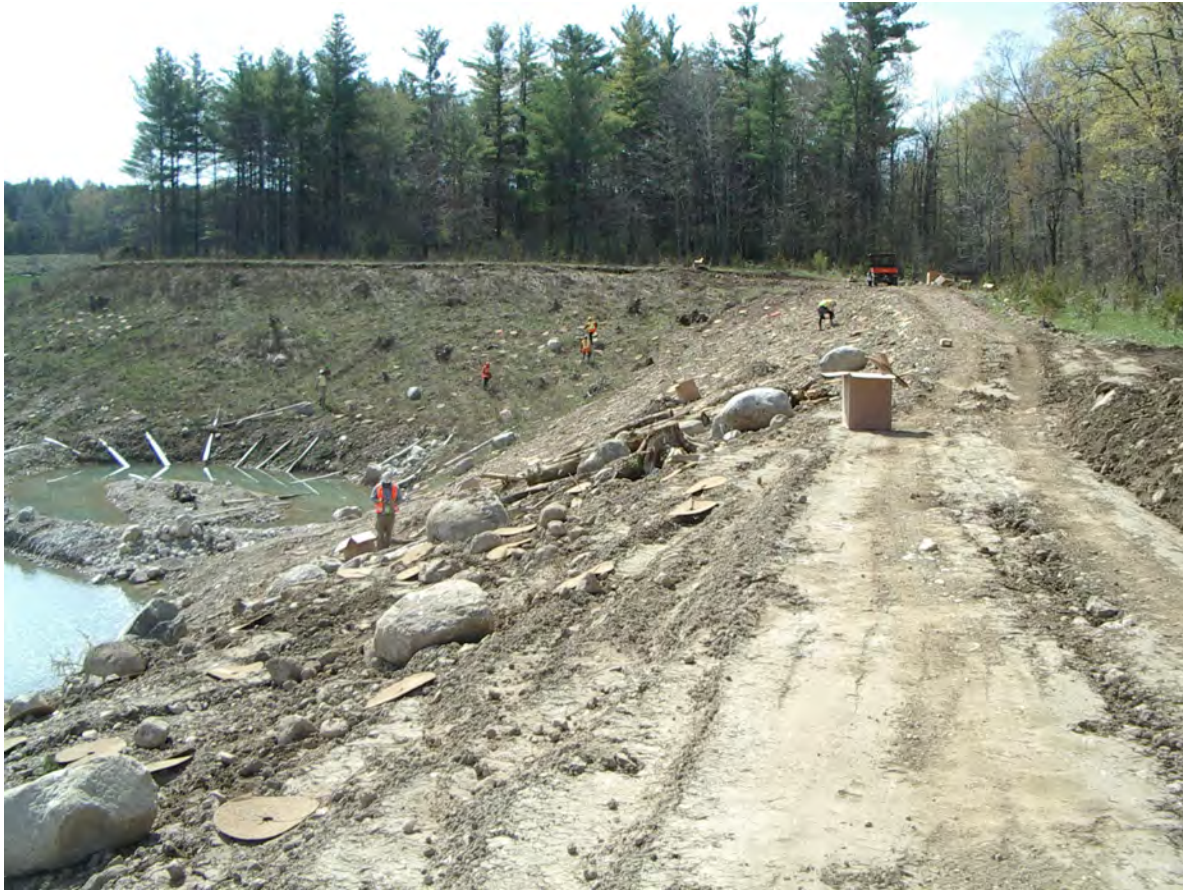
Photo 7: View looking south at side slope Unit RSW1 and Shoreline Wetland SW1.  
GEC 2023-04-27

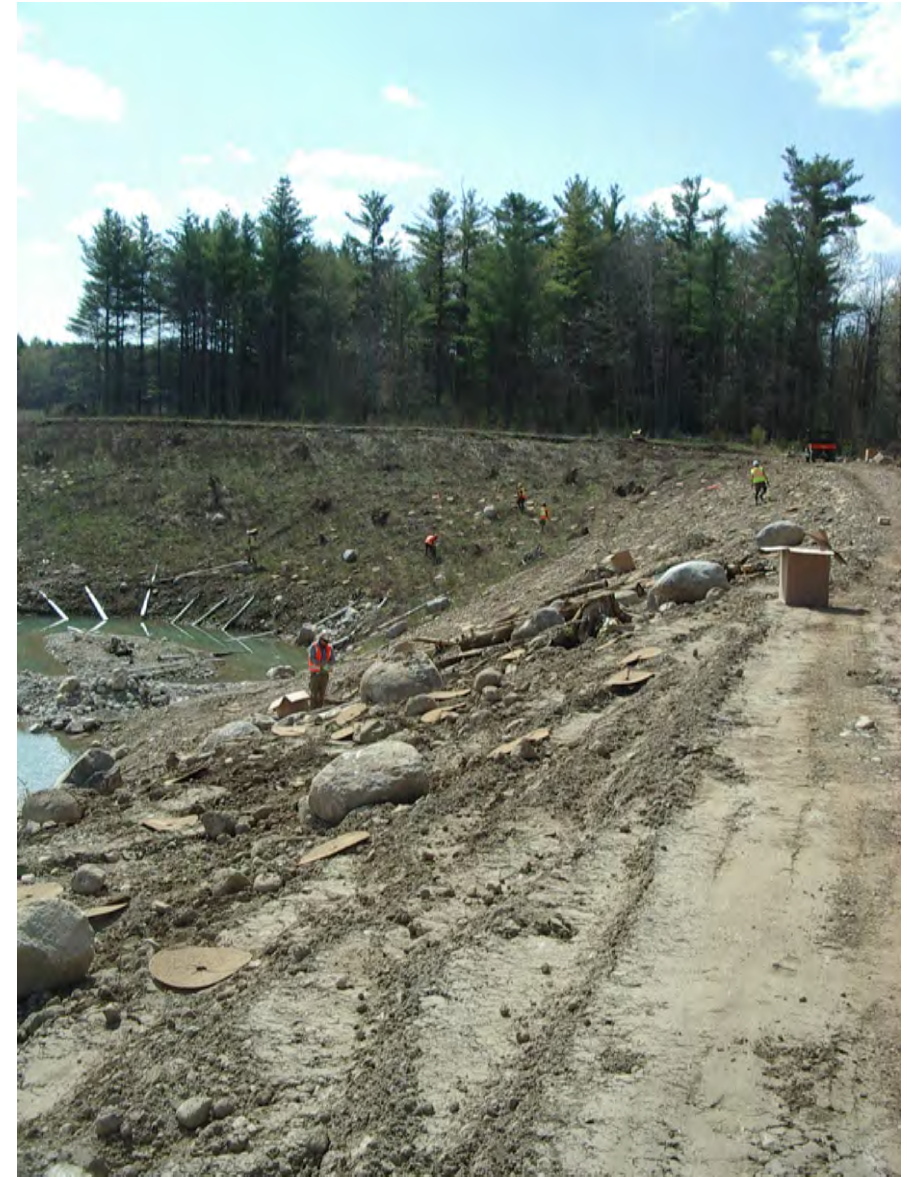
Photo 8: Second view of Units RSW1 and SW1. The White Pine stand in the distance was excluded from the Phase 6 extraction area by Dufferin Aggregates. GEC 2023-04-27

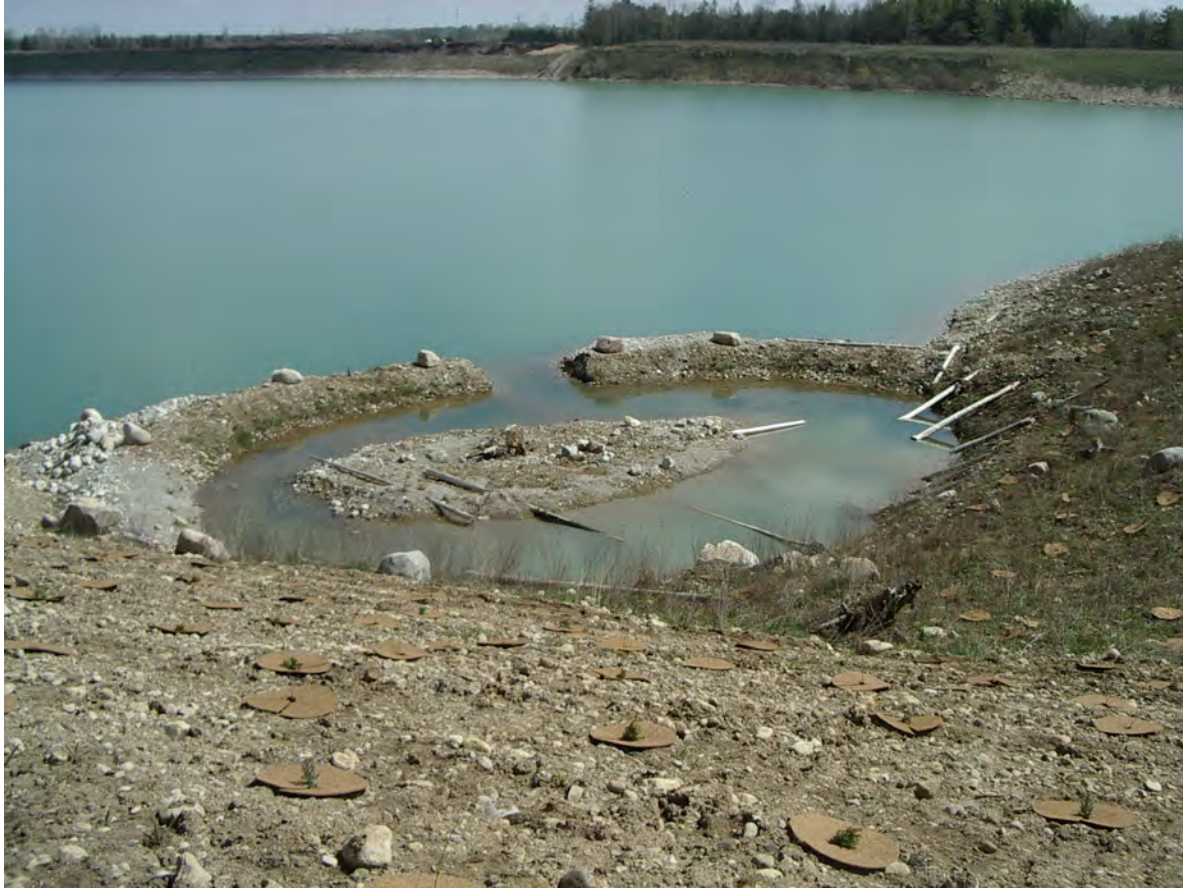
Photo 9: View of Shoreline Wetland SW1. The wetland has a surface water connection to the Phase 2/6 Lake and a number of habitat features including rock piles, gravel bars, stumps and logs. Note the Cocodisc weed control mats being installed on the plantings in the foreground. GEC 2023-04-27

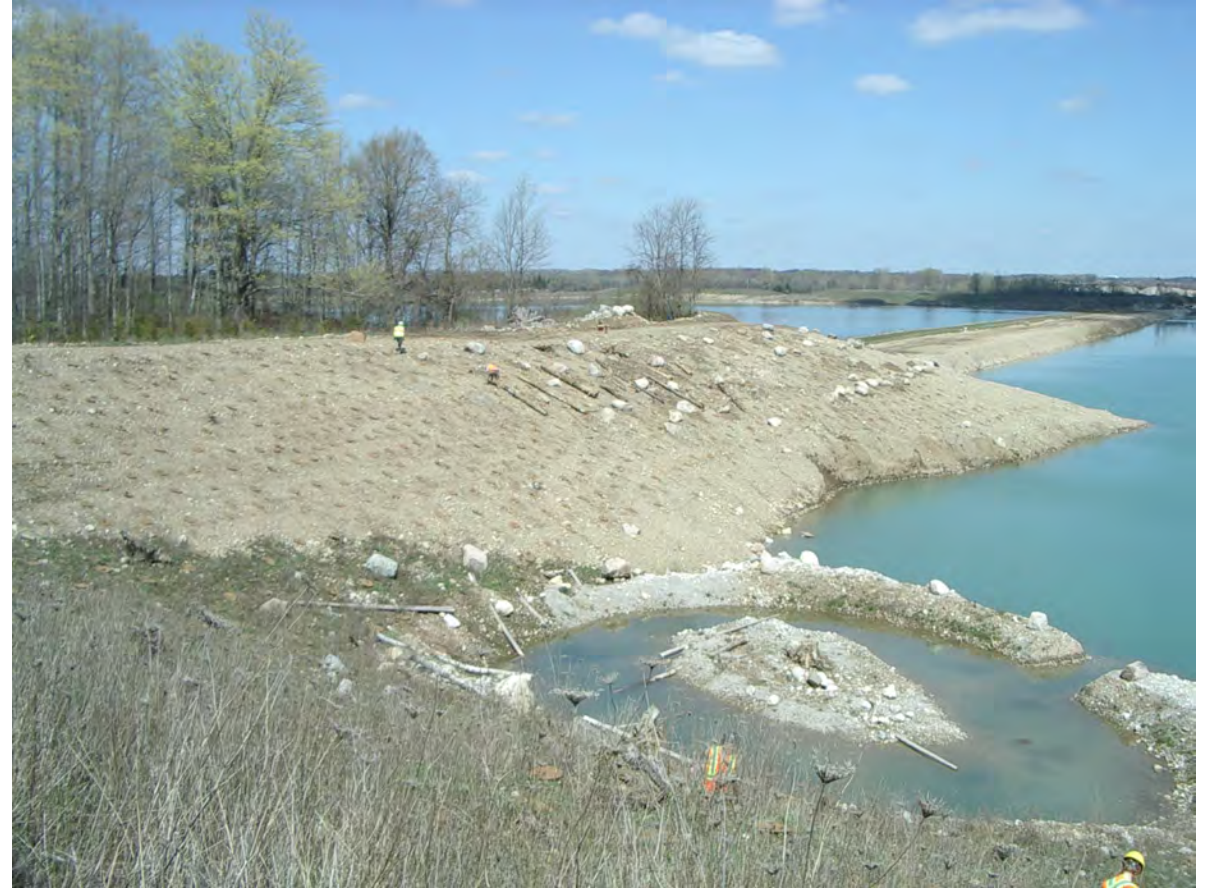
Photo 10: View looking northwest towards Shoreline Wetland SW2 and side slope Unit RSW1. Note the tree-planters from Tamarack Reforestation on the slopes. GEC 2023-04-27

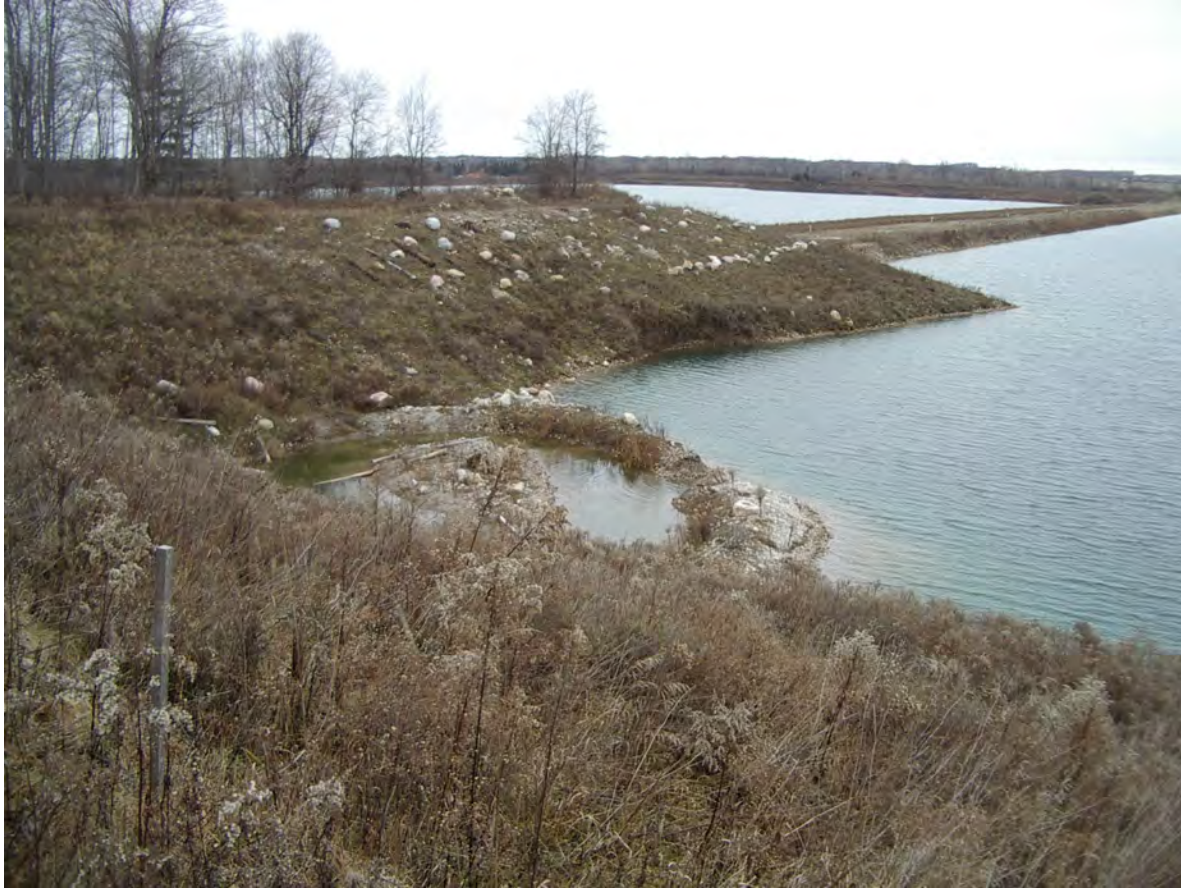
Photo 11: Similar view to that shown as Photo 10, taken late in the year, showing Shoreline Wetland SW1 and rehabilitation side slope Unit RSW1. GEC 2023-12-30

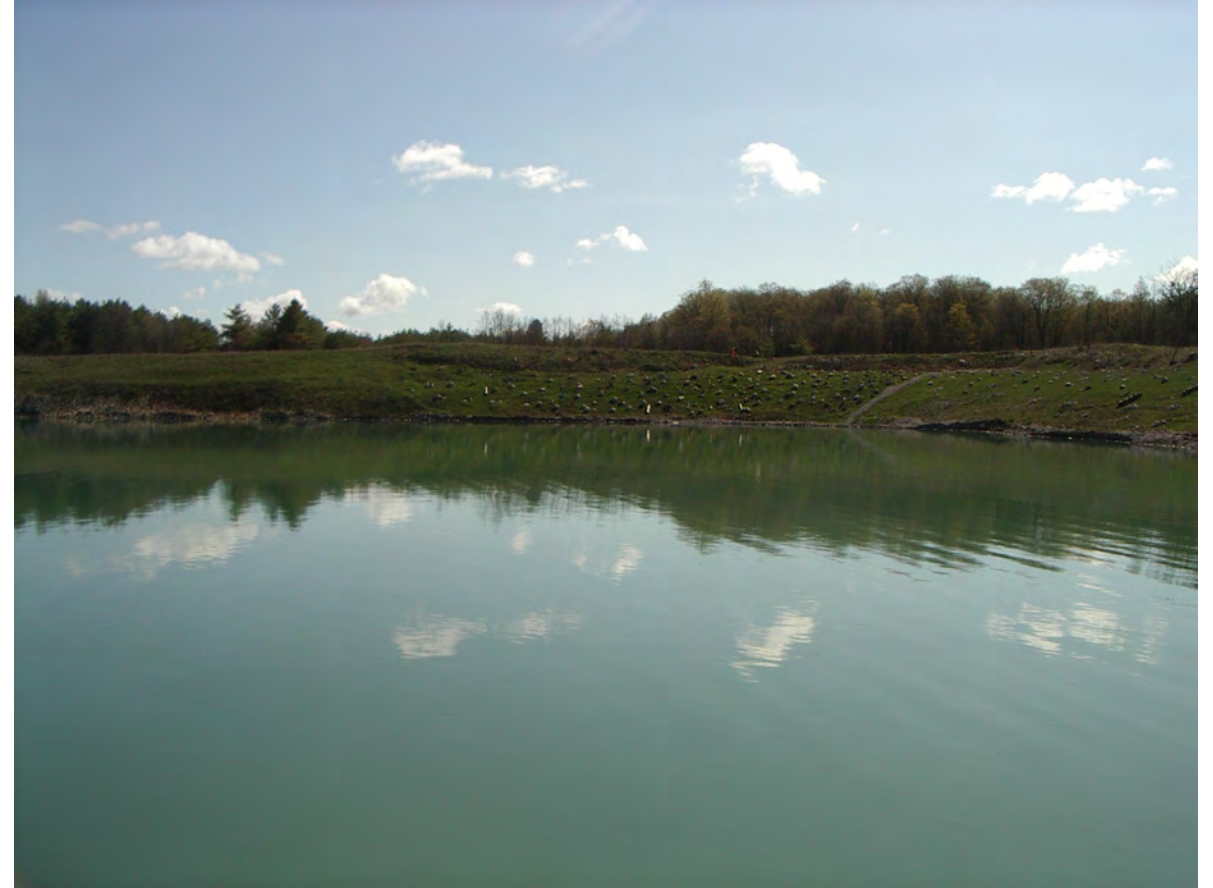
Photo 12: View looking east towards rehabilitation side slope Units RSM2 (left), RSW4 (middle) and RSW3 (right). GEC 2023-04-26

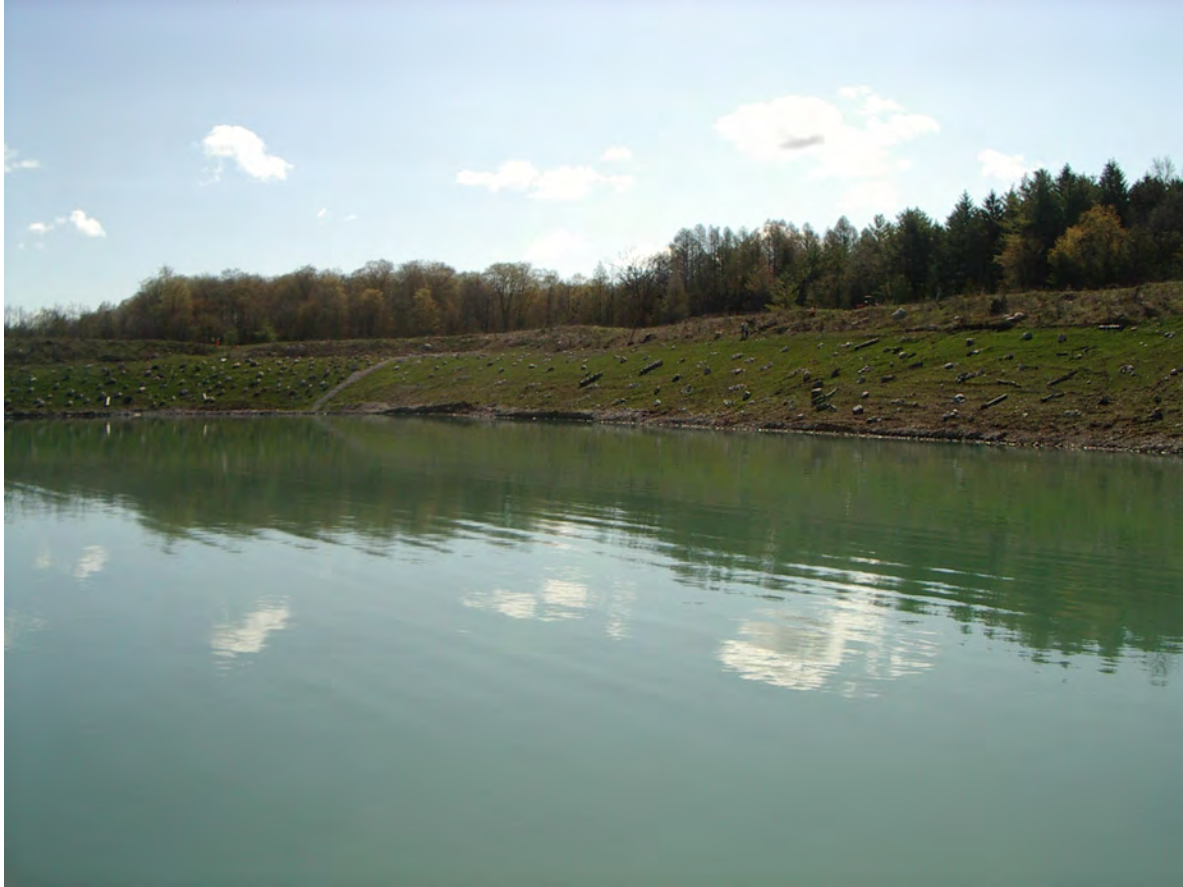
Photo 13: View looking southeast towards rehabilitation side slopes RSW4 (left) and RSW3. GEC 2023-04-26

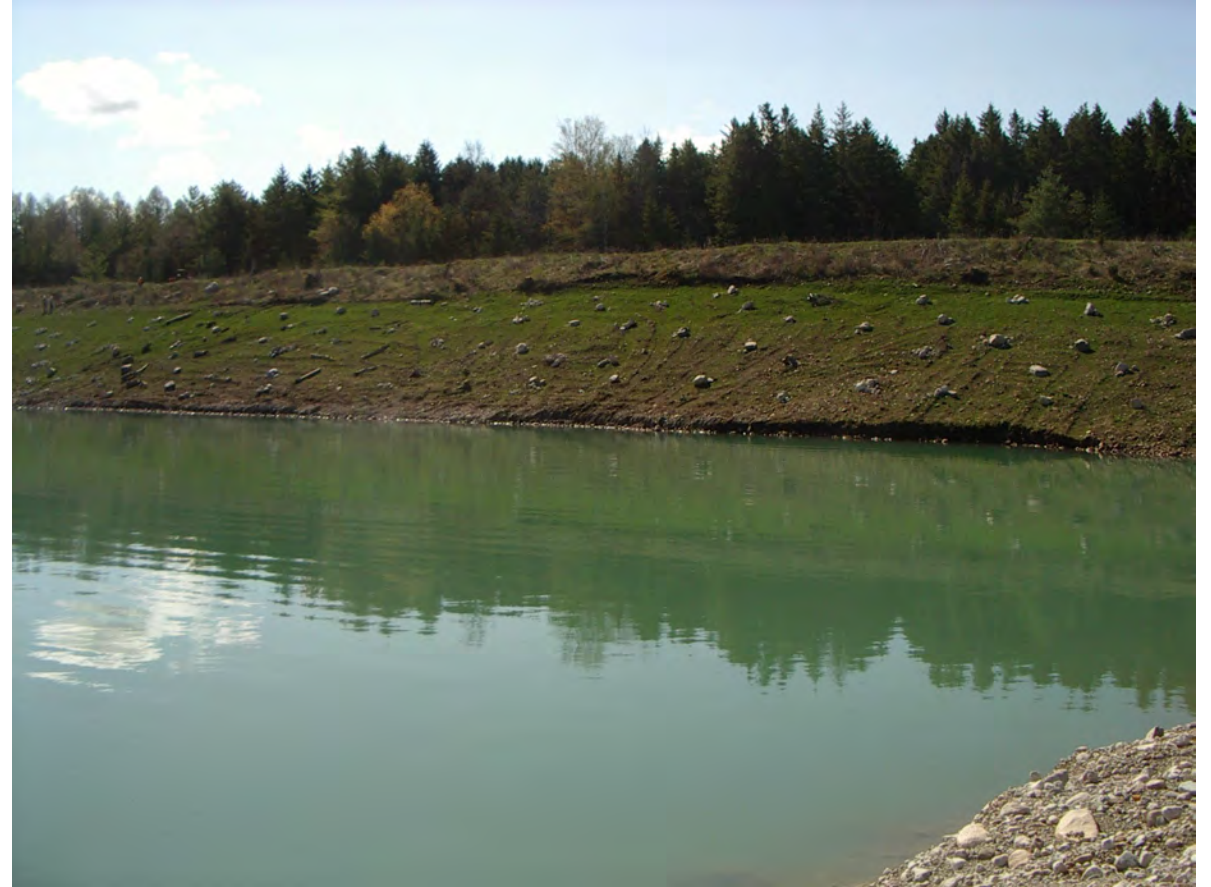
Photo 14: View looking south southeast towards rehabilitation side slope Unit RSW3. GEC 2023-04-26

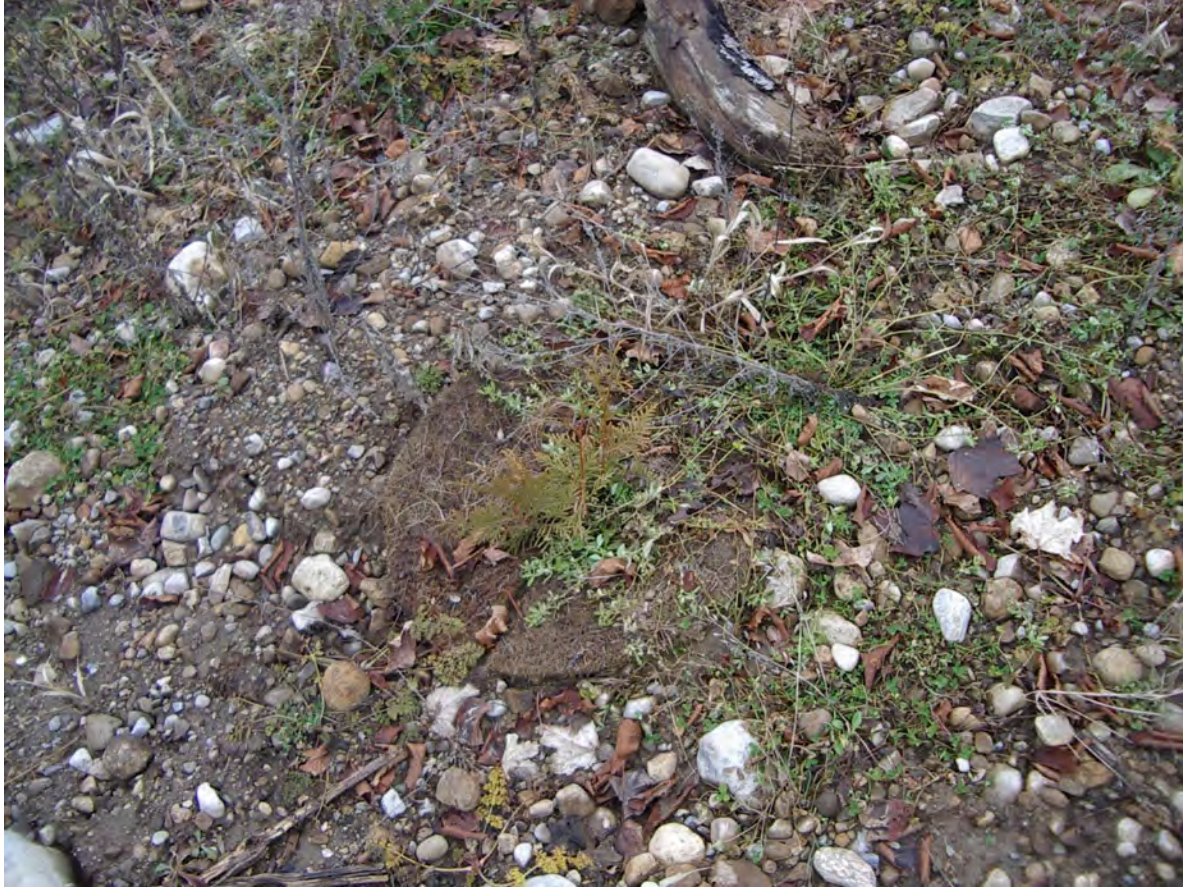
The tree and shrub plugs that were planted in 2023 on the rehabilitation side slopes showed fair to good survivorship. Conditions were wetter than normal during the spring and early summer period and drier than normal later in the year.

Photo 15: View showing White Cedar planted in April 2023. Despite the challenging conditions, survivorship was fair to good for most of the 2023 plantings.  
GEC 2023-12-30

- Custom native seed mixes should be sown in 2024 on select portions of the rehabilitation side slopes, where unvegetated patches are present.
- Descriptions of any Ecological Management Plan (EMP) and Rehabilitation Plan (RP) activities completed in 2024, including photos, mapping and monitoring observations, should be provided in the 2024 Ecological Monitoring Report, to demonstrate the implementation of the Ecological Management Plan and Rehabilitation Plan within Phase 6 of the Mill Creek Pit.

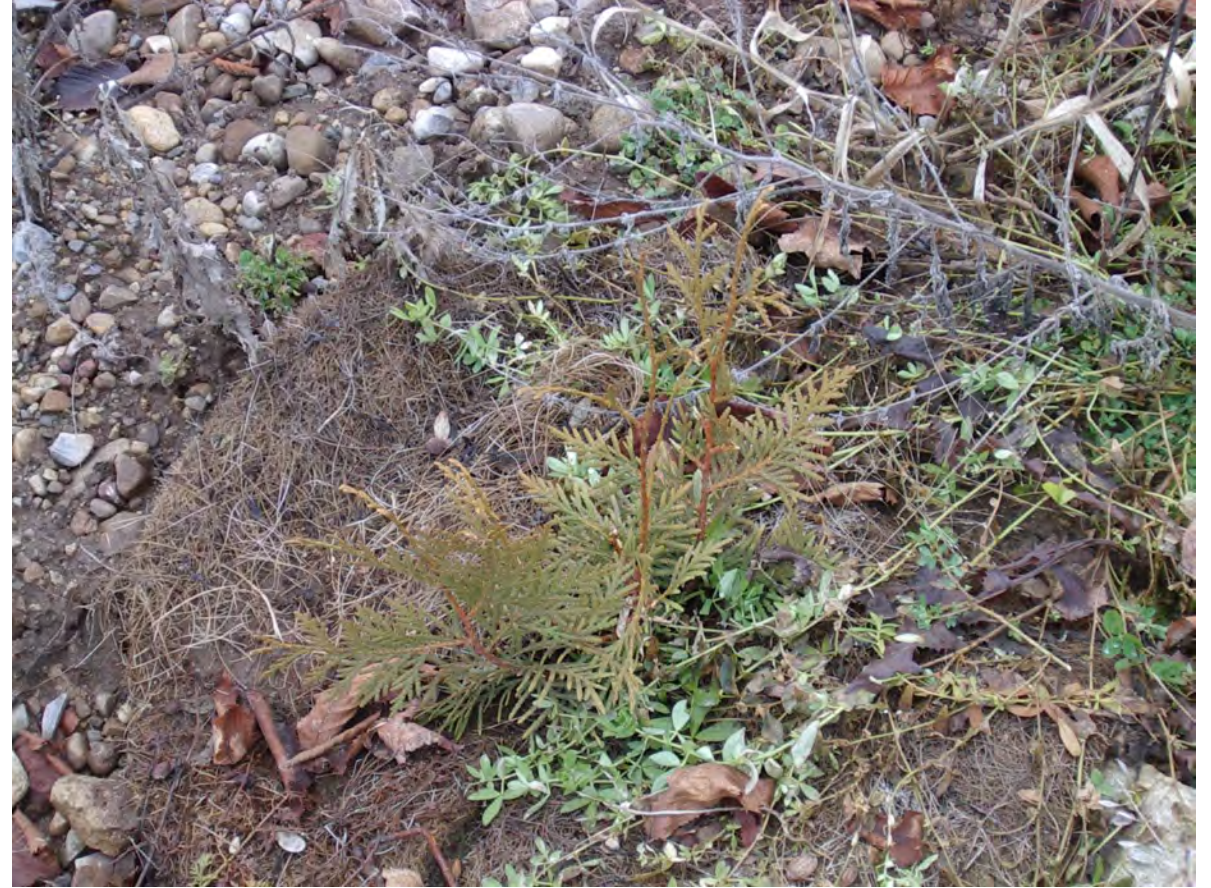
Photo 16: Close-up view of White Cedar planting. The Cocodisc mats control weedy competition and promote soil moisture retention. GEC 2023-12-30
