Comment Summary – September 5, 2024 Submission - Zoning By-law Amendment Application – WDD Main St. Inc.

3rd Submission

RE: **NPG Comments
Main St
RE: Application for Zoning By-law Amendment & Draft Plan of Subdivision**

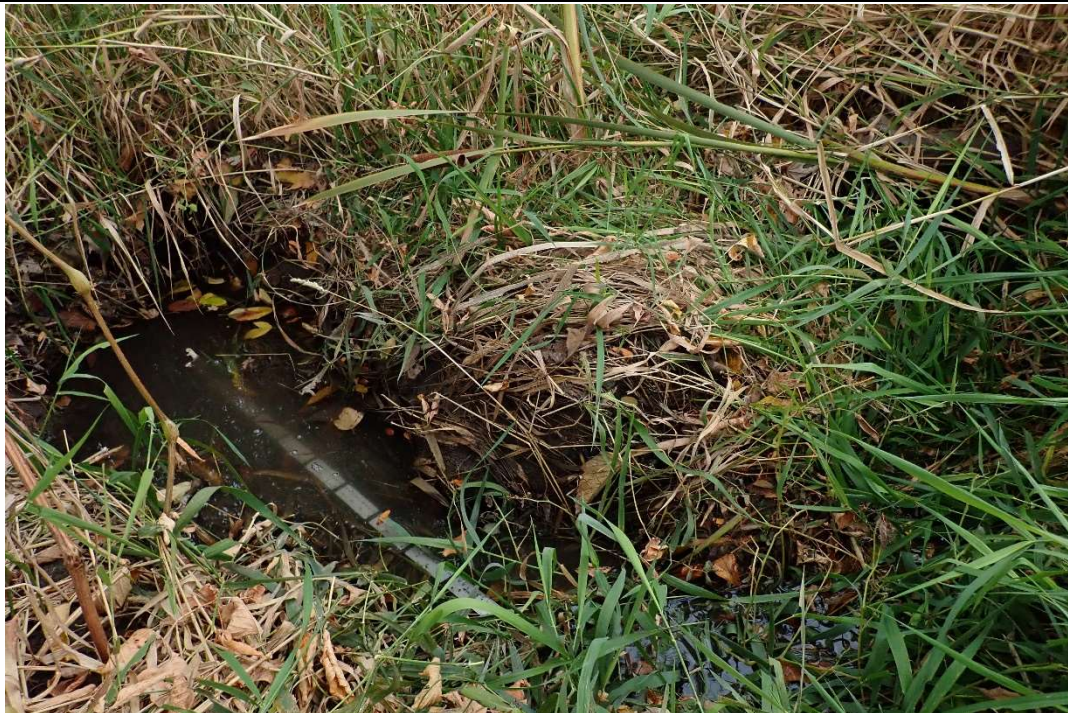
Tributary of Bronte Creek
Reach TBC-1
Photo 2

Defined bankfull conditions downstream of culvert. Metre stick for scale.

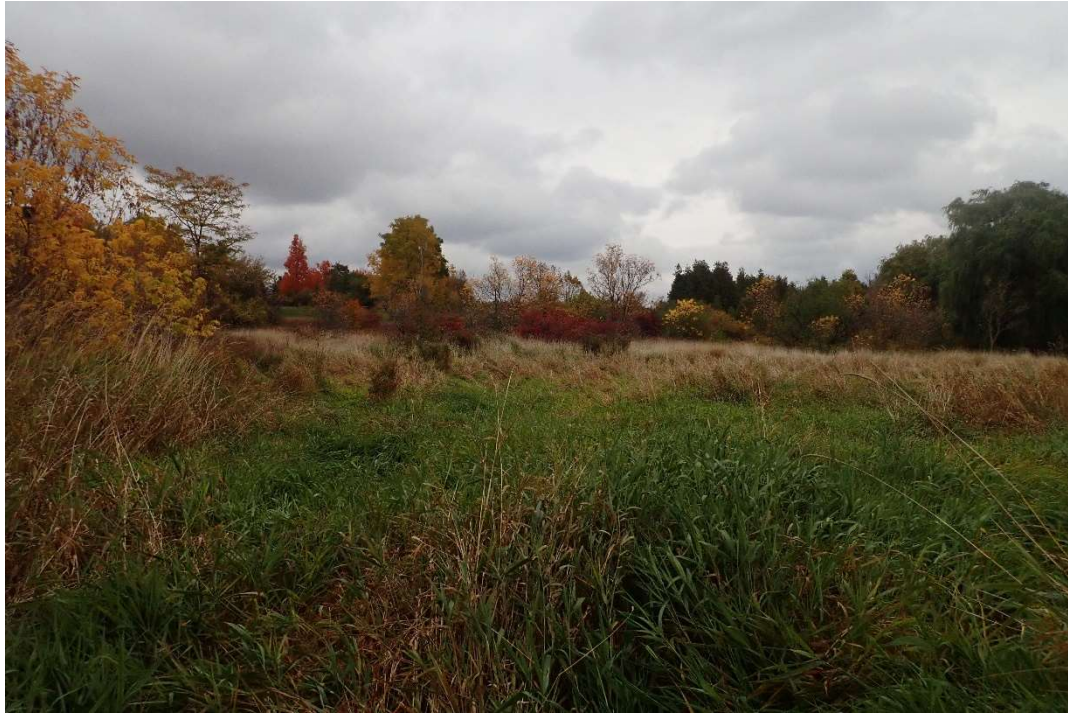
Tributary of Bronte Creek
Reach TBC-1
Photo 3

The riparian area consisted mainly of tall grasses with sparse herbaceous shrubs and trees. Bankfull channel was poorly defined throughout.

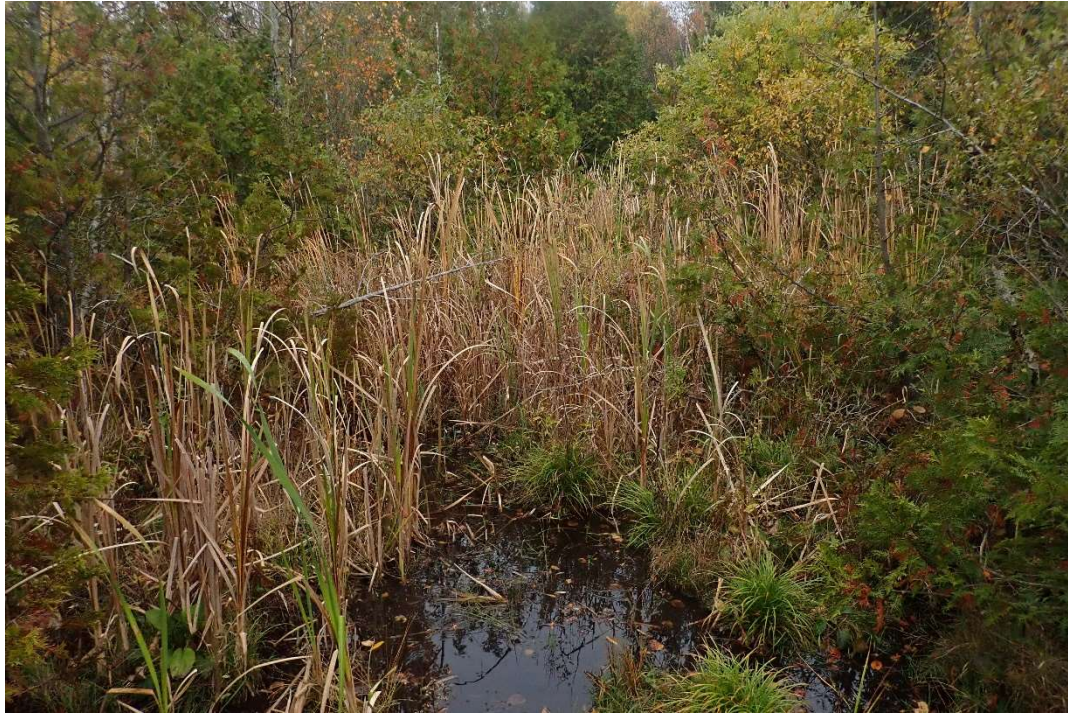
Tributary of Bronte Creek
Reach TBC-2
Photo 5

Hummocky areas with instream grasses and pooled, standing water is typical condition along Reach TBC-2

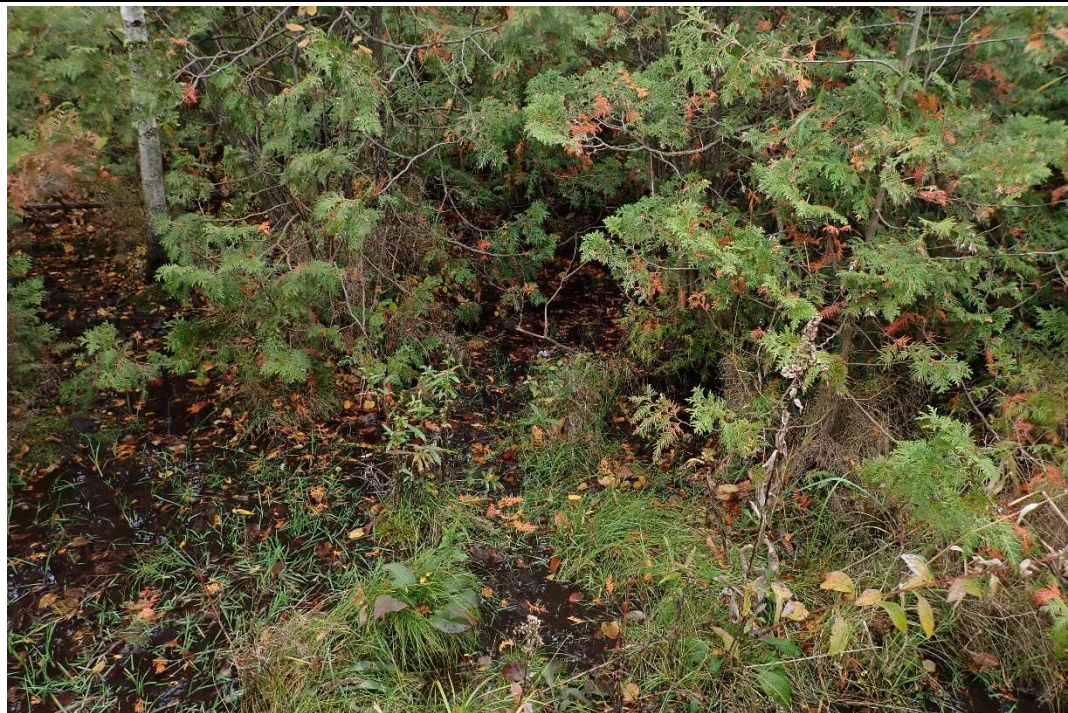
Tributary of Bronte Creek
Reach TBC-2
Photo 6

Grassy hummocks and trees throughout pools of water. No defined bankfull channel present along Reach TBC-2

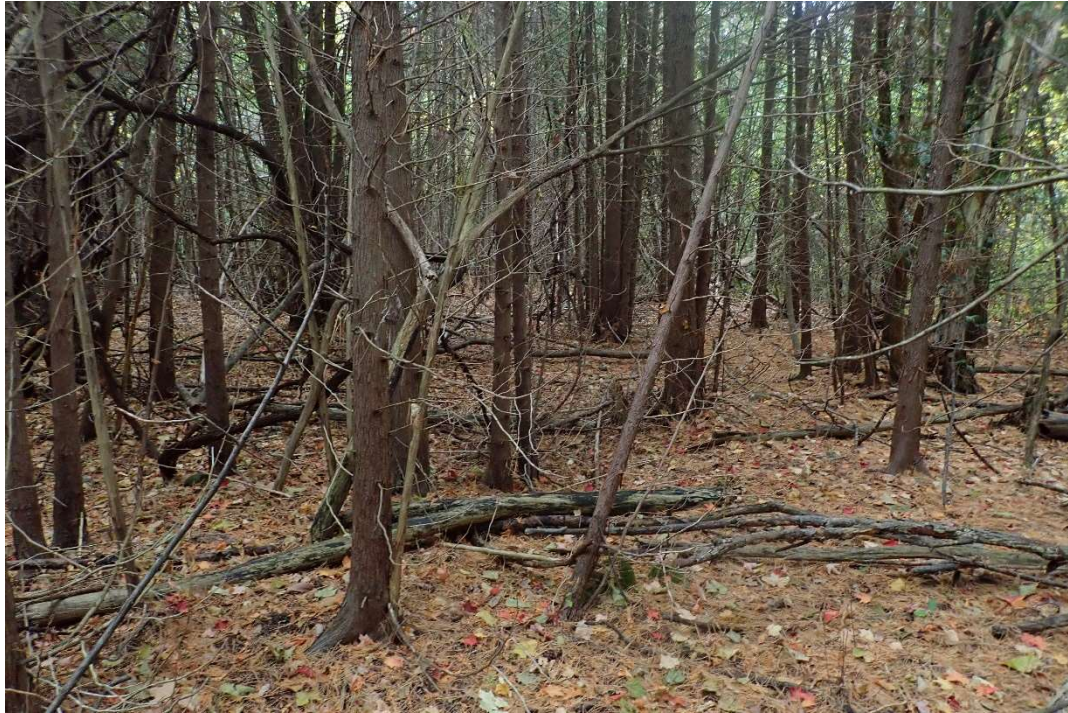
Tributary of Bronte Creek
Reach TBC-3
Photo 7

The riparian zone of Reach TBC-3 contained wooded area. No bankfull channel or flow paths observed in the upstream sections.

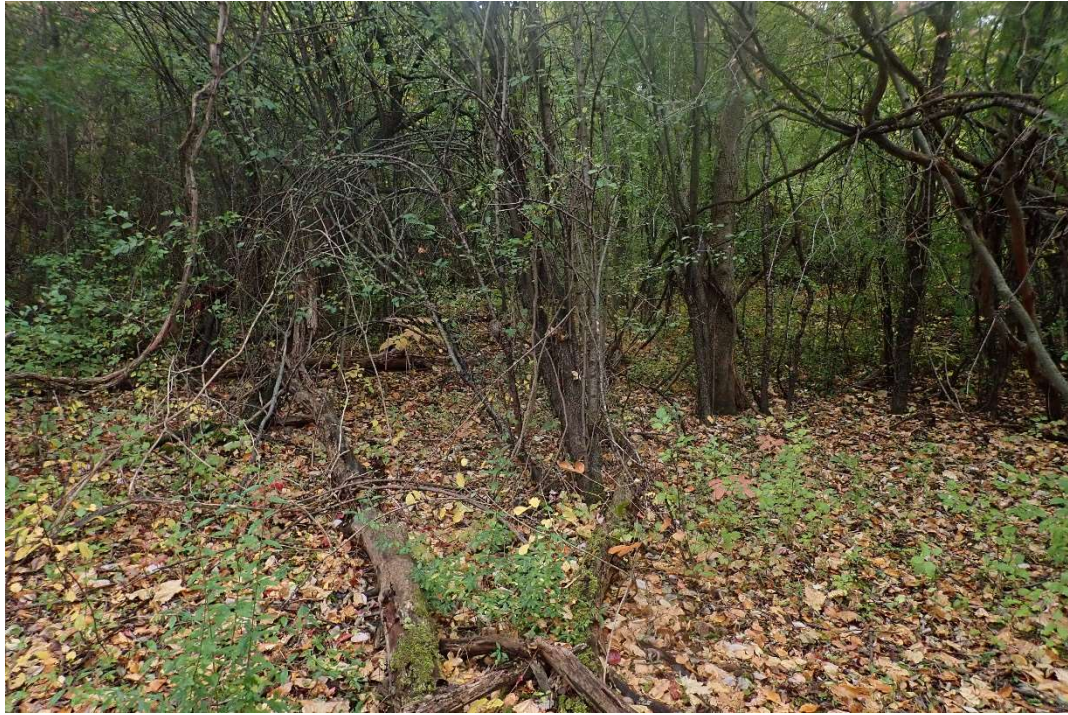
Tributary of Bronte Creek
Reach TBC-3a
Photo 9

The riparian area consisted of wooded area. No defined flow path observed in association with mapped stream Reach TBC-3a

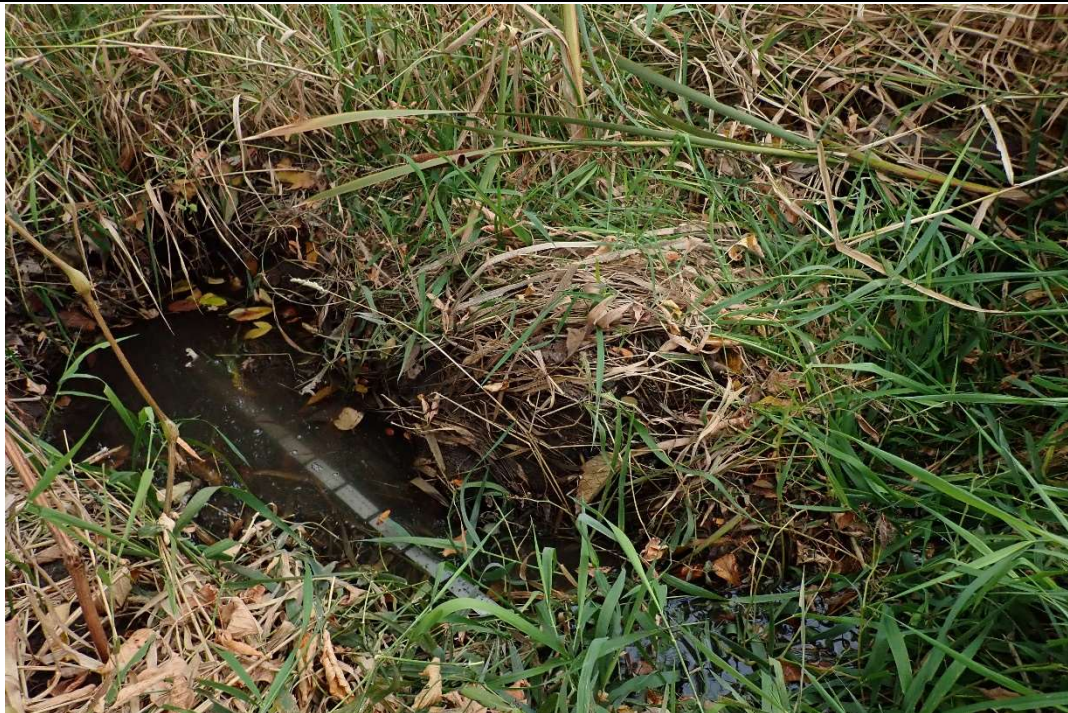
Tributary of Bronte Creek
Reach TBC-1
Photo 2

Defined bankfull conditions downstream of culvert. Metre stick for scale.

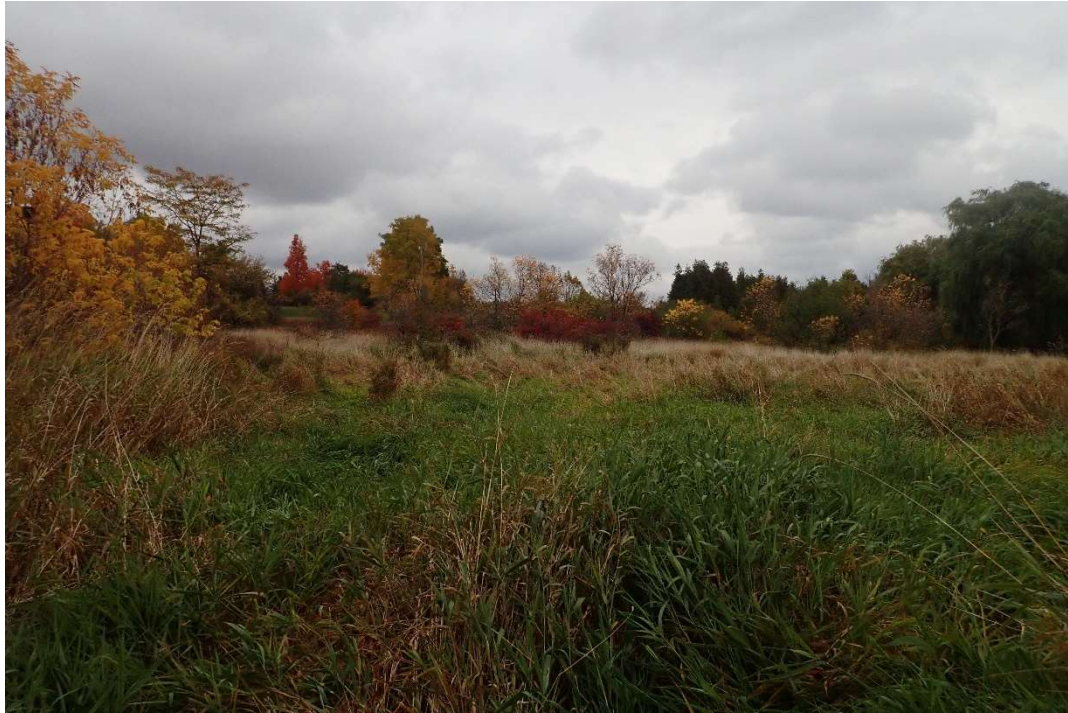
Tributary of Bronte Creek
Reach TBC-1
Photo 3

The riparian area consisted mainly of tall grasses with sparse herbaceous shrubs and trees. Bankfull channel was poorly defined throughout.

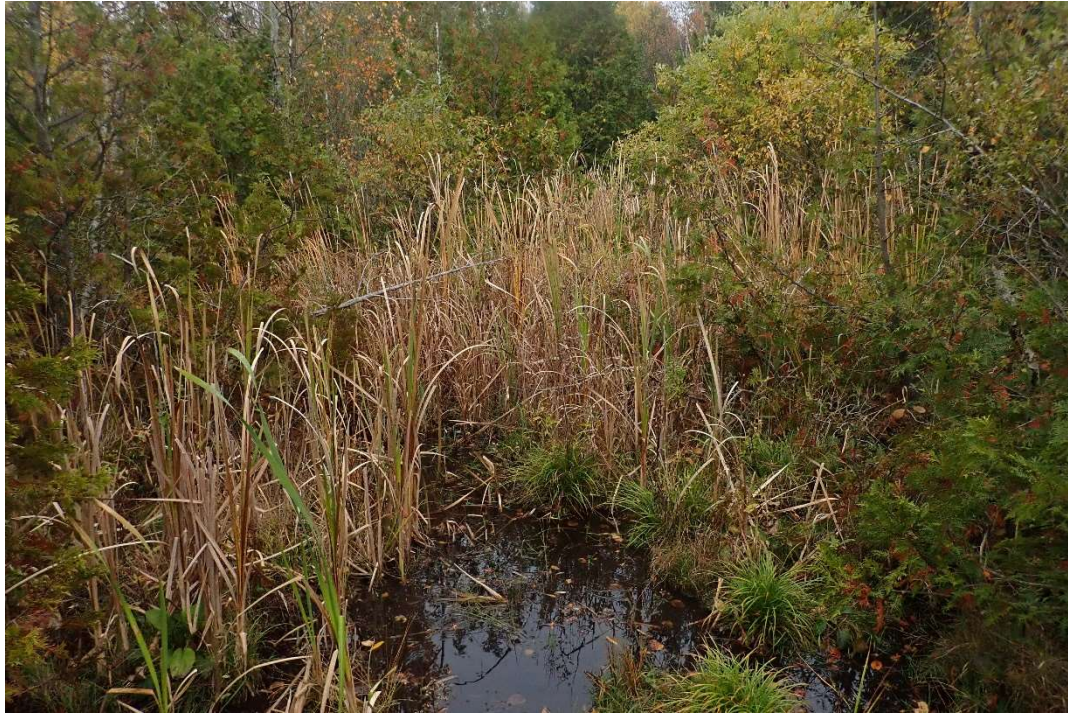
Tributary of Bronte Creek
Reach TBC-2
Photo 5

Hummocky areas with instream grasses and pooled, standing water is typical condition along Reach TBC-2

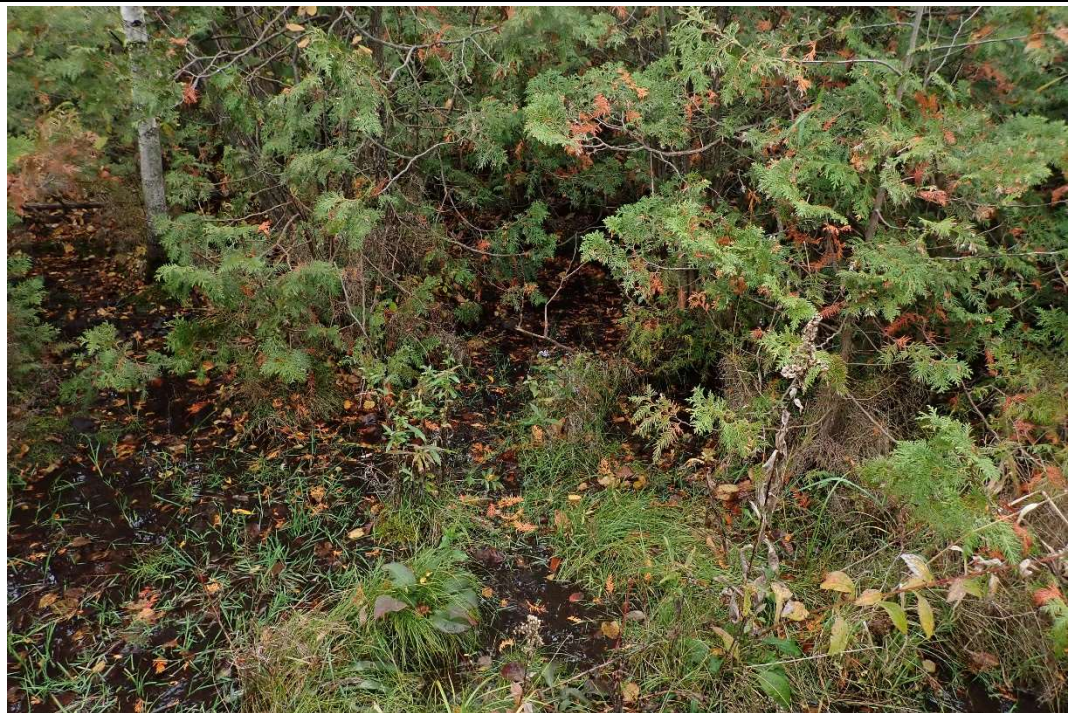
Tributary of Bronte Creek
Reach TBC-2
Photo 6

Grassy hummocks and trees throughout pools of water. No defined bankfull channel present along Reach TBC-2

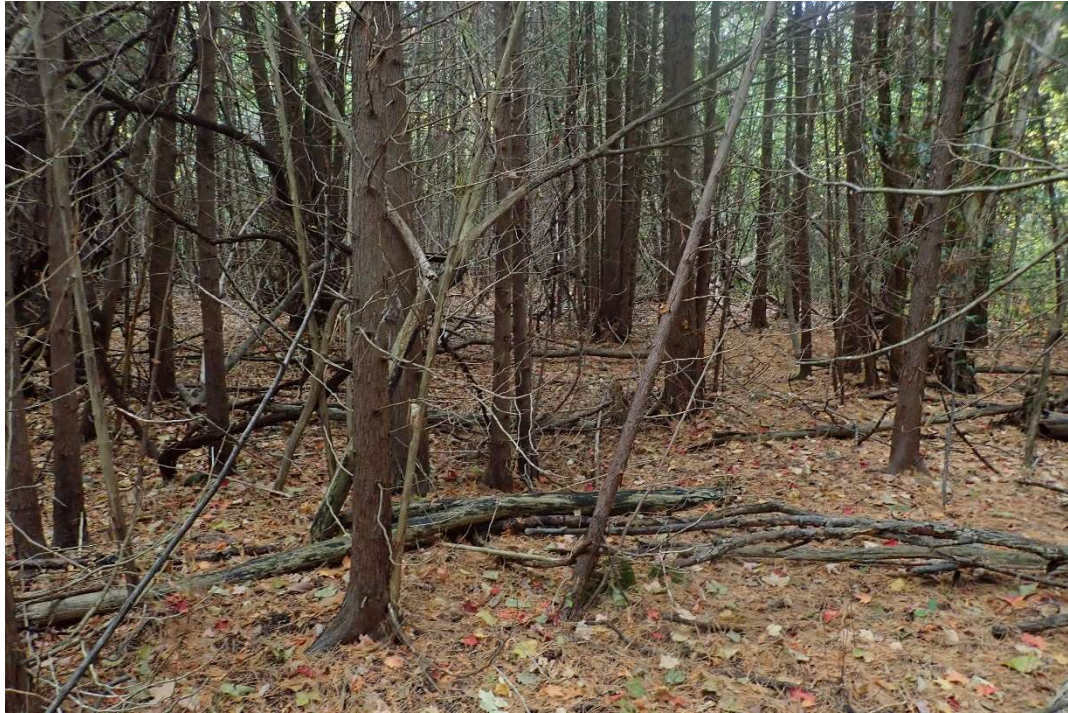
Tributary of Bronte Creek
Reach TBC-3
Photo 7

The riparian zone of Reach TBC-3 contained wooded area. No bankfull channel or flow paths observed in the upstream sections.

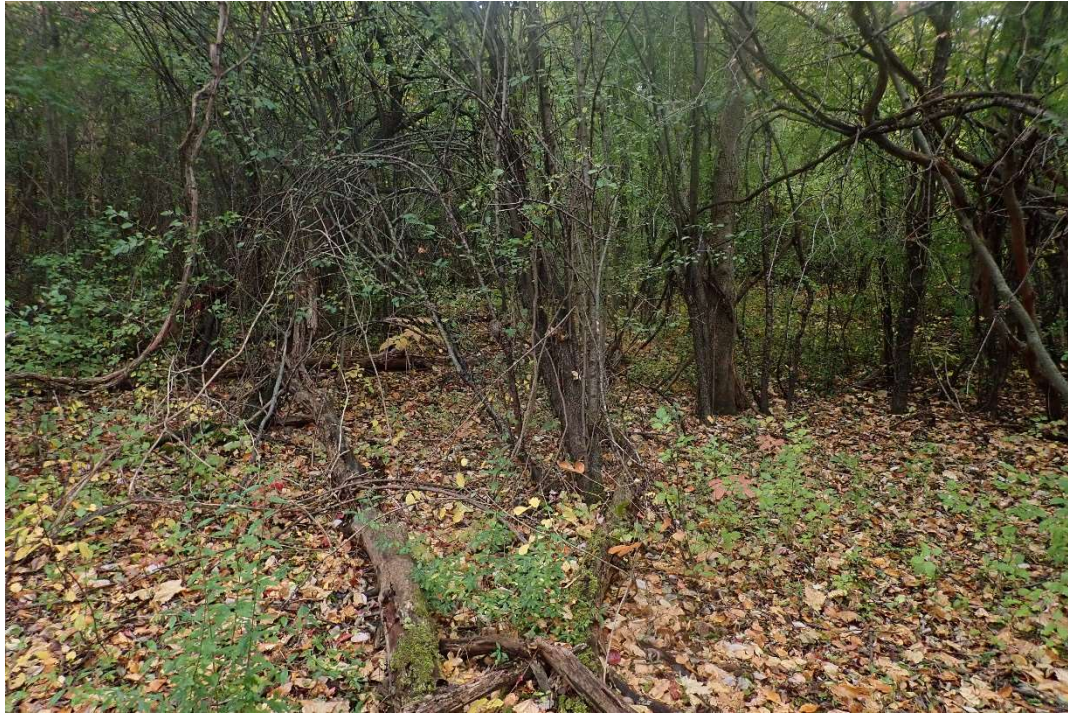
Tributary of Bronte Creek
Reach TBC-3a
Photo 9

The riparian area consisted of wooded area. No defined flow path observed in association with mapped stream Reach TBC-3a

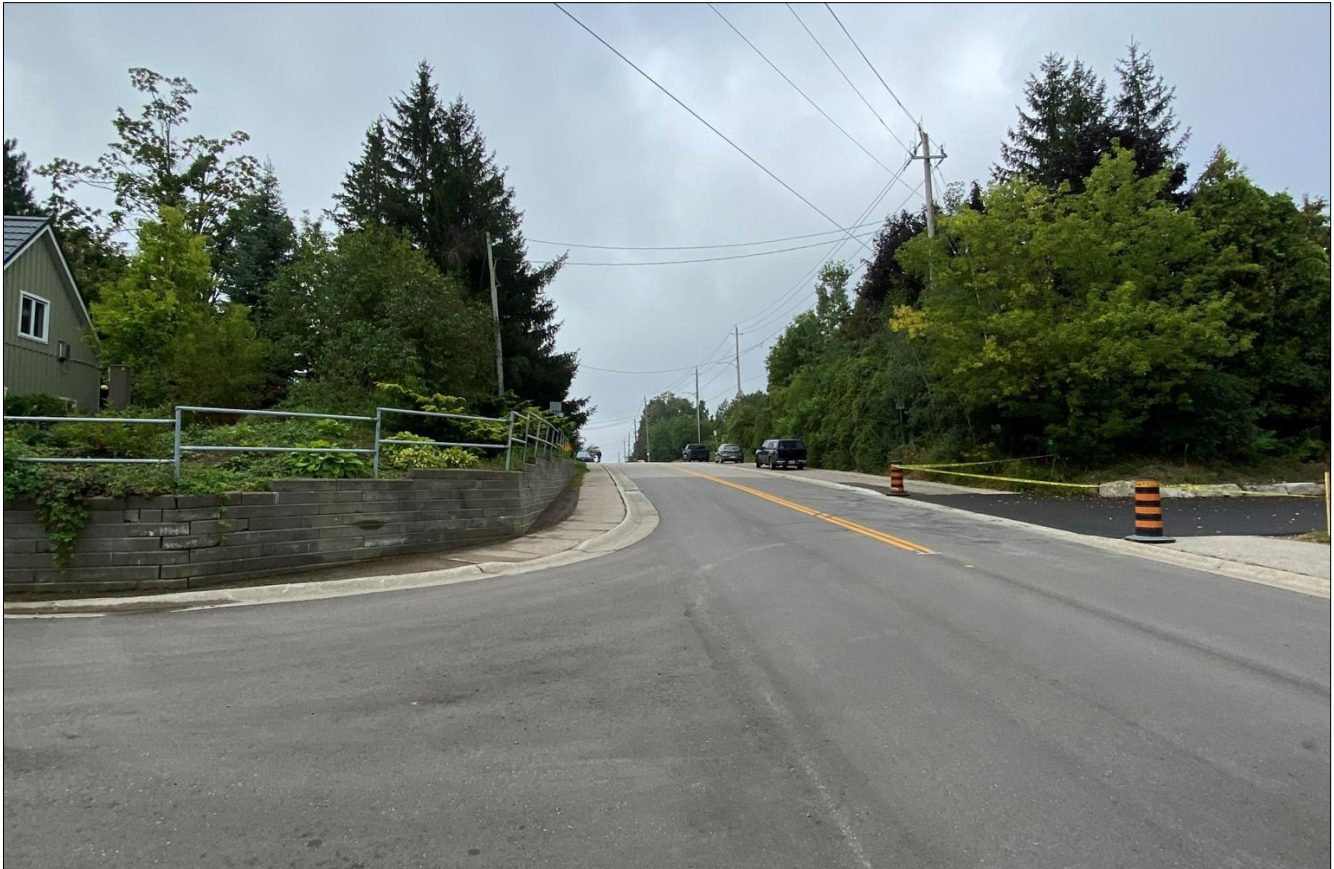
The sightline assessment completed using the vertical profile drawings is provided in **Appendix D**, while the results from the field observations are provided in **Figure 14**.

Figure 14 *Field Observations*
