THE ARCHITECTURAL HERITAGE OF PUSLINCH

Welcome to the Township of Puslinch on-line record of built heritage. All photographs are from the pictorial heritage inventory of Puslinch initiated in 2000, unless otherwise noted.

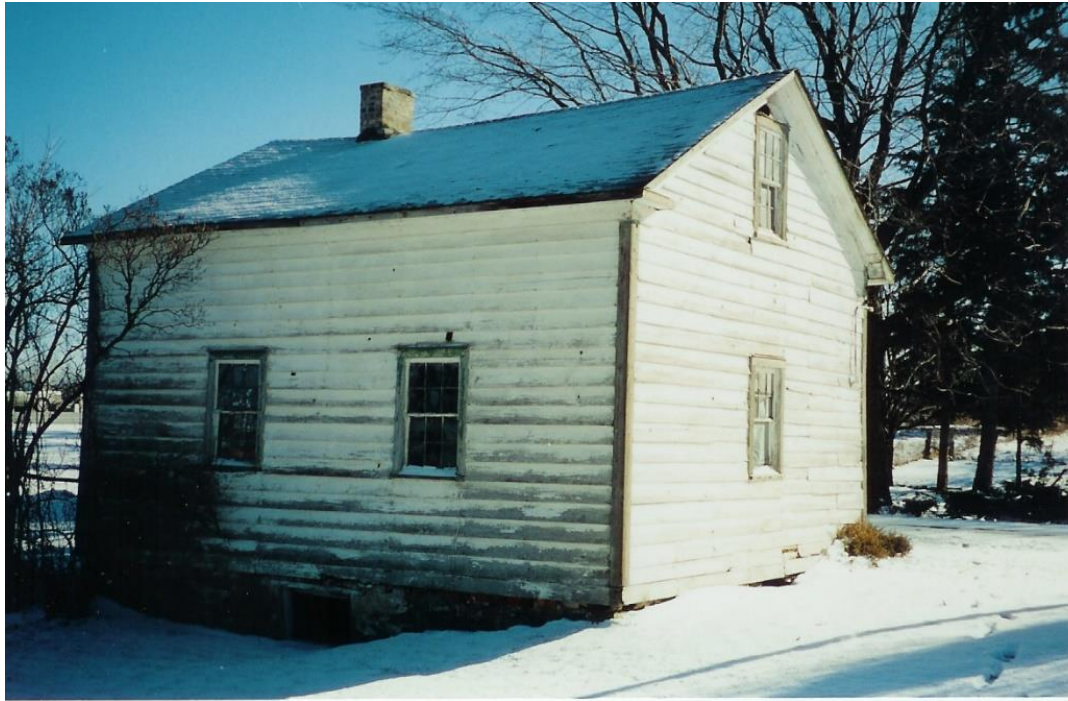
2000 PHOTO

1829 Winer Family's Cedar Log Dwelling
Ship's-lap siding was added over a century ago to protect the logs and cut down drafts.

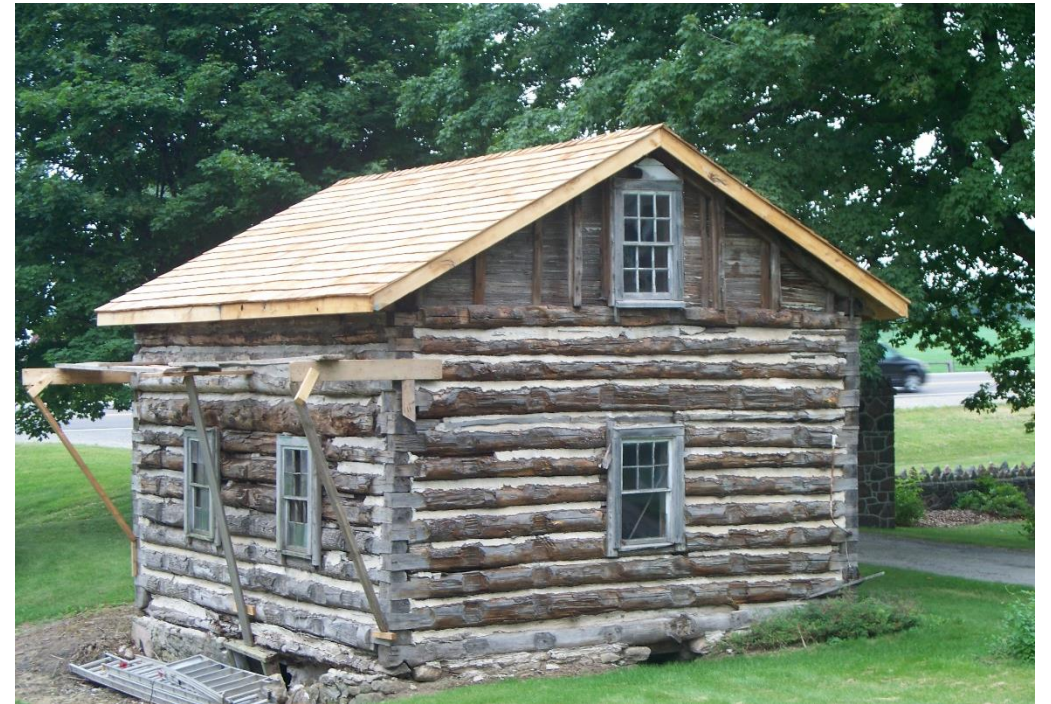
2012 PHOTO

Winer descendants have recently begun restoring their family's cabin, making the cedar logs visible once again.

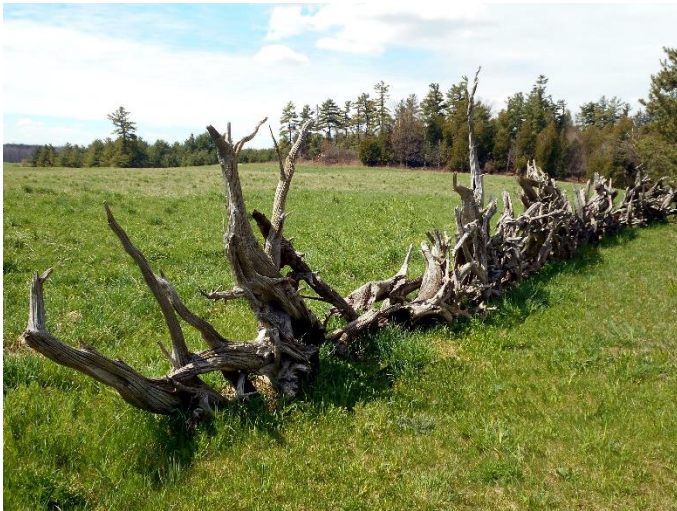
LOT 13, R. GORE

Stump fences have all but disappeared, but this one on the Gore reminds passers-by of earlier days.

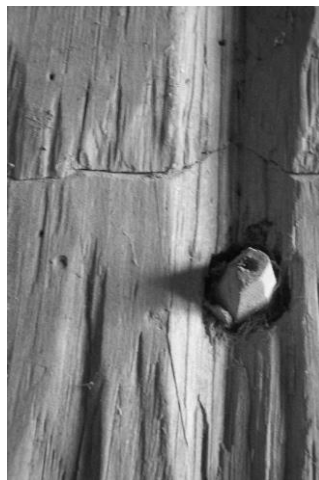
Lot17, R 2

Left: A **Master carpenter's eye for beauty** in the **overshot** built over the drive-floor's barn doors of the Hector McCaig barn.

Right: The **adze marks** indicate how the beams were shaped and then pegged in the Hector McCaig barn in 1859 by the Baer family (carpenters from Preston).

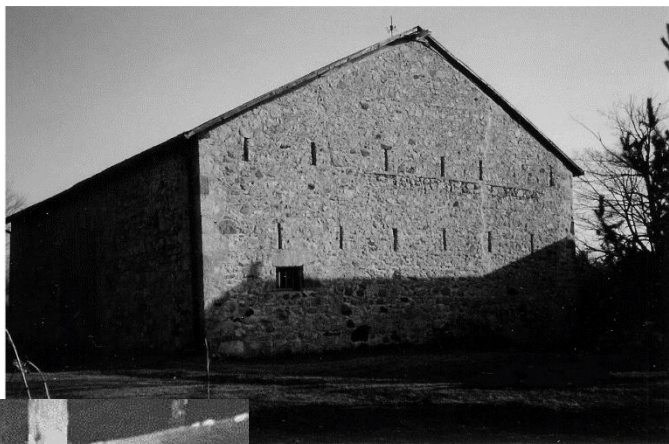
Hewn **swing beam** in 1860s Orme **stone barn**, Arkell.

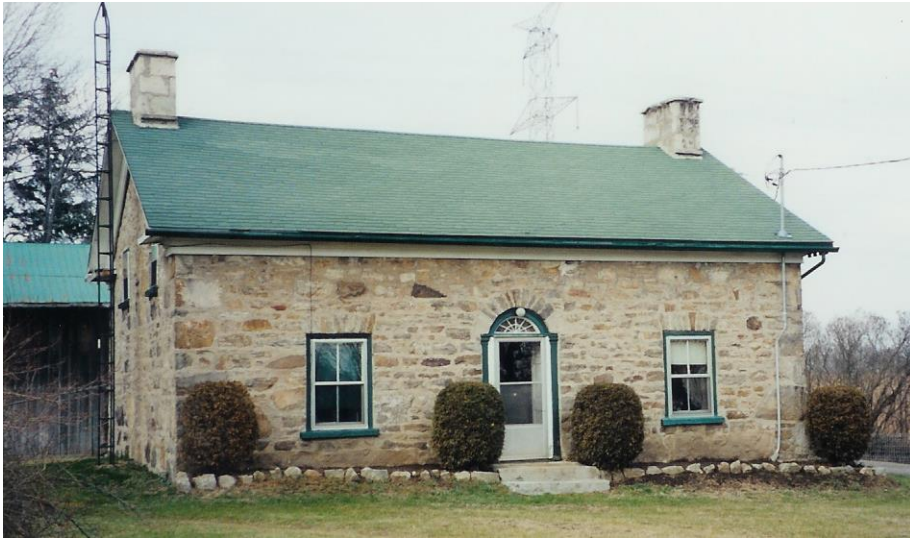
John Clark Senior farmhouse, Lots 29 & 30, R. 8

On left: Stone masonry without pointing, the absence of door sidelights, a Loyalist-style door transom (upper left) and roof-lines unbroken by gables all indicate the early construction of these fieldstone houses.

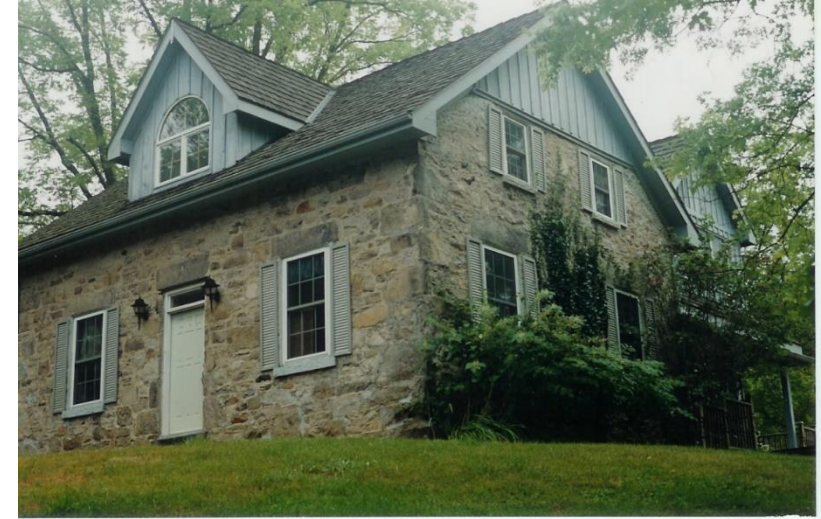
Johnston house, E. side Brock Rd., Lot 18 F. 8

At right: Twentieth-century home renovations raised the rooflines and added gables to some of the stone houses listed on the 1851 census. Stone slab lintels over apertures of the Johnston house and the doors without sidelights reflect their age though.

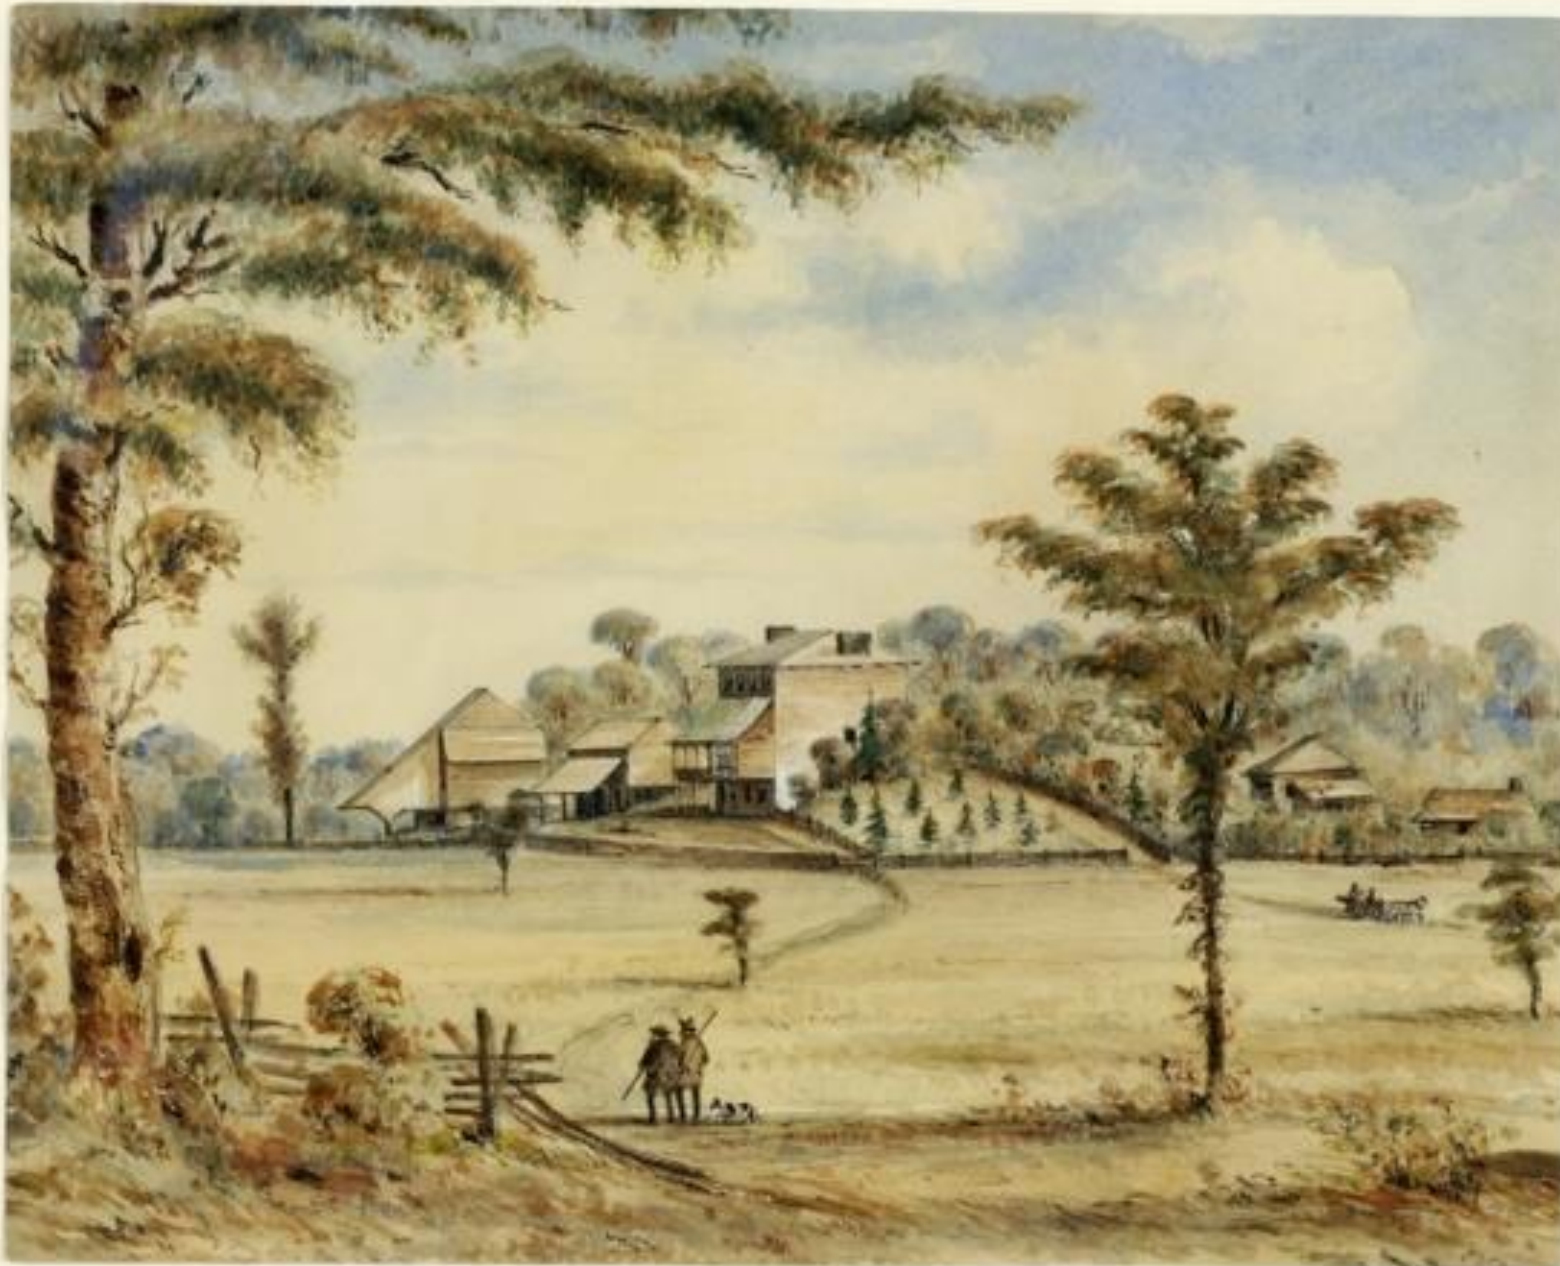
This watercolour by W. H. E. Napier, commissioned by Thomas Saunders in 1855, illustrates the Saunders' farmstead – *Woodlands* – with its three stages of architecture. The three-storey Georgian ashlar farmhouse, center, was flanked by two frame barns on the left and the original log house and barn on the right. A unique second-storey balcony on posts at the rear of the stone house overlooks the pastoral grounds.

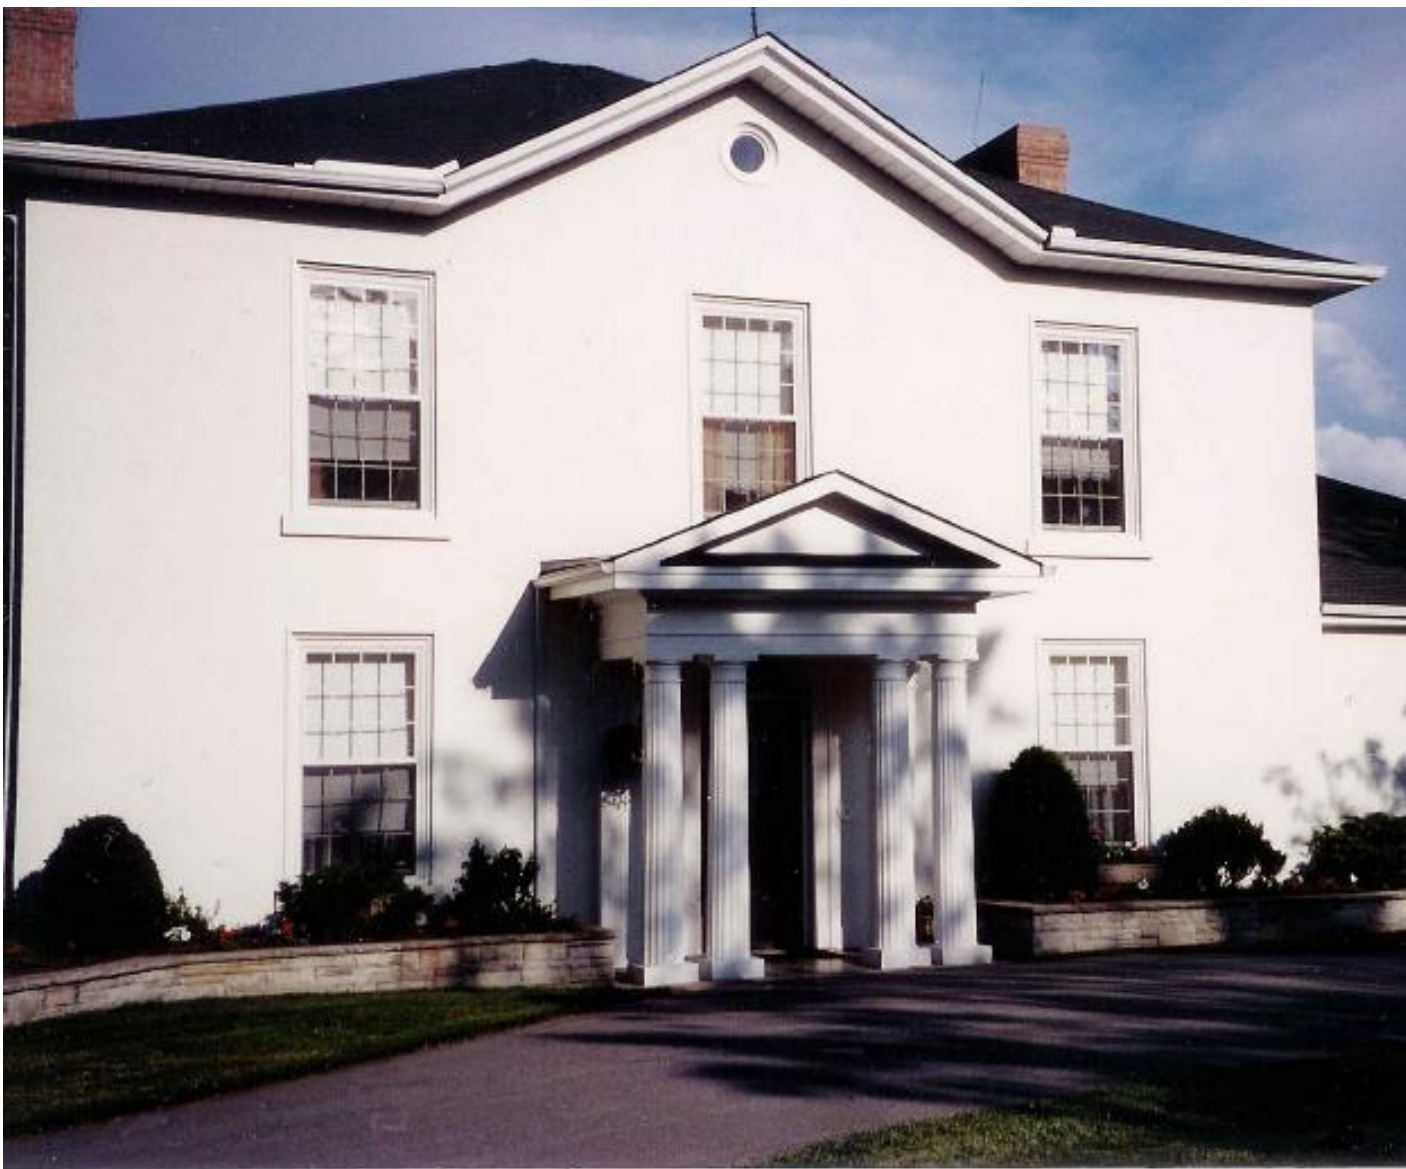
When the government purchased the farm, as a rehabilitation centre for returning soldiers following W.W.I and an agricultural training centre for young boys brought out from England, the large stones used to construct the farmhouse were stuccoed over.

A *Greek-revival* portico was added to the front entrance of Vimy Ridge Farm at the time that the stone structure was covered with stucco.

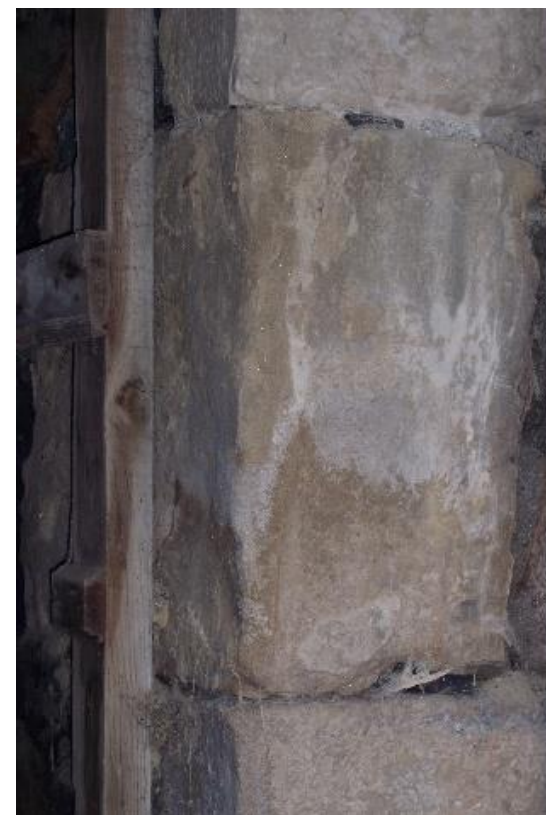
Right: This recent photograph, taken inside the lower entrance to Vimy Ridge farmhouse on a heritage tour, provides a view of the large blocks of stone used in the 1840 construction now under stucco on the exterior of the house.

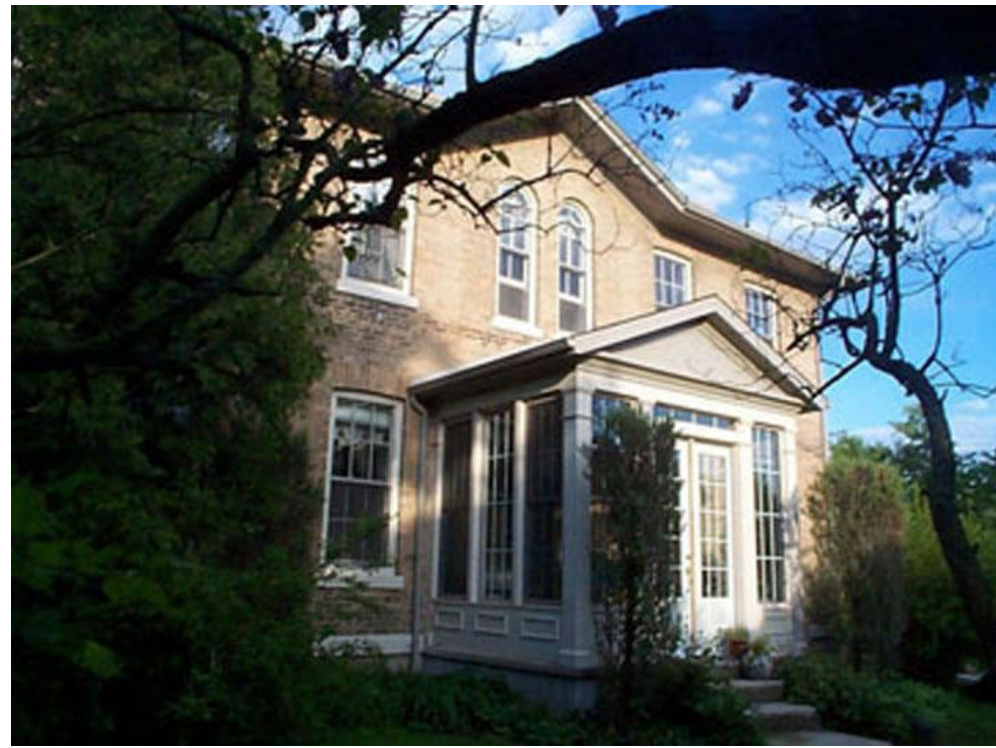
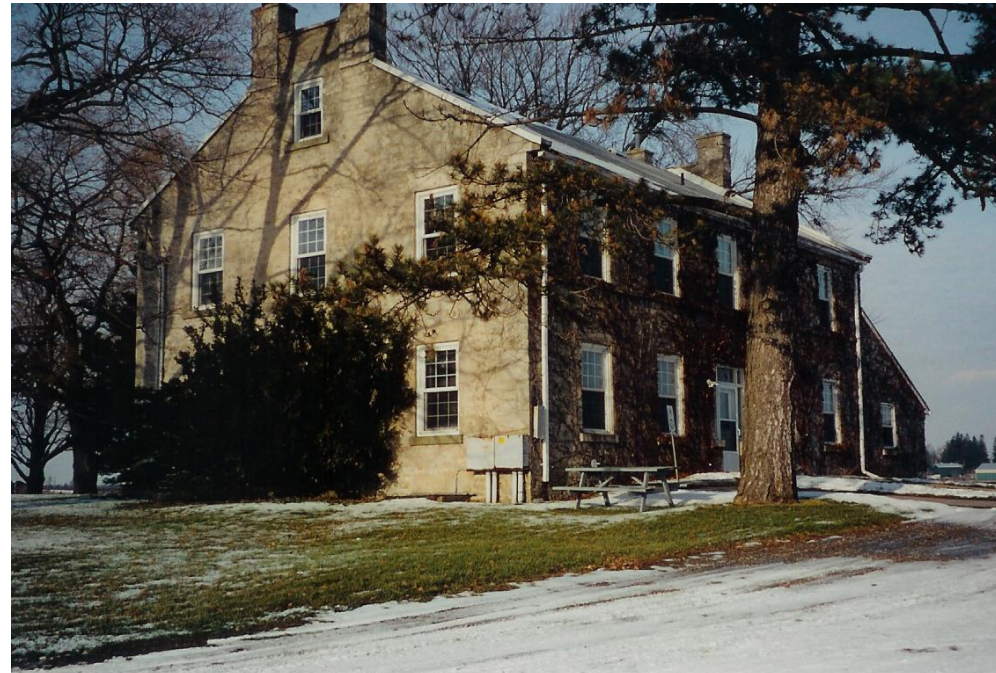
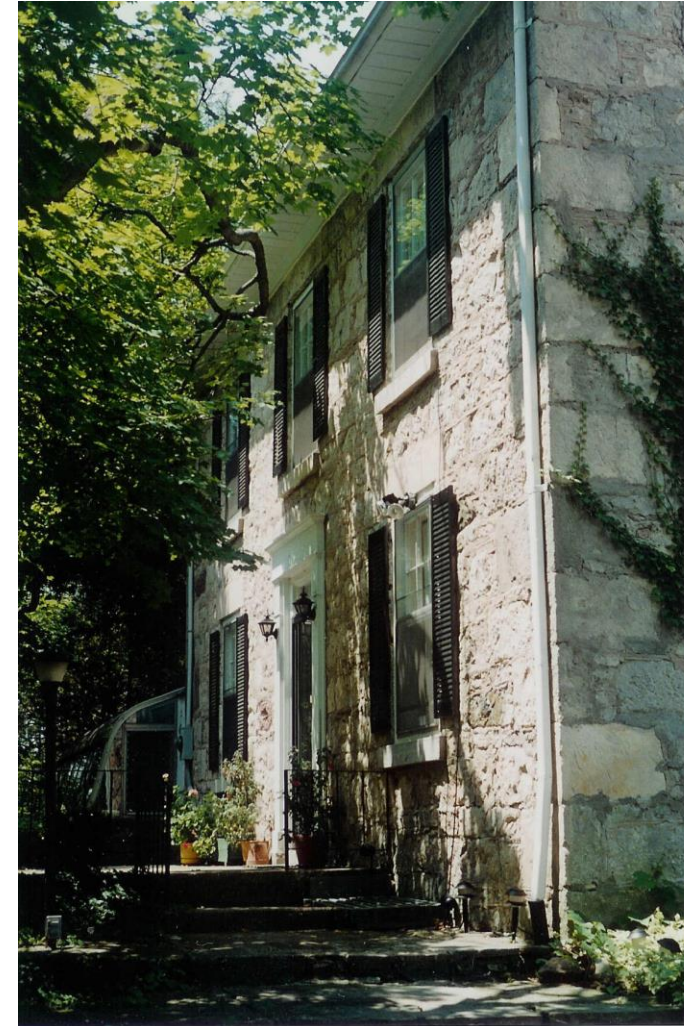
Above left: *The Laird of Puslinch*, James Anderson, had a 5-bay Georgian built of yellow brick.

Lower left: Thomas Arkell, from Swindon England, had a 5-bay ashlar-cut limestone farmhouse built with chimneys in the English style in 1852.

Right: John Thompson, one of the first Scottish settlers to take up land on the 1st Concession in SW Puslinch, built a 3-bay fieldstone Georgian house.

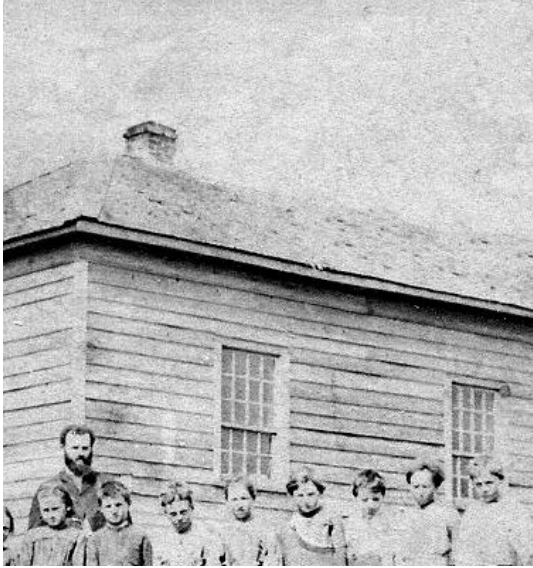
Early frame Crieff school
12-over-12 paned windows

When glass panes were packed in sawdust and transported by wagon, the panes were of necessity small. As transportation methods improved, so did the size of the panes.

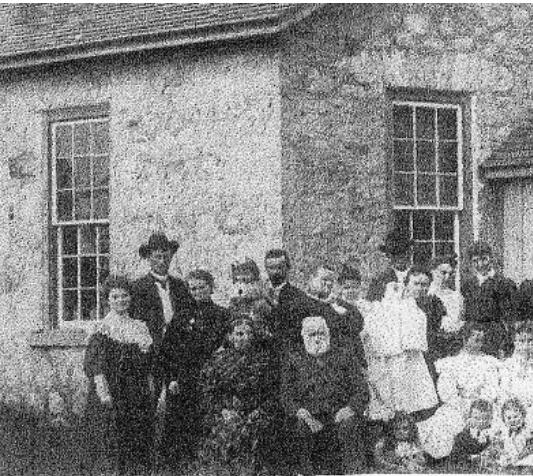
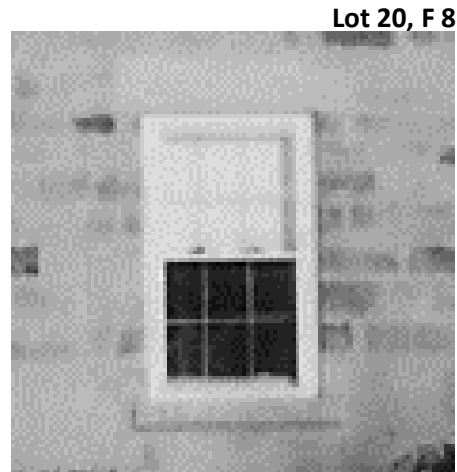
Killean fieldstone schoolhouse
9-over-9 paned windows

1860s Richard Ellis farmhouse
6-over-6 paned windows

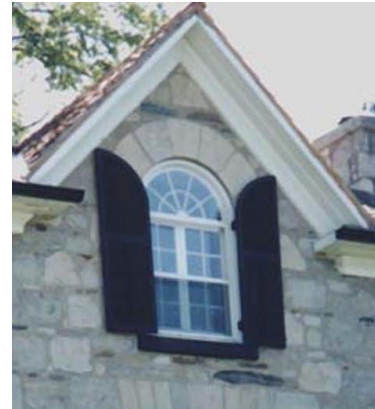
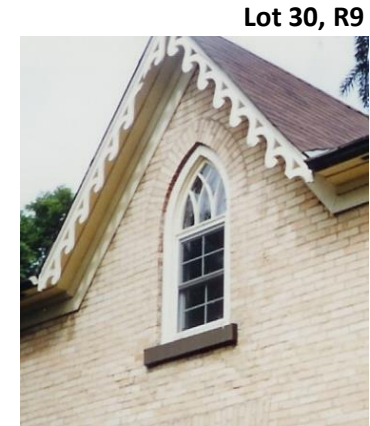
1860 former Becker store, Crieff
arched gable window

1870 Alexander McLean
farmhouse
chapel/gothic gable window

When dating a heritage house today look for original wood muntins that divide panes, as modern window replacements have muntins built in between the glass that look authentic from a distance.

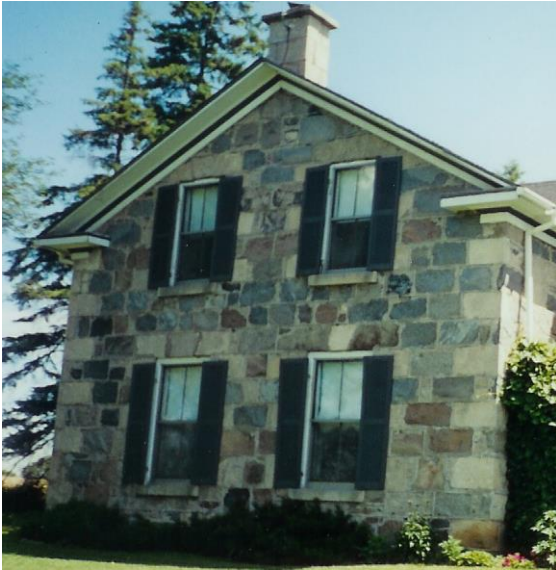
Lot 17, R 2

As roads and methods of transport improved, the size of window panes increased. By 1870, 14" x 28" rectangles became the norm, with 4 panes per window.

14" x 28" paned windows introduced in 1870

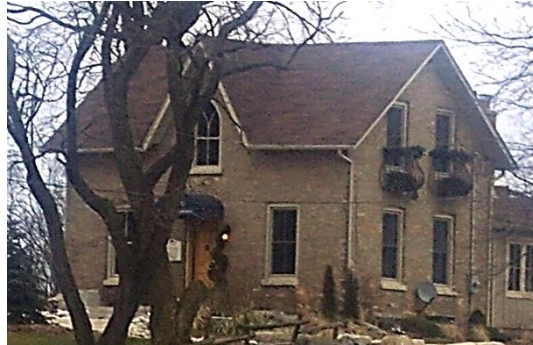
William Black brick farmhouse (above) with 4-paned windows;

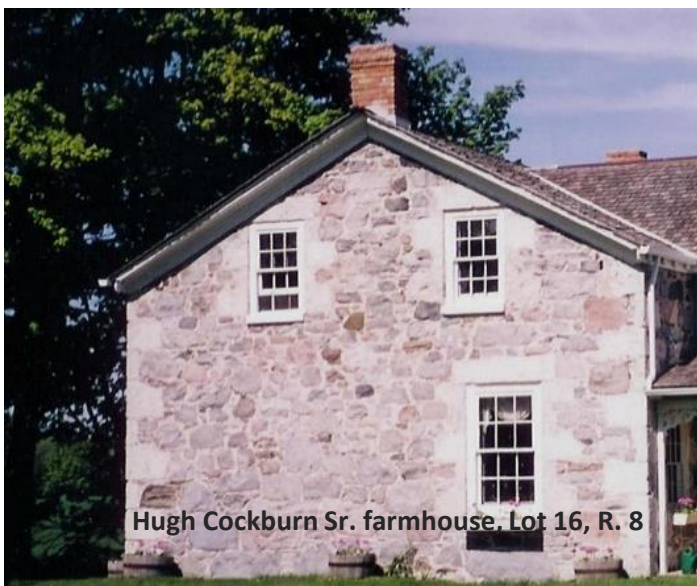
Hugh Cockburn Sr. farmhouse, Lot 16, R. 8

Rubblestone (above).

Straight-coursed *granite*, with *limestone* quoins, and voussoirs over gable window (below).

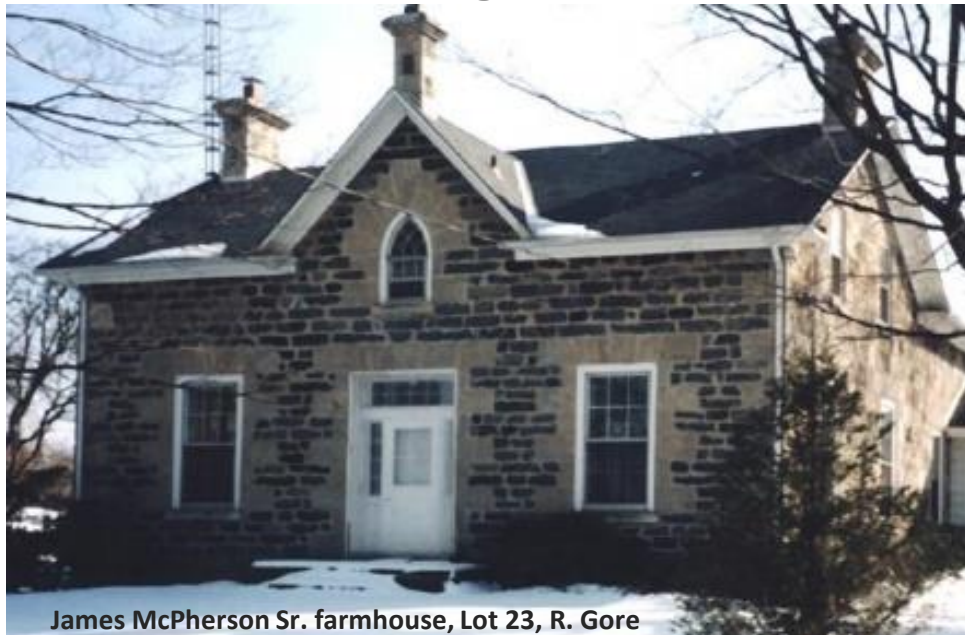
James McPherson Sr. farmhouse, Lot 23, R. Gore

Masonry styles

progressed in 19th -
century houses in
Puslinch.

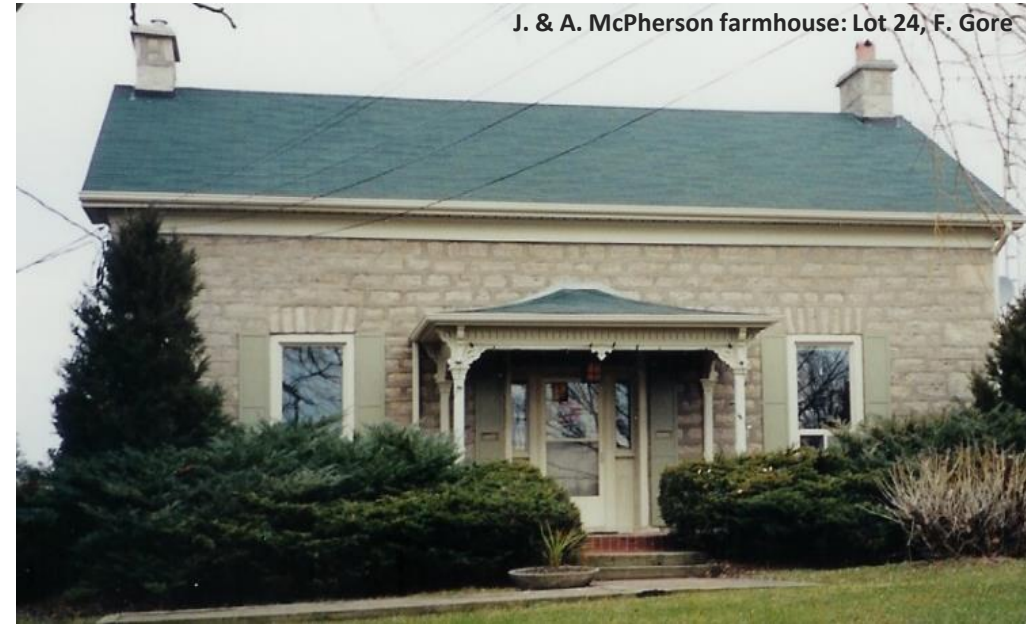
J. & A. McPherson farmhouse: Lot 24, F. Gore

Straight-coursed *limestone* (above).

Edinburgh-coursing of *fieldstones* with H-PATTERN CONNECTORS made of *limestone* (below) and *granite* (right)

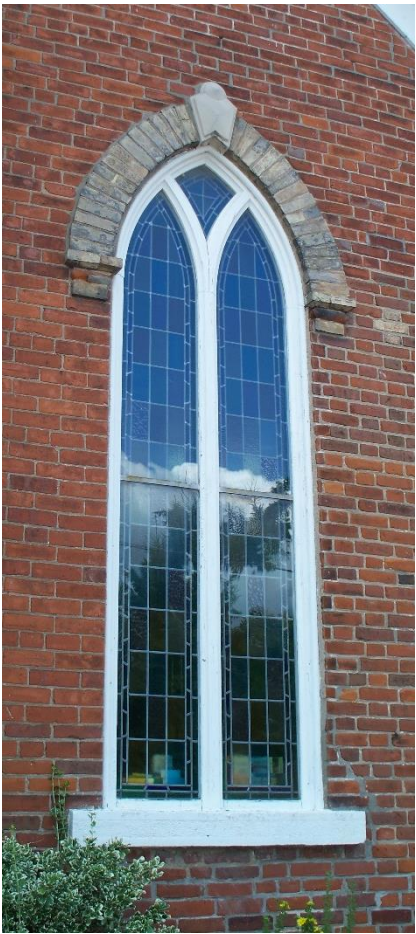
German church, Morriston

KEYSTONE and LINTELS
over 1880 church window

VOUSSOIRS
fanned stones
arranged over
aperture

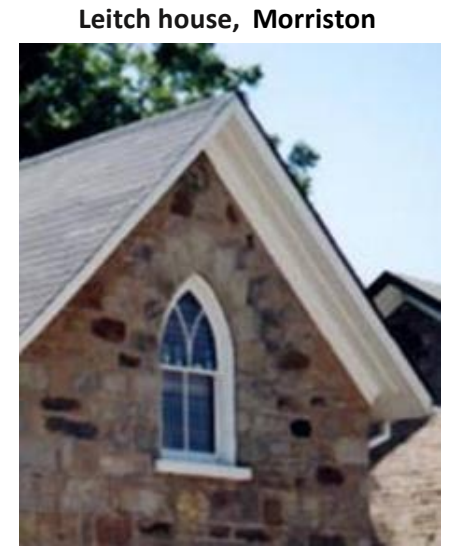
Leitch house, Morriston

Masons also showcased their skills in the 19th Century.

ARTICULATED QUOINS
outlining entryway

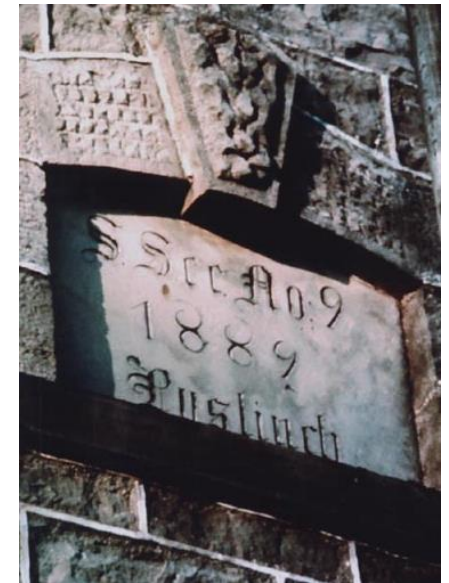
DATE STONE
features intricate carving in
soft limestone

DATE STONES

- a mason's pride

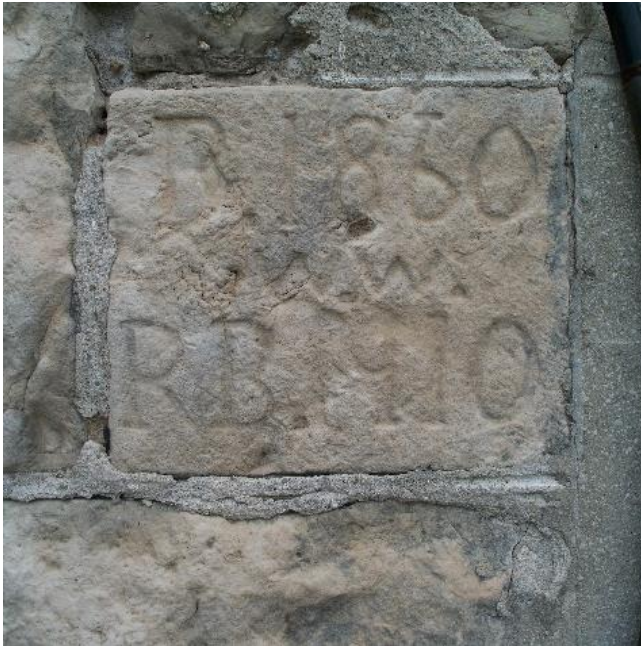
Lot 33, R 7

Noted on the date stone is that the **William Winer barn** was built in 1860 (B.) and remodelled in 1910 (RB).

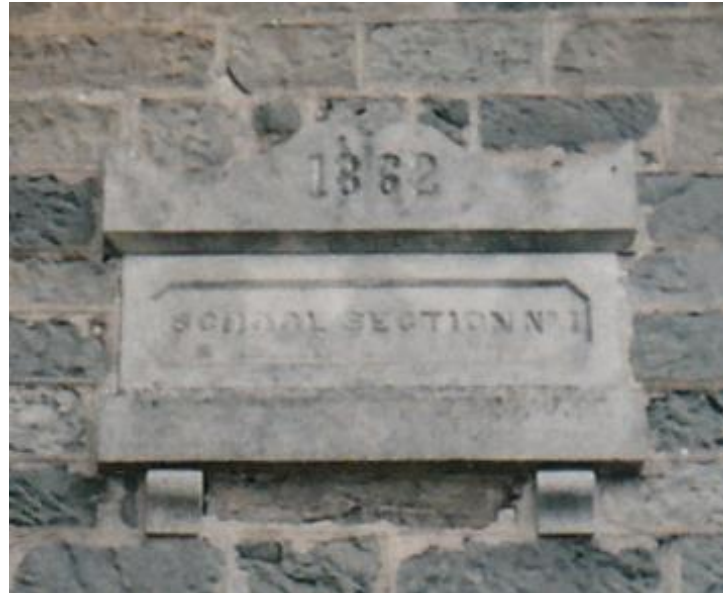
Part Lot 7, R 9

The mason who built the Arkell schoolhouse, **SCHOOL SECTION No. 1**, created a unique date stone in 1862.

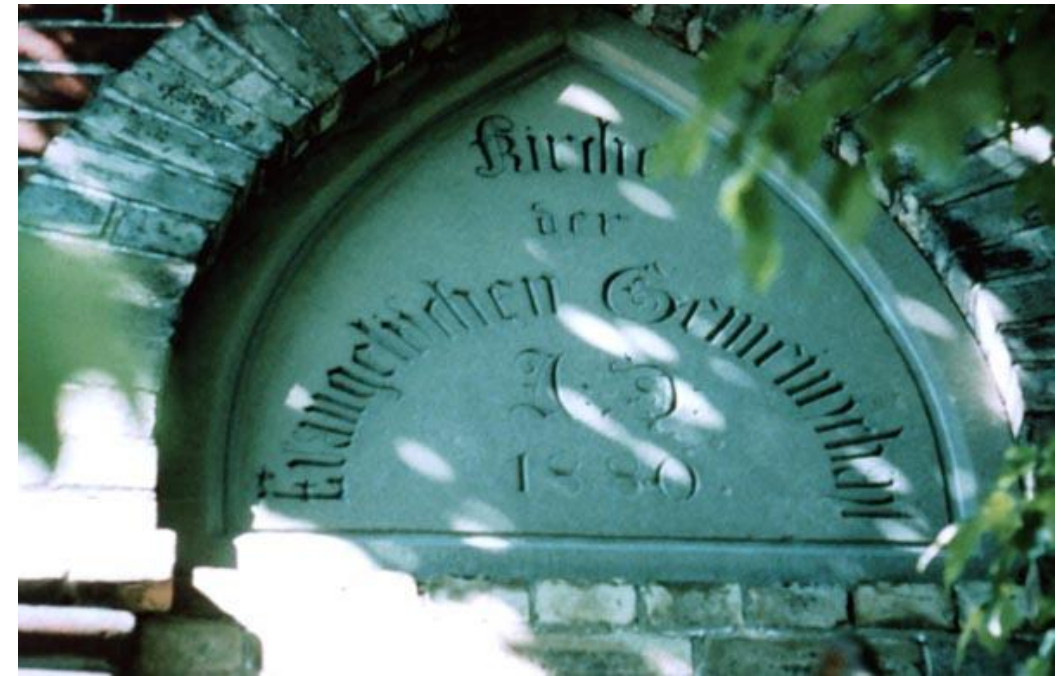
Mount Carmel-Zion United Church in Morriston was originally a German congregation. In 1880 they expanded their church. The mason created a beautiful date stone, carving the phrase, **Kirche der Evangelischen Gemeinschaft, A. D. 1880**, which translates as the *Church of the Evangelical Community*.

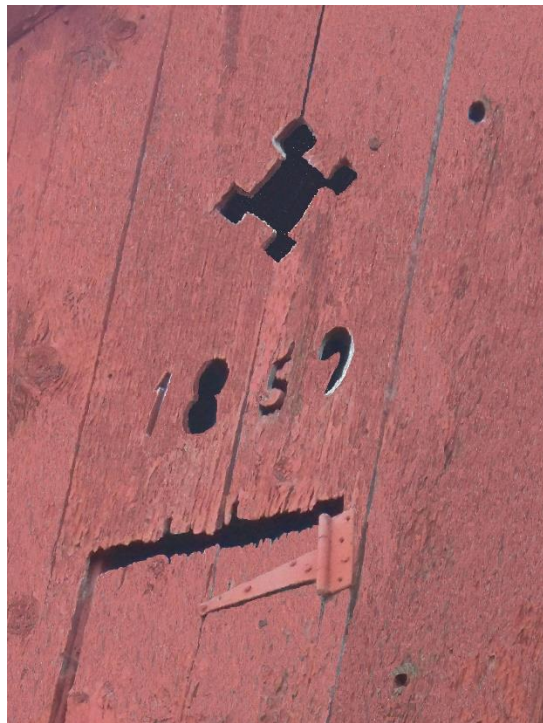
Close-up of hex sign and date carving on east side of Hector McCaig Pennsylvania Swiss-style bank barn (below) which was built by the Baer family of the Preston area. Lot 17, R. 2

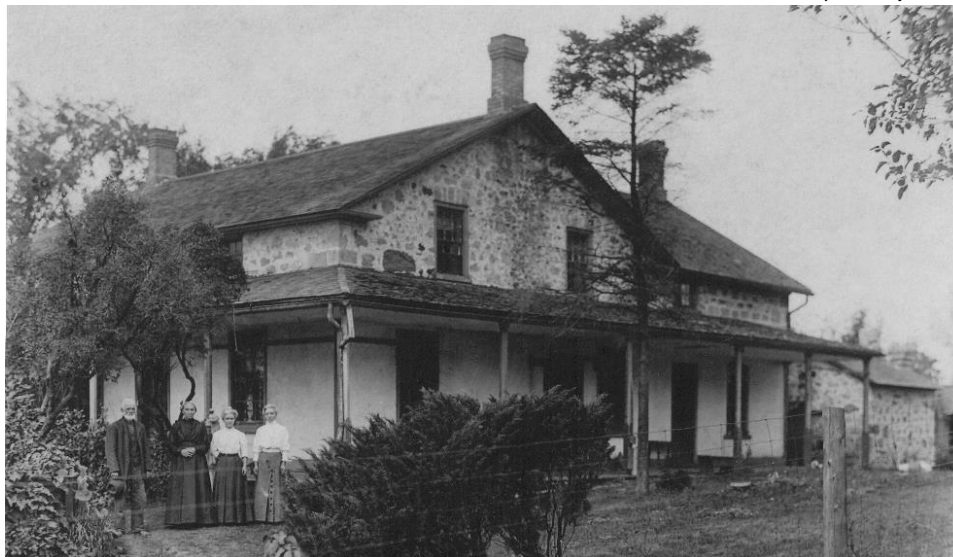
1853 Pannebacker farmhouse, Lot 3, R.3

Rubblestone masonry, whitewashed under the porch where the farm workers washed up before entering the kitchen, reflects Waterloo County architectural style.

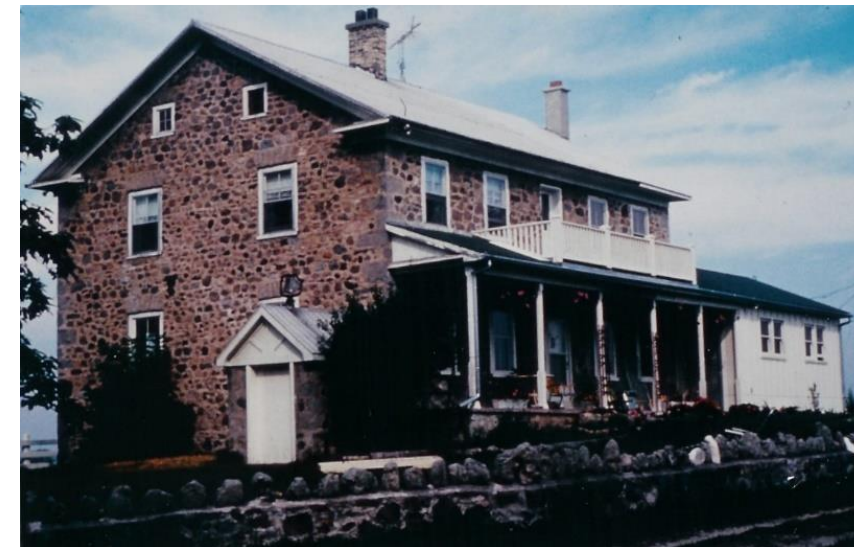
Strome farmhouse, Lot 5, R.4

Above & below: Note the narrow side doors with small peaked roofs – a style not seen in the rest of Puslinch.

Thirty years before Puslinch was surveyed, Waterloo County was settled. Its tradesmen carried a signature style of

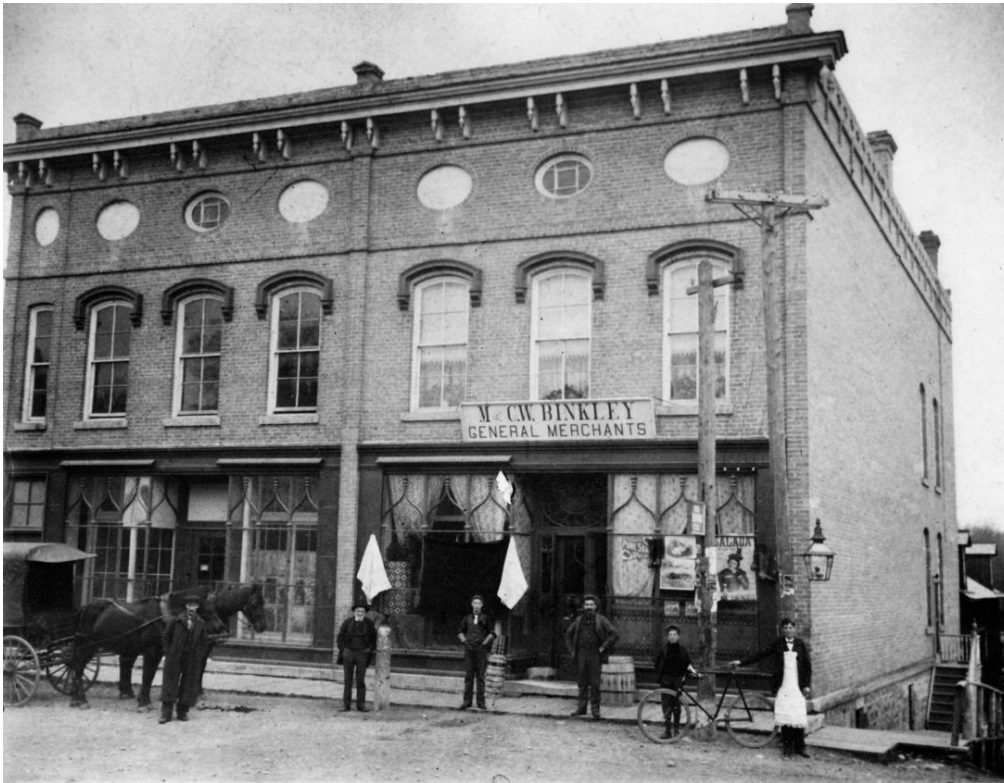
R. B. Morrison Store, built 1860 on Queen Street, Morrilton

LABELS and STOPS were created to protect the 2nd floor windows. The carpenters created MUNTINS for 1st floor windows that formed distinctive OGEE SHAPES.

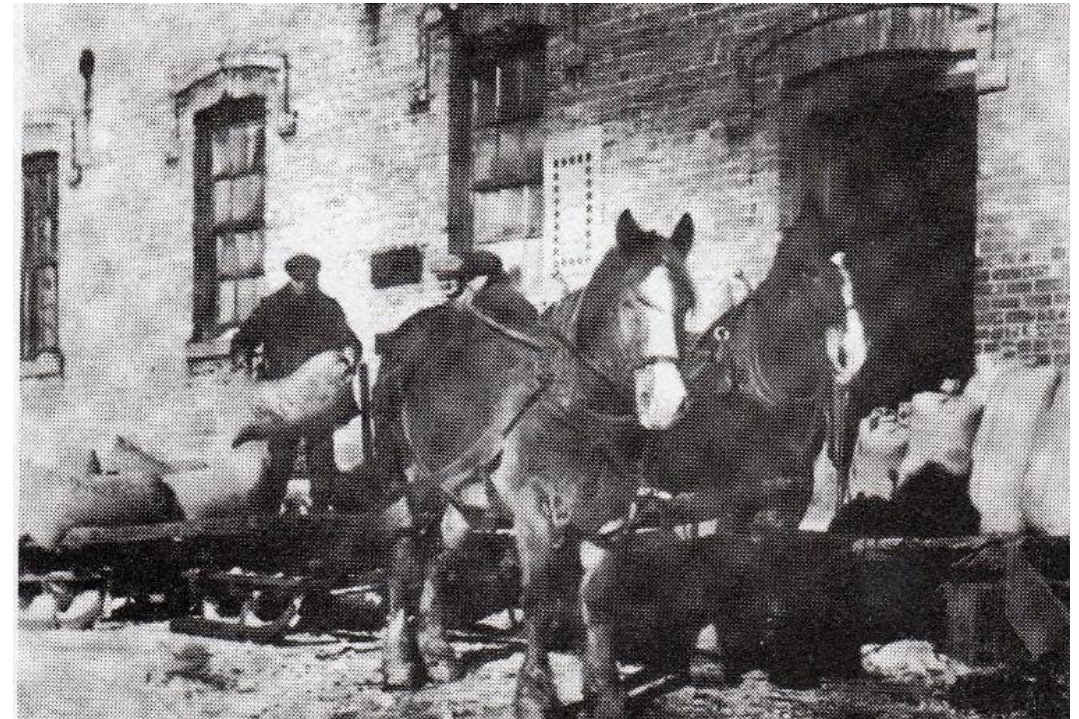
1860 Aberfoyle Grist Mill, Village of Aberfoyle

The mill also had LABELS and STOPS fashioned to deflect rain and protect doors and windows from moisture.

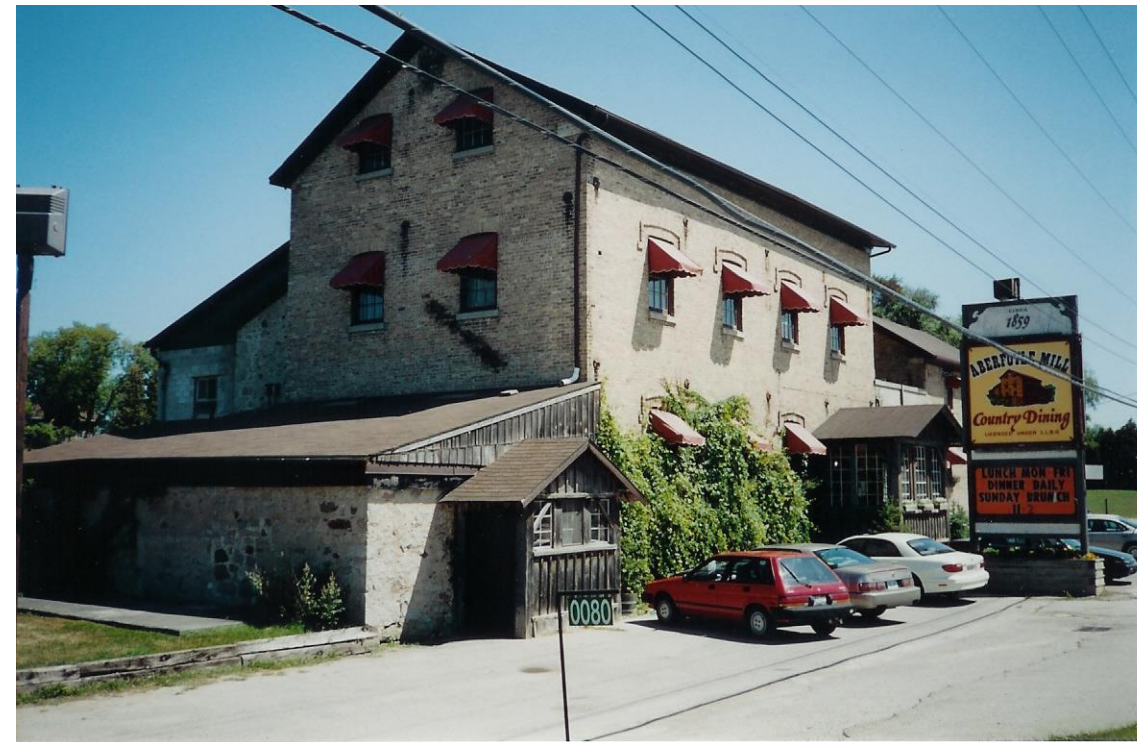
Aberfoyle Mill Restaurant

A modern addition has been added to the left of the old carriage-works building, with its roof in line with the original roofline.

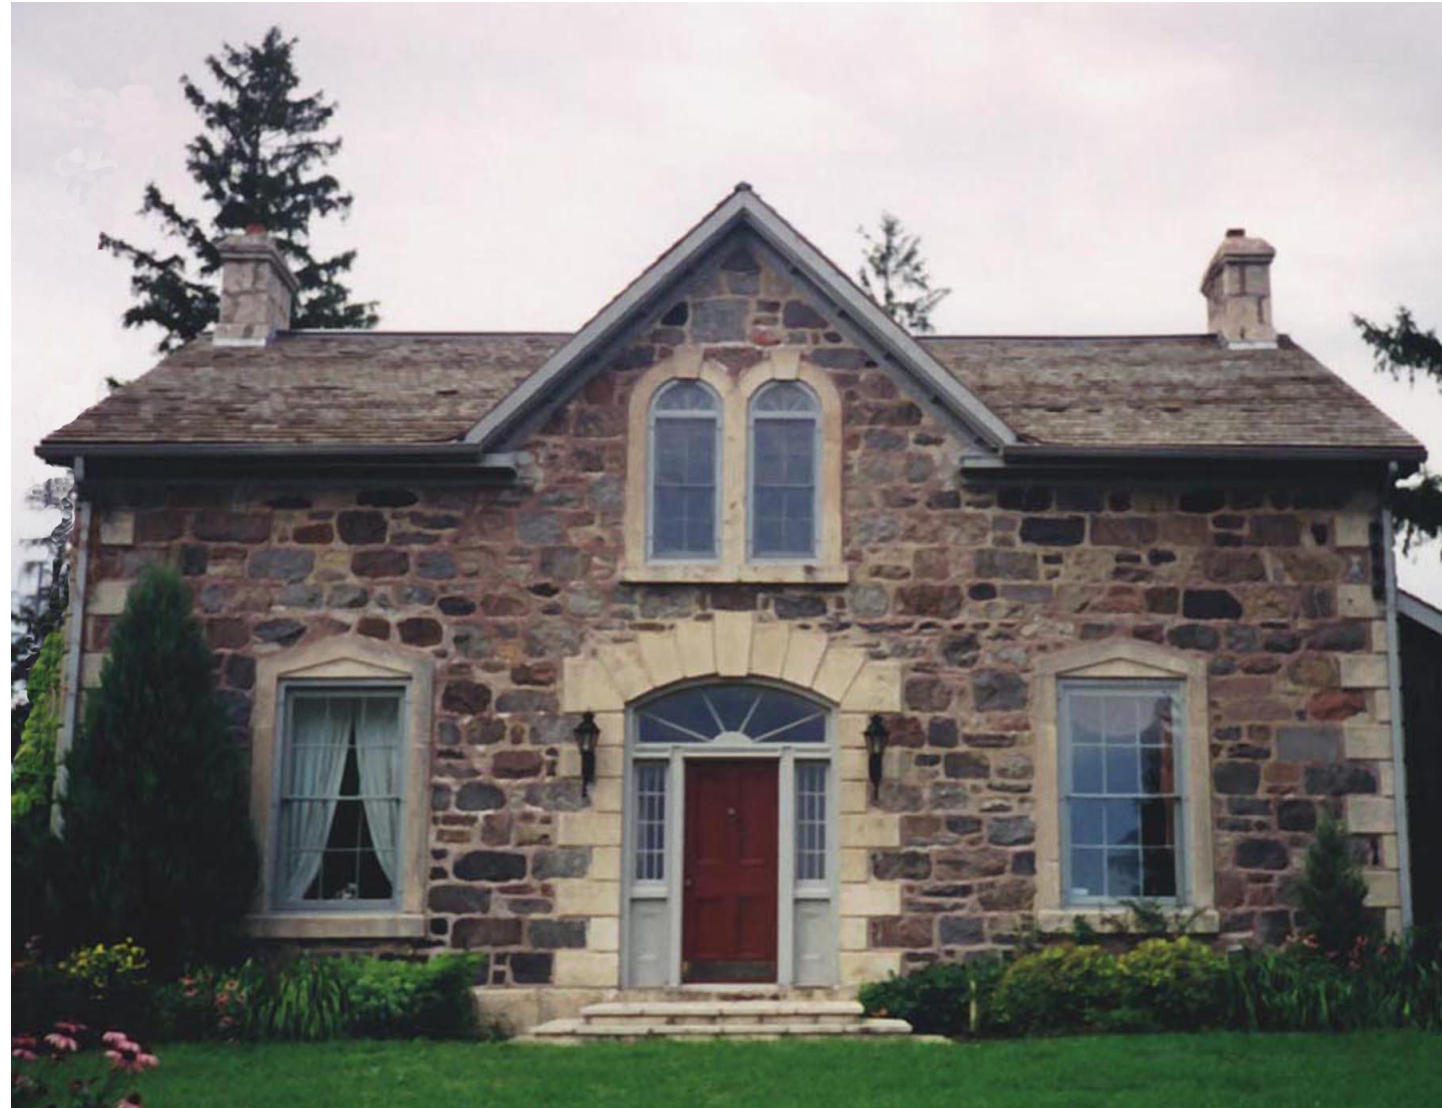
Lot 19, R 3 – now part of the Donkey Sanctuary of Canada

From top to bottom, the 1860s
Peter Stewart farmhouse
exudes country charm:

Cedar shakes were locally sourced for every roof in the mid-1800s.

An upper gable breaking the roofline was the newly-introduced design of the quintessential *Ontario-style farmhouse* of that era.

The twin arched windows in the upper hall were separated by limestone *mullions* with *keystones*.

The *articulated quoins* around the door and at the corners dressed up the fieldstone masonry.

Fanned *transom* and *double sidelights* complemented the panels of the center-hall entrance.

Limestone *labels* outlining the windows were incorporated to keep rain off the wooden window sashes.
