THE ARCHITECTURAL HERITAGE OF PUSLINCH

Welcome to the Township of Puslinch on-line record of built heritage. All photographs are from the pictorial heritage inventory of Puslinch initiated in 2000, unless otherwise noted.

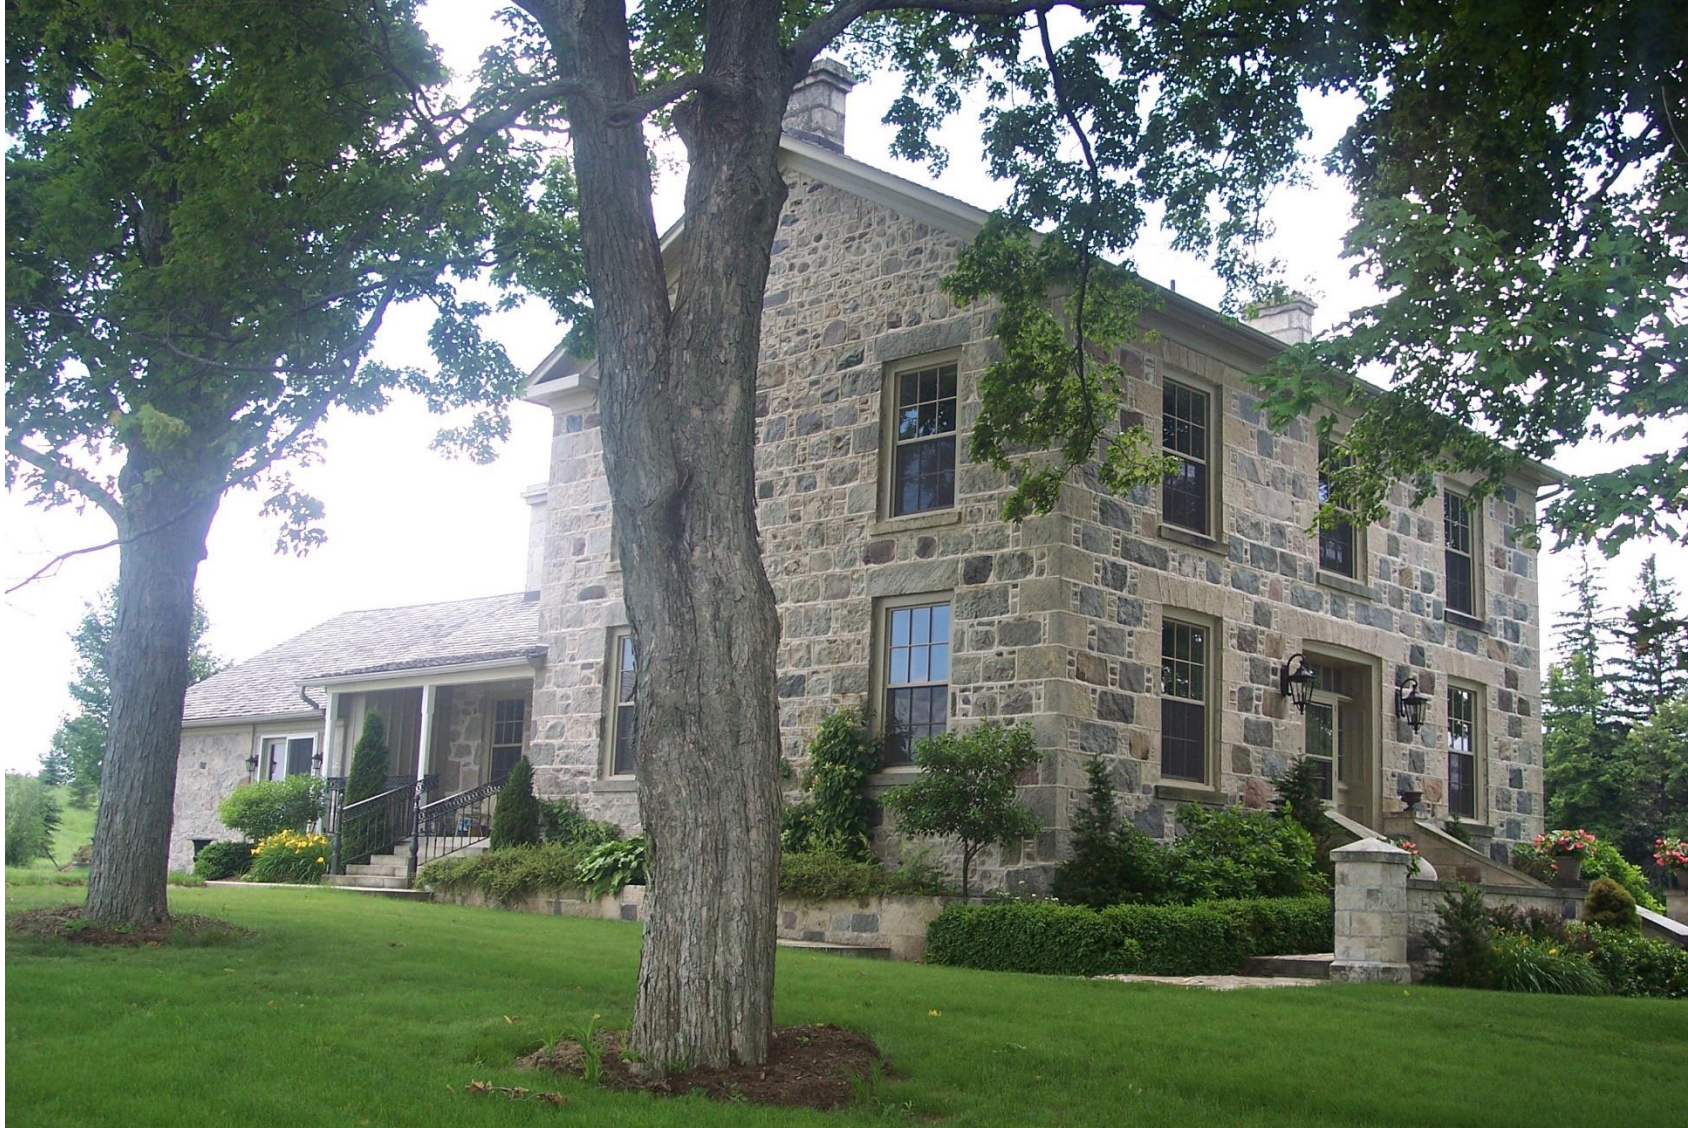
Lot 16, F & R 10

This Georgian farmhouse was built for Duncan McFarlane Sr. in the 1870s. (The McFarlanes appear on the property on the 1861 Leslie map of Puslinch and lived in a log dwelling on the property even earlier.)

In restoring the house, the colour for the windows and doors was carefully chosen to complement the shades in the fieldstone. Repointing included the H-pattern connectors used in Edinburgh-style coursing .

Sympathetic renovations in the extension, at back, complete the restoration of a worthy heritage property.
