TECHNICAL MEMORANDUM

Project No. CA-GLD-1791470A

RESPONSES TO ABOUD AND ASSOCIATES INC. / TOWNSHIP OF PUSLINCH REVIEW COMMENTS – PROPOSED CBM ABERFOYLE SOUTH LAKE PIT

The table below provides WSP's responses to review comments made by Aboud and Associates Inc. (Aboud) on February 8, 2024, related to the ARA licence application for the proposed CBM Aberfoyle South Lake Pit.

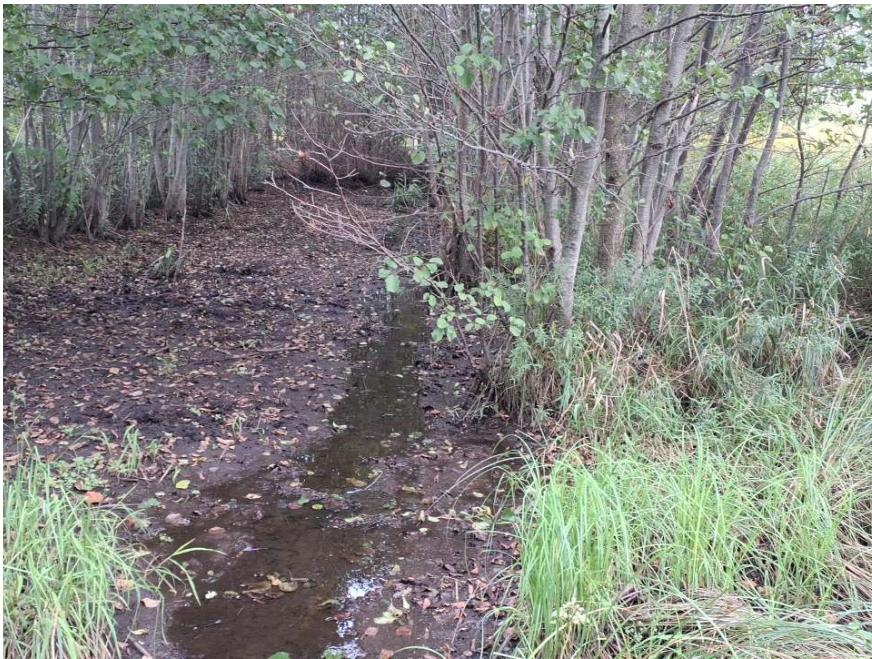
Photo 7. Tributary #3 (September 2024)

During the September 2024 survey, it was noted that the average wetted depth was less than 0.3 m with deep organic muck sections present through the middle reach of Tributary #3 (APPENDIX B). The presence of watercress indicates that the tributary is likely groundwater-fed (O'Neil and Hildebrand 1986 and WSP 2024). No specialized habitats (e.g., spawning) were identified in Tributary #3.

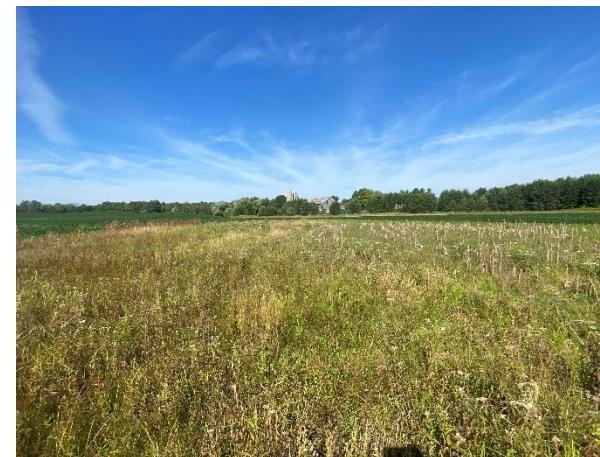
Photo 7 : HDF2 taken 2024-08-30 during Sample Event 3 - Summer. Photo looking northeast from the agricultural field where the HDF started.
