NATURAL ENVIRONMENT AND WATER REPORT TERMS OF REFERENCE CONCORDANCE CROSS-CHECK - PROPOSED CBM ABERFOYLE SOUTH LAKE PIT

CBM ABERFOYLE SOUTH LAKE PIT – FISH COMMUNITY ASSESSMENT

FLOOD MAPPING – PROPOSED ABERFOYLE SOUTH LAKE PIT

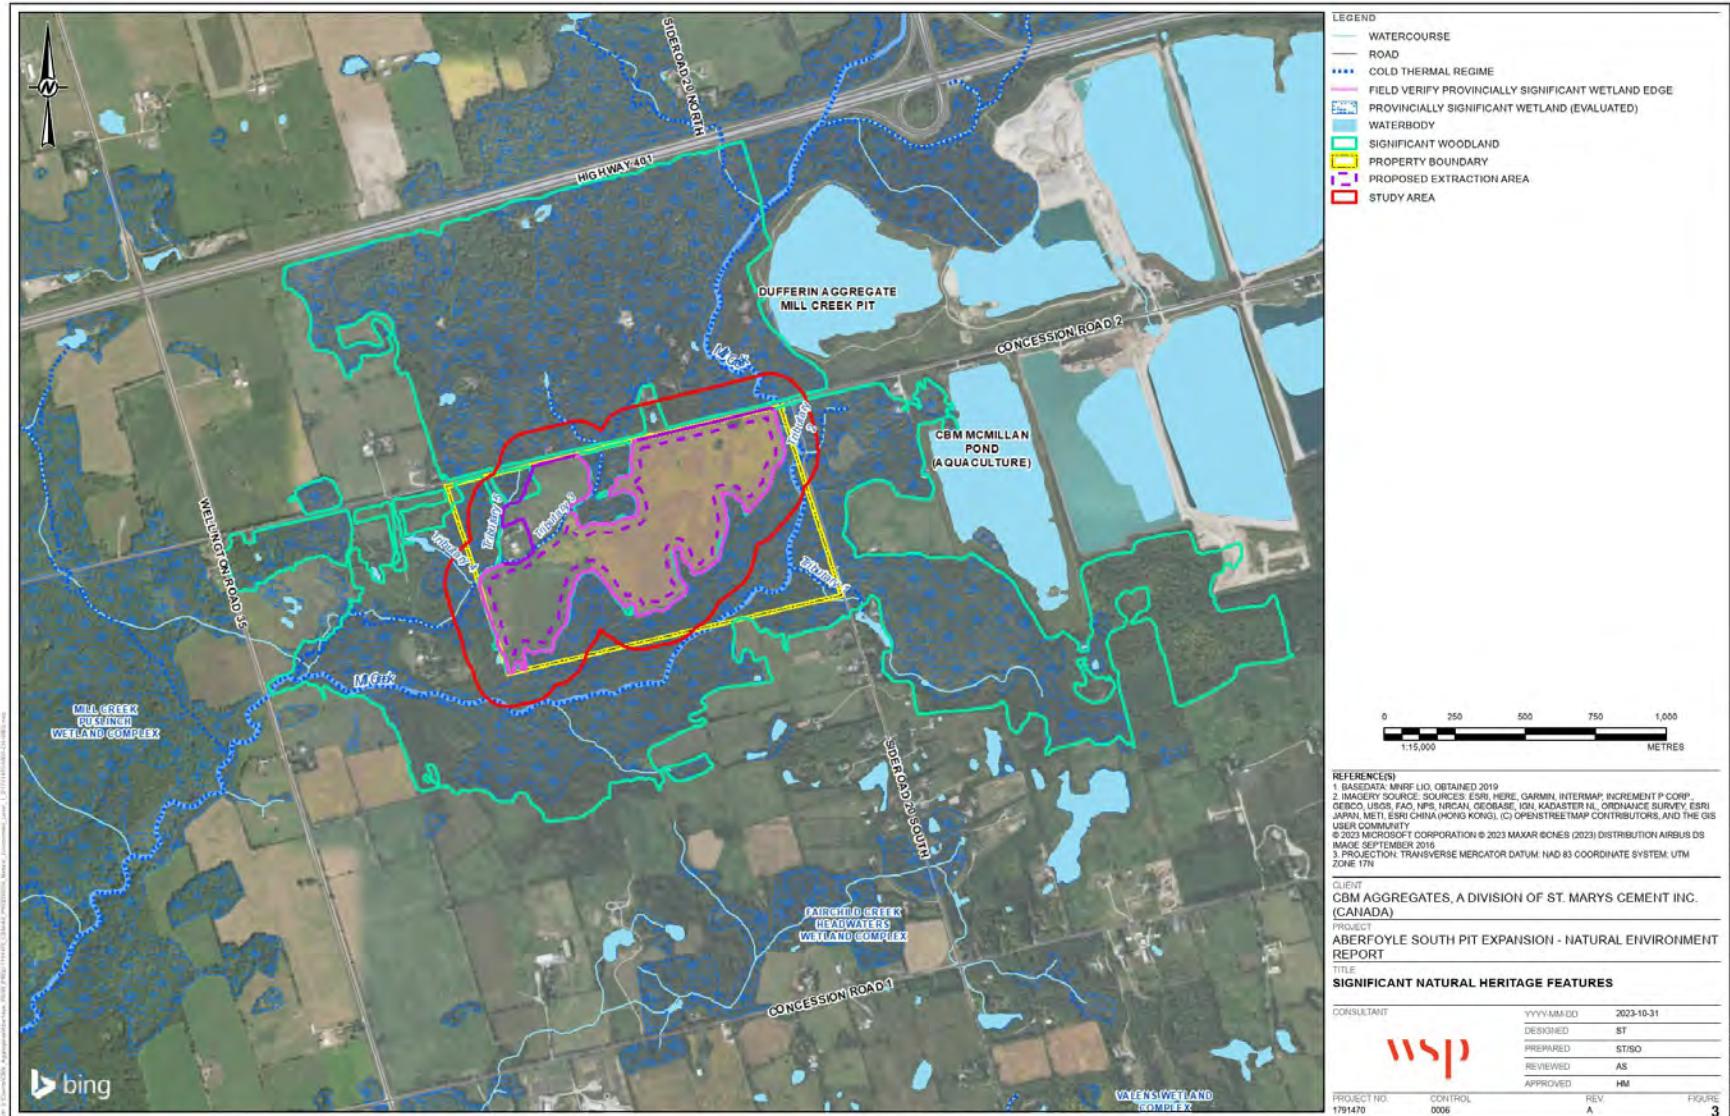
Study Area - Associated Watercourses

There are five unnamed tributaries to Mill Creek associated with the Site. The following four unnamed tributaries (excluding Tributary #3) lie outside of the licence boundary, as seen on the figure attached (APPENDIX A).

Tributary #3 originates in the Mill Creek-Puslinch PSW approximately 330 m north of the property, flowing first through the Mill Creek-Puslinch PSW and then through the northwest portion of the Site before re-entering the Mill Creek-Puslinch PSW and joining Mill Creek approximately 530 m west of the property (APPENDIX A).

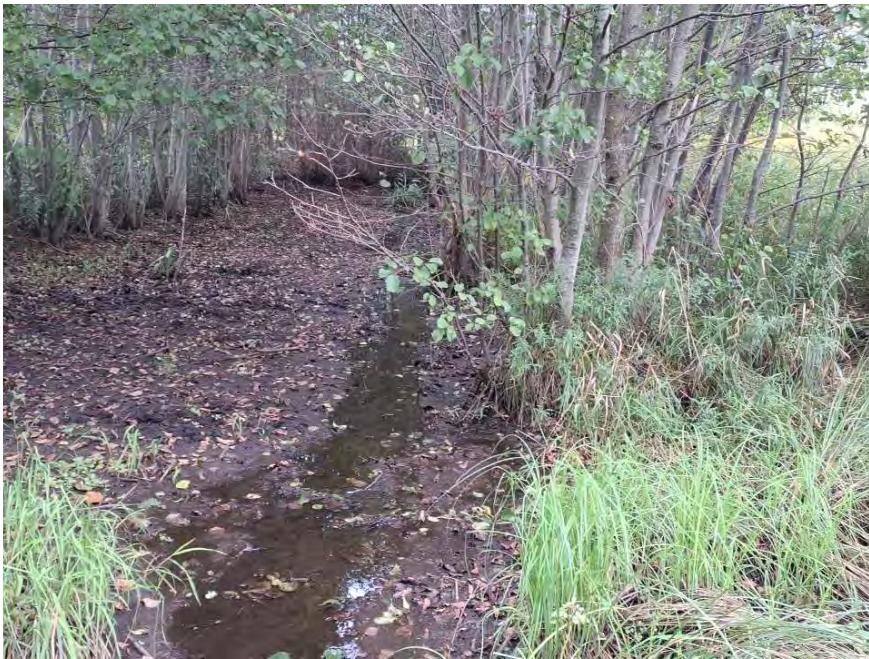
Photo 7. Tributary #3 (September 2024)

During the September 2024 survey, it was noted that the average wetted depth was less than 0.3 m with deep organic muck sections present through the middle reach of Tributary #3 (APPENDIX B). The presence of watercress indicates that the tributary is likely groundwater-fed (O’Neil and Hildebrand 1986 and WSP 2024). No specialized habitats (e.g., spawning) were identified in Tributary #3.

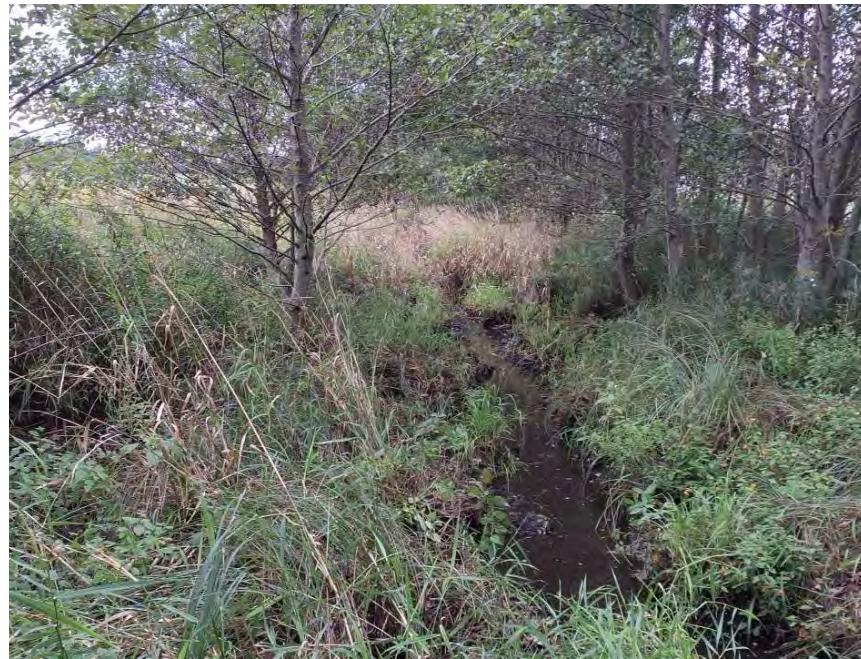
Photo 8. Tributary #3 (September 2024)

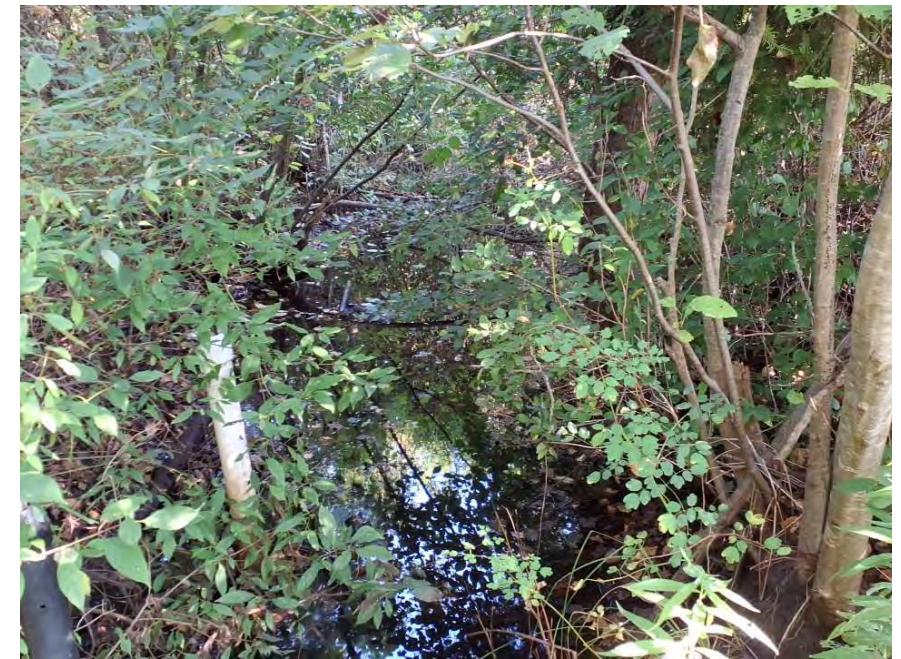
Photo 9. Tributary #3 (September 2024)

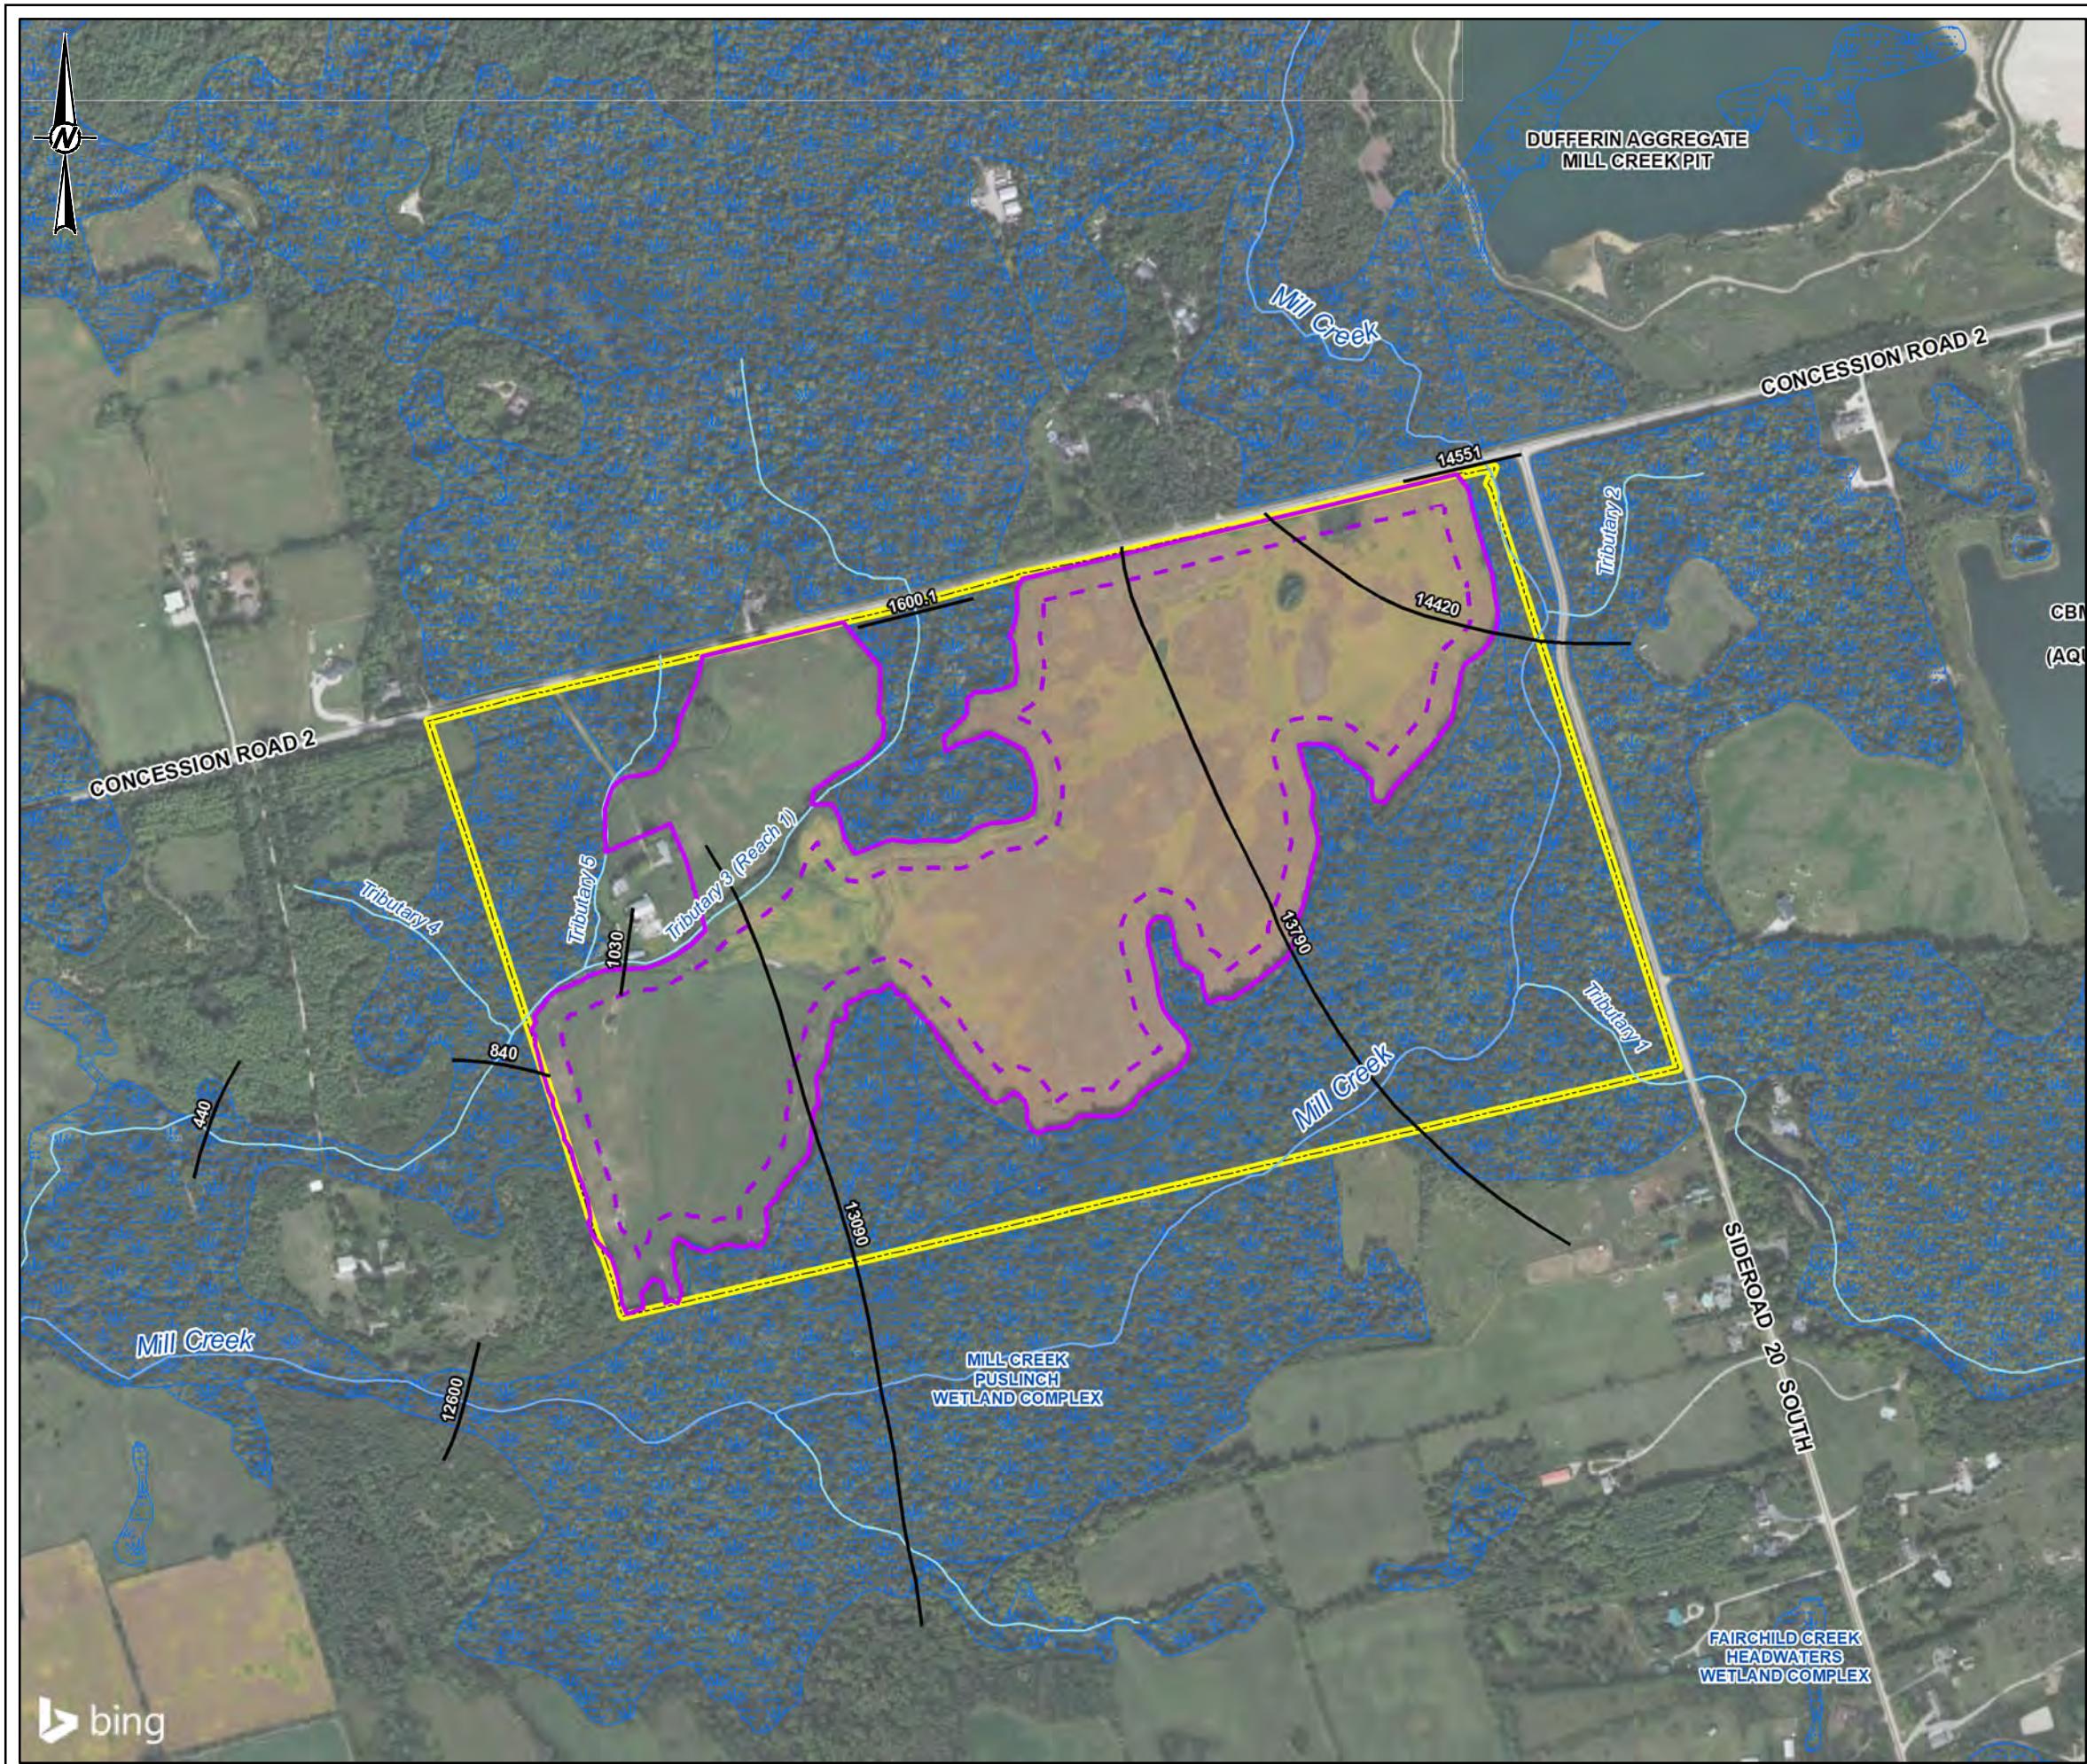
PROJECT NO. 1791470 CONTROL 0017 REV. 0 FIGURE 1.1

TITLE
SITE LOCATION AND CROSS-SECTIONS

The Property is approximately 85 hectares (ha) in size and is located at 6947 Concession Road 2, in the Township of Puslinch, County of Wellington, Ontario. Of this Property, approximately 44 ha are proposed for licensing under ARA (referred herein as Site) and the extraction area within the Site is approximately 27 ha in size (Figure 1.1). The Property is comprised of approximately 50% agricultural fields which are flanked by three wooded areas in the northwest, north-central and southeast portions of the Property and an unoccupied residence in the western portion of the Property (Figure 1.1).

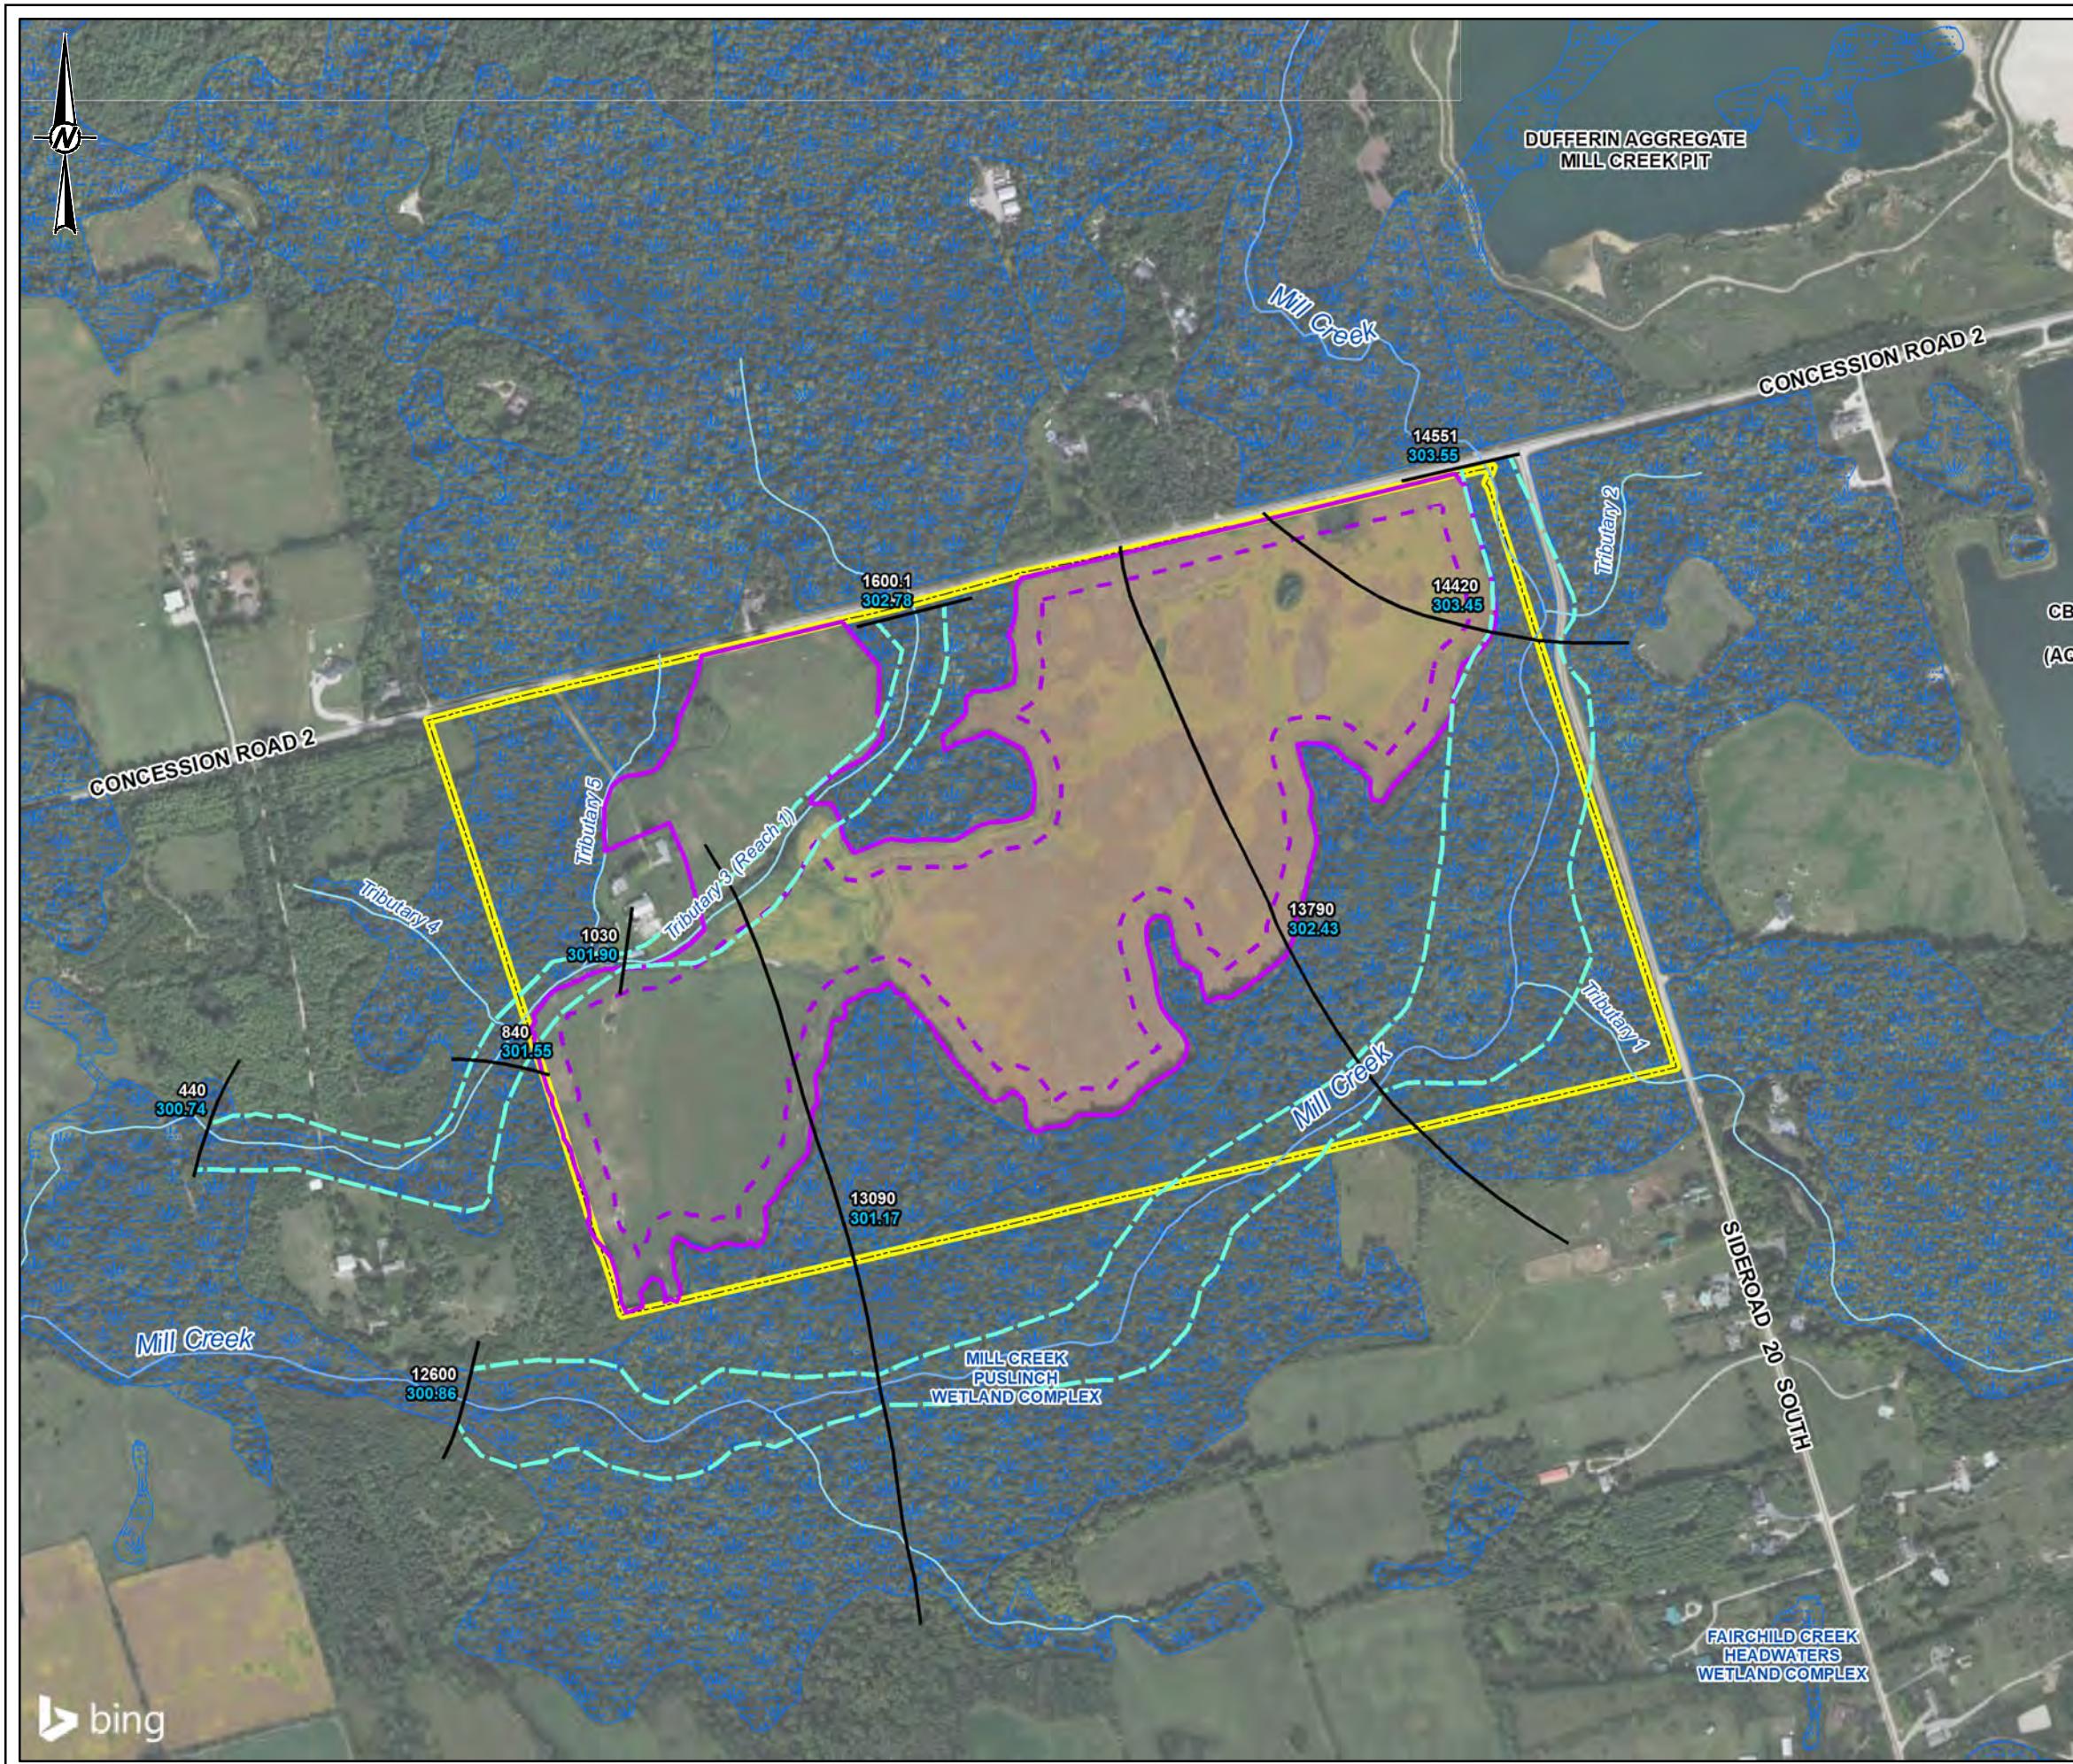
FIGURE 1.3

TITLE: STORM FLOOD ELEVATION MAP - 50 - YEARS FLOOD LEVELS (CGVD2013)

The results of the HEC-RAS modeling based on CGVD2013 / NAD1983 are presented as storm flood elevations (Tables 3 and 4) and the floodplain maps (Figures 1.2 through 1.6) along the reaches of Mill Creek and Tributary 3. The summary of results is as follows:

- Floodplain boundaries of 100-year and 50-year storm floods, were found to overlap the Site boundary at the northeastern corner of the Property, however, floods were not found to extend beyond the extraction area limit. No flooding was observed in the other parts of the Site due to Mill Creek.
- Storm flood elevations at the northeast corner of the Property, where the Mill Creek flood water is found to enter the Property (Section 14551), ranged from 303.61 metres above sea level (masl) for 100-year storm flood to 303.17 masl for 5-year storm flood.

- Floodplain boundaries of all storm floods were found to overlap the Site boundary, however, only the 100-year and 50-year storm floods were found to extended beyond the extraction area limit. Note that the extraction area is located on the southern side of the Tributary 3.
- Storm flood elevations at the northern corner of the Property, where the Tributary 3 flood water is found to enter the Property (Section 1600.1), ranged from 302.8 masl for 100-year storm flood to 302.61 masl for 5-year storm flood.
