REPORT HER-2021-002

SUBJECT: 880 Victoria Road S – Caulfield-Carter Farm

1.0 Heritage Building Protection Plan

CARTER FARM ASSESSMENT

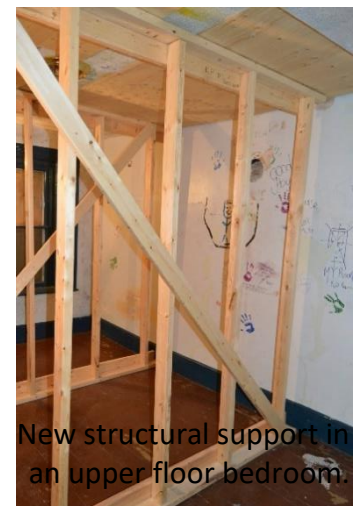
A site visit was made on May 13, 2021, with the intent of reviewing the current condition of the House. Several instances of deterioration were identified, and there was evidence of relatively recent interventions. Stabilisation work already undertaken includes the installation of new roofing, eavestroughs and soffits and eaves and down installed in 2018. The windows and doors are boarded, there are installation of vents in upper floor windows, the construction of a wood stud frame

to brace the ceiling in one upper floor room, the disconnection of sanitary and water, and the 2017 installation of a new electrical panel.

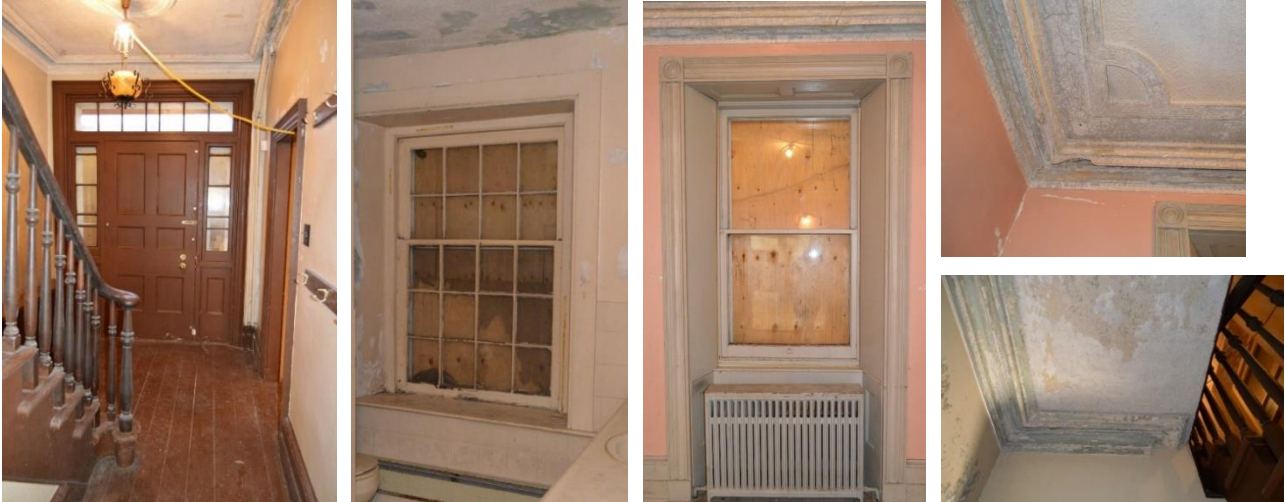
Nineteenth century woodwork survives in several interior locations. The most prevalent is the main doorway including the surrounding transom and sidelights. The staircase, balustrade, baseboards, casework and mouldings extending into the adjacent living room are intact. The following photos shows some of the woodwork and moulding mentioned above:

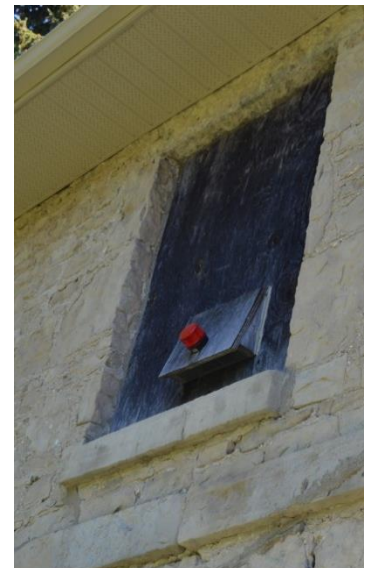
The building does not have an operating source of ventilation. The windows and doors are boarded up and the washroom fans are inoperable. There is an inadequate air infiltration through the building due to the sealed fenestrations and the original heavy stone wall construction. As noted above two of the windows have had vents installed. These vents were powered but were not functioning at the time of the visit.

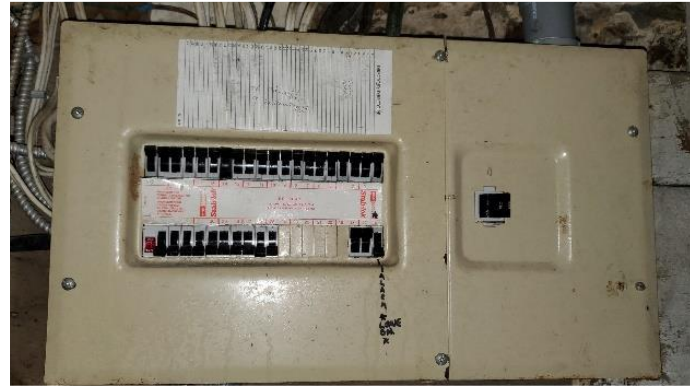
The house is supplied with 200A single phase electrical service which enters the building in its south corner; this is where the meter is located. The service connects to a 200A electrical panel on the south wall of the basement. Connected to it is a 120/240V single phase, 3-wire, 40 circuit panel with a 200A main breaker and mini breakers that feed the remainder of the house. It is unconfirmed whether the panel directory is accurate as it is untested. Testing is recommended. While it is suspected that wiring has been upgraded in the past, this could not be confirmed as a part of our investigations.

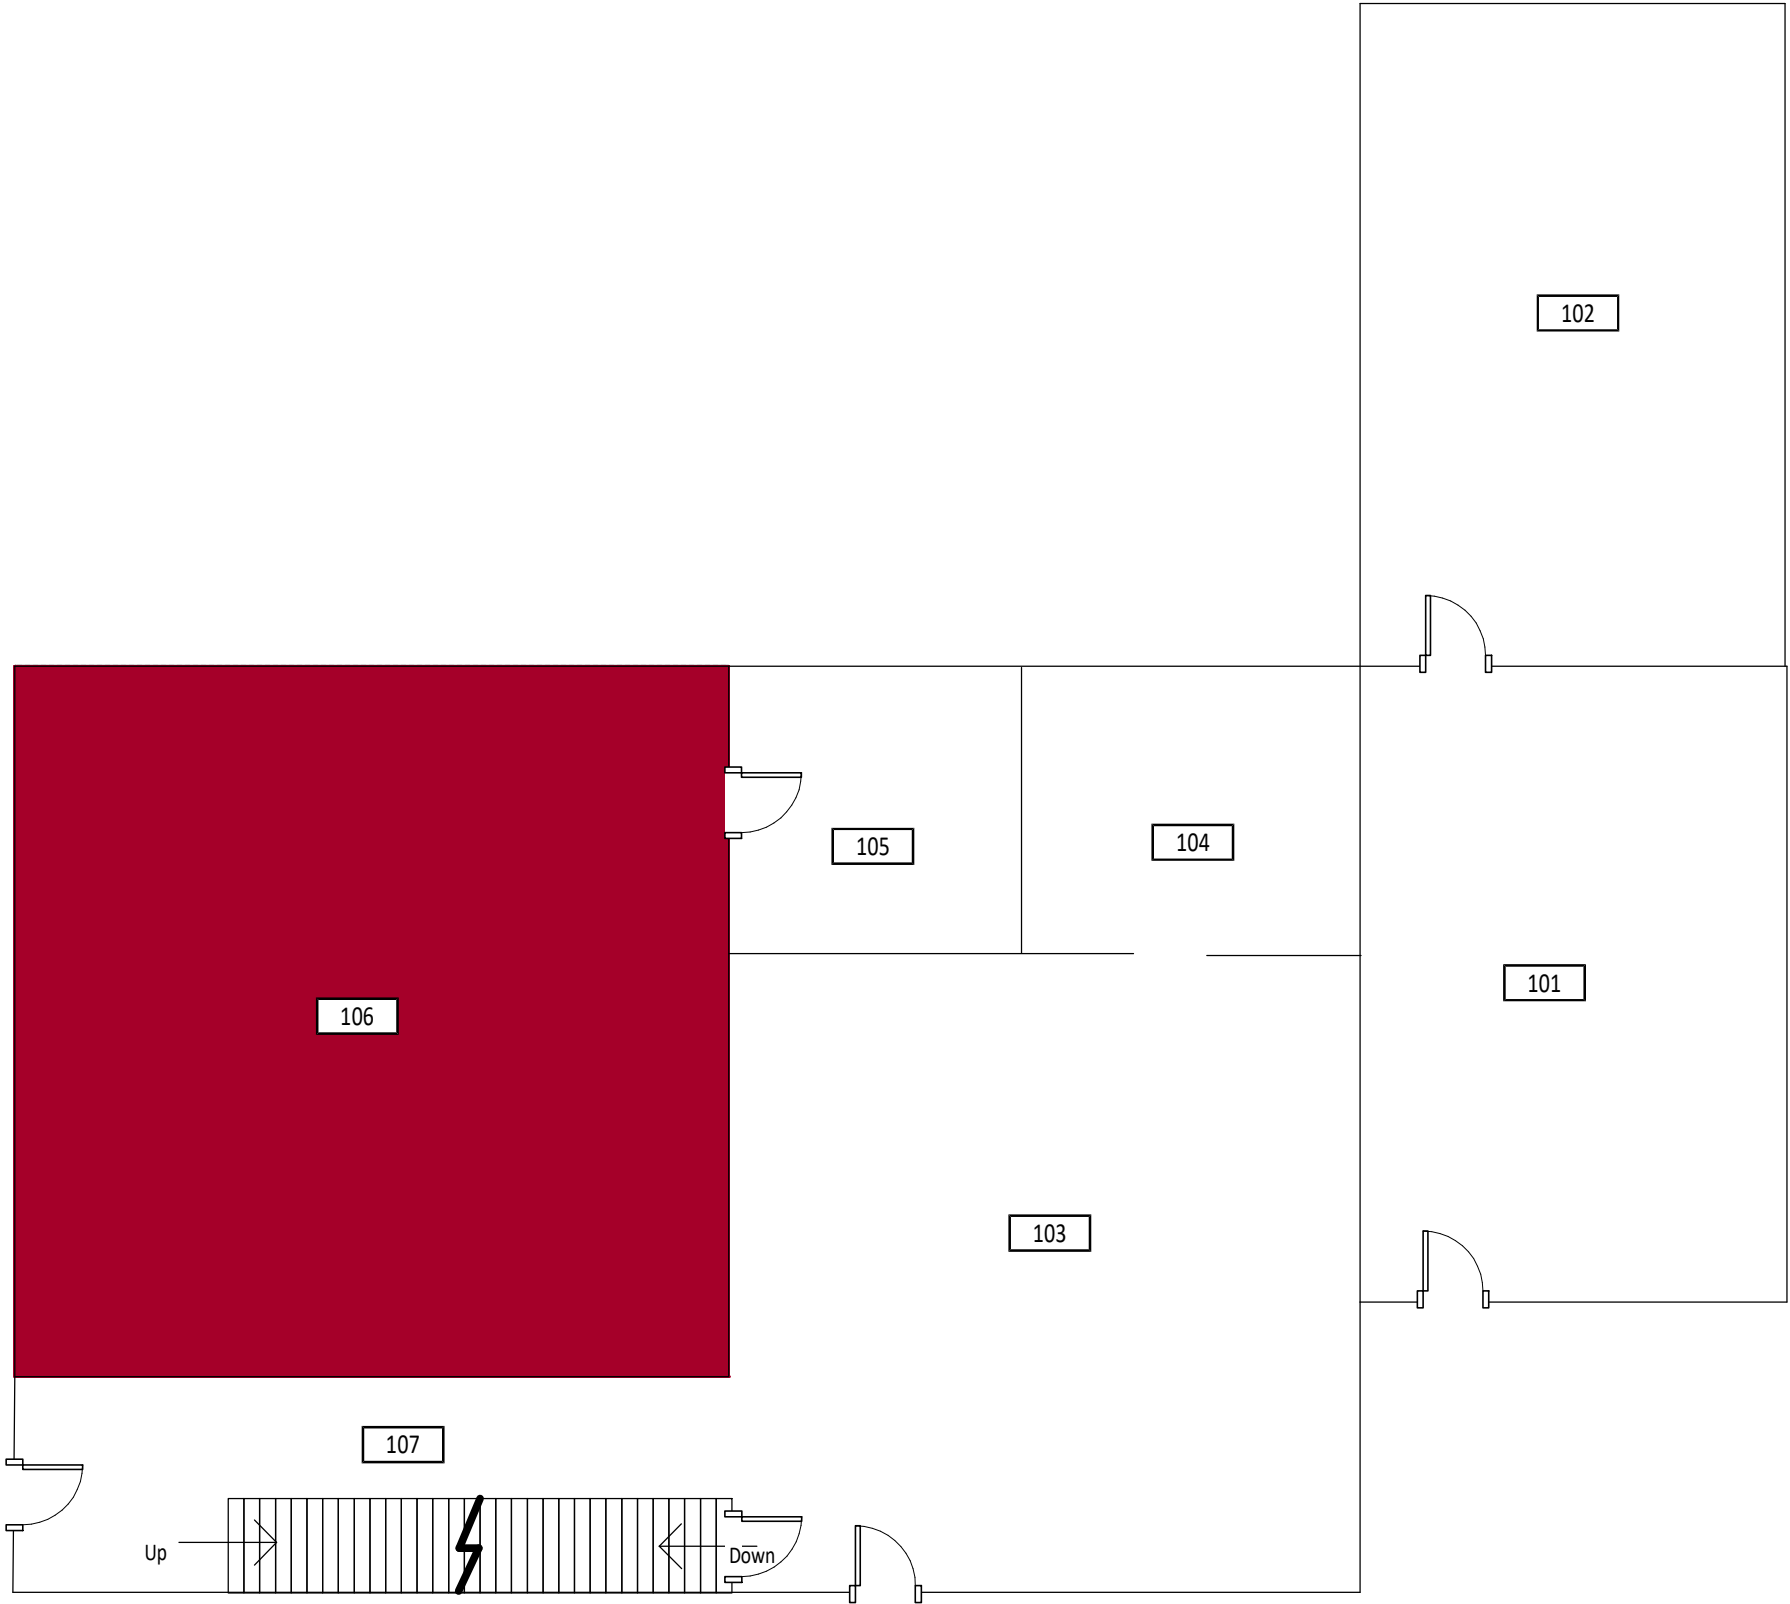
Figure 1:
Asbestos Containing Materials
Main Floor
Prepared By: OC
Date: January 13, 2020
Project:
Re-Baseline Survey 01190159
Carter Farm House
Location:
880 Victoria Road South
Guelph Ontario
Prepared For:
City of Guelph Corporate
Properties

Appendix A contains a listing and quantification of all ACM observed in the building located at Carter Farm House. **Figure 1** identifies the location of the ACM identified.
