Harden Environmental Services Ltd.
4622 Nassagaweya-Puslinch Townline Road
Moffat, Ontario, L0P 1J0
Phone: (519) 826-0099 Fax: (519) 826-9099

August 9, 2023

**Re: Mill Creek Aggregates Pit –Review of 2022 Monitoring Data
Part Lot 24, Concession 1, and
Part Lots 21, 22, 23, and 24, Concession 2**

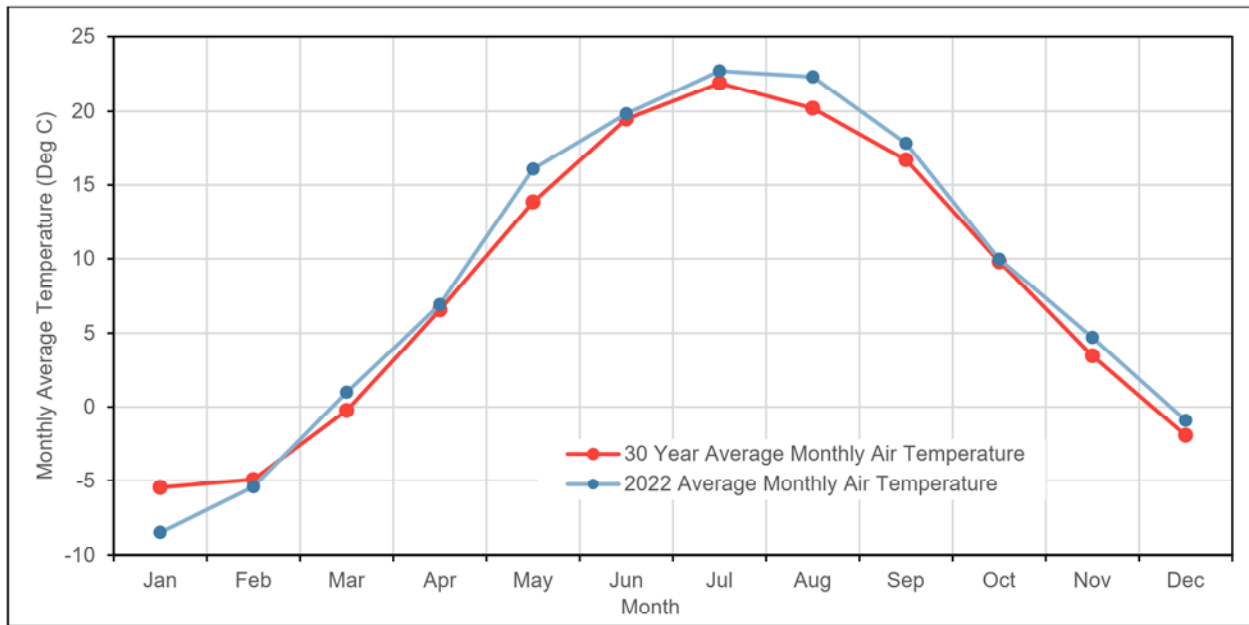
Figure 2-1 shows the monthly average air temperatures observed in 2022 compared to the 30-year average. The mean monthly air temperature in 2022 was 8.9°C, which is 0.6°C higher than the 30-year average.

Figure 2-1 2022 GRCA Shade's Mills Mean Monthly Air Temperatures Compared to 30-year Normal Temperatures

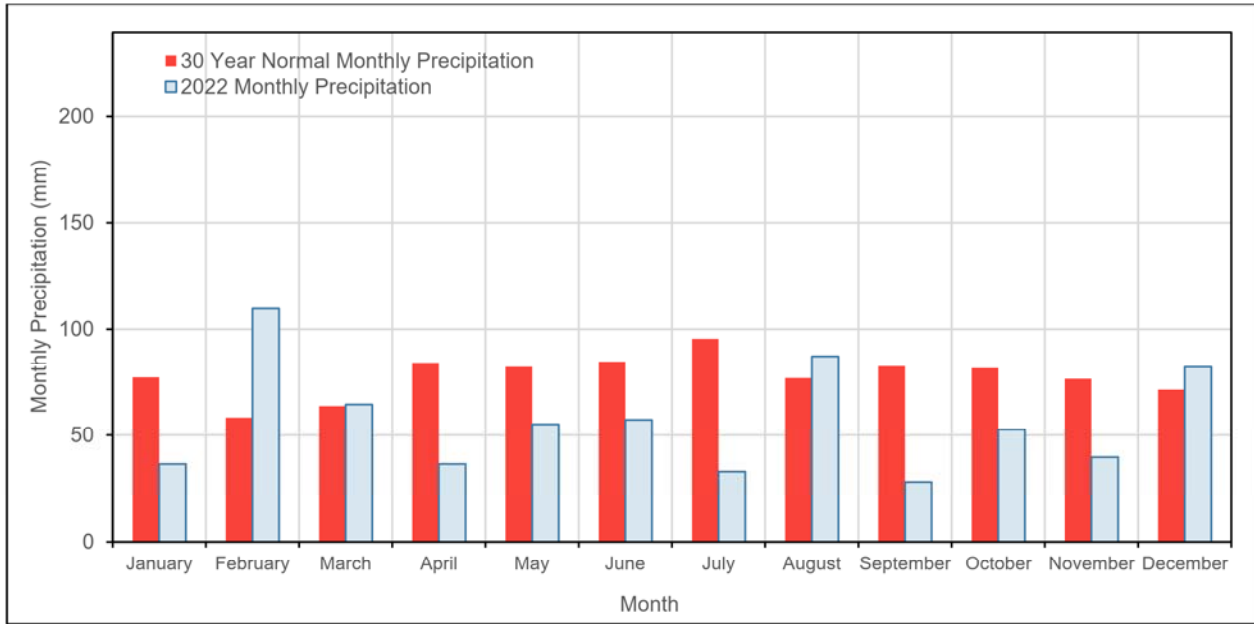
Monthly precipitation for 2022 is illustrated in Figure 2-2 along with the 30-year average. In 2022, total monthly precipitation was appreciably lower than the 30-year average for the month in eight months of the year. Total precipitation in 2022 was 682 mm, which is 27% lower than the 30-year average of 935 mm.

Figure 2-2 Total 2022 Monthly Precipitation (mm) at GRCA Shade's Mills Climate Station Compared to the 30-year Average

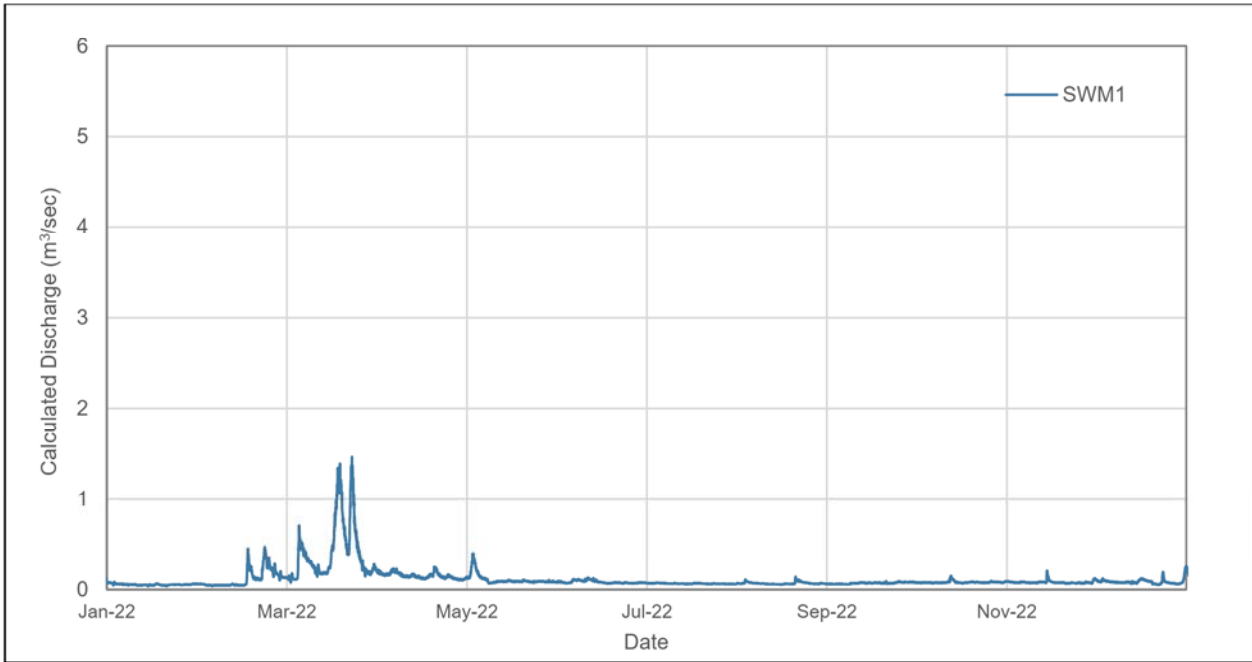
Figure 2-3 2022 Mill Creek Hourly Discharge at Surface Water Monitoring Station SWM1

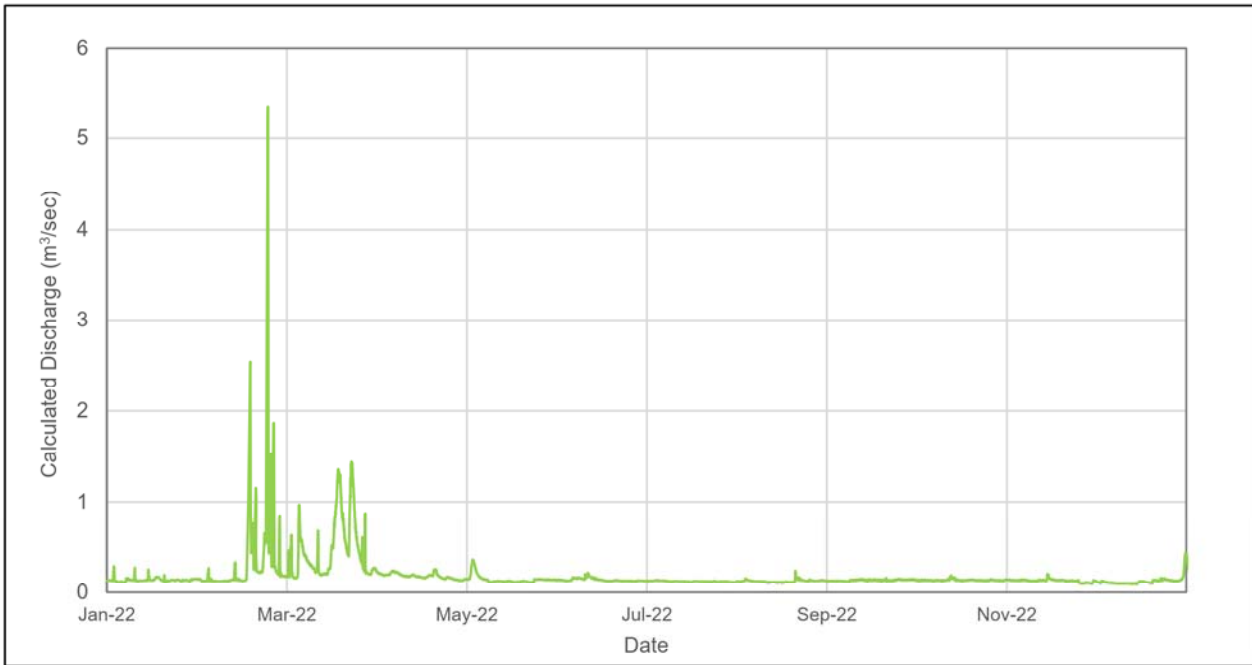
Figure 2-4 2022 Mill Creek Hourly Discharge at Surface Water Monitoring Station SWM2

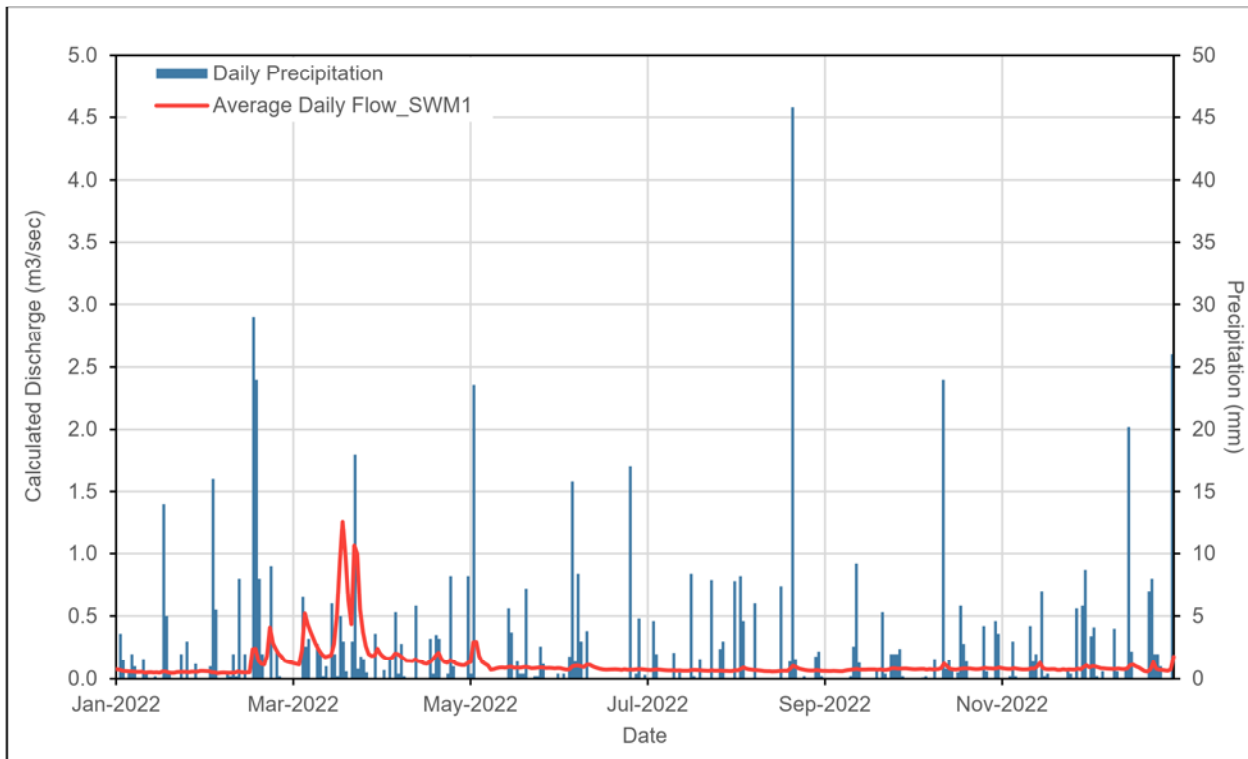
The maximum daily average flow at SWM1 in 2022 occurred on March 20, after 16 mm of precipitation occurred between March 16 and 20 and air temperatures rose above 0°C, which likely resulted in snow melt. The maximum daily average flow at SWM2 in 2022 occurred on February 22, which followed 63 mm of precipitation that fell between February 17 and 20 and air temperatures which rose above 0°C on February 22, which likely resulted in snow melt. The maximum average daily flow rates measured at SWM1 and SMW2 (1.26 and 2.64 m³/s, respectively) are interpreted to be overestimated due to the lower accuracy of the rating curve formula at higher flows. These maximum values should, therefore, be interpreted with caution.

Figure 2-5 Daily Average Flow in 2022 at SWM1 Compared to Precipitation Events

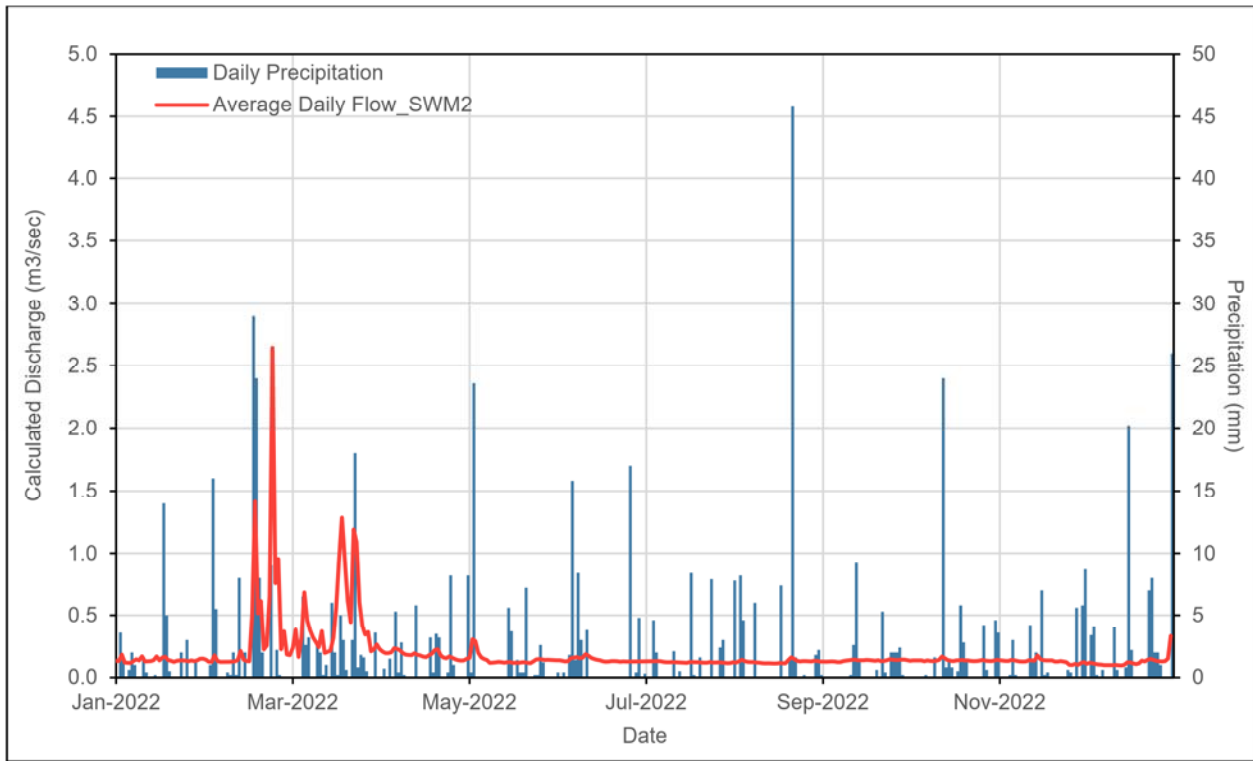
Figure 2-6 Daily Average Flow in 2022 at SWM2 Compared to Precipitation Events

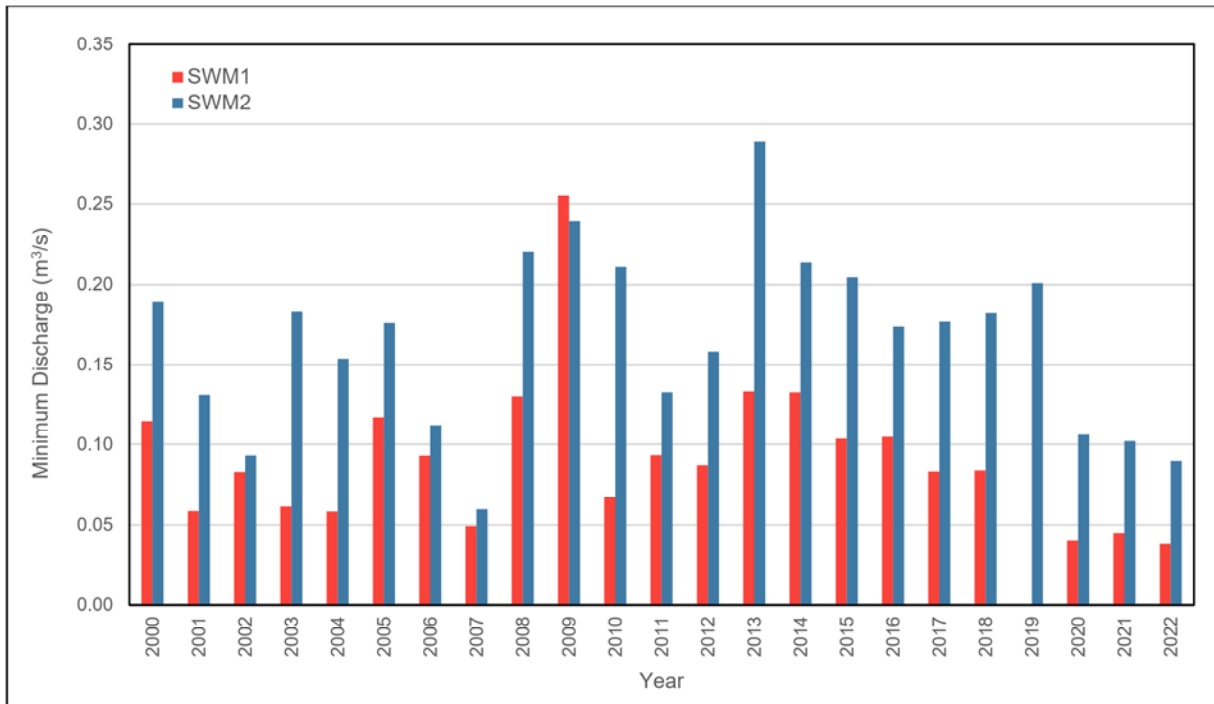
Figure 2-7 Instantaneous Minimum Stream Discharges at SWM1 and SWM2, 2000 through 2022

The 2022 minimum instantaneous stream discharge values at SWM1 and SWM2 are similar to the 2020 and 2021 minimum instantaneous stream discharge values. The 2022 minimum instantaneous stream discharge value at SWM1 is marginally lower than the historical range of values from SWM1, while the 2022 minimum instantaneous stream discharge value at SMW2 is within the historical range of values at SWM2, but the second lowest value recorded since 2000. The 2022 maximum instantaneous stream discharge values are within the historical range of values recorded since 2000.

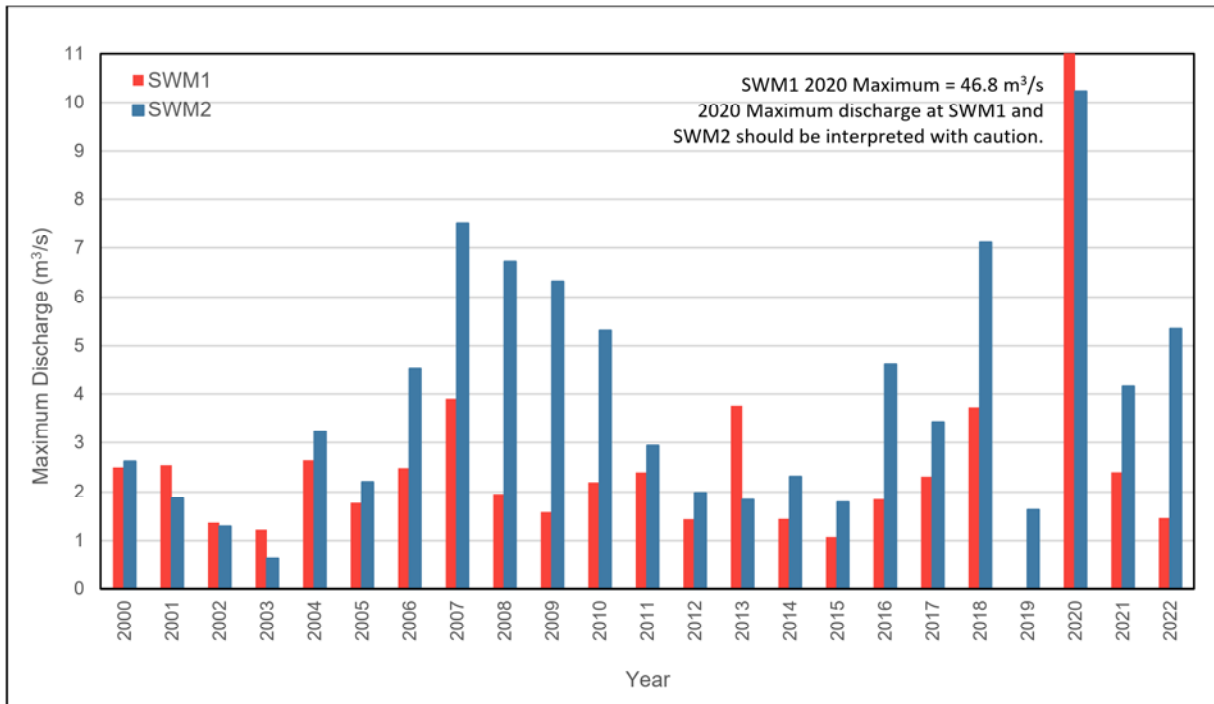
Figure 2-8 Instantaneous Maximum Stream Discharge at SWM1 and SWM2, 2000 through 2022

Estimates of peak flows may be less accurate than low flow estimates since the higher flow rates are well above manual measurements used for the rating curves. It is not safe for field staff to attempt manual flow measurements during periods of peak runoff.

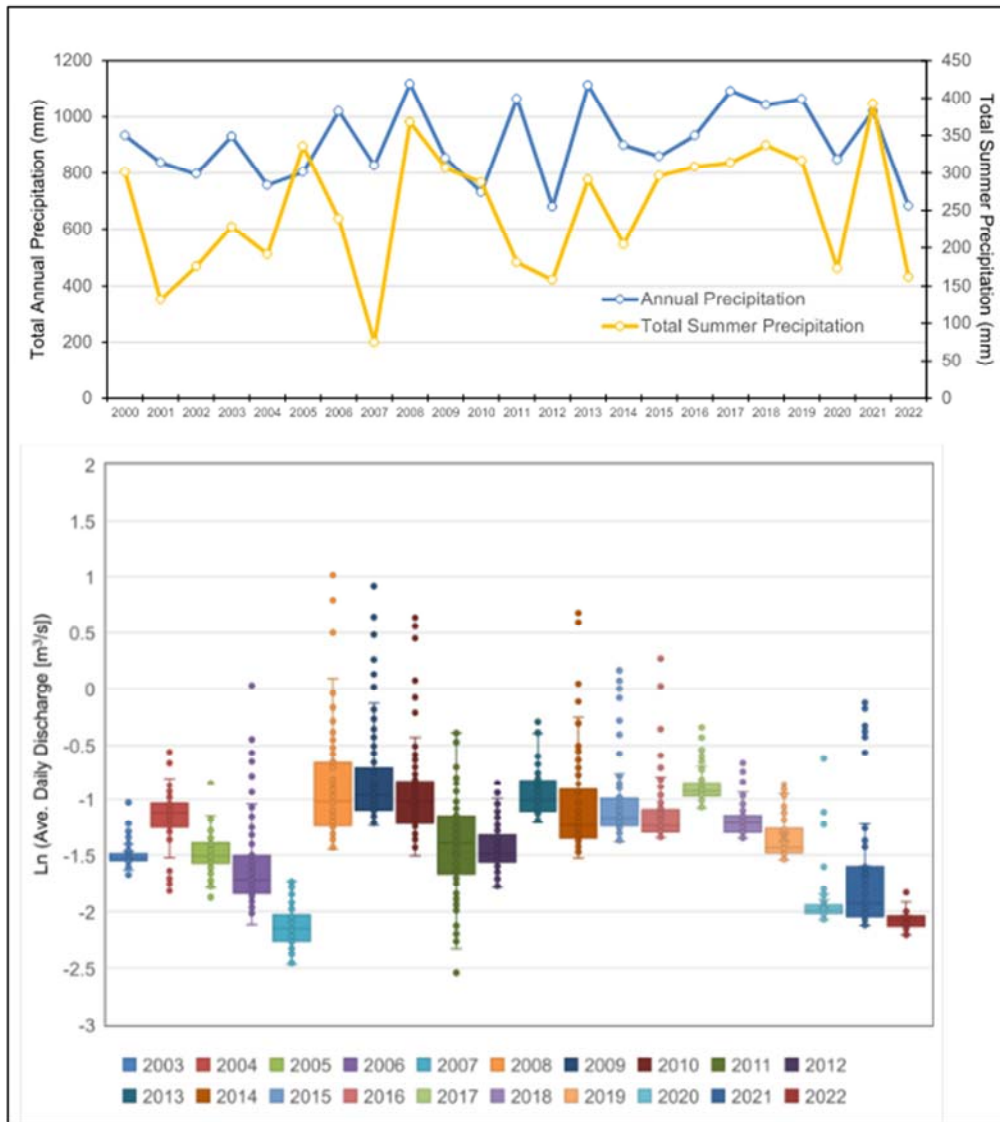
In 2022, the boxplot indicates that the daily average flow was often closer to the minimum flow recorded for the year. Figure 2-10 also shows that a long-term fluctuating trend in daily average summer flows has occurred in Mill Creek since 2003, rather than an increasing or decreasing trend.

Figure 2-10 Boxplot of Mean Daily Average Summer (June-September) Stream Flows at SWM2, 2000 to 2022

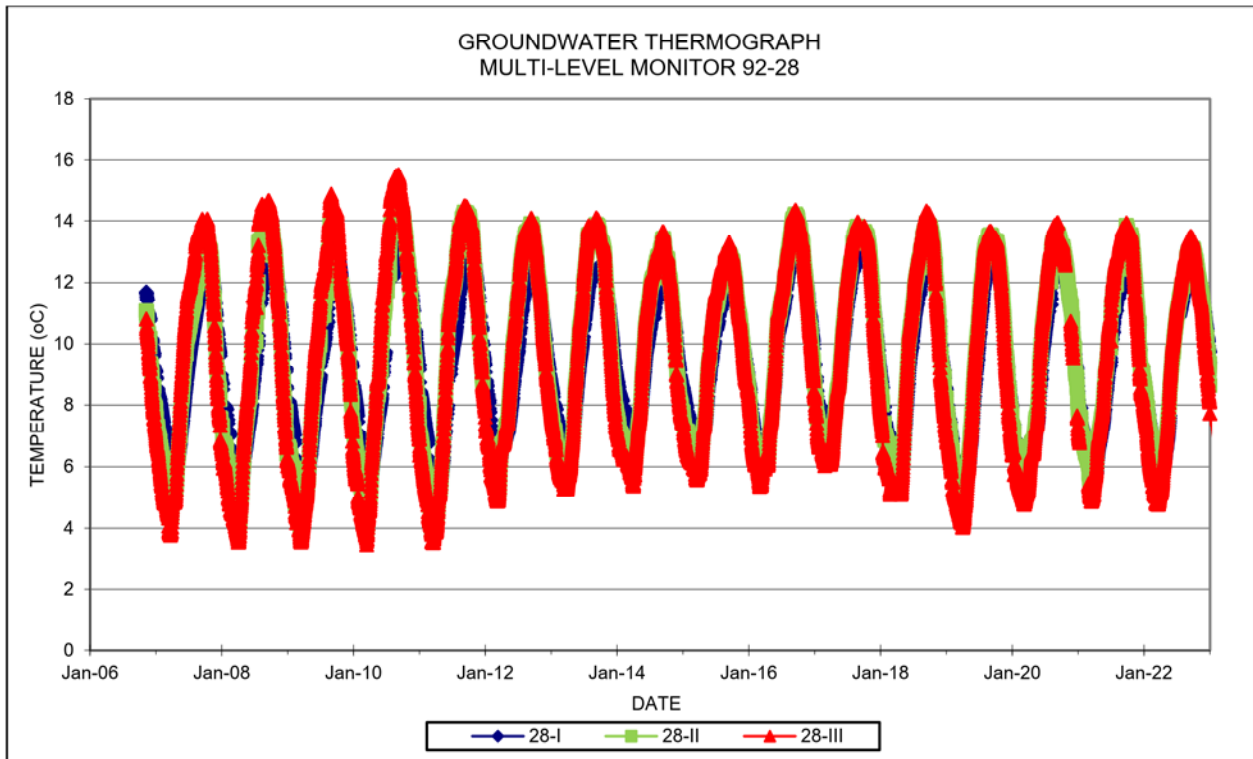
Shallow groundwater monitoring immediately downgradient of the pit ponds show the influence of the ponds on groundwater temperatures and that temperatures quickly dissipate within a short distance from the ponds. For example, at the west side of the site, shallow groundwater temperatures at Monitor 92-29 have increased while the shallow groundwater temperatures at Monitor 92-28, located between Monitor 92-29 and Mill Creek, have remained relatively stable (Figures 3-1 and 3-2).

Figure 3-1 Groundwater Thermograph of Multi-level Monitor 92-28

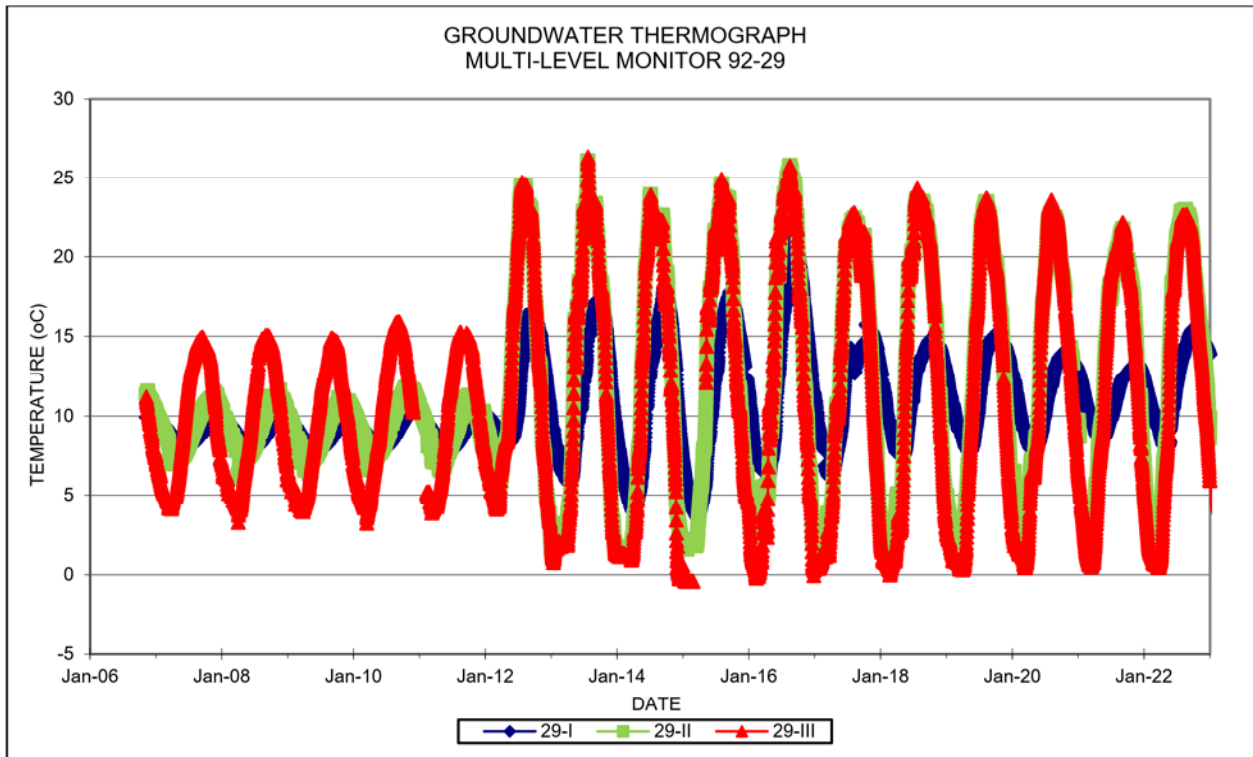
Figure 3-2 Groundwater Thermograph of Multi-level Monitor 92-29

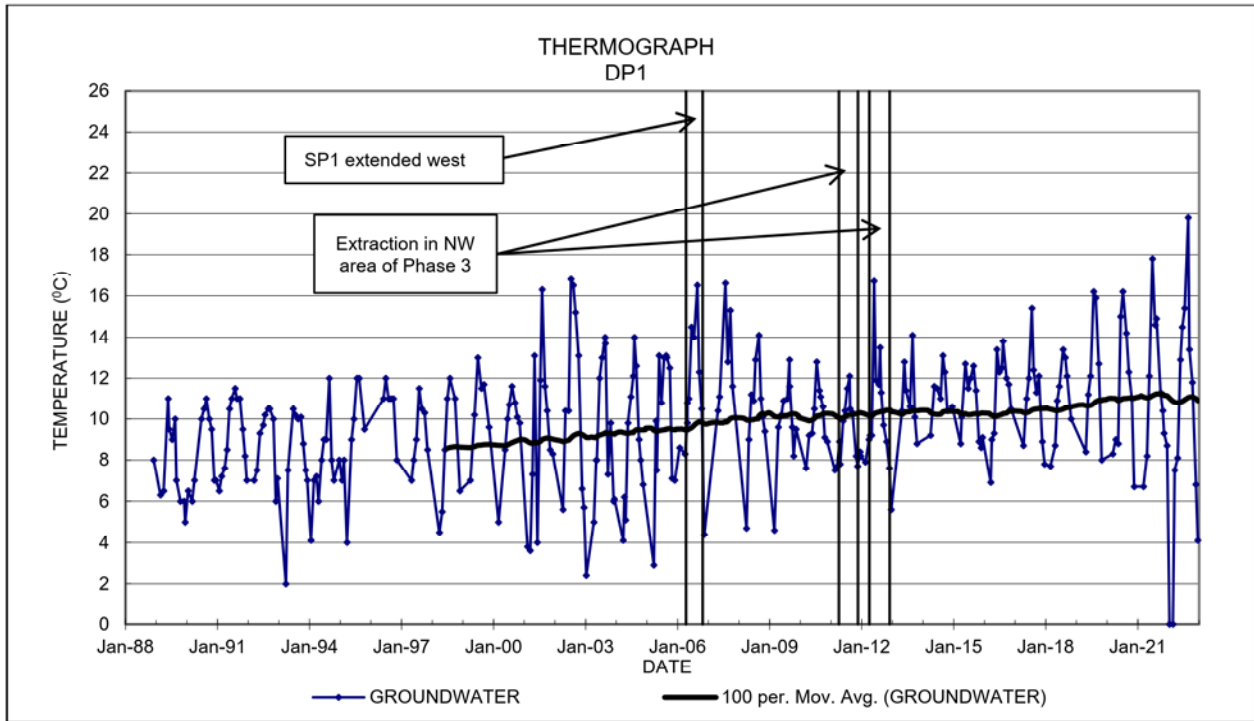
Further downgradient of 92-29 is DP1, located in Mill Creek. 92-29 and DP1 represent a monitoring pair for Threshold pair monitoring (see Section 3.2.5). The thermograph for DP1 (Figure 3-3) suggests that development of the Phase 3 pond in 2012 has not influenced groundwater temperatures in Mill Creek to any notable degree.

Figure 3-3 Groundwater Thermograph of Drive Point DP1

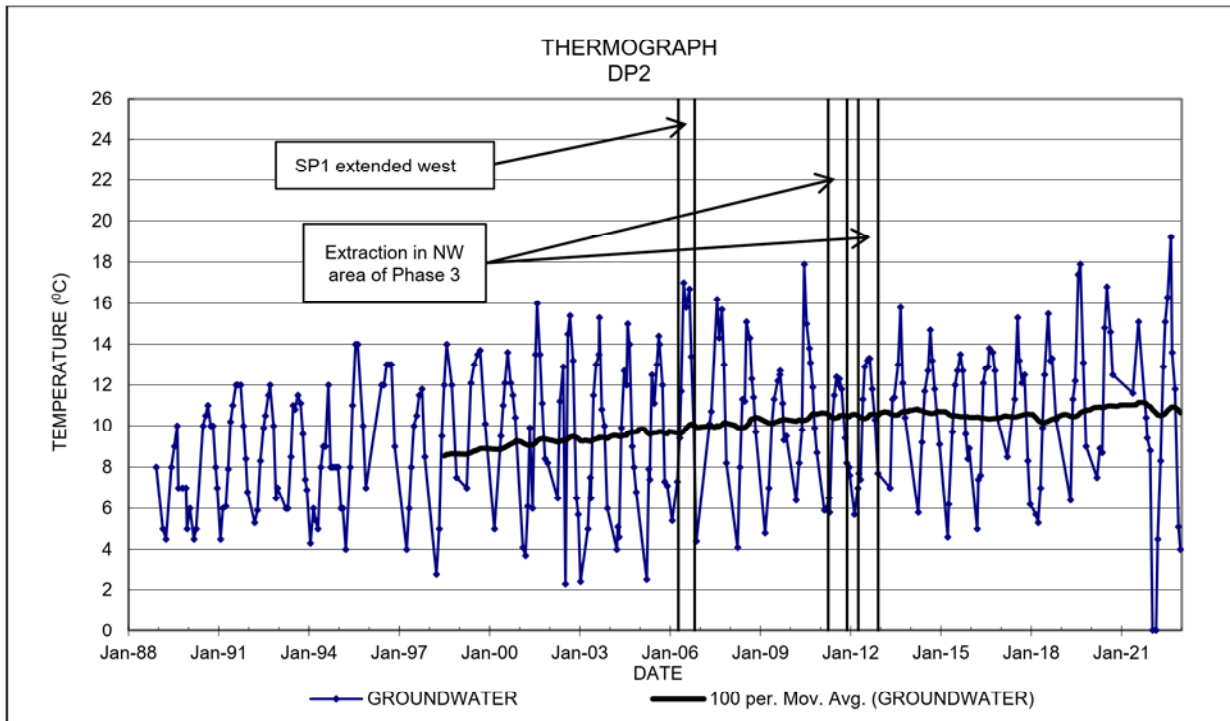
Monitor 92-27 is also adjacent to the Phase 3 pond, and with DP2 represents a threshold monitoring pair. This threshold pair exhibits a similar groundwater temperature relationship as the 92-29 to DP1 threshold pair. Similar to DP1, the thermograph for DP2 (Figure 3-4) suggests that development of the Phase 3 pond in 2012 has not influenced groundwater temperatures in Mill Creek to any notable degree. However, there does appear to be a subtle almost 2°C increase in groundwater temperature at DP1 and DP2 that began prior to operational activities in this area and may be a regional phenomenon, as suggested by a similar subtle increasing trend observed at upstream drive point DP20 (Figure 3-5).

Figure 3-4 Groundwater Thermograph of Drive Point DP2

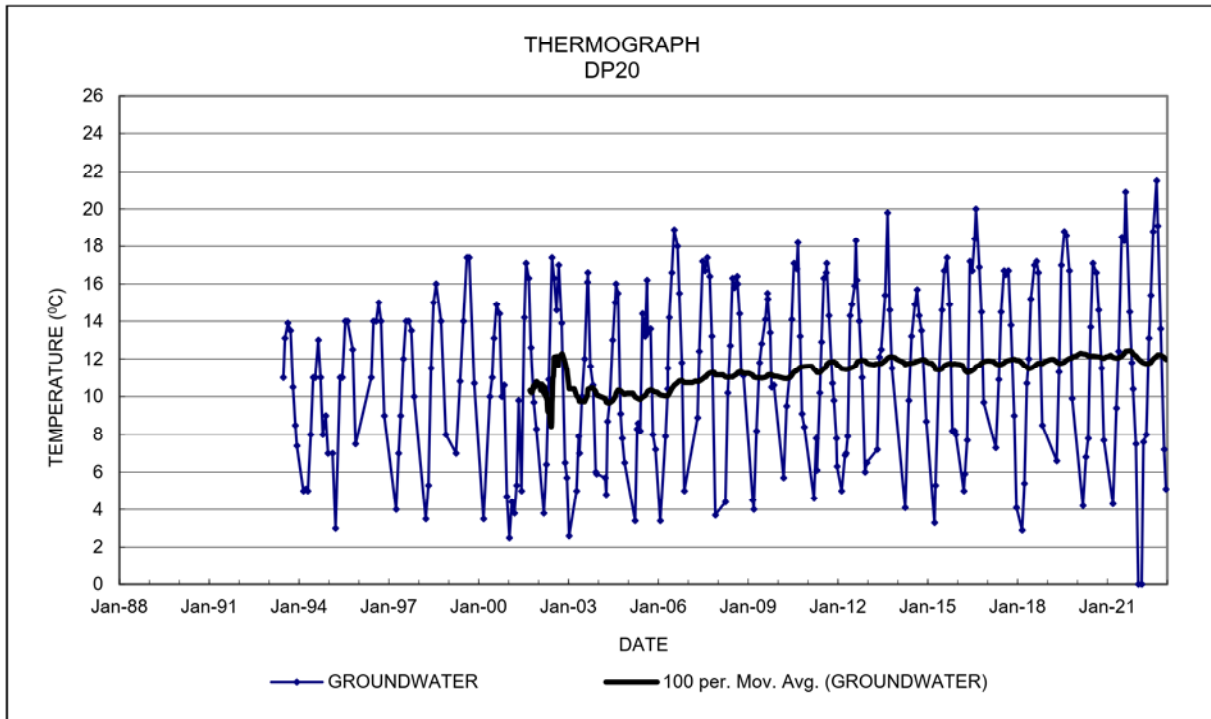
Figure 3-5 Groundwater Thermograph of Drive Point DP20.

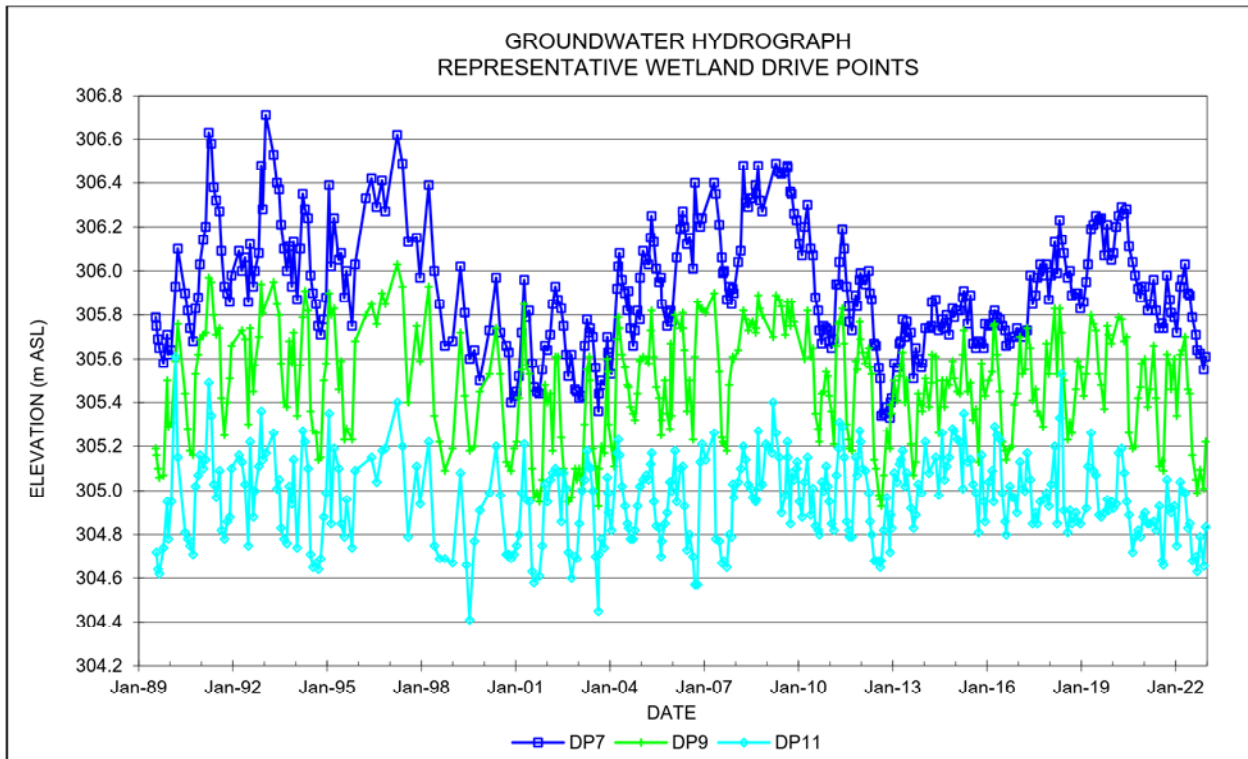
The groundwater level recorded within the wetland areas in 2022 averaged about 0.12 m below the historical average, and about 0.06 m below the 2021 average for the site. The lower levels compared to 2021 are attributed to the lower water surplus that occurred at the site in 2022 compared to historic results. The decrease in water levels within the wetland areas generally is less than the decrease experienced at other locations across the site. This is primarily due to the proximity of the wetland areas to Mill Creek, which acts as a buffer, or hinge point, for the water table that reduces the magnitude of seasonal variations. The wetland groundwater levels recorded in 2022 were within the historical maximum and minimum groundwater levels. An aggregate extraction influence is not apparent.

Figure 3-6 Groundwater Hydrograph of Three Representative Drive Points in the Wetland

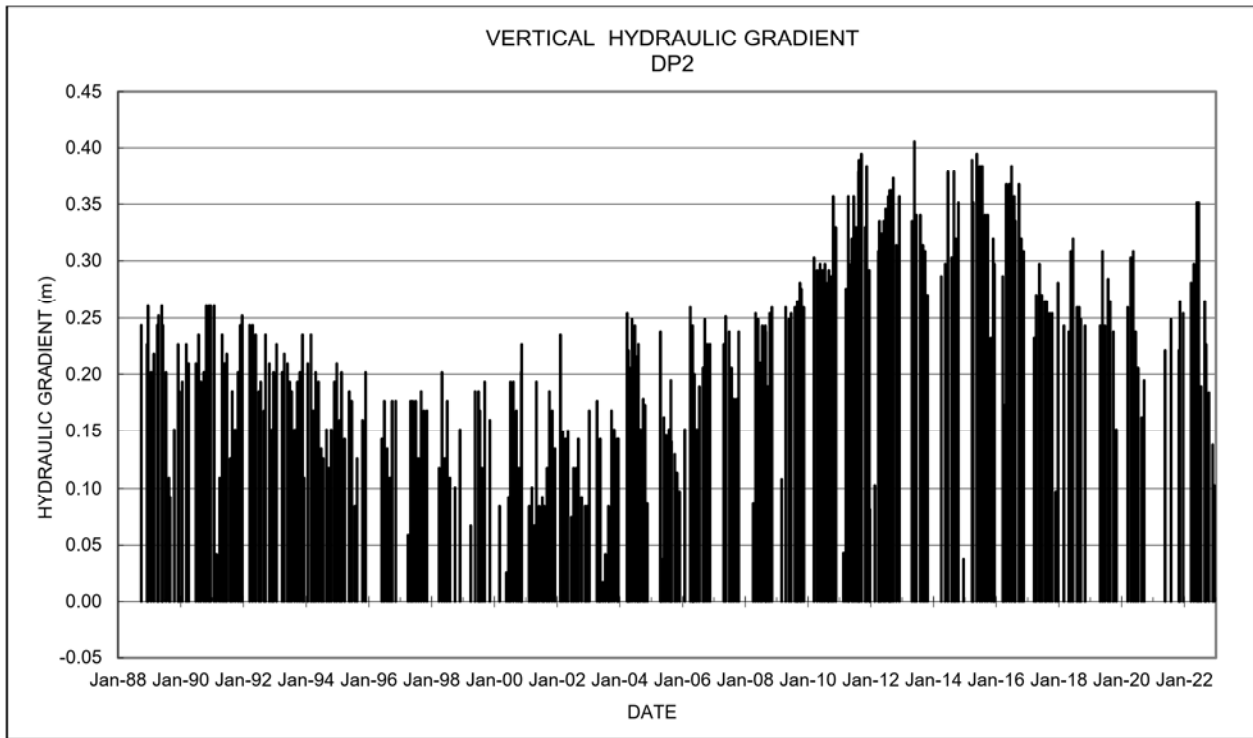
Figure 3-7 Hydraulic Gradient at Stream Drive Point Station DP2

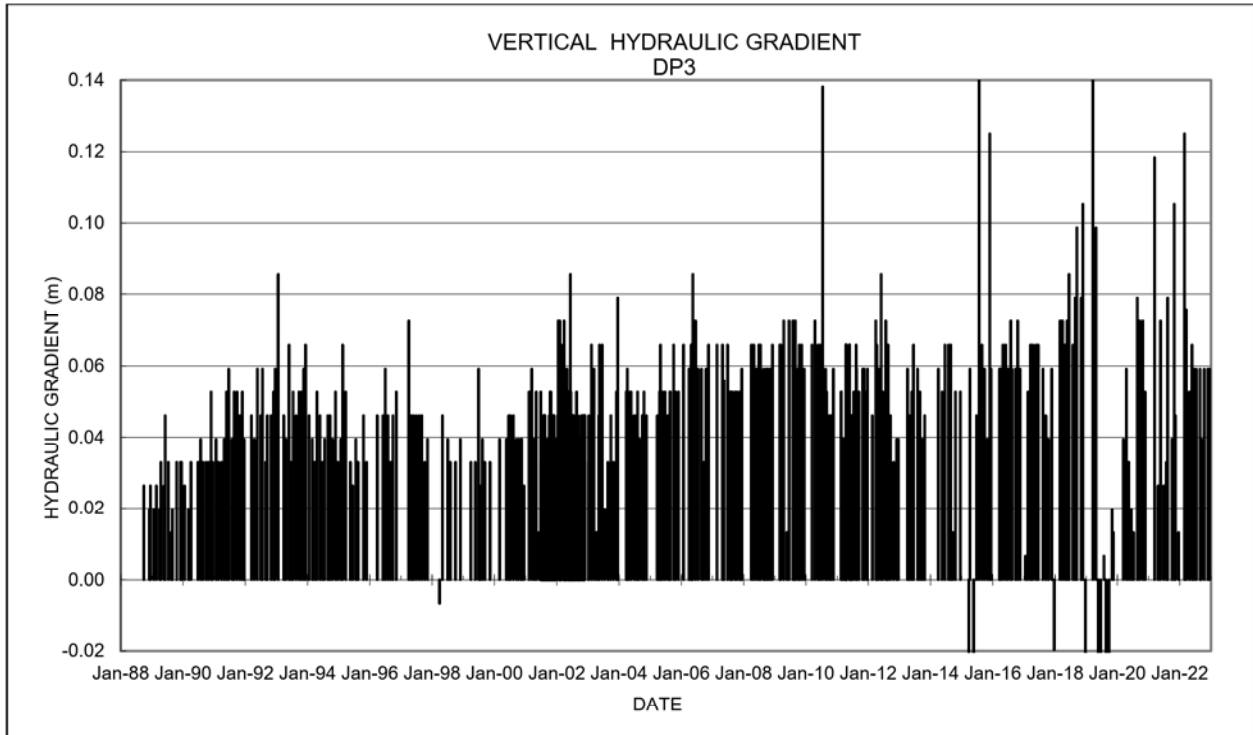
Figure 3-8 Hydraulic Gradient at Stream Drive Point Station DP3

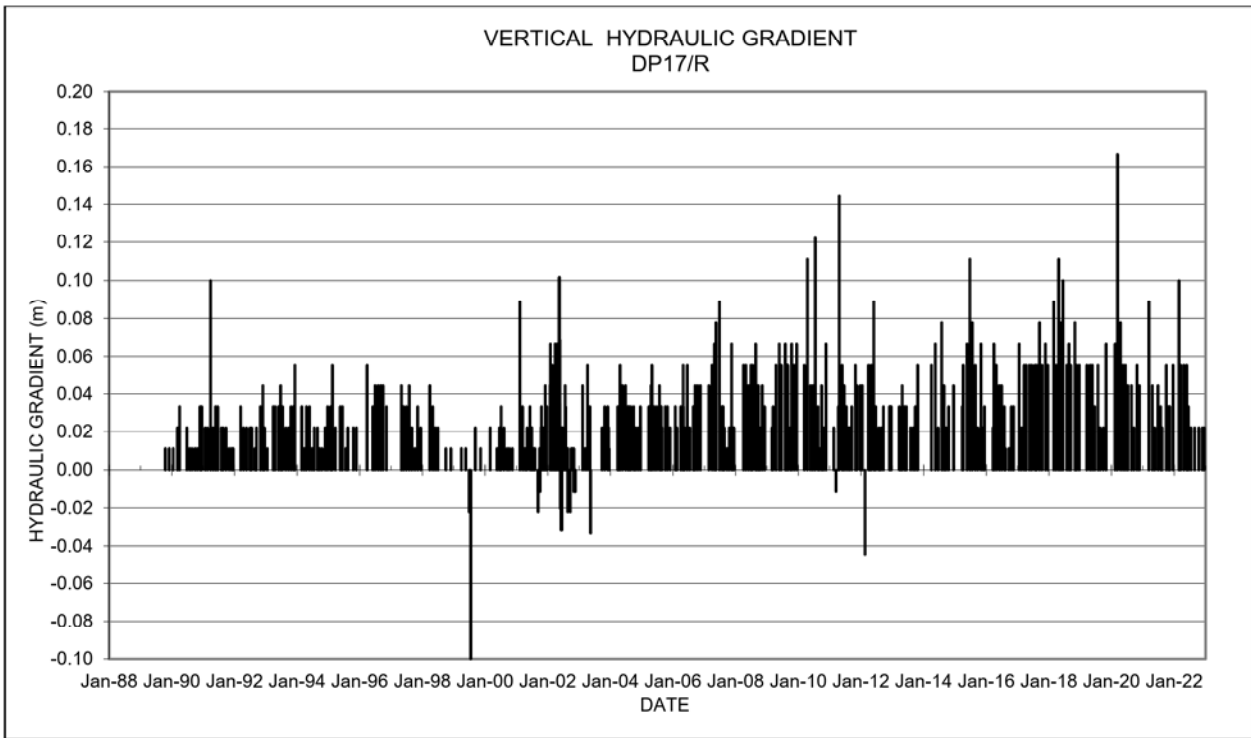
Figure 3-9 Hydraulic Gradient at Stream Drive Point Station DP17/R

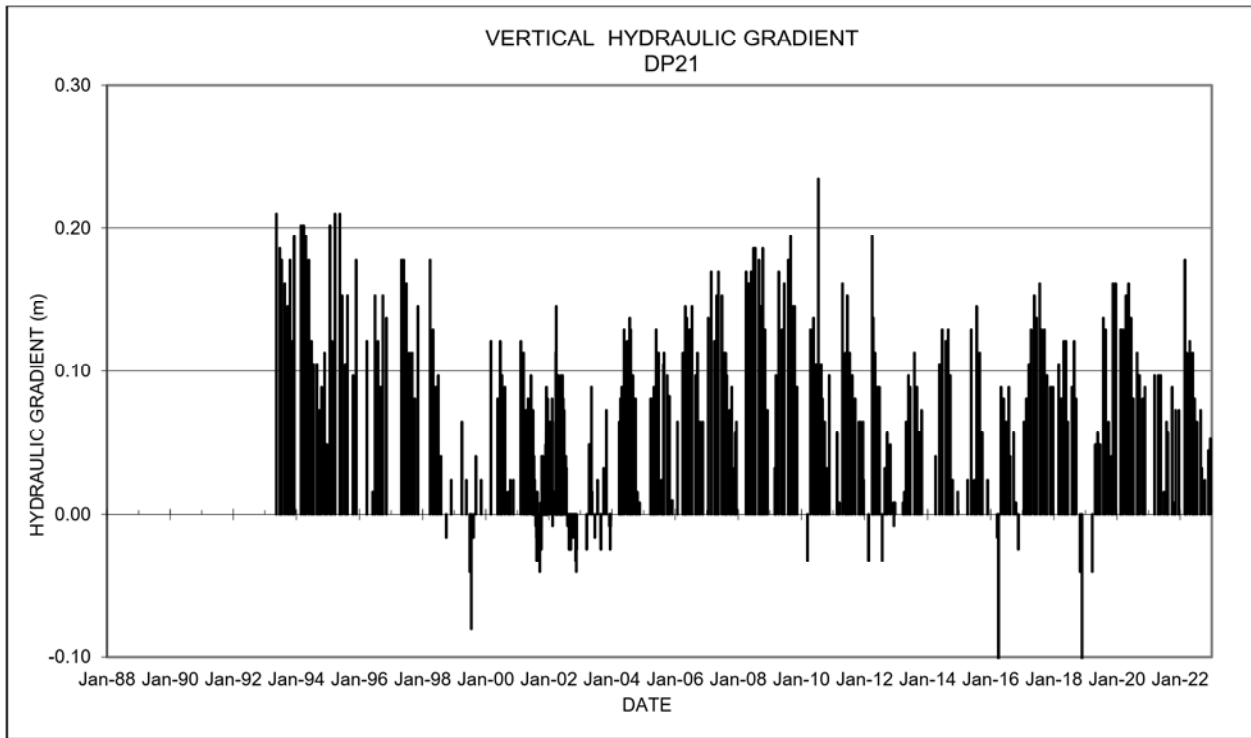
Figure 3-11 Hydraulic Gradient at Stream Drive Point Station DP21

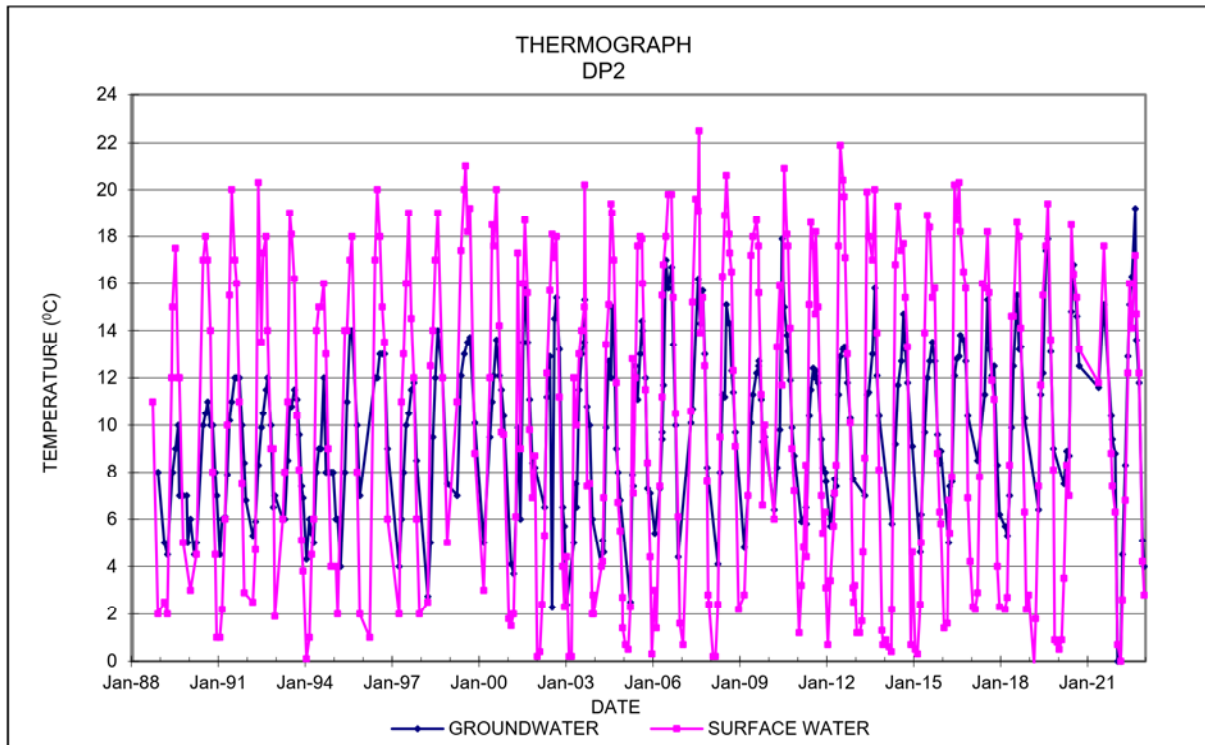
- The temperature patterns for 2022 shown on the thermographs are generally consistent with historic patterns. At the Mill Creek drive points, average 2022 groundwater temperatures were higher than the historical averages. The surface water temperatures downstream of Highway 401 were lower in 2022 compared to the historical averages, while surface water temperatures upstream of Highway 401 were equal to, or higher in 2022 compared to the historical averages. Compared to the historical averages (start of monitoring to 2021), the 2022 groundwater temperature averages differed by between 0.5°C and 1.6°C, and the surface water temperature averages differed by between -1.4°C and 0.7°C.

Figure 3-12 Thermograph for DP2

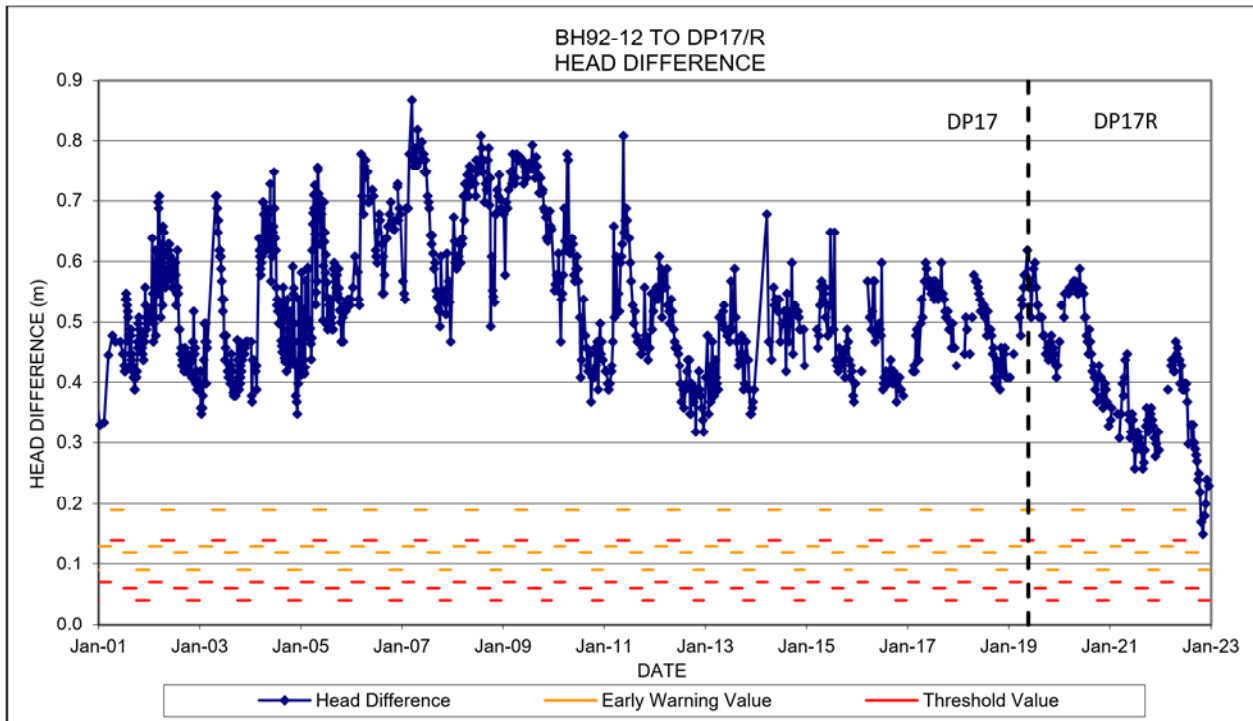
BH92-12 to DP17/R (Figure 3-16)

BH92-12 was established in 2001 just outside the licensed area of extraction, west of Phase 5 (extraction began in the northeast corner of Phase 5 at the end of 2019). Monitor DP17 is an in-creek drive point located at the Hanlon interchange, upstream from DP3. The threshold values have not been exceeded since its implementation on June 30, 2001. The early warning and threshold values were not exceeded at this pair in 2022.

Figure 3-16 Hydraulic Head Difference for Monitoring Pair BH92-12/DP17/R; July 2000 to December 2022

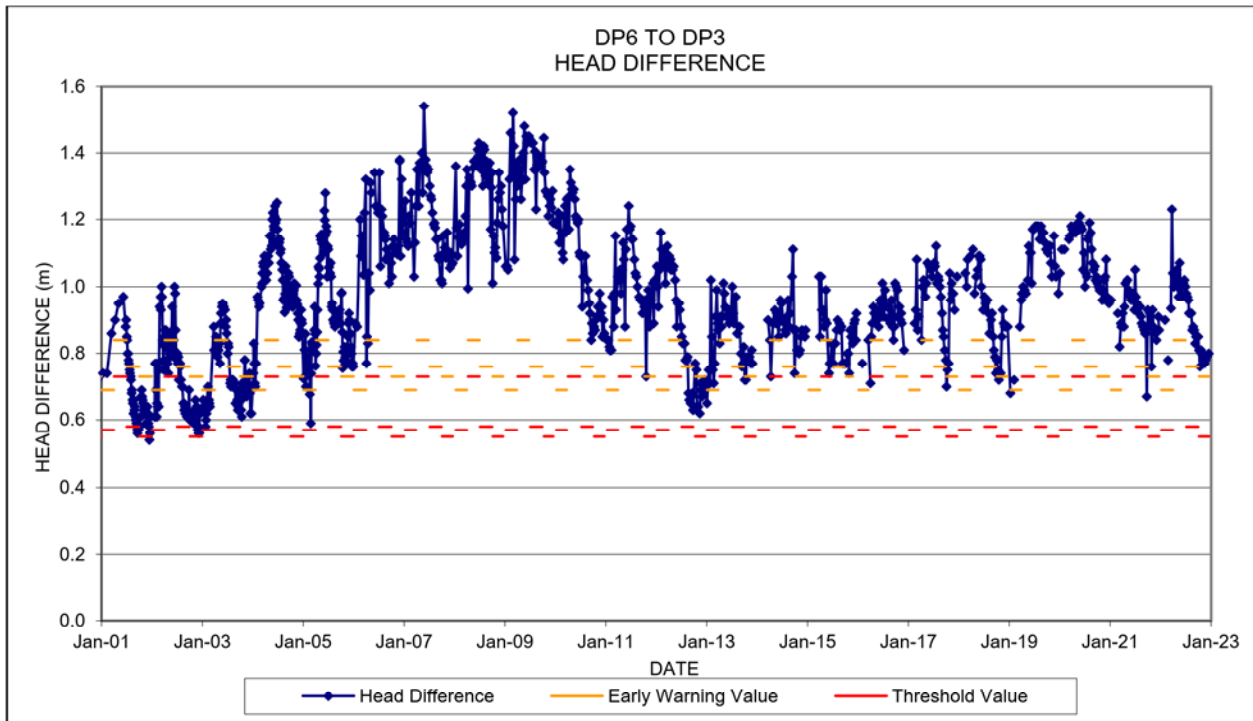
DP6 to DP3 (Figure 3-17)

DP6 is located at the eastern limit of the central wetland area, adjacent to Phase 5, and DP3 is an in-creek drive point monitor located directly south of the Hanlon interchange. There were no exceedances of the threshold values or the early warning values at this pair in 2022.

Figure 3-17 Hydraulic Head Difference for Monitoring Pair DP6/DP3; July 2000 to December 2022

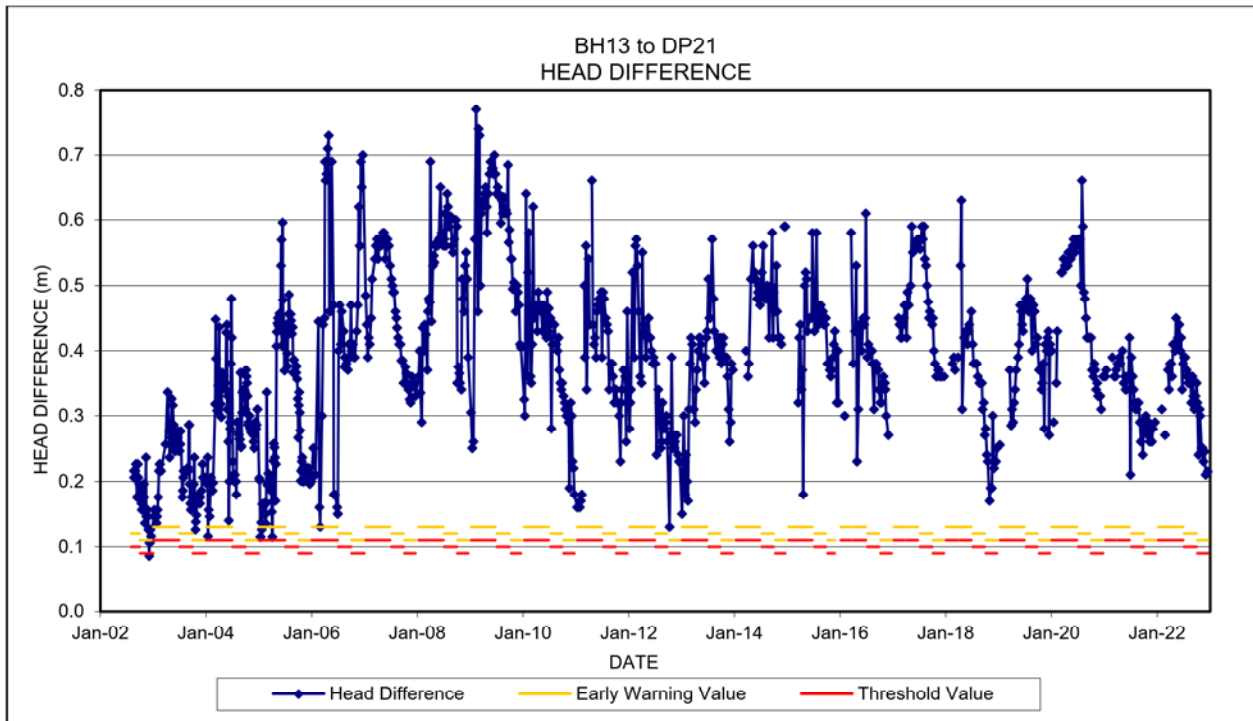
BH13 to DP21 (Figure 3-18)

BH13 is located adjacent to the northern boundary of the property (north of Phase 5) and to the east of DP21. DP21 is an in-creek drive point monitor located immediately downstream of the property line, south of Highway 401. There were no exceedances of the threshold values or the early warning values at this pair in 2022.

Figure 3-18 Hydraulic Head Difference for Monitoring Pair BH13/DP21; August 2002 to December 2022
