Harden Environmental Services Ltd.
4622 Nassagaweya-Puslinch Townline Road
Moffat, Ontario, L0P 1J0
Phone: (519) 826-0099 Fax: (519) 826-9099

August 9, 2023

**Re: Mill Creek Aggregates Pit –Review of 2022 Monitoring Data
Part Lot 24, Concession 1, and
Part Lots 21, 22, 23, and 24, Concession 2**

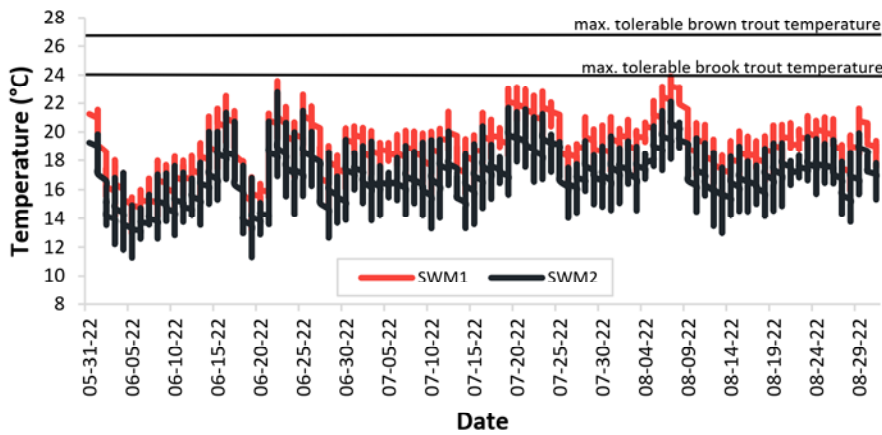
The maximum summer water temperature in Mill Creek in 2022 was 23.9°C at SWM1 on August 7 at 17:00 hours (Figure 4-1). The highest water temperature ever recorded in the Study Area was 27.9°C in 2002. Water temperatures relative to air temperatures are discussed in further detail in Technical Appendix A. The main branch of Mill Creek within the study area did not exceed the upper tolerable temperature for Brown trout (26.8°C) in 2022. The maximum temperature which Brook trout can tolerate is 24°C (Raleigh 1982) and this was also not exceeded in 2022 (Figure 4-1).

Figure 4-1 Thermographs from SWM1 and SWM2, for June 1 to August 31, 2022

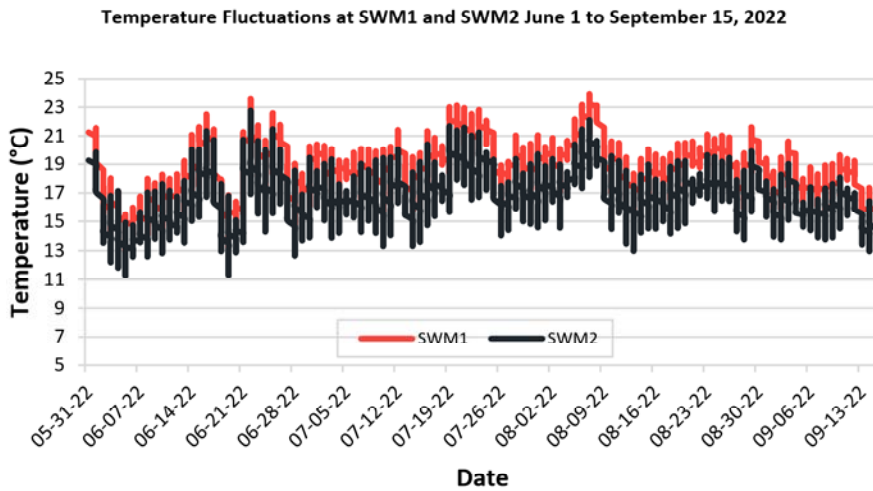
Stream water temperatures have traditionally been cooler at the downstream SWM2 station compared with SWM1 and this trend continued in 2022. When the maximum water temperature occurred at SWM1 (23.9°C: August 7, 17:00), the temperature at SWM2 was 1.9°C lower (Figure 4-2). The maximum summer temperature at SWM2 in 2022 was 22.8°C, on June 22nd, at 17:00. The greatest temperature difference between SWM1 and SWM2 during the summer of 2022 occurred on July 23rd at 13:00 when SWM2 was 3.2°C cooler than SWM1.

Figure 4-2 Diurnal Temperature Fluctuations from June 1 to September 15, 2022 at SWM1 and SWM2

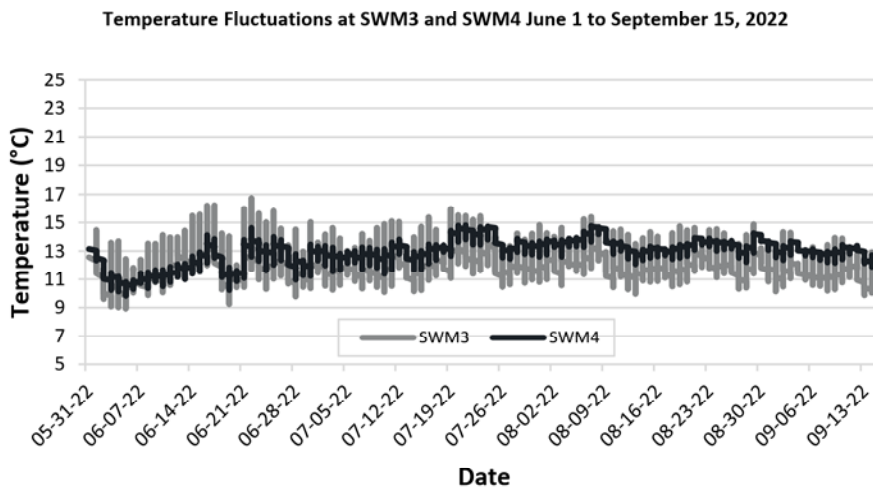
The continuous temperature recorders also illustrate the effect of diurnal solar warming on Mill Creek as the water temperatures gradually rise during the day and cool off at night. At SWM1 the temperature fluctuation was 1.8°C between August 7th and August 8th, following the maximum temperature. At SWM2 the temperature fluctuation was 7.2°C. At SWM3 and SWM4, the temperature fluctuation was 5.7°C and 1.3°C, respectively (Figure 4-3), again supporting the conclusion that the temperatures at SWM3 and SWM 4 are controlled by groundwater inputs.

Figure 4-3 Diurnal Temperature Fluctuations from June 1 to September 15, 2022 at SWM3 and SWM4
