## TECHNICAL MEMORANDUM

**Project No.** CA-GLD-1791470A-VCNA

### **SUPPLEMENTAL ASSESSMENT AND MITIGATION OF POST-REHABILITATION GROUNDWATER UPLIFT – PROPOSED CBM ABERFOYLE SOUTH LAKE PIT**

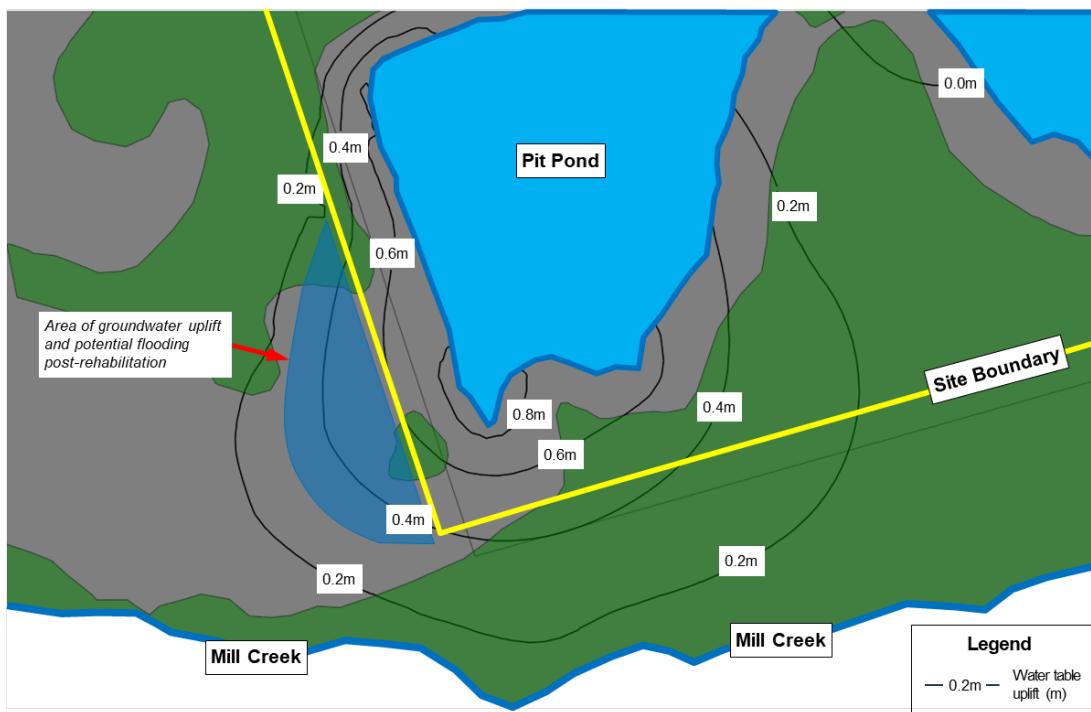
**Figure 1:** Numerical simulation results predicting an area of post-rehabilitation groundwater uplift, which could create minor flooding in during seasonal periods of a high water table.

As discussed in the Water Report, during aggregate extraction below the water table, a pit pond is gradually formed as extraction proceeds, which typically results in a “flattening” of the water table relative to pre-extraction conditions, with drawdown on the upgradient side, and groundwater uplift on the downgradient side. Water table flattening that is predicted to occur at the site is presented on Figure 14b in Appendix G of the Water Report, and again on Figure 1 below.

Numerical modelling simulations predict post-rehabilitation groundwater uplift at the site of approximately 0.6 m to occur immediately southwest of the proposed pit pond beyond the property limits, as shown on Figure 1. While the steady state groundwater level in this area is predicted to be below the ground surface, when seasonal variability is considered (approximately +/- 0.3 m annually at nearby MW18-01B) there is a potential for occasional flooding to occur on adjacent low lying lands during periods of high groundwater levels (e.g. during the spring freshet).

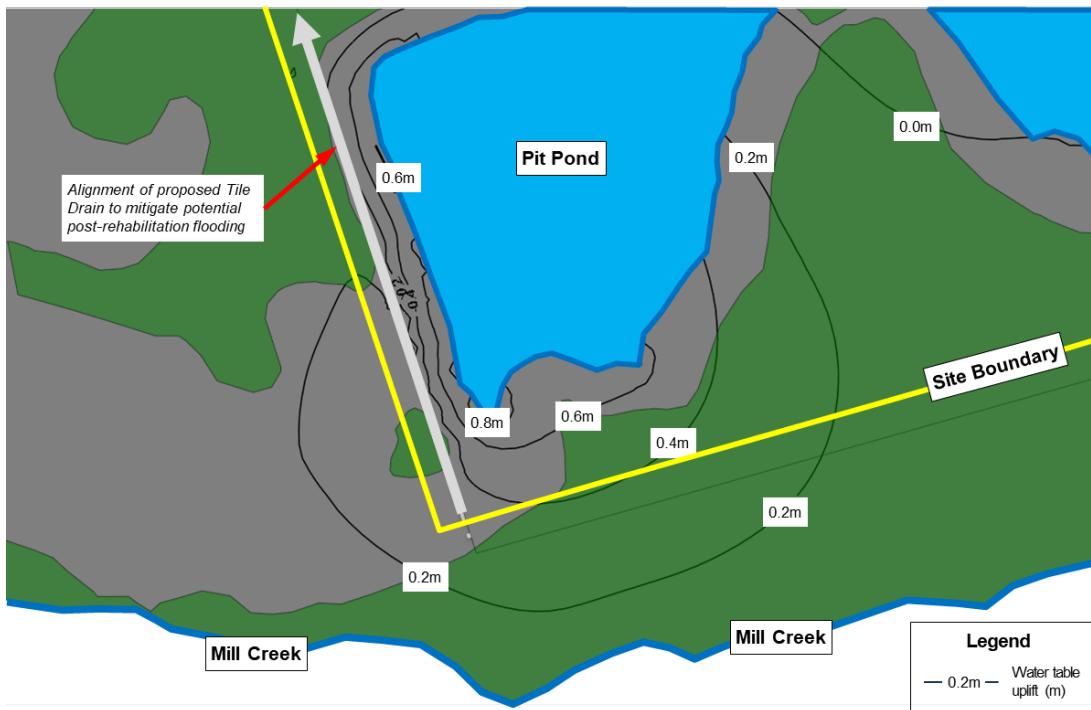
**Figure 2:** Numerical simulation of the installation of a tile drain to alleviate localized post-rehabilitation groundwater uplift and mitigate the potential for flooding during periods of a high water table.

To address this potential impact, the installation of a tile drain is proposed in this area as a mitigation measure, to reduce the risk of occasional flooding on the neighbouring property, as shown on Figure 2. The tile drain would be installed in the setback area, between the pit pond to the east and the licence / property limit to the west.

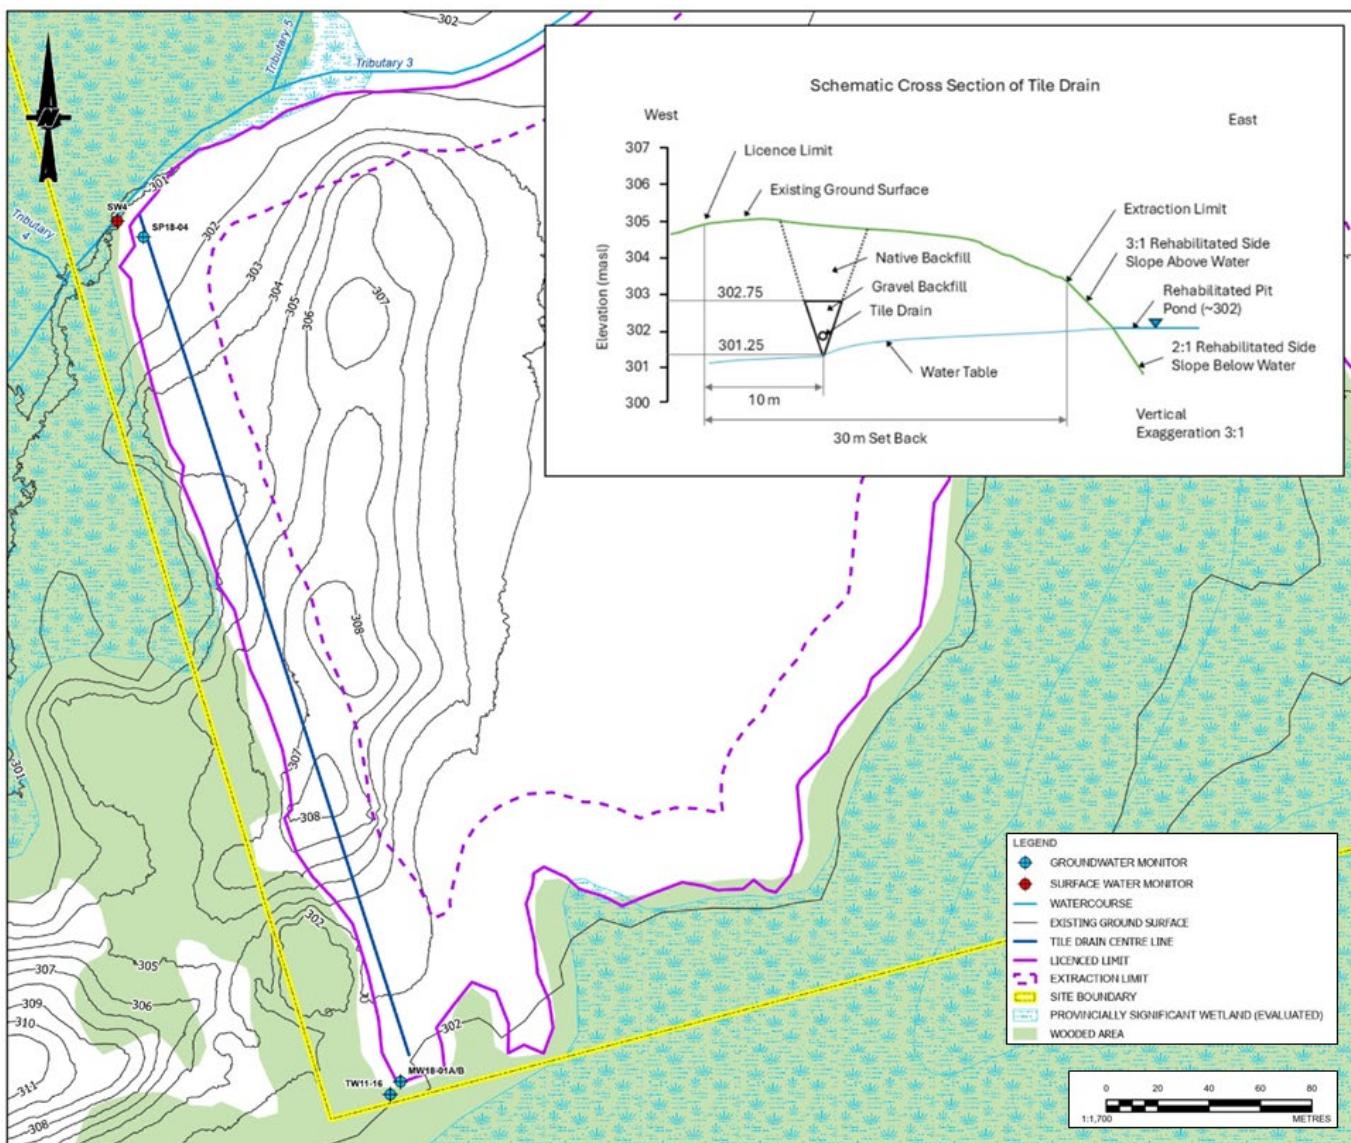
**Figure 3: Proposed Tile Drain Alignment and Cross Section Detail**

This tile drain would convey excess groundwater through the subsurface during high water table periods in a northward direction, with excess groundwater reporting to Tributary 3 as additional baseflow. A detailed plan view of the proposed tile drain alignment, and a schematic cross section of the tile drain's configuration are shown on Figure 3 and would generally be constructed as follows.

- Excavation of V-shaped trench with 1:1 side slopes to an elevation of 301.25 masl, with a 200 to 300 mm perforated tile drain placed near the base of the trench.

- The ground surface along the alignment ranges from approximately 301.25 masl at the northern end to approximately 308 masl at the crest of a hill, back down to 302 masl at the south end of the tile drain.

- The tile drain will be approximately 350 m long and positioned in the setback area approximately 10 m east of the western licence limit.
- The trench walls will be lined with a non-woven geotextile liner and backfilled with a clean coarse grained granular material (e.g. 19 mm clear stone) up to a height of 1.5 m from the bottom of the trench.

- Non-woven geotextile liner will also be placed on top of the backfill to prevent fines from above entering the tile drain.
- The trench will be backfilled above the non-woven geotextile with native materials removed from the setback, such that no extraction is taking place in the set backs.

- The toe of the tile drain will terminate proximal to Tributary 3 on a rip-rap outfall apron, allowing excess water discharge to the stream as baseflow. No adverse impact to surface water quality in Tributary 3 is anticipated as the tile drain will receive clean cool groundwater from the subsurface and transmit it along.

The current buffer area is an active crop production area that is subject to annual ploughing, cultivating, and planting. The area occurs on a higher elevation of land relative to the surrounding lands. The proposed tile drain alignment would be installed in a trench at depth as shown as Figure 3 prior to the on-set of operation and prior to the need for the buffer. The area would be excavated to the noted depth, the tile drain installed, and the material replaced its original elevation and topography. Generally, there are no concern with this pre-operations work in this agricultural setting, and the installation would be generally consistent with activities that are actively undertaken year to year under current agricultural practice with the implementation of several mitigation measures as follows:

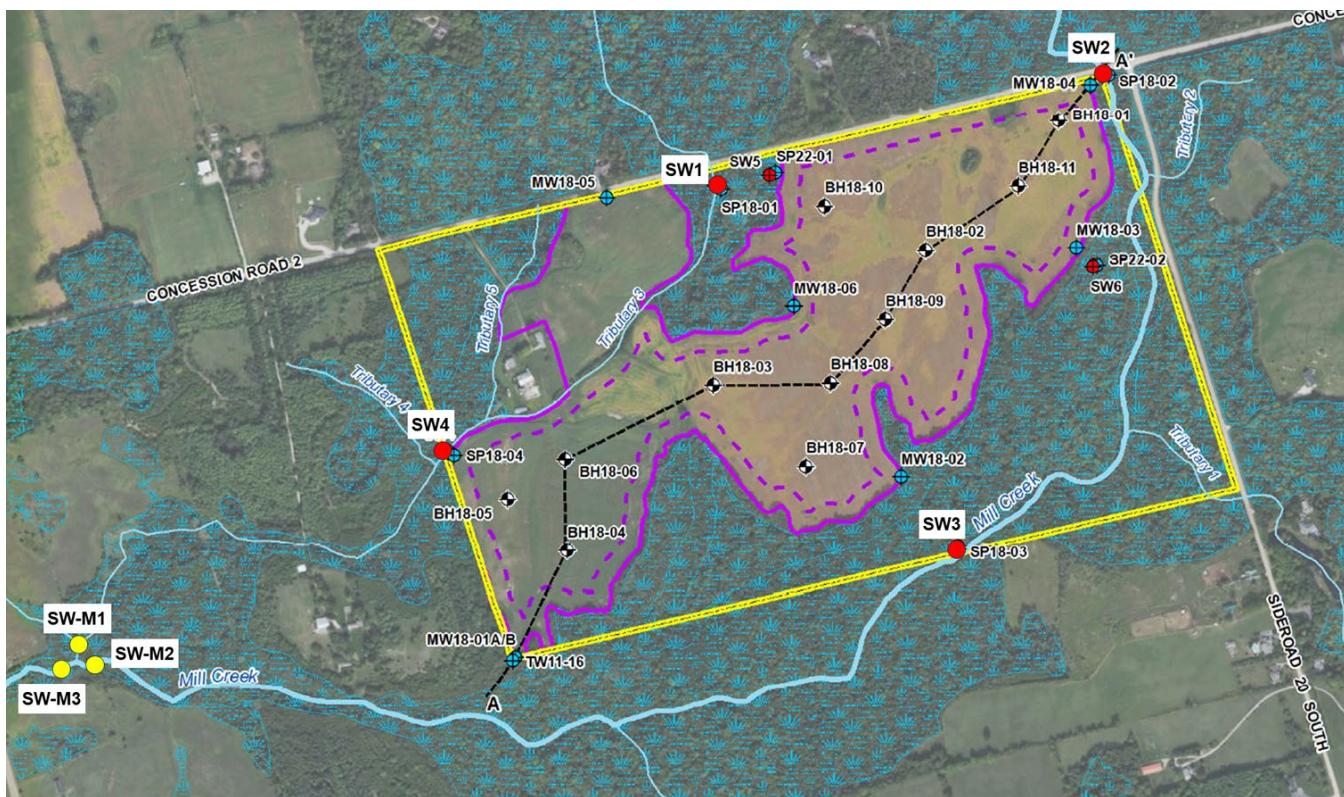
**Figure 4: Surface Water Stations on Mill Creek and Tributary 3 (SW1 to SW4), and modelled surface water stations (SW-M1 to SW-M3) at the confluence of Tributary 3 and Mill Creek.**

- With reference to Figure 4 and Table 1, the numerical simulations suggest that of the groundwater that reports to the tile drain (212 m<sup>3</sup>/day), most of that groundwater would have otherwise discharged to the low-lying area of groundwater uplift and 6 m<sup>3</sup>/day would have reported to Mill Creek as groundwater discharge.

- The implementation of the tile drain mitigation effectively transfers a small portion of groundwater from Mill Creek to Tributary 3 along the reach between the toe of the drain (near SW4), and the confluence of Tributary 3 and Mill Creek (approximately 750 m downstream at SW-M1 to SW-M3).

- When compared to the original post-rehabilitation scenario (i.e. with no tile drain), there is an increase in baseflow of 14% predicted to Tributary 3 (at SW-M1) and negligible decrease in Mill Creek upstream of the confluence (at SW-M2). The downstream of the confluence (at SW-M3) the tile drain scenario results in a slight net increase in baseflow (1.4%) to the overall system.
