Re: Puslinch Community Centre – Parkland Trail

1.0 Introduction

Puslinch Community Centre

Figure 1-ELC Vegetation Communities

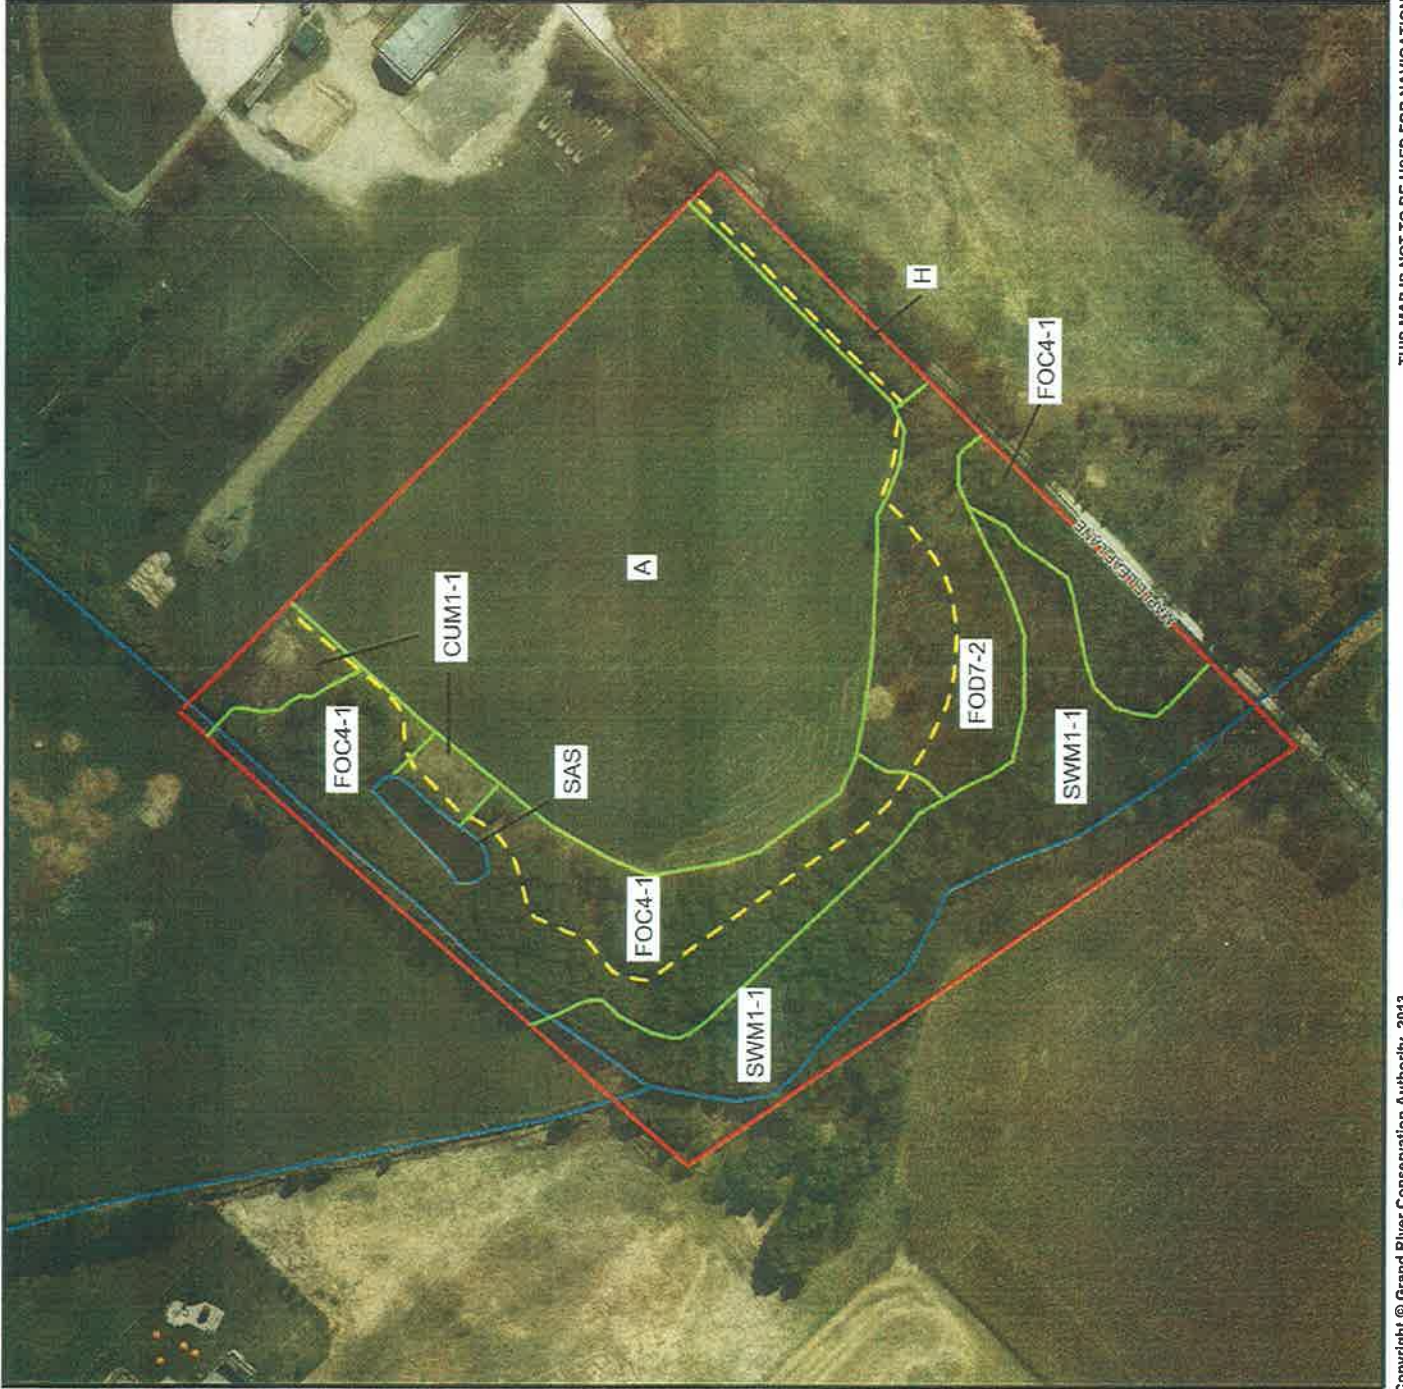
Vegetation communities on the subject lands were initially identified through interpretation of aerial photography available on the GRCA website. Vegetation mapping was done in accordance with the Ecological Land Classification (ELC) system for southern Ontario. Fieldwork confirmed the presence of three naturally established vegetation communities, as well as an old field meadow, a coniferous hedgerow and a dug pond. Figure 1 illustrates the spatial distribution of these vegetation communities.

A fresh-moist cedar coniferous forest (FOC4-1) occurs along the northern property boundary and it extends southward around the hay field. It is characterized by a pure, dense stand of immature white cedar that is approximately 1.7 acres in size. Most trees are of poletimber size being 4 to 9 inches in diameter at breast height (dbh). Tree regeneration and shrub growth are sparse in the understory of this community. Groundflora are also negligible due to the dense overstory. A small man-made pond occurs within this cedar stand. A small stand of upland cedar about 0.4 acres in size also occurs along Maple Leaf Lane. Two small meadow communities (CUM1-1) totalling 0.2 acres occur adjacent to FOC4-1 and the hay field.

The balance of the agricultural land is bordered by a fresh-moist ash lowland deciduous forest (FOD7-2) and a dense white cedar hedgerow (H). The ash stand is 0.8 acres in size and it is characterized by a moderately dense mixture of deciduous trees, including white and black ash, trembling aspen, white and yellow birch, red and sugar maple, black cherry, basswood, Manitoba maple, butternut and black walnut. Most trees are immature in age/size being 4 to 14 inches dbh. The understory is moderately dense and consists mostly of ash and aspen regeneration as well as shrubs such as dogwood, white elderberry, common buckthorn and red raspberry. Groundflora are uniformly distributed throughout the stand and consist of common woodland wildflowers, ferns, asters, goldenrods and grasses. Butternut is an endangered species and must be protected from disturbance. Immature butternut trees 6 to 13 inches dbh are found in this stand, as well as regeneration which mostly occurs along the forest edge. Most of these butternuts appeared to be cankered but would still be considered retainable trees.

A white cedar-hardwood mineral mixed swamp (SWM1-1) is found along the west boundary of the property and it covers about 2 acres. Hardwoods growing in association with cedar include yellow birch, red maple, sugar maple, black ash and butternut. Most dominant and codominant trees are 10 to 16 inches dbh and represent immature sawtimber. However, a mature butternut about 20 inches dbh occurs near the road. This tree exhibits cankers on its trunk but the crown nonetheless appears healthy. Although several trees have blown down the stand is still fully stocked. The forest understory is sparse and mainly consists of cedar regeneration and shrubs such as red-osier dogwood and white elderberry. Groundflora cover is moderate and mainly consists of sedges, sensitive fern, jack-in-the-pulpit and jewelweed.

Given the above mentioned constraints, it is recommended that a recreational trail should be located around the perimeter of the woodland within vegetation units CUM1-1, FOC4-1 and FOD7-2 as shown in Figure 1. In this constrained woodland environment a trail width of 8 feet (2.4m) is considered most appropriate in order to minimize tree loss and impacts to other vegetation. Either a stonedust or stonedust over compacted granular surface treatment could be used in this setting as per the Wellington County Active Transportation Master Plan (May, 2012). Alternatively, woodchips could be utilized in some sections of the trail. Based on these trail design parameters it is estimated that only about 10 living trees ranging in size from 4 to 10 inches dbh (10-26cm) would have to be removed to accommodate trail construction. However, 7 dead trees would also have to be removed along with cedar and hardwood regeneration (i.e. young trees 1 to 3 inches dbh). This assumes only hand held equipment and small machines are used in trail construction (e.g. chainsaws, bobcats etc.).
