Comment Summary – Zoning By-law Amendment Application – WDD Main St. Inc.

1st Submission

Re: Pre-Submission Consultation
11 Main Street, Morriston
Township of Puslinch

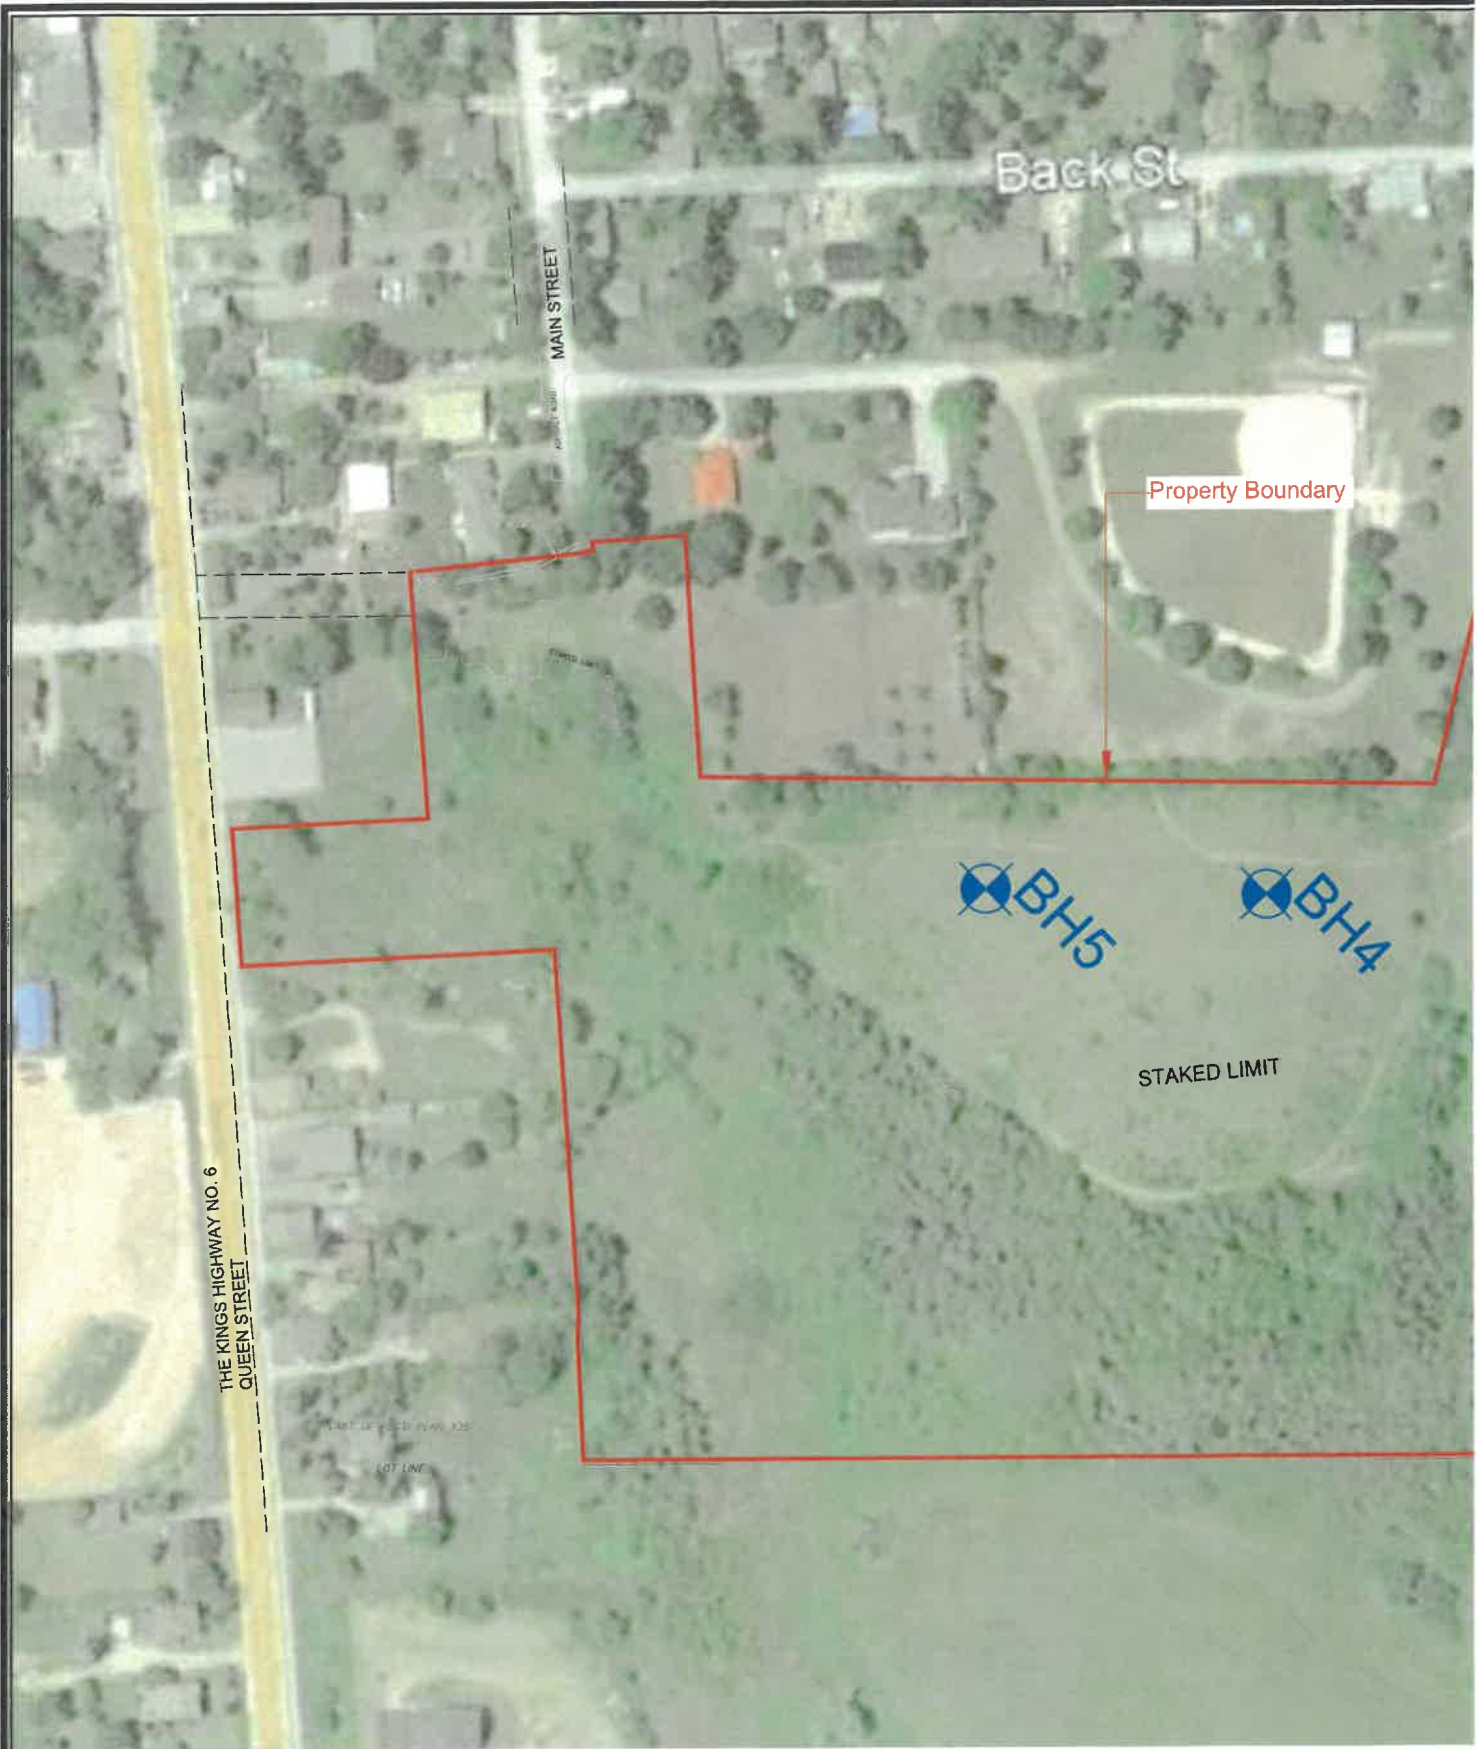
FIGURE :
1

LEGEND
Approximate Borehole Location

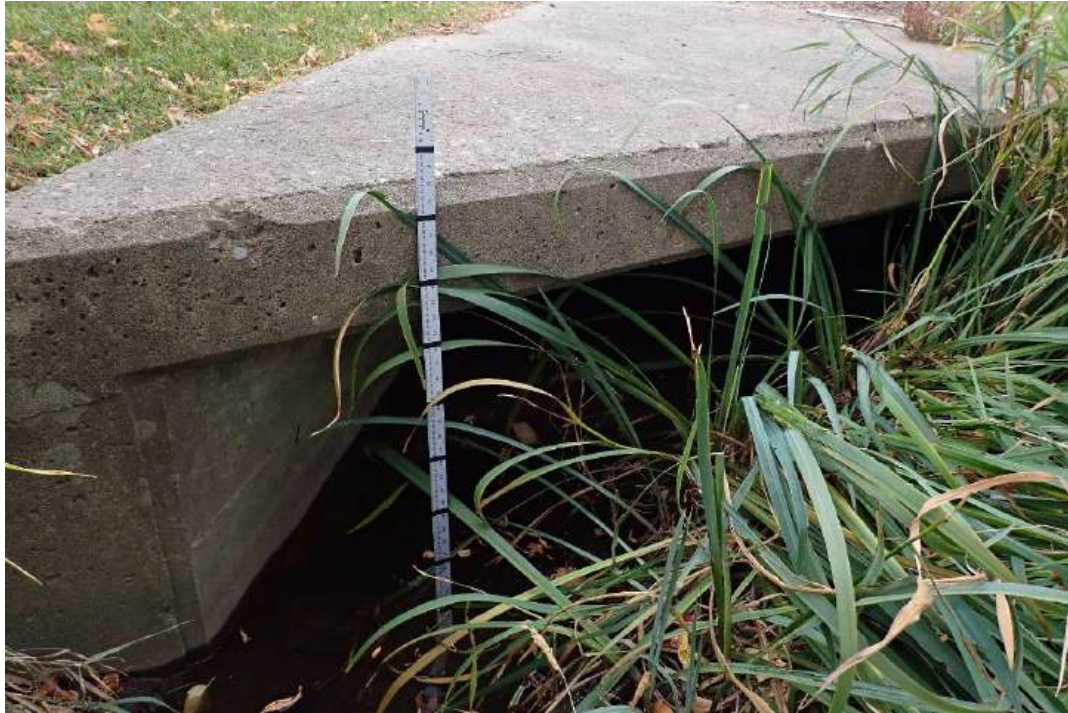
Tributary of Bronte Creek
Reach TBC-1
Photo 1

Highway 6 Concrete box culvert at the upstream extent of TBC-1

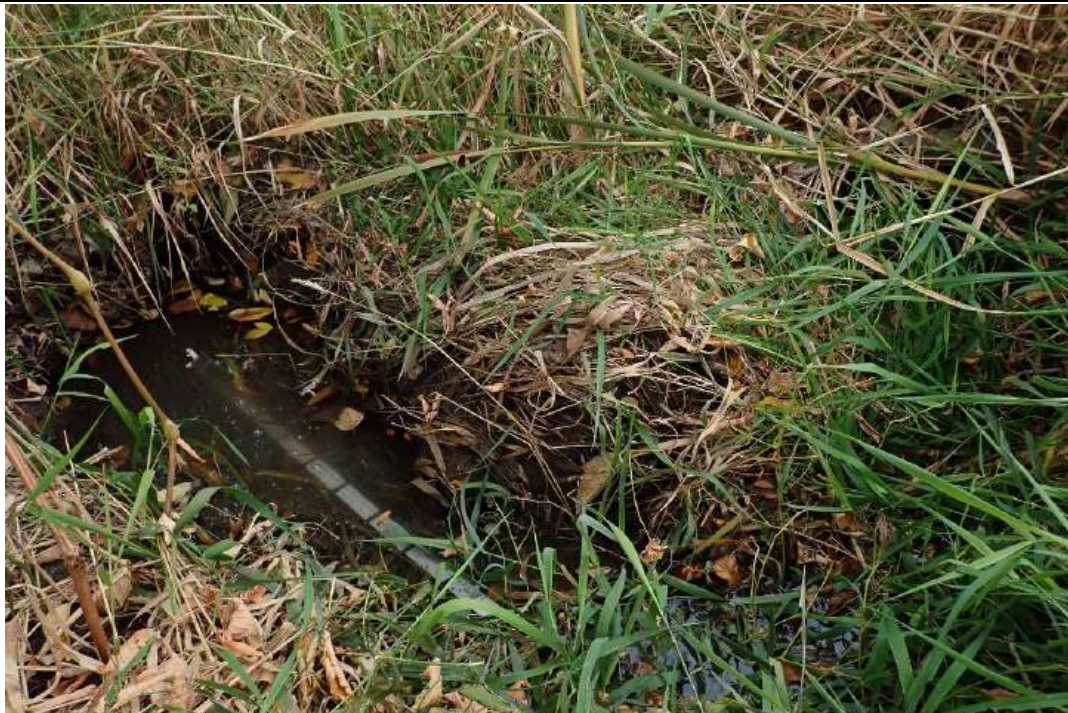
Tributary of Bronte Creek
Reach TBC-1
Photo 2

Defined bankfull conditions downstream of culvert. Metre stick for scale.

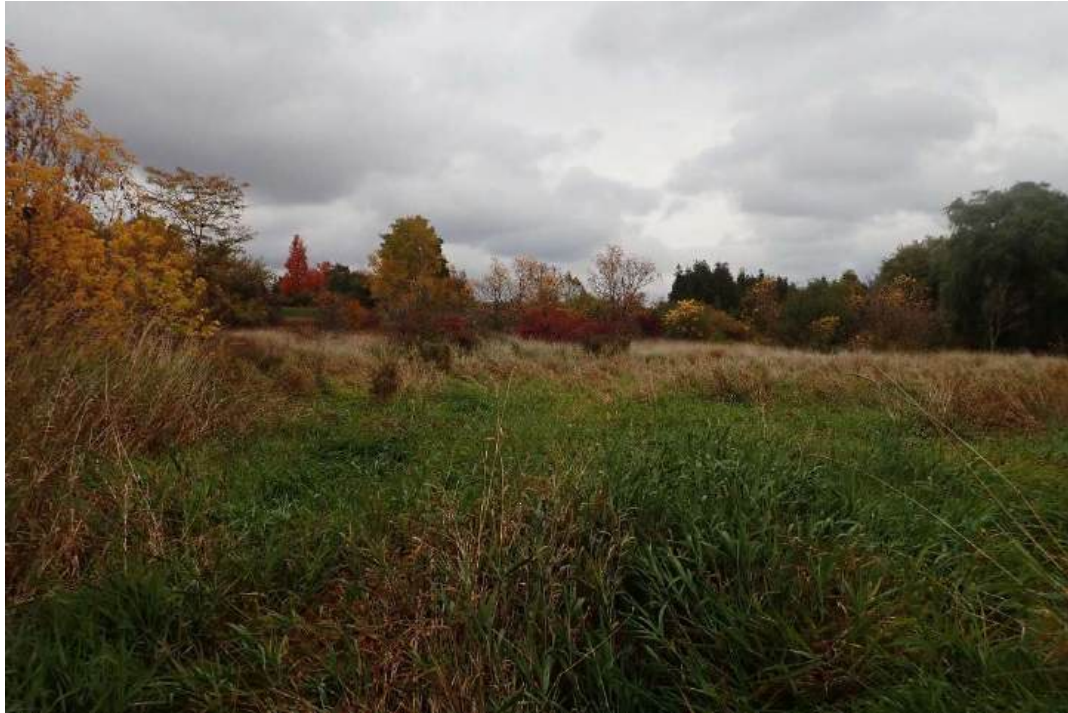
Tributary of Bronte Creek
Reach TBC-1
Photo 3

The riparian area consisted mainly of tall grasses with sparse herbaceous shrubs and trees. Bankfull channel was poorly defined throughout.

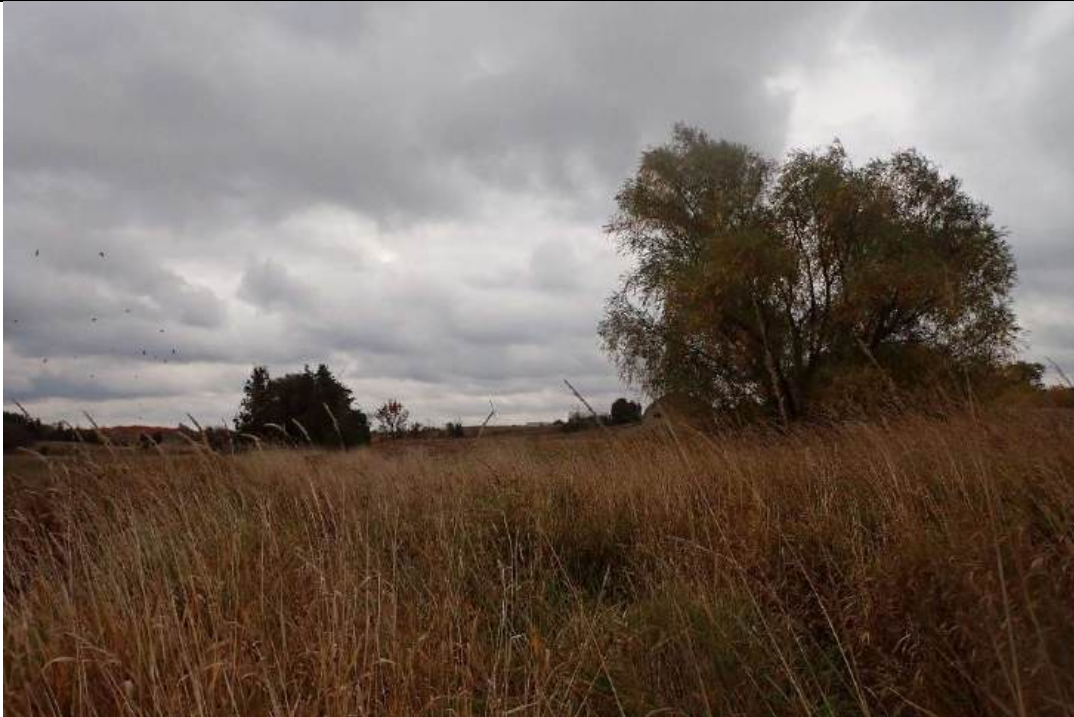
Tributary of Bronte Creek
Reach TBC-1
Photo 4

Downstream of reach as it continues to flow off property boundaries. Outside of pictured grassy riparian area is agricultural field.

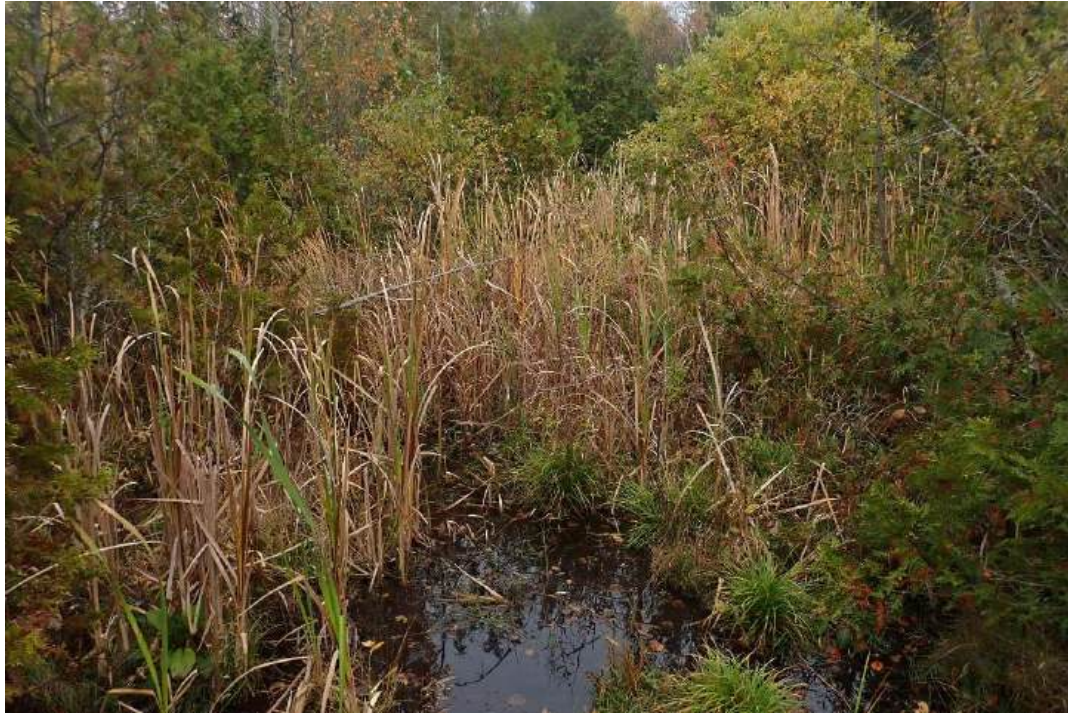
Tributary of Bronte Creek
Reach TBC-2
Photo 5

Hummocky areas with instream grasses and pooled, standing water is typical condition along Reach TBC-2

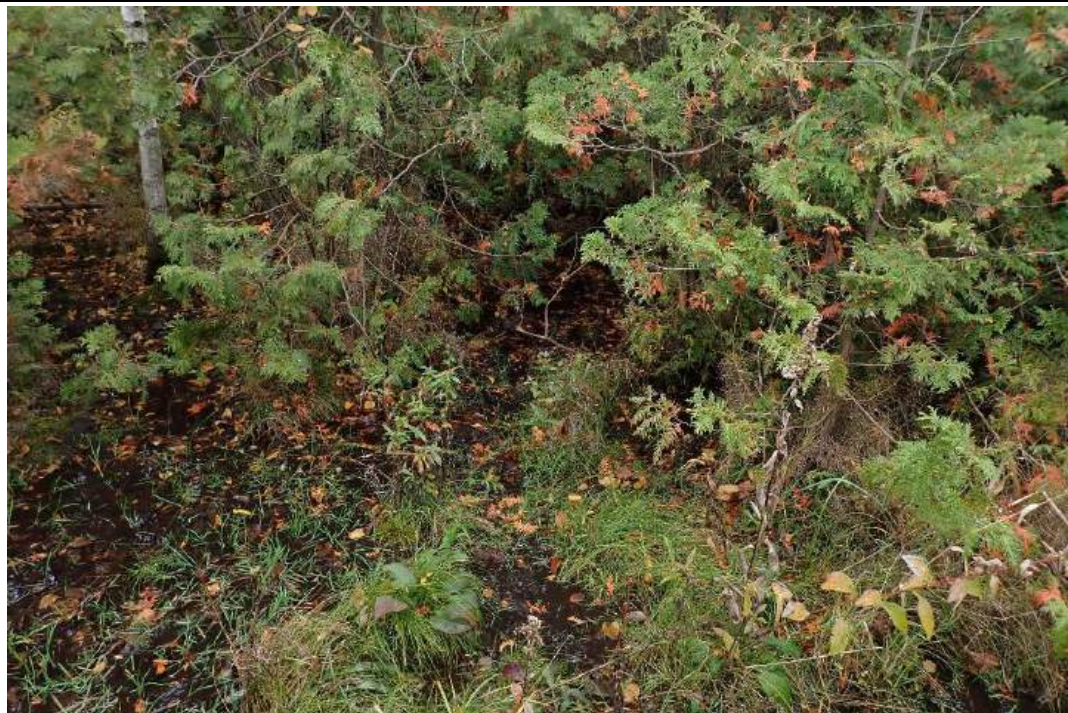
Tributary of Bronte Creek
Reach TBC-2
Photo 6

Grassy hummocks and trees throughout pools of water. No defined bankfull channel present along Reach TBC-2

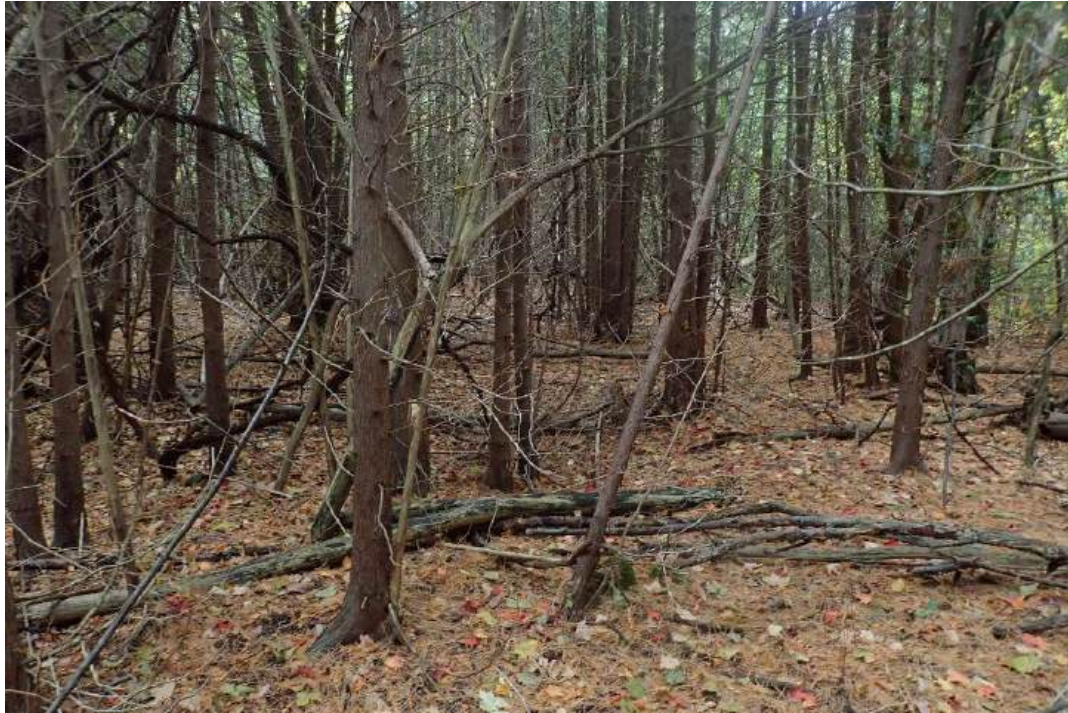
Tributary of Bronte Creek
Reach TBC-3
Photo 7

The riparian zone of Reach TBC-3 contained wooded area. No bankfull channel or flow paths observed in the upstream sections.

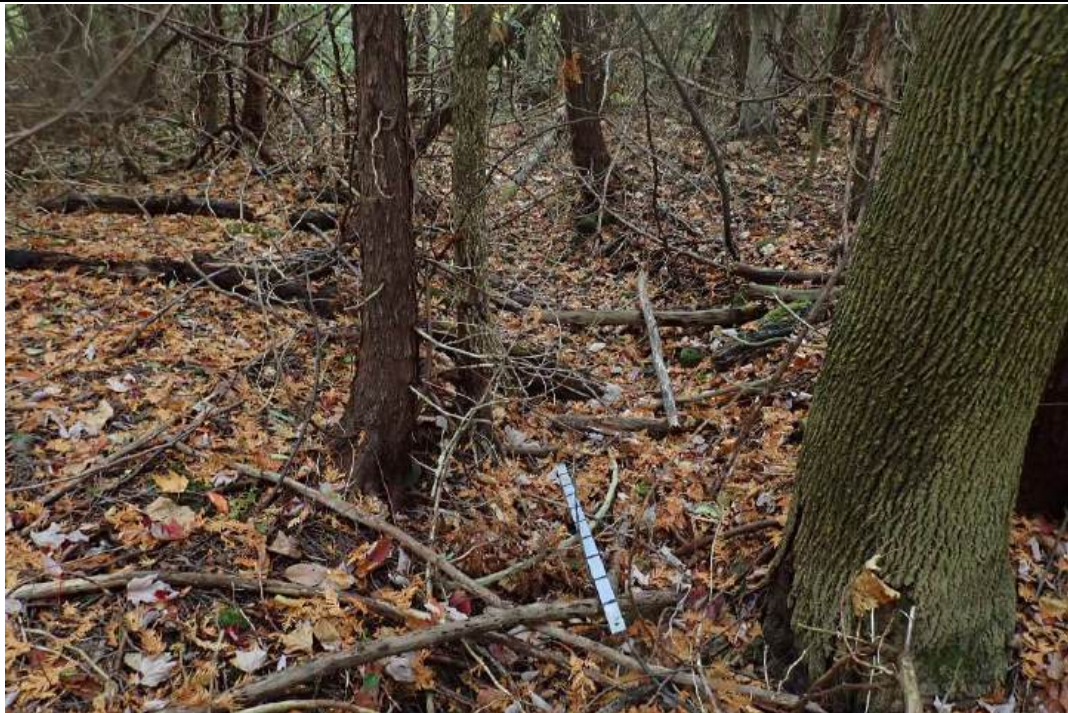
Tributary of Bronte Creek
Reach TBC-3
Photo 8

A minor flow path was observed in the very downstream extent of the study site, presumed to be associated with mapped stream Reach TBC-3.

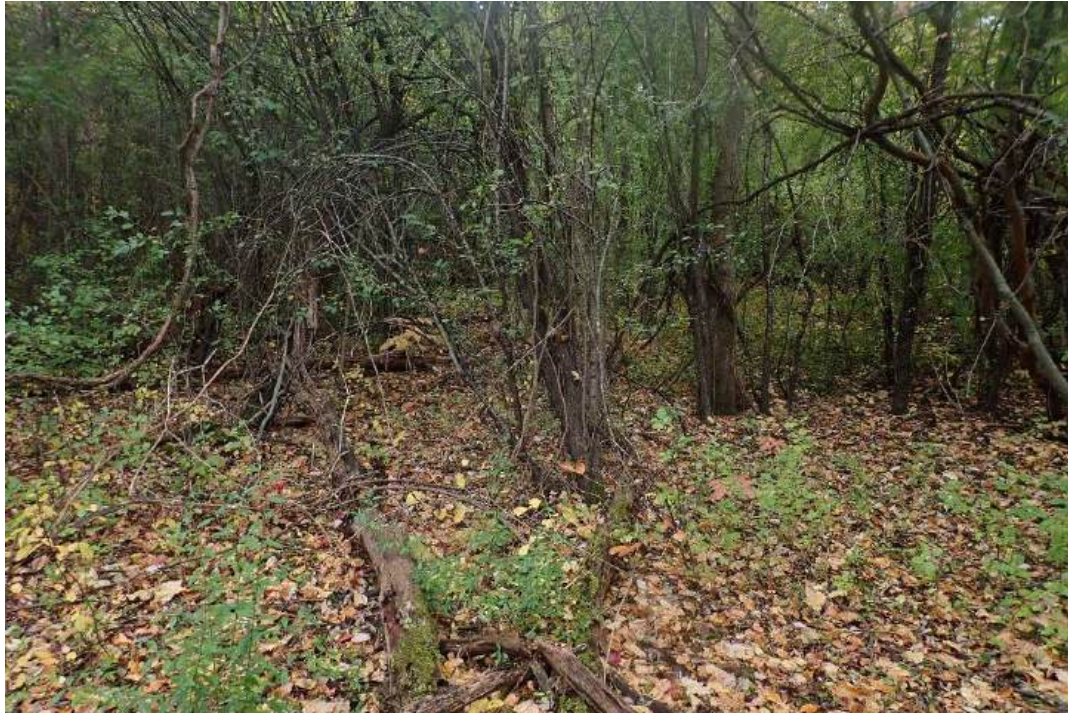
Tributary of Bronte Creek
Reach TBC-3a
Photo 9

The riparian area consisted of wooded area. No defined flow path observed in association with mapped stream Reach TBC-3a

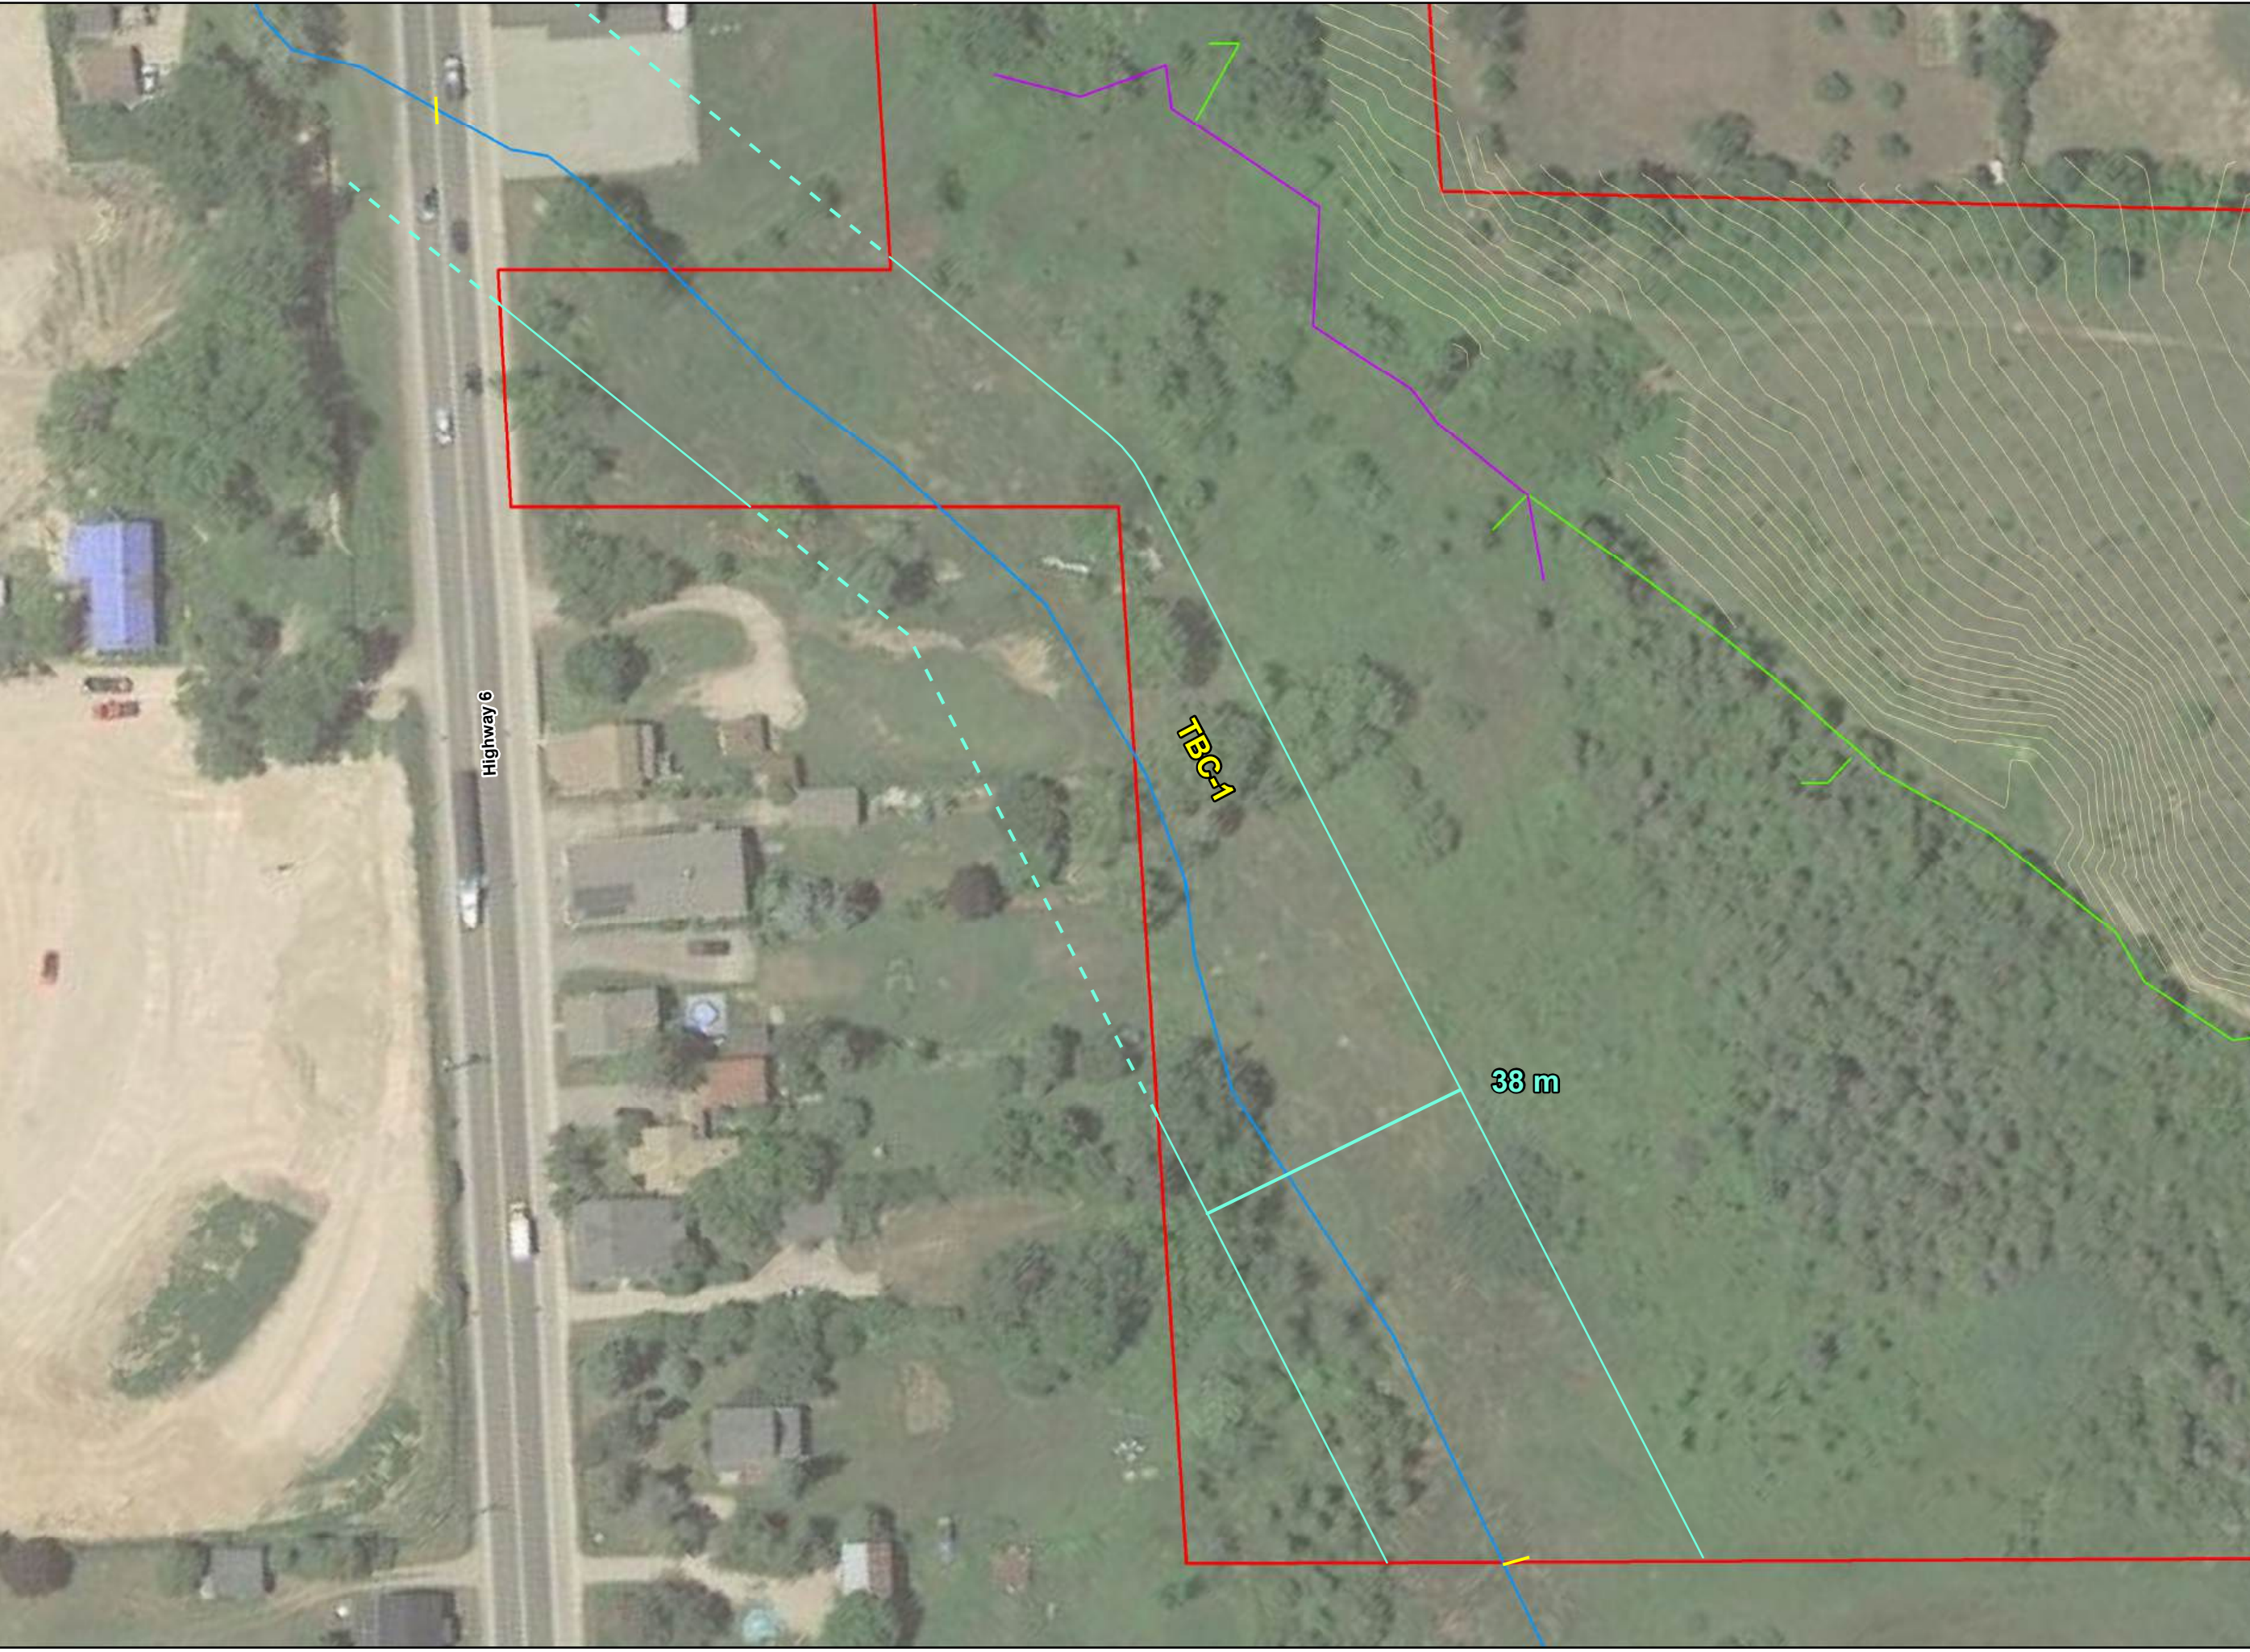
- Reach Break and ID
- Watercourse
- 0.25 m Contour
- Meander Belt Width
- Meander Belt Width (Off Property - Field Verification Required)
- Staked Wetland
- Staked Woodland
- Study Boundary

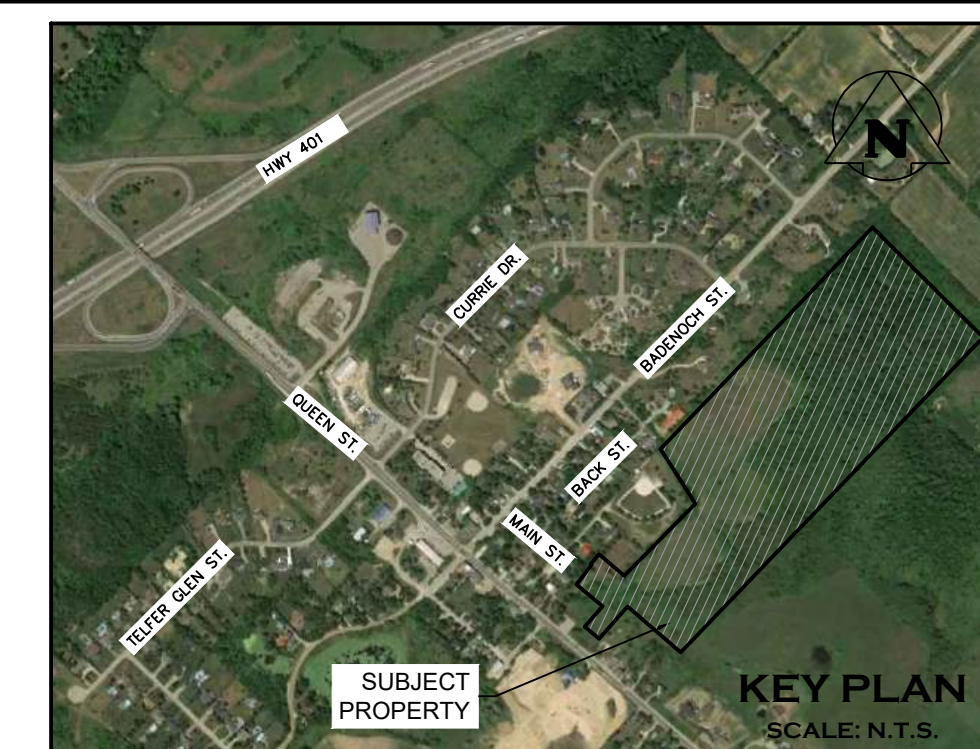
TYPICAL LOT SCHEMATIC (LOT 8)

- PROPERTY LINE
- EXISTING CONTOUR (0.5m)
- EXISTING CONTOUR (1.0m)
- EXISTING GRADE
- PROPOSED GRADE
- PROPOSED GRADE (TO MATCH EXISTING)
- PROPOSED MINOR FLOW DIRECTION
- REGIONAL FLOODPLAIN (CONSERVATION HALTON)
- REGIONAL FLOODPLAIN 15.0m BUFFER
- STAKED WOODLOT BY COLVILLE CONSULTING INC. (SEPT 20, 2022)
- STAKED WETLAND BY COLVILLE CONSULTING INC. (SEPT 20, 2022)
- MEANDER BELT 15m BUFFER
- CONCEPTUAL 360 m² BUILDING ENVELOPE
- PROPOSED TYPE A DISPERSAL BED 368 m²
- CONCEPTUAL PROPOSED DRILLED WELL LOCATION C/W 15.0m OBC SETBACK

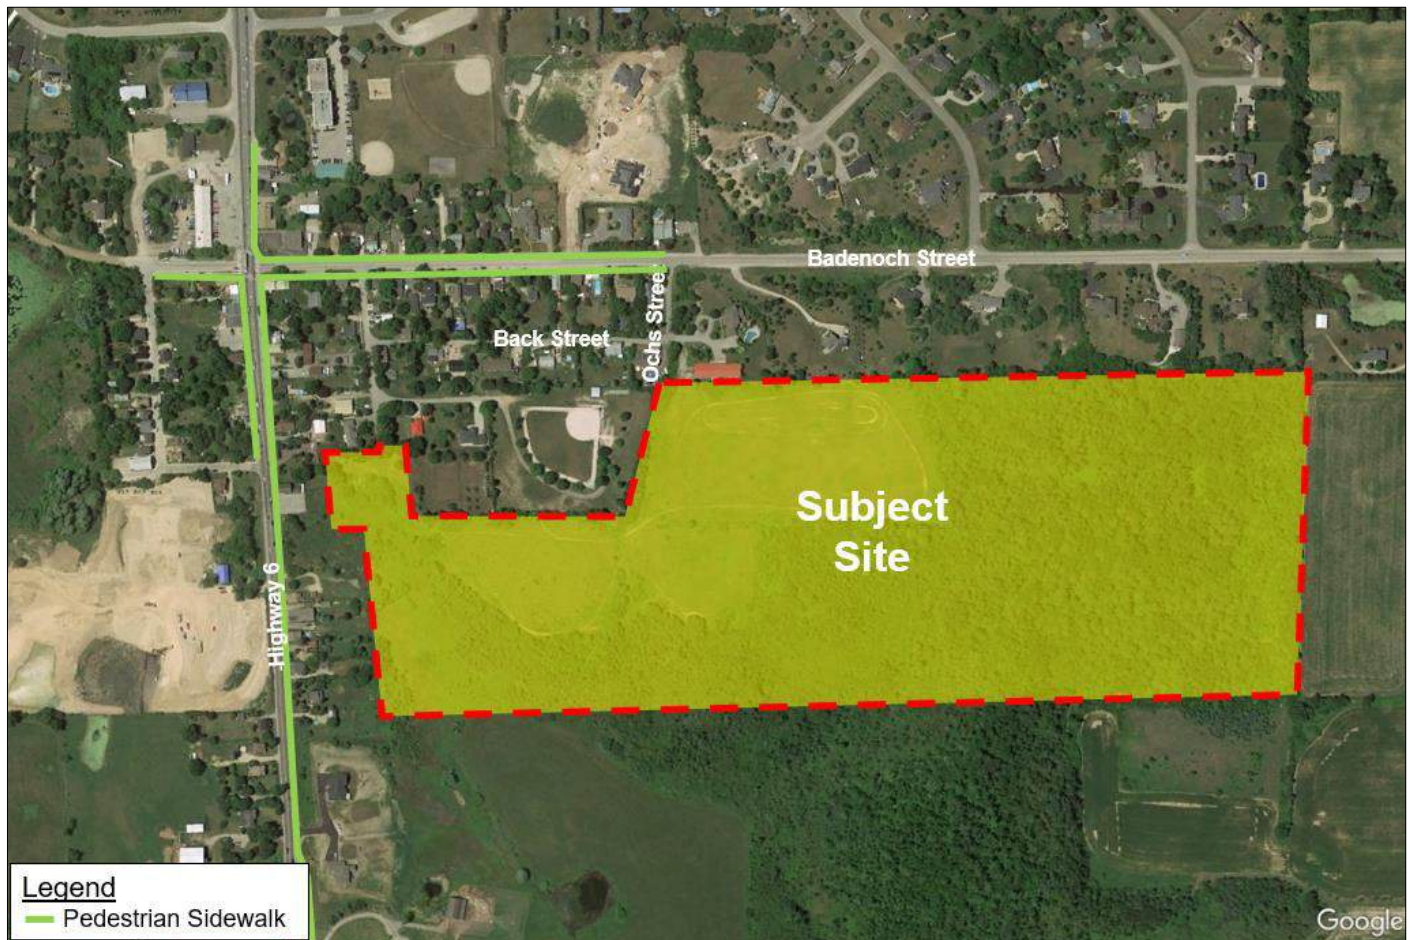
Figure 4 Existing Sidewalk

All existing pedestrian and cycling amenities within the study area are shown on **Figure 4**.

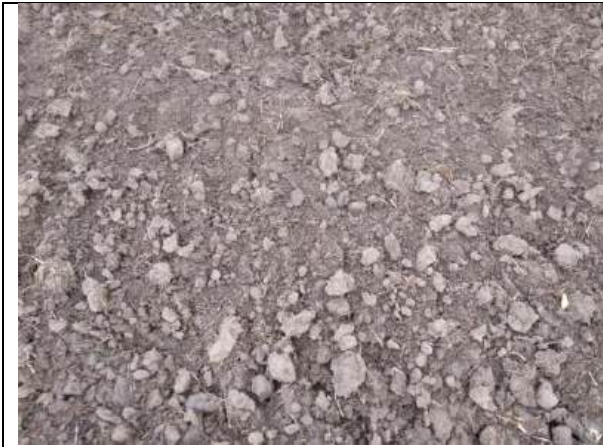
IMAGE 1 VIEW OF PEDESTRIAN SURVEY SOIL CONDITIONS

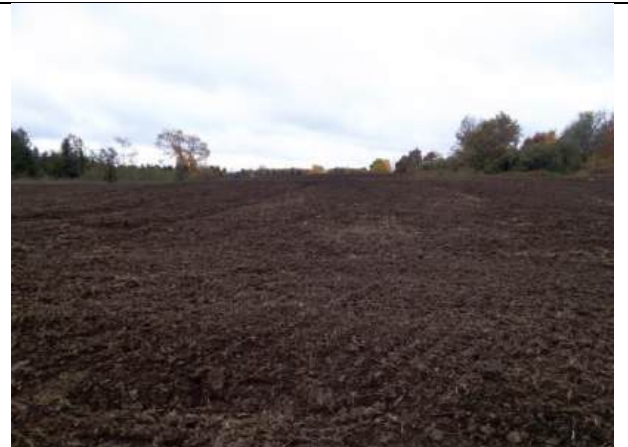
IMAGE 2 OVERVIEW OF PEDESTRIAN SURVEY AREA

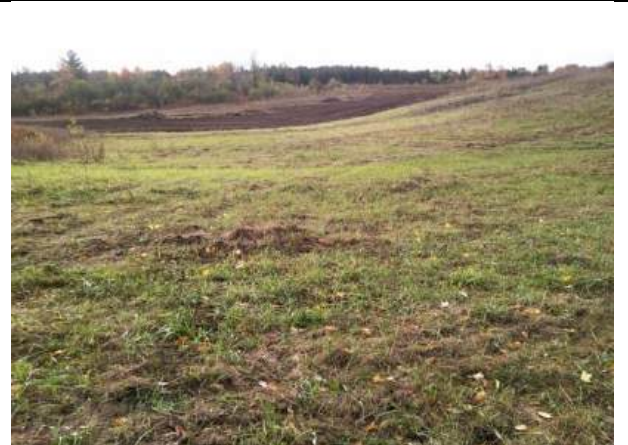
IMAGE 4 OVERVIEW OF TEST PIT SURVEY CONDITIONS

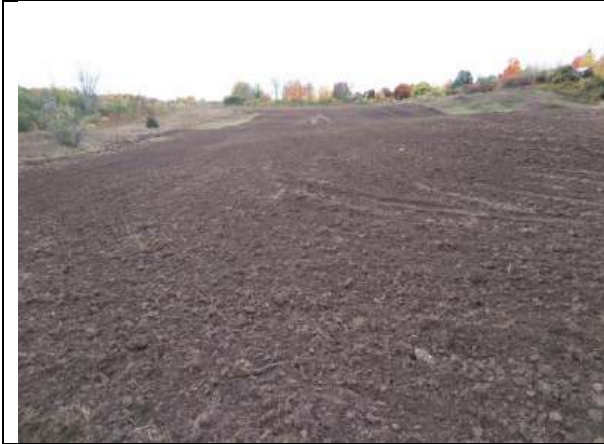
IMAGE 6 VIEW OF COMPLETED TEST PIT

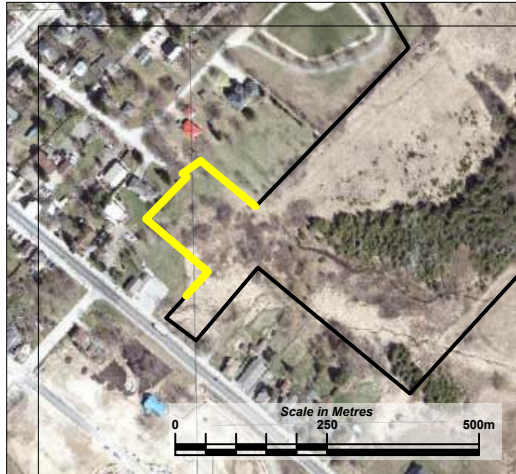
NO:
Figure 3

AREAS OF POTENTIAL ENVIRONMENTAL CONCERN

- #1 10. Commercial Autobody Shops.
- #2 33. Metal Treatment, Coating, Plating and Finishing.
