Water Report Level 1/2

Aberfoyle South Pit Expansion

WSP Canada Inc.

November 2023

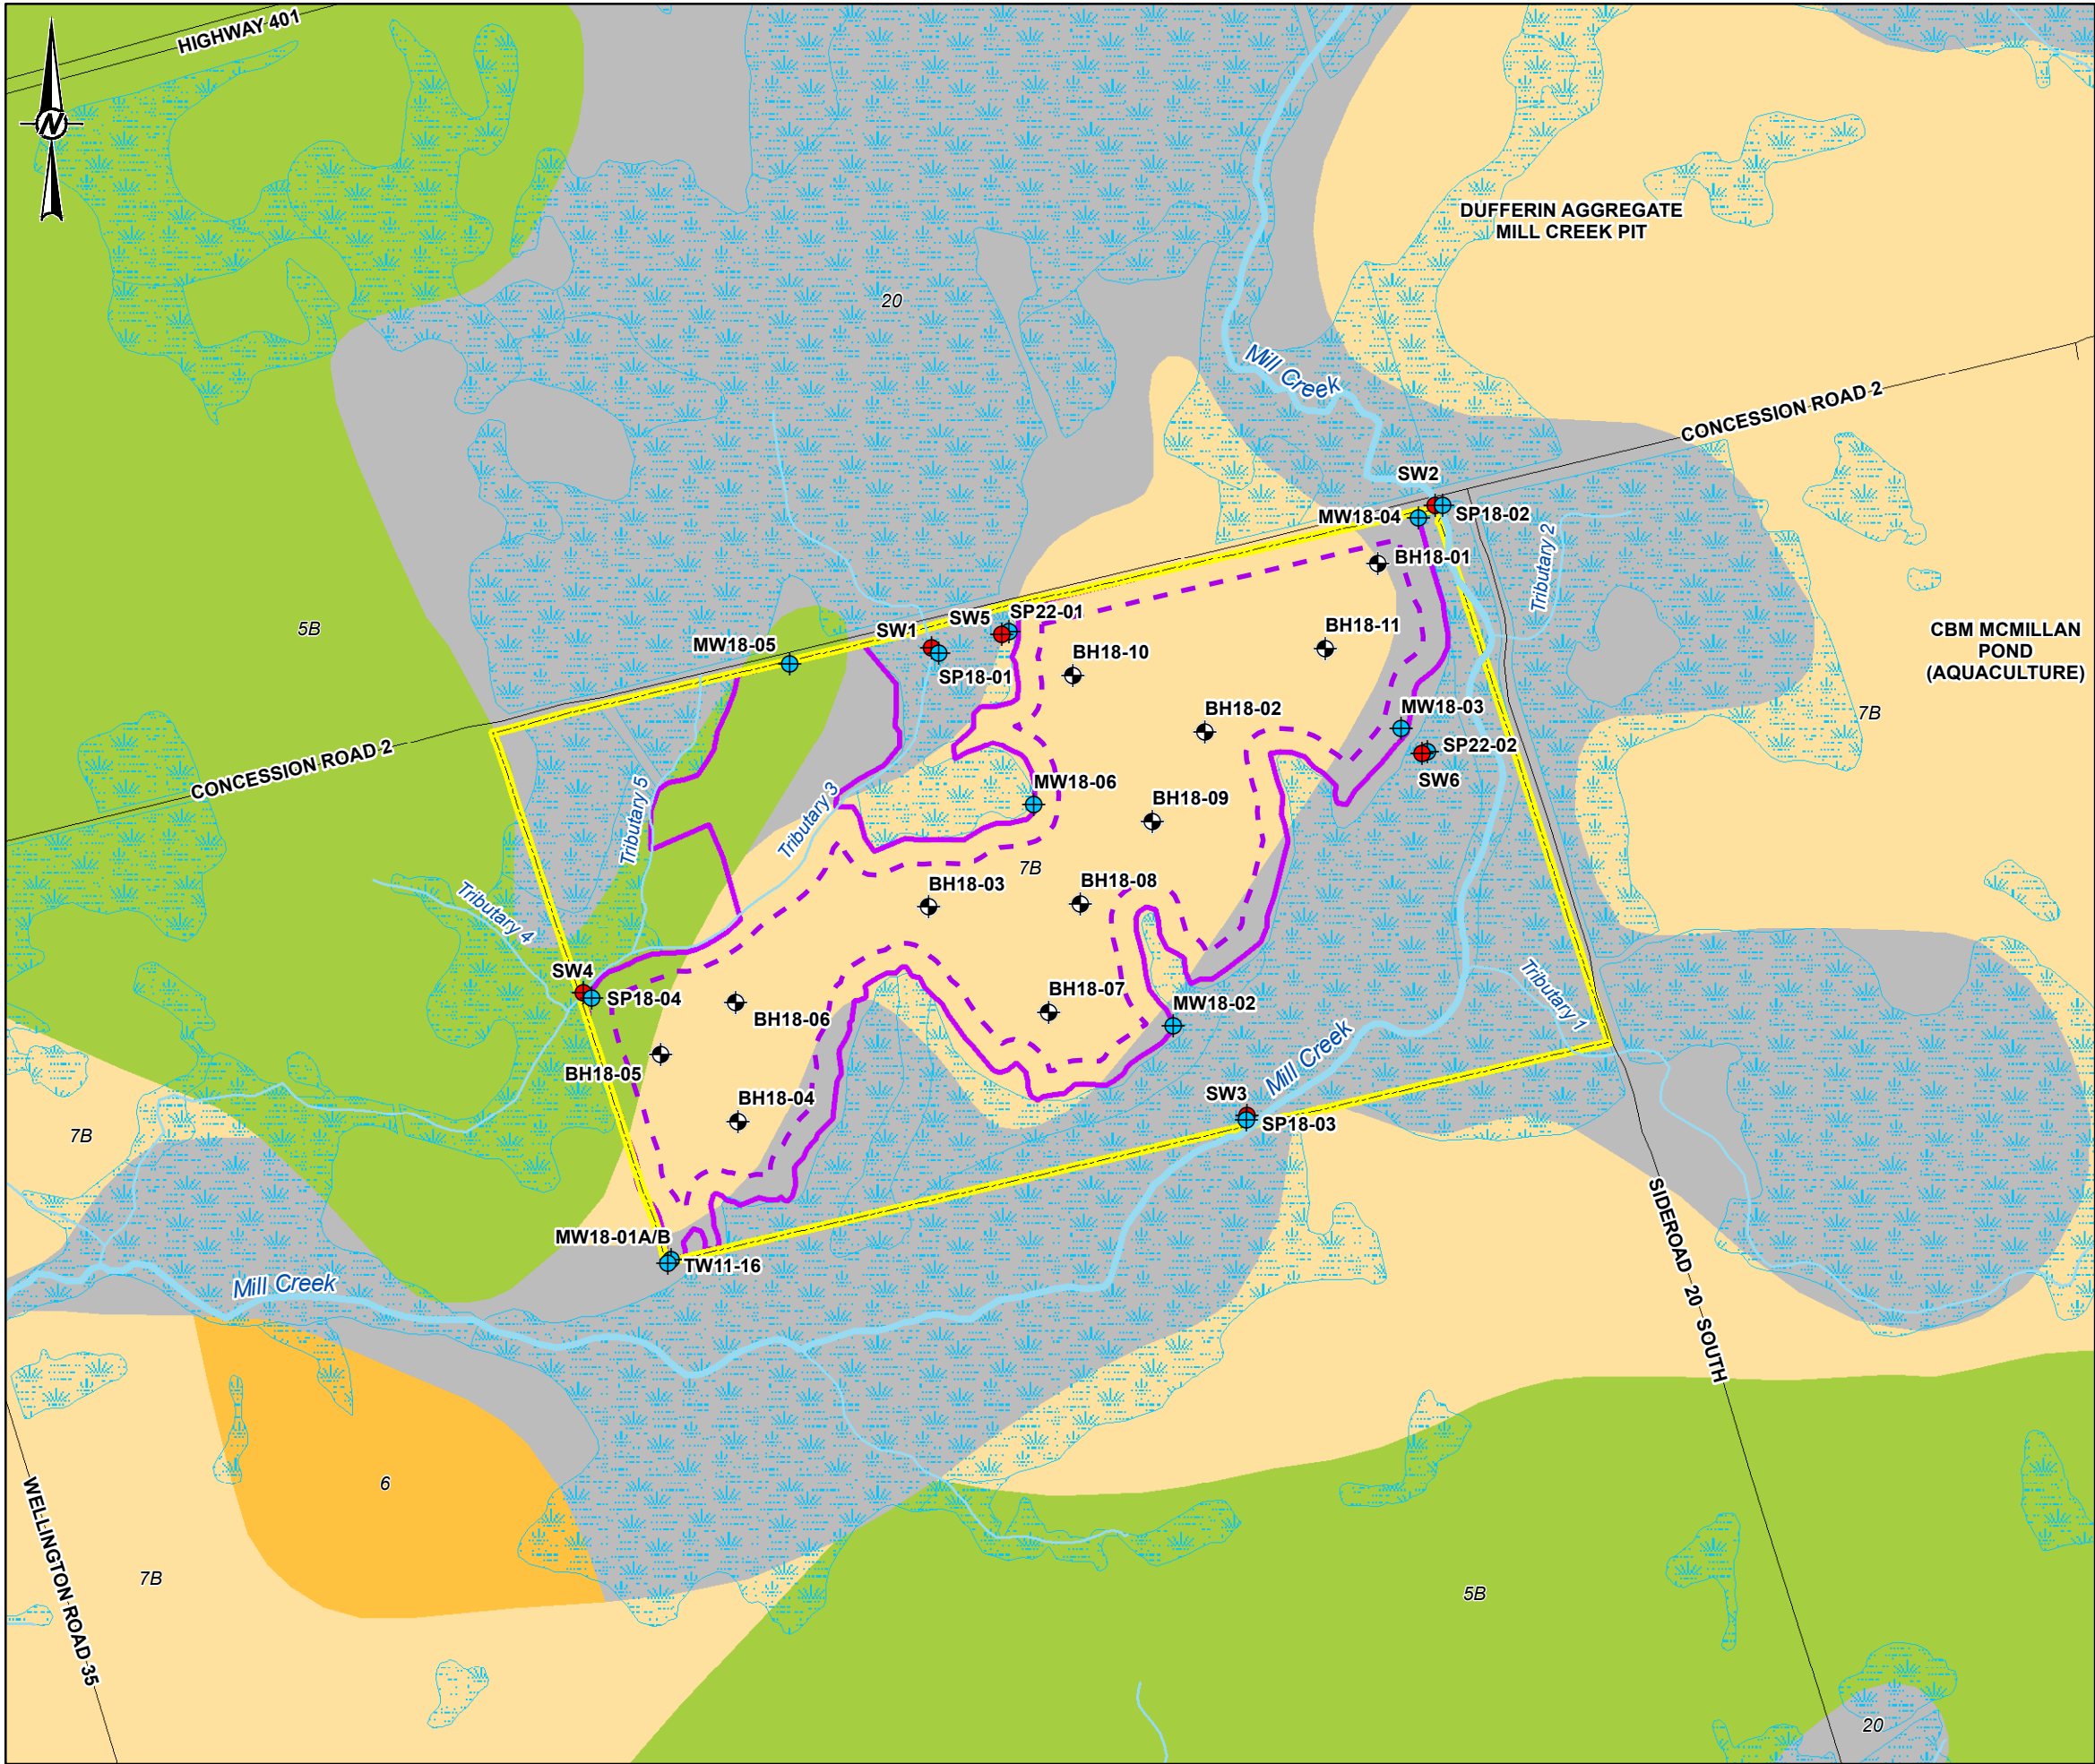
PROJECT NO.	CONTROL	REV.	FIGURE
1791470	0008	0	3

- Resource Evaluation Borehole
- Groundwater Monitor
- Surface Water Monitor
- Watercourse
- Field Verified Wetland Edge
- Provincially Significant Wetland (Evaluated)
- Property Boundary
- Licence Boundary / Site Boundary
- Proposed Extraction Area

There are three main surficial soil units mapped by the Ontario Geologic survey (OGS) on and in the vicinity of the property (Figure 3):

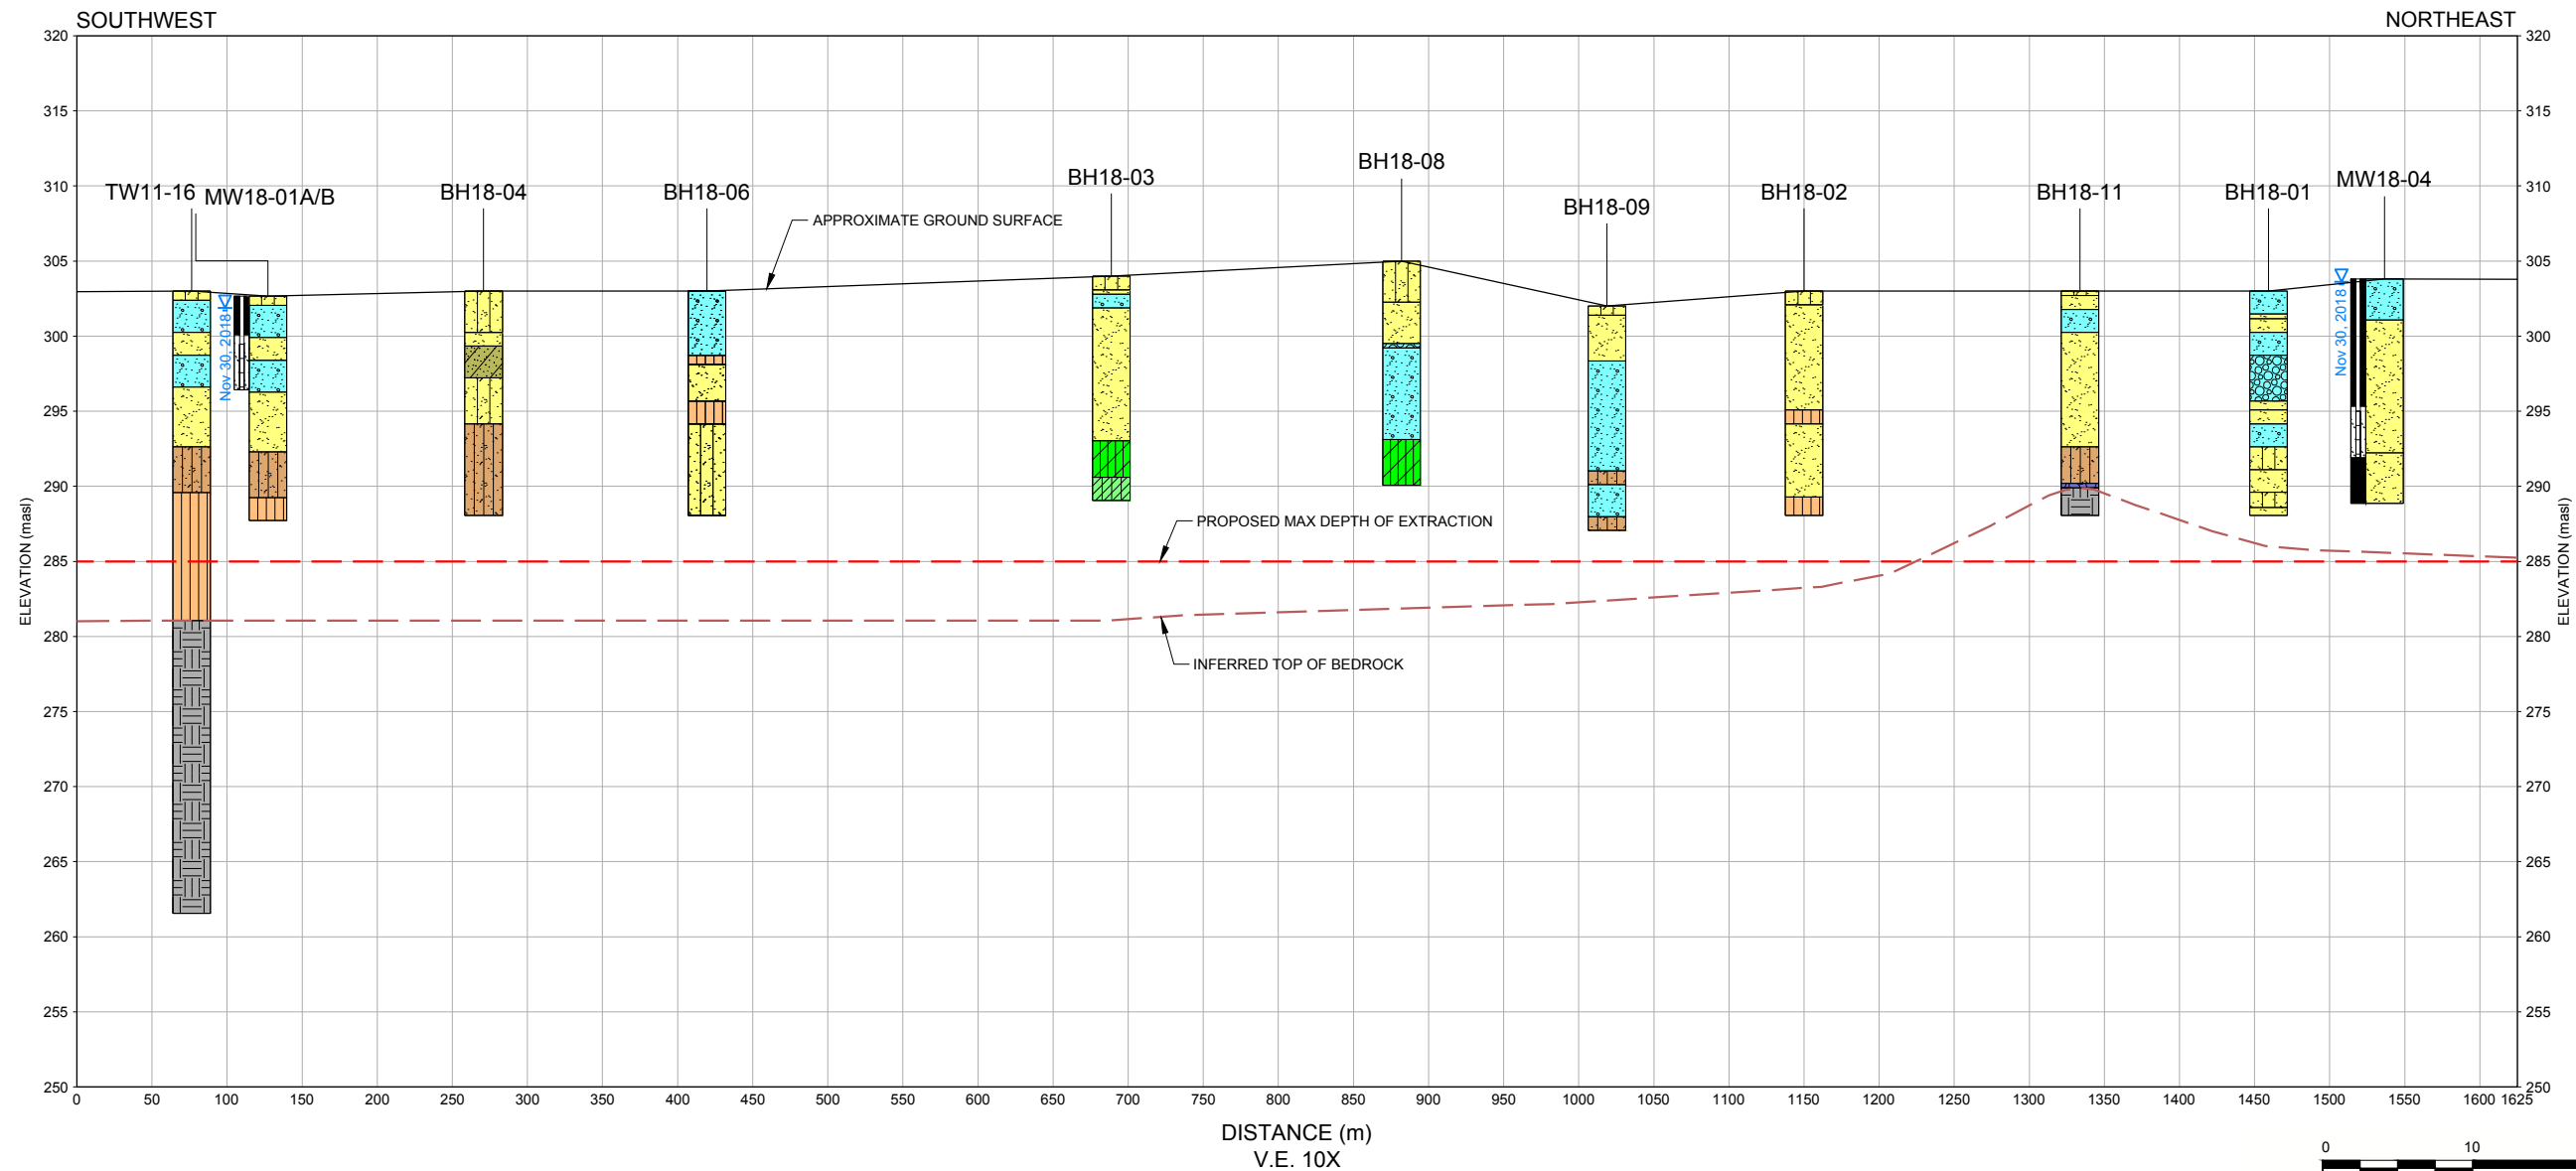
CLIENT		CBM AGGREGATES, A DIVISION OF ST. MARYS CEMENT INC.(CANADA)	
PROJECT		ABERFOYLE SOUTH PIT EXPANSION	
TITLE		GEOLOGICAL CROSS-SECTION A-A'	
CONSULTANT		YYYY-MM-DD	2023-02-08
		DESIGNED	
		PREPARED	DD
		REVIEWED	GS
		APPROVED	GS
PROJECT NO.	PHASE	REV.	FIGURE
1791470	(4000)	A	4

With reference to the cross-section A-A' presented on Figure 4, the confirmed base of the aggregate resource varies from a high elevation of 294 masl to a low elevation of ~287 masl. It is noted that BH18-01, BH18-09, BH18-10, MW18-03 and MW18-04 were terminated at elevations ranging from 290.7 to 287.1 masl while still in sand and gravel and before fine grained material or bedrock was encountered, indicating that sand and gravel is present below the confirmed elevation of 287.1 masl at some locations within the property.

With reference to the borehole logs provided in Appendix C, a southwest to northeast geological cross-section is presented on Figure 4. A generalized description of subsurface conditions encountered during drilling is as follows, from ground surface downwards:

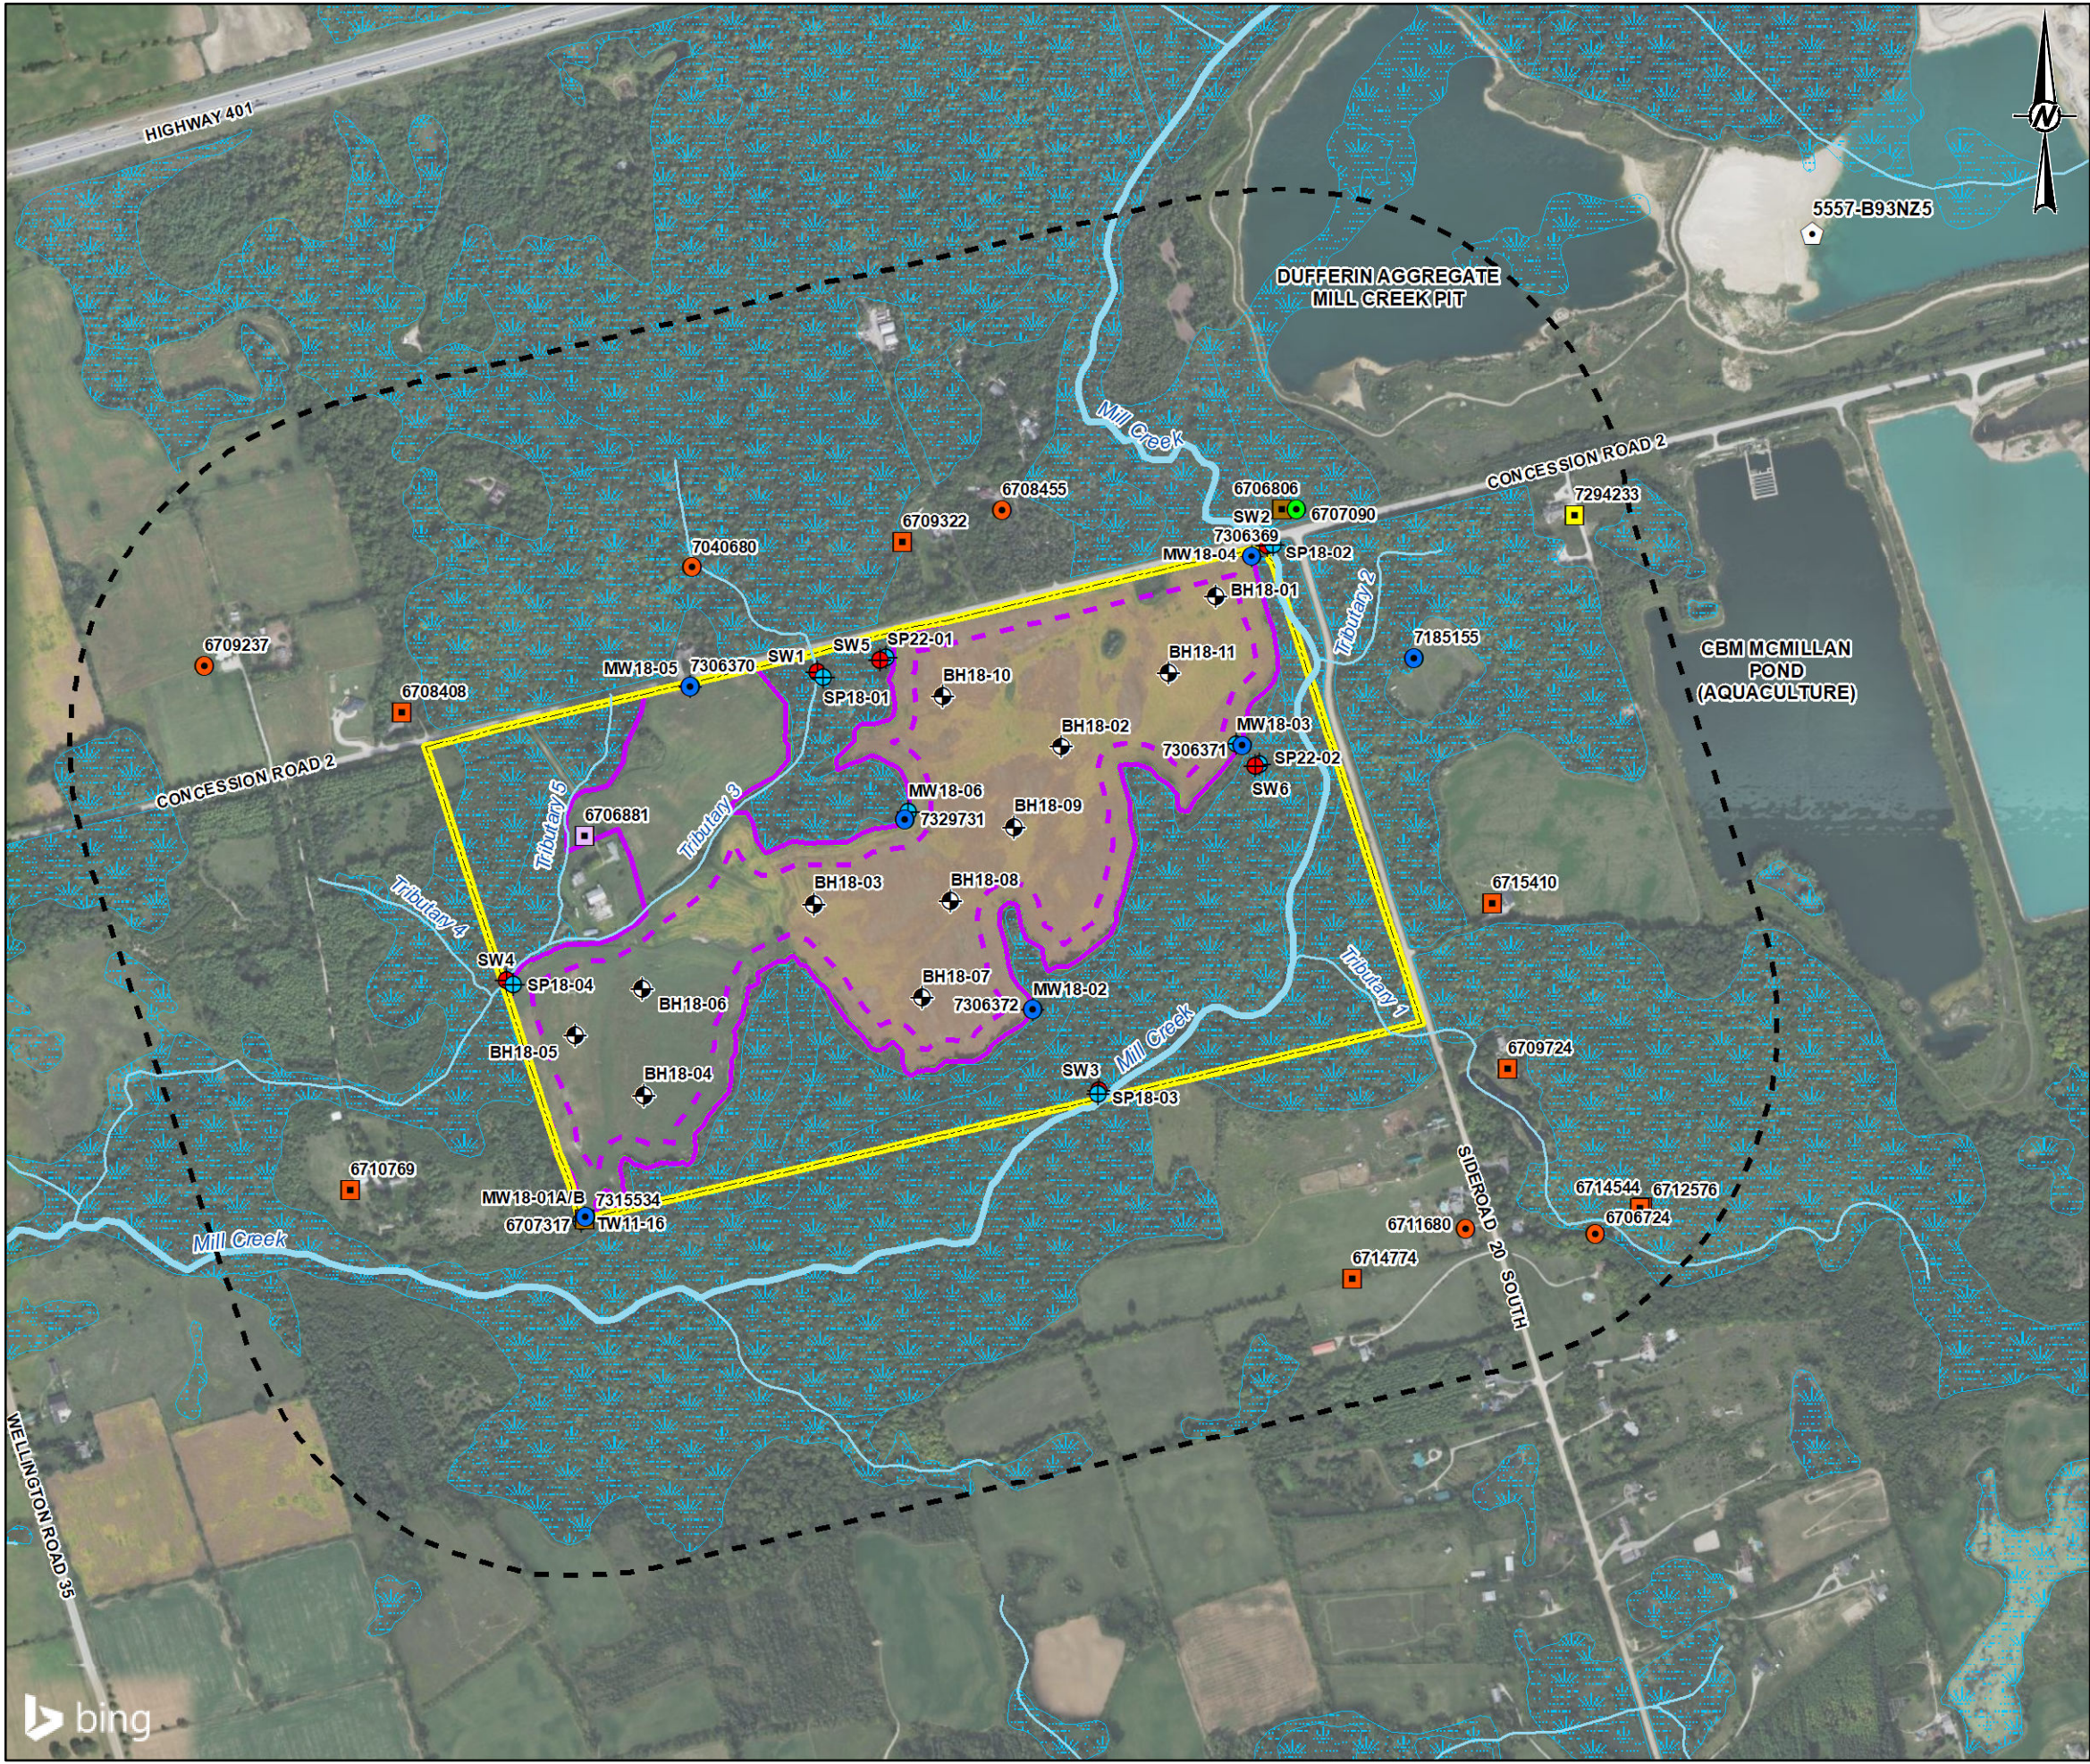
FIGURE
5

- Resource Evaluation Borehole
- Groundwater Monitor
- Surface Water Monitor
- Permit to Take Water Location

According to the MECP Water Well Information System (WWIS) database, there are 17 neighbouring wells within 500 m of the property in addition to eight wells on the property itself, as shown on Figure 5.

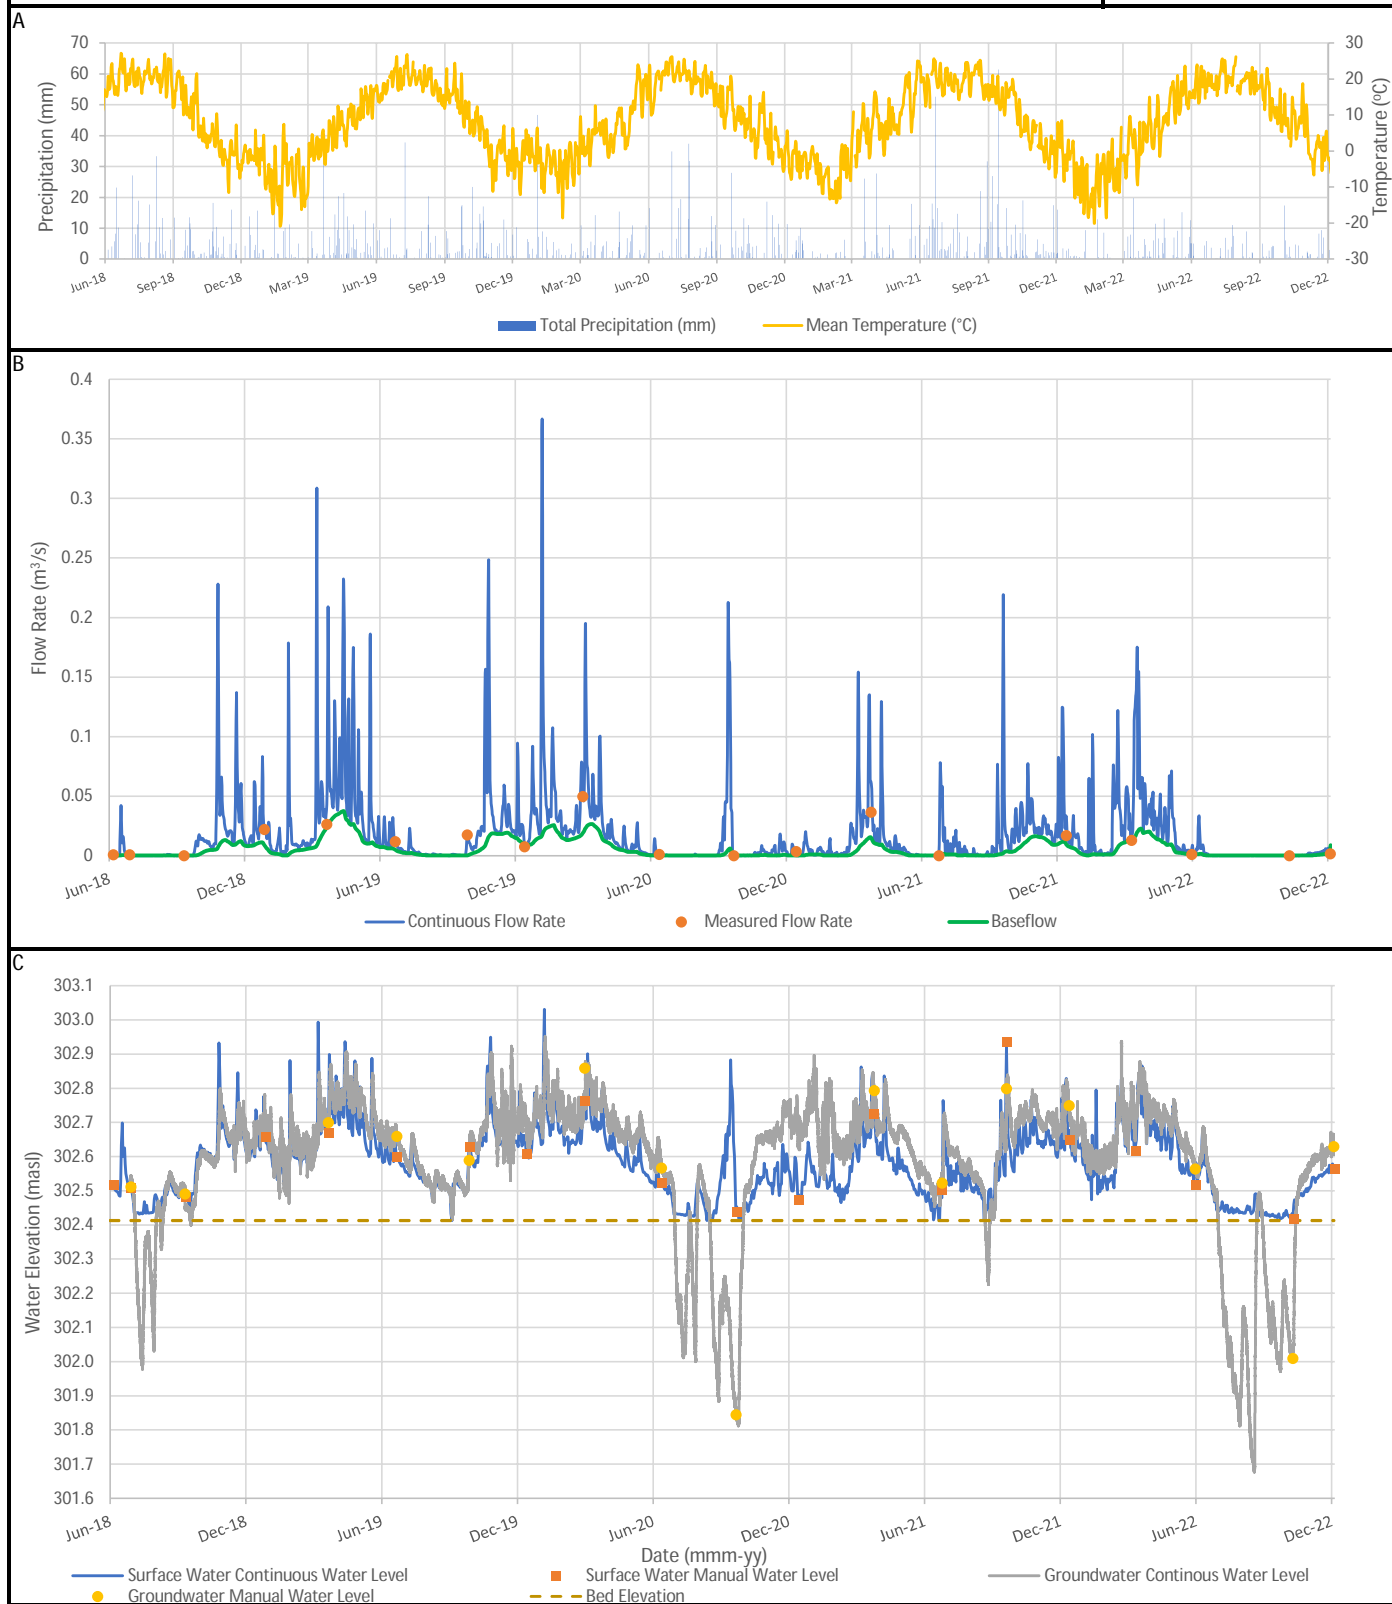
FIGURE 8

Water Levels at Mill Creek (SW-2 and SP18-02) Adjacent to Aberfoyle South Pit Expansion (2018 - 2022)

Figures 7 to 12 display the continuous water level data for each monitoring station. Generally, water level records at the surface water stations are marked by low water levels during the summer and early fall. Winter water levels generally remained low, marked with high water events likely caused by short melt events. Water levels through the spring were moderate to high following the freshet. Water levels in the fall were marked with responses to large precipitation events.

An increase in water level, not in response to a precipitation event recorded at any Environment Canada (EC) or GRCA meteorological stations, was noted in late August to late September in 2020, on Figures 7 to 10. The GRCA has two flow gauges on Mill Creek including the Mill Creek (Side Road 10) flow gauge (8797042), approximately 3 km downstream of the Site and the Aberfoyle flow gauge (9668042), approximately 2.6 km upstream from the Site. Data provided by the GRCA at the Mill Creek (Side Road 10) flow gauge did not record a similar peak level event over this period. The increase in the water level records in both Tributary #3 and Mill Creek are likely reflective of a significant local discharge event upstream of the Site as the sporadic rainfall events over the month-long period do not support the steady increase and sharp decline of the water level seen at each station.

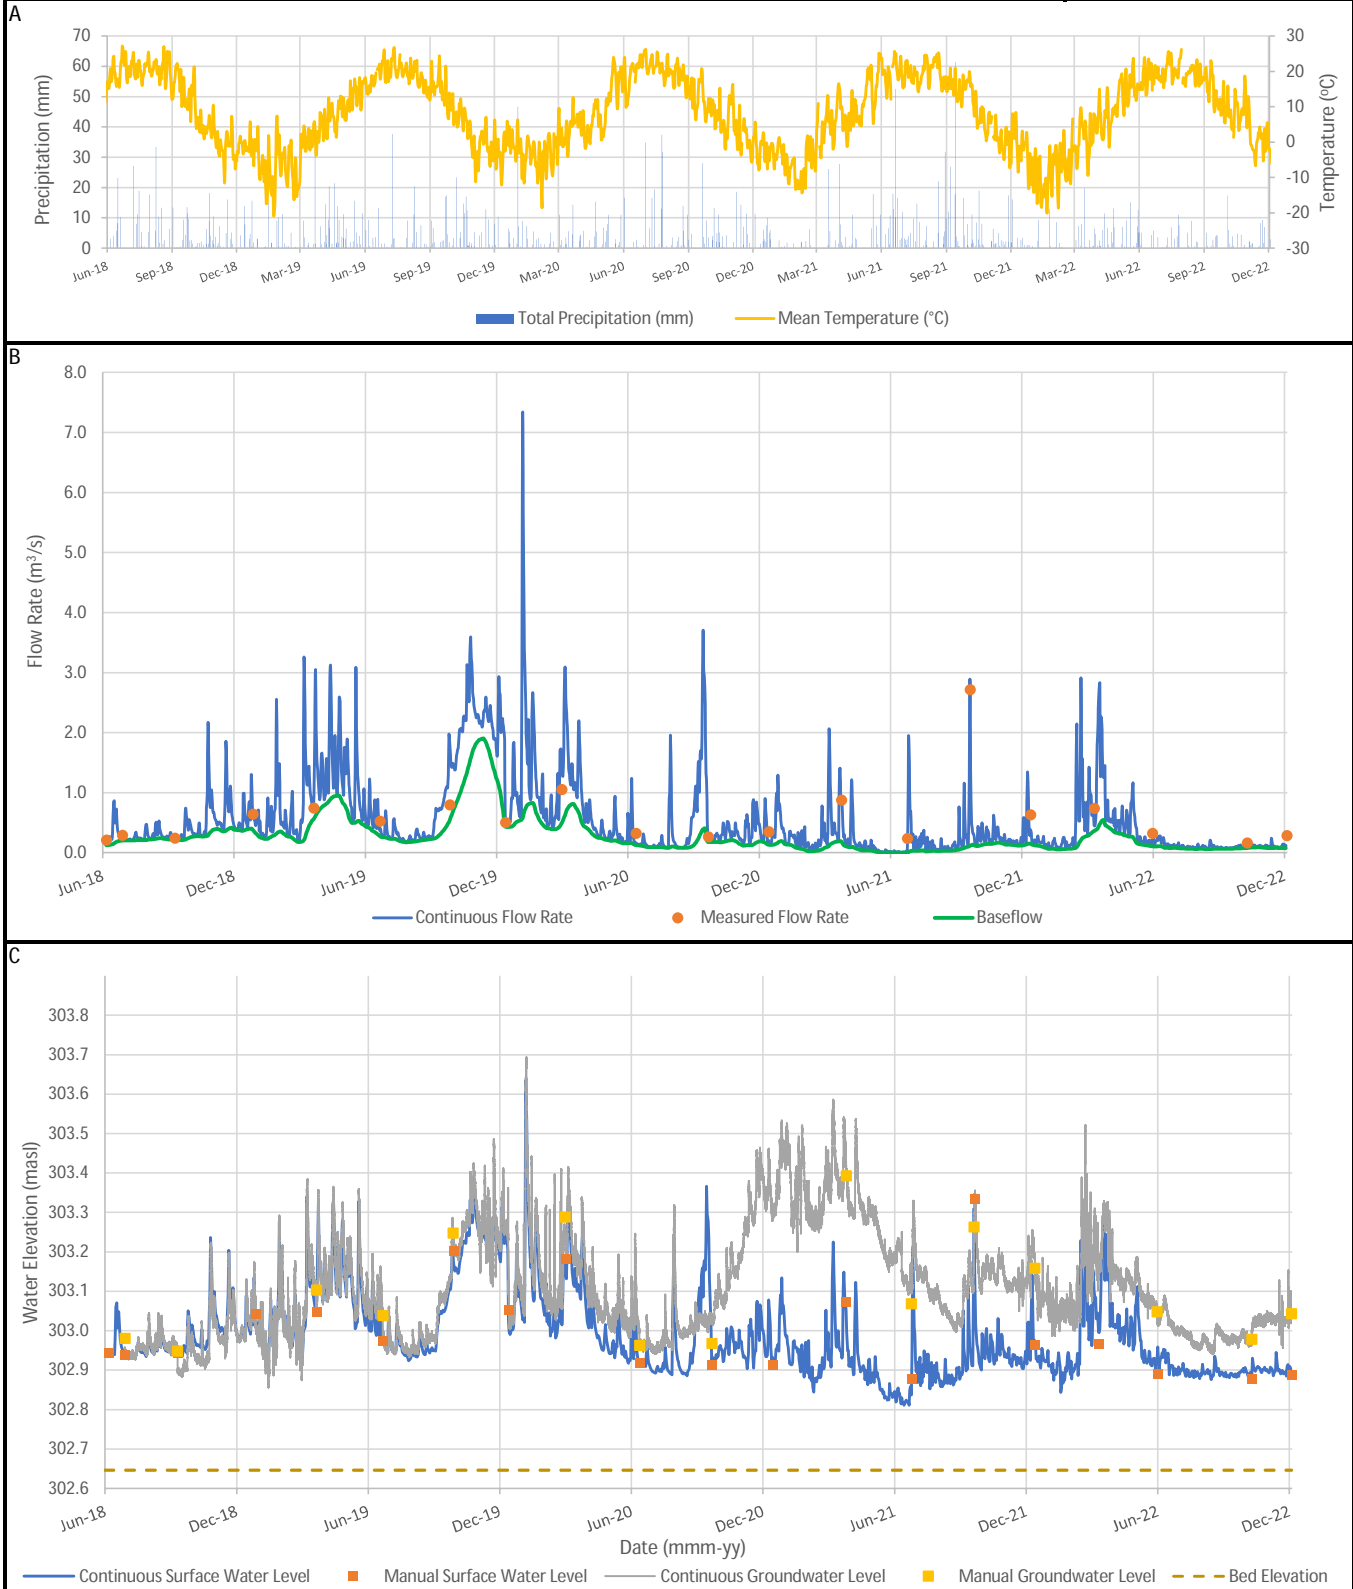
FIGURE 9

Water Levels at Mill Creek (SW-3 and SP18-03) Adjacent to Aberfoyle South Pit Expansion (2018 - 2022)

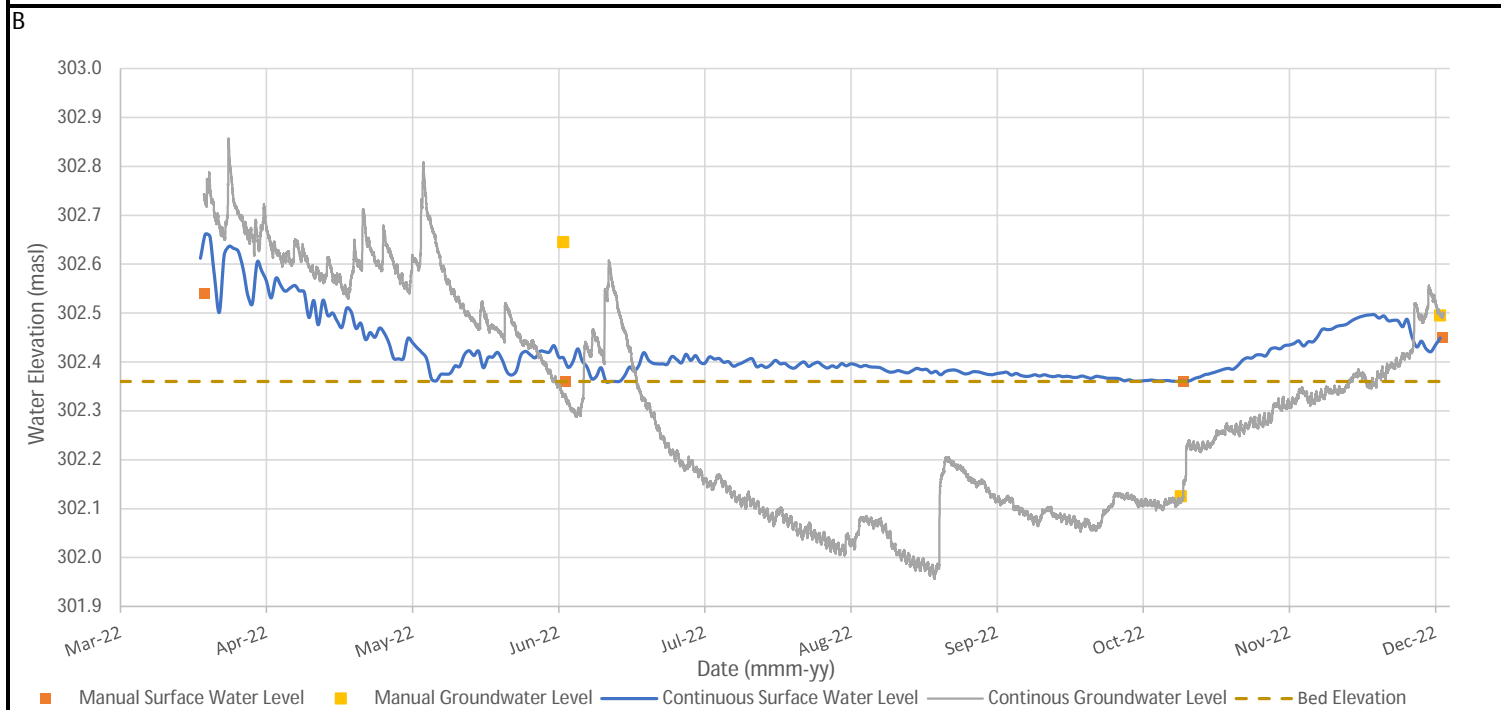
FIGURE 12

Water Levels Within the Mill Creek-Puslinch PSW (SW-6 and SP22-02) Adjacent to Aberfoyle South Pit Expansion (2022)

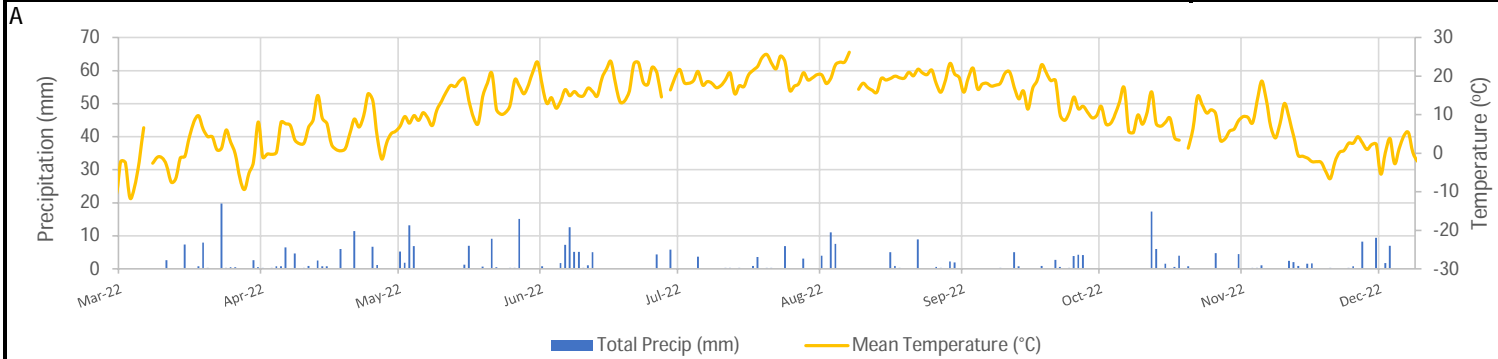
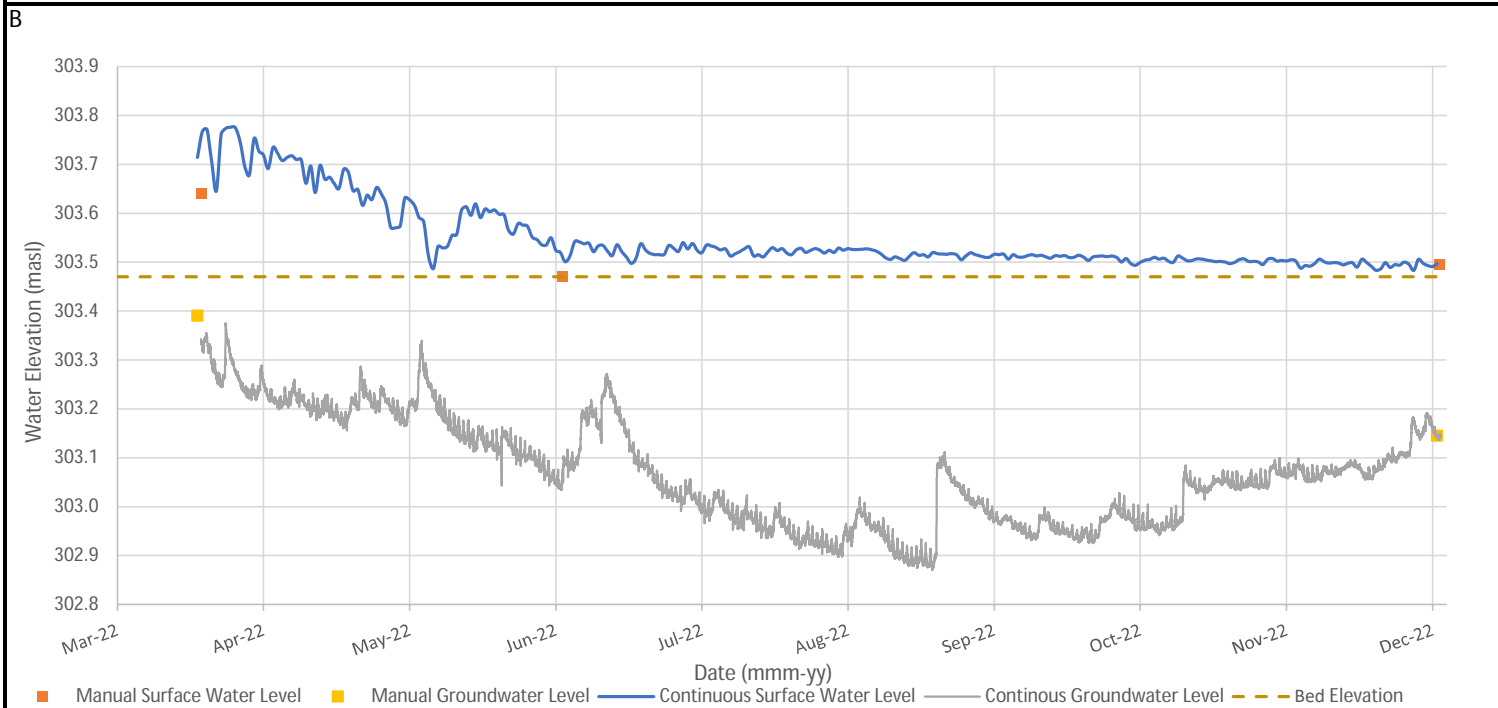
A. Total Daily Precipitation and Mean Daily Temperature (Kitchener/Waterloo, ON, EC Climate ID#6144239) B. Water Level

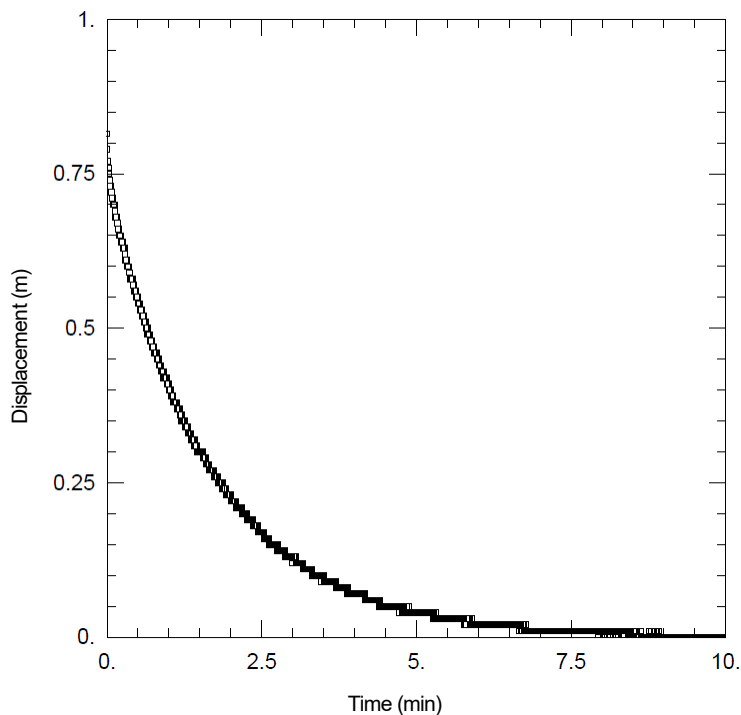
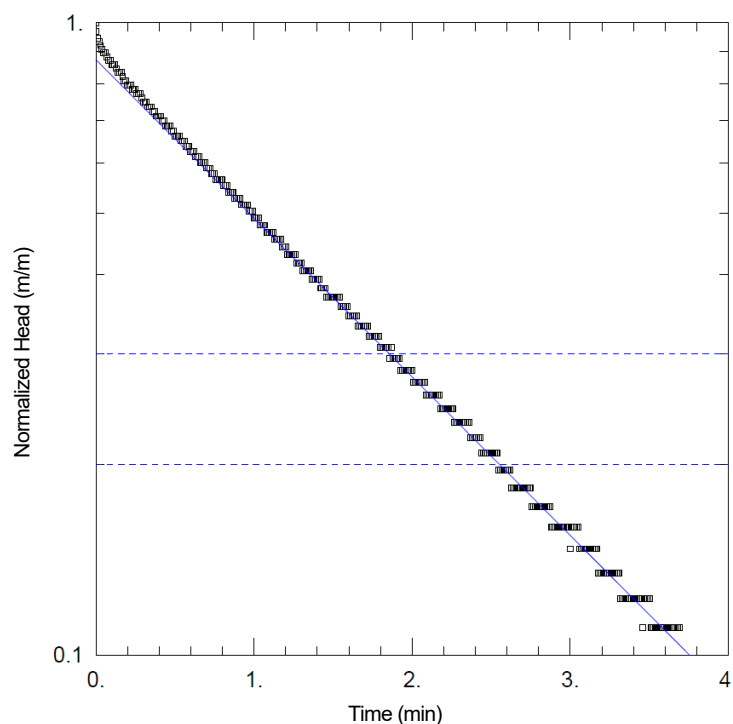
Test Well: MW18-01B
 Time of Test: August 3, 2018
 Test Type: Rising Head Test
 Test Method: Pneumatic displacement, rising head test
 Static Water Level: 1.895 mbmp
 Initial Displacement: 0.815 m
 Casing Radius: 0.026 m
 Borehole Radius: 0.057 m
 Open Well Screen Interval: 3.50 to 6.50 mbgs
 Geology: Silt and Sand

Solution Method: Bouwer-Rice
 Solution Type: Zero Storage
 Aquifer Model: Unconfined

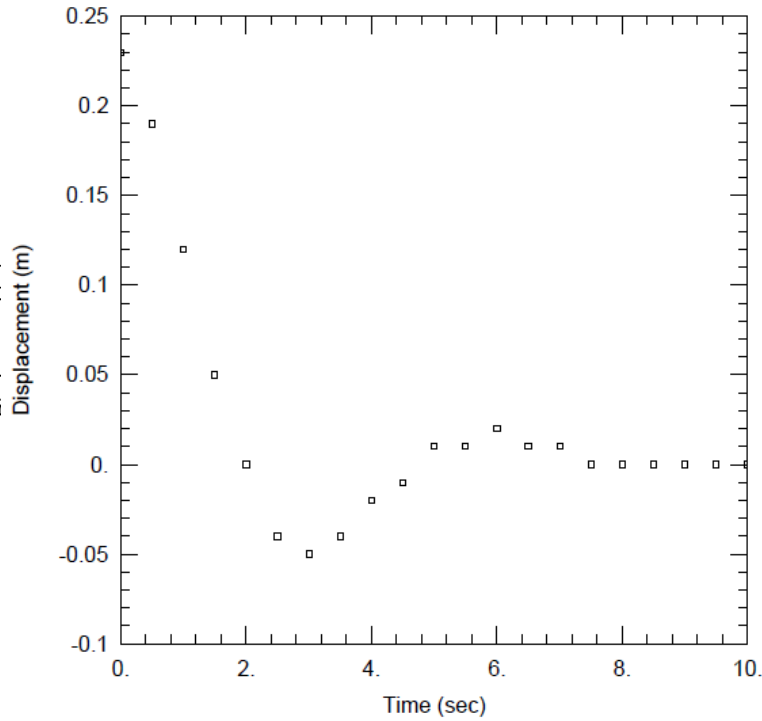
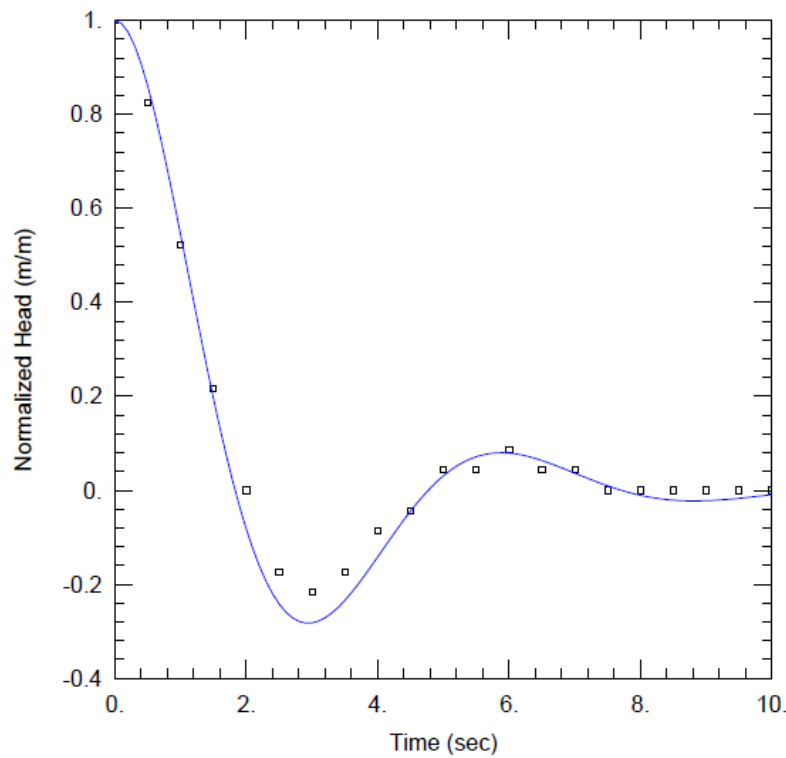
Solution Method: Springer-Gelhar
Solution Type: Inertial
Aquifer Model: Unconfined

Hydraulic Conductivity (K) =

$$1 \times 10^{-3} \text{ m/s}$$

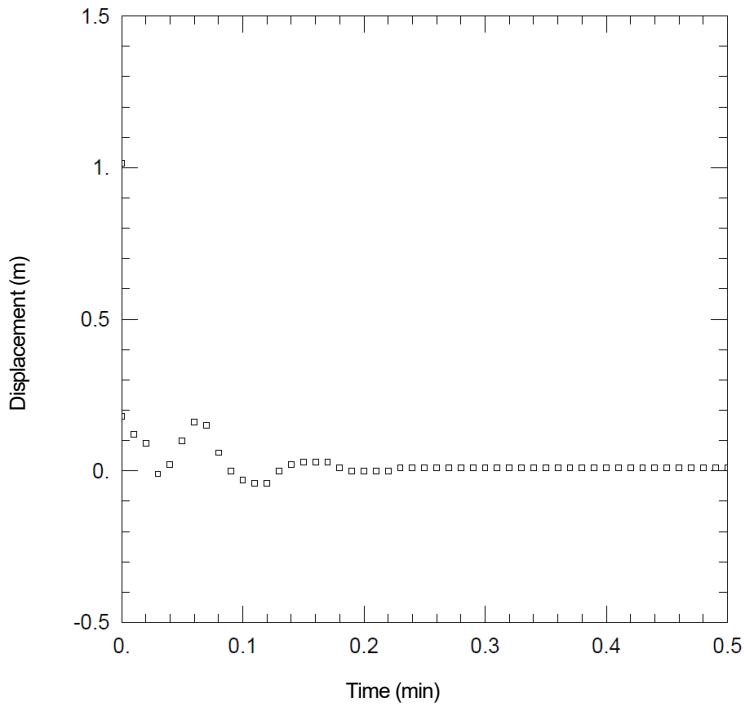
Solution Method: Springer-Gelhar
Solution Type: Inertial
Aquifer Model: Unconfined

Hydraulic Conductivity (K) =

$$8 \times 10^{-4} \text{ m/s}$$

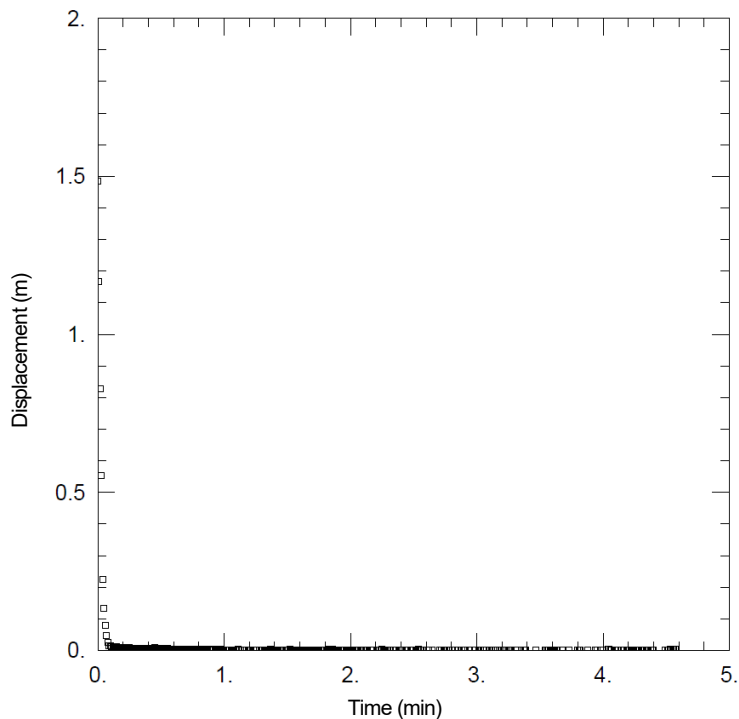
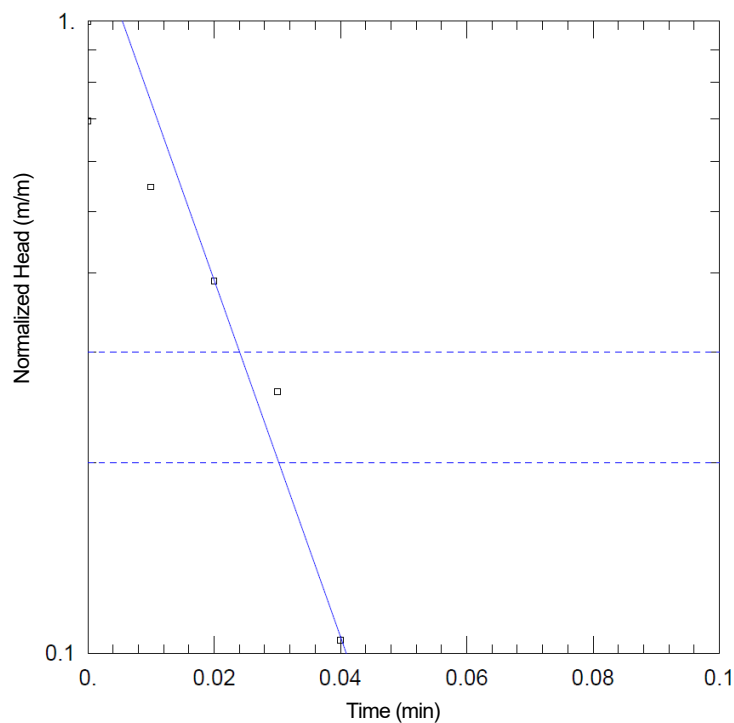
FIGURE
4

Test Well: MW18-04
 Time of Test: August 2, 2018
 Test Type: Rising Head Test
 Test Method: Pneumatic displacement, rising head test
 Static Water Level: 1.477 mbmp
 Initial Displacement: 2.133 m
 Casing Radius: 0.026 m
 Borehole Radius: 0.057 m
 Open Well Screen Interval: 8.80 to 11.80 mbgs
 Geology: Sand

Solution Method: Bouwer-Rice
 Solution Type: Zero Storage
 Aquifer Model: Unconfined
