Water Report Level 1/2

Aberfoyle South Pit Expansion

WSP Canada Inc.

November 2023

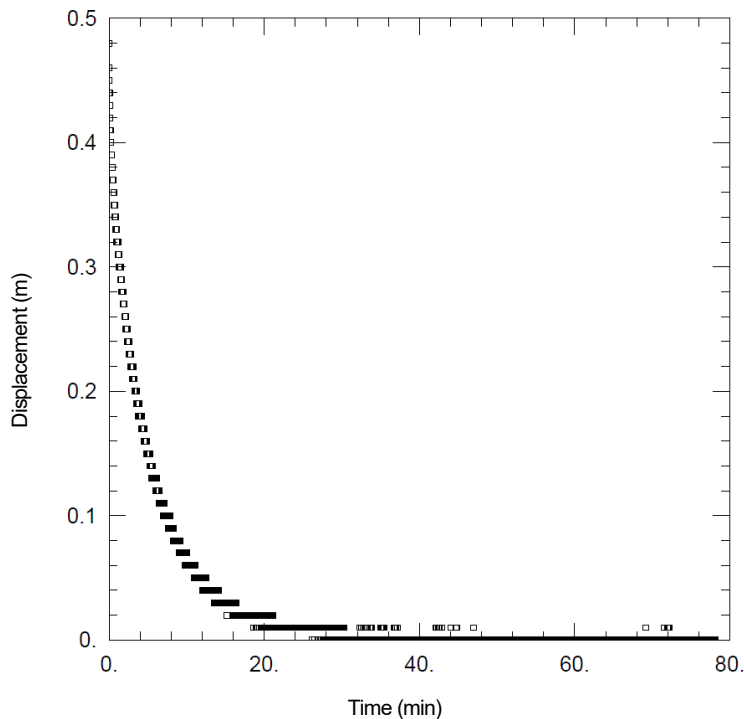
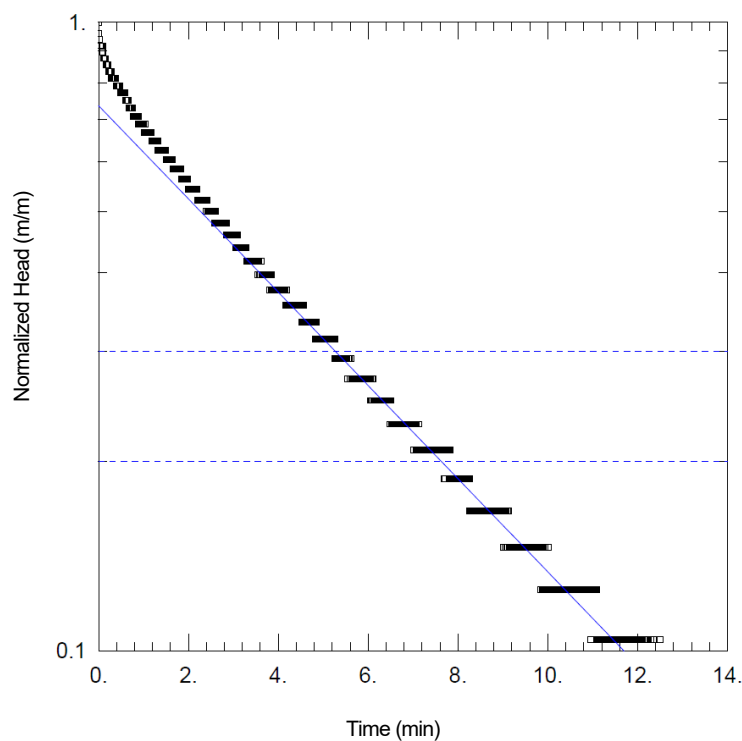
FIGURE
5

Test Well: MW18-05
 Time of Test: August 2, 2018
 Test Type: Rising Head Test
 Test Method: Physical slug, rising head test
 Static Water Level: 1.895 mbmp
 Initial Displacement: 0.479 m
 Casing Radius: 0.026 m
 Borehole Radius: 0.057 m
 Open Well Screen Interval: 8.80 to 11.80 mbgs
 Geology: Silt and Sand

Solution Method: Bouwer-Rice
 Solution Type: Zero Storage
 Aquifer Model: Unconfined

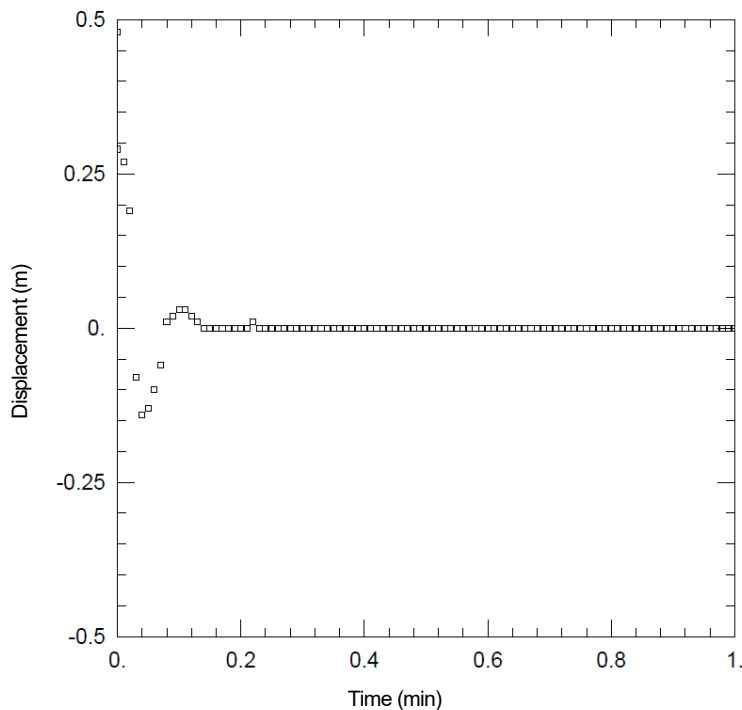
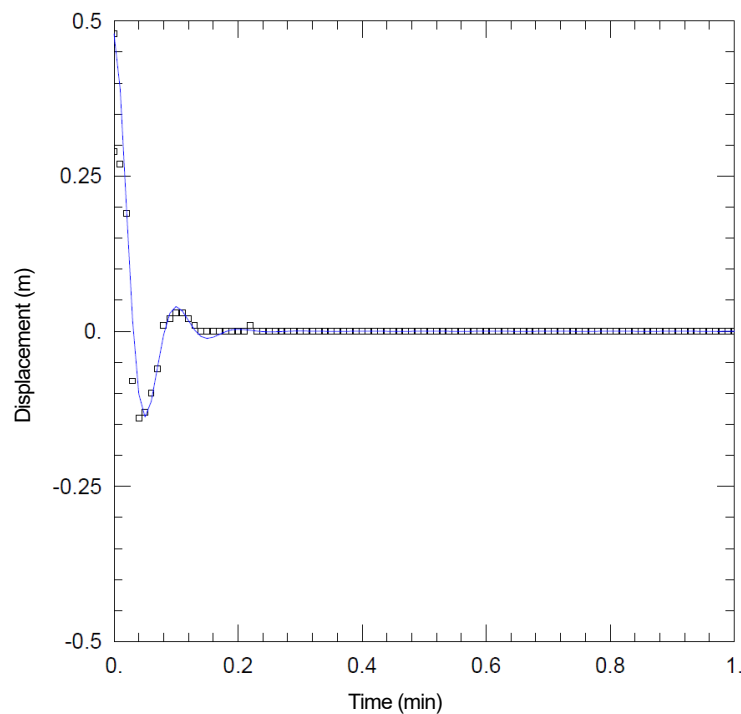
Test Well: MW18-06
 Time of Test: February 5, 2019
 Test Type: Rising Head Test
 Test Method: Physical slug, rising head test
 Static Water Level: 0.71 mbmp
 Initial Displacement: 0.48 m

Casing Radius: 0.026 m
 Borehole Radius: 0.057 m
 Open Well Screen Interval: 6.10 to 9.14 mbgs

Geology: Sand and Gravel

Solution Method: Springer-Gelhar
 Solution Type: Inertial
 Aquifer Model: Unconfined

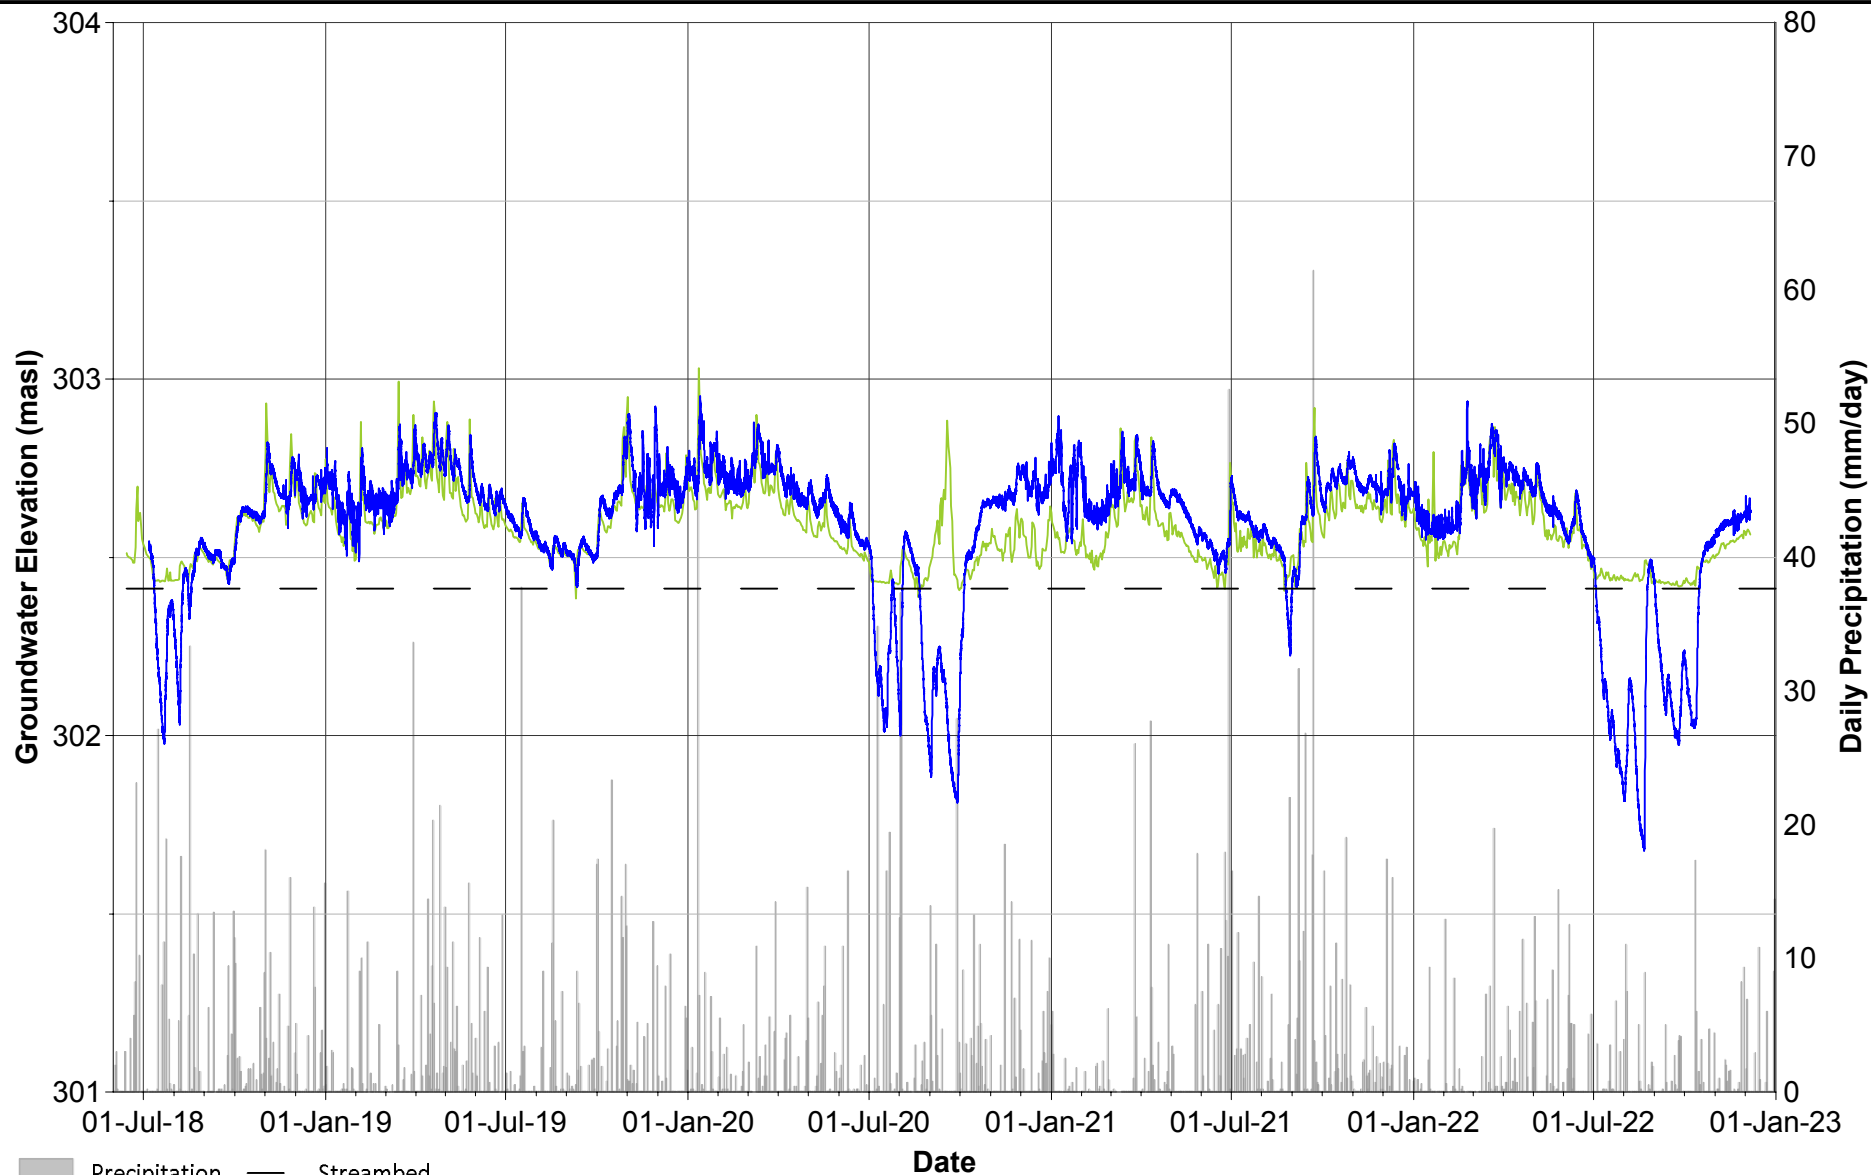
FIGURE
F.1.

Precipitation — Streambed
SW-1 SP18-01

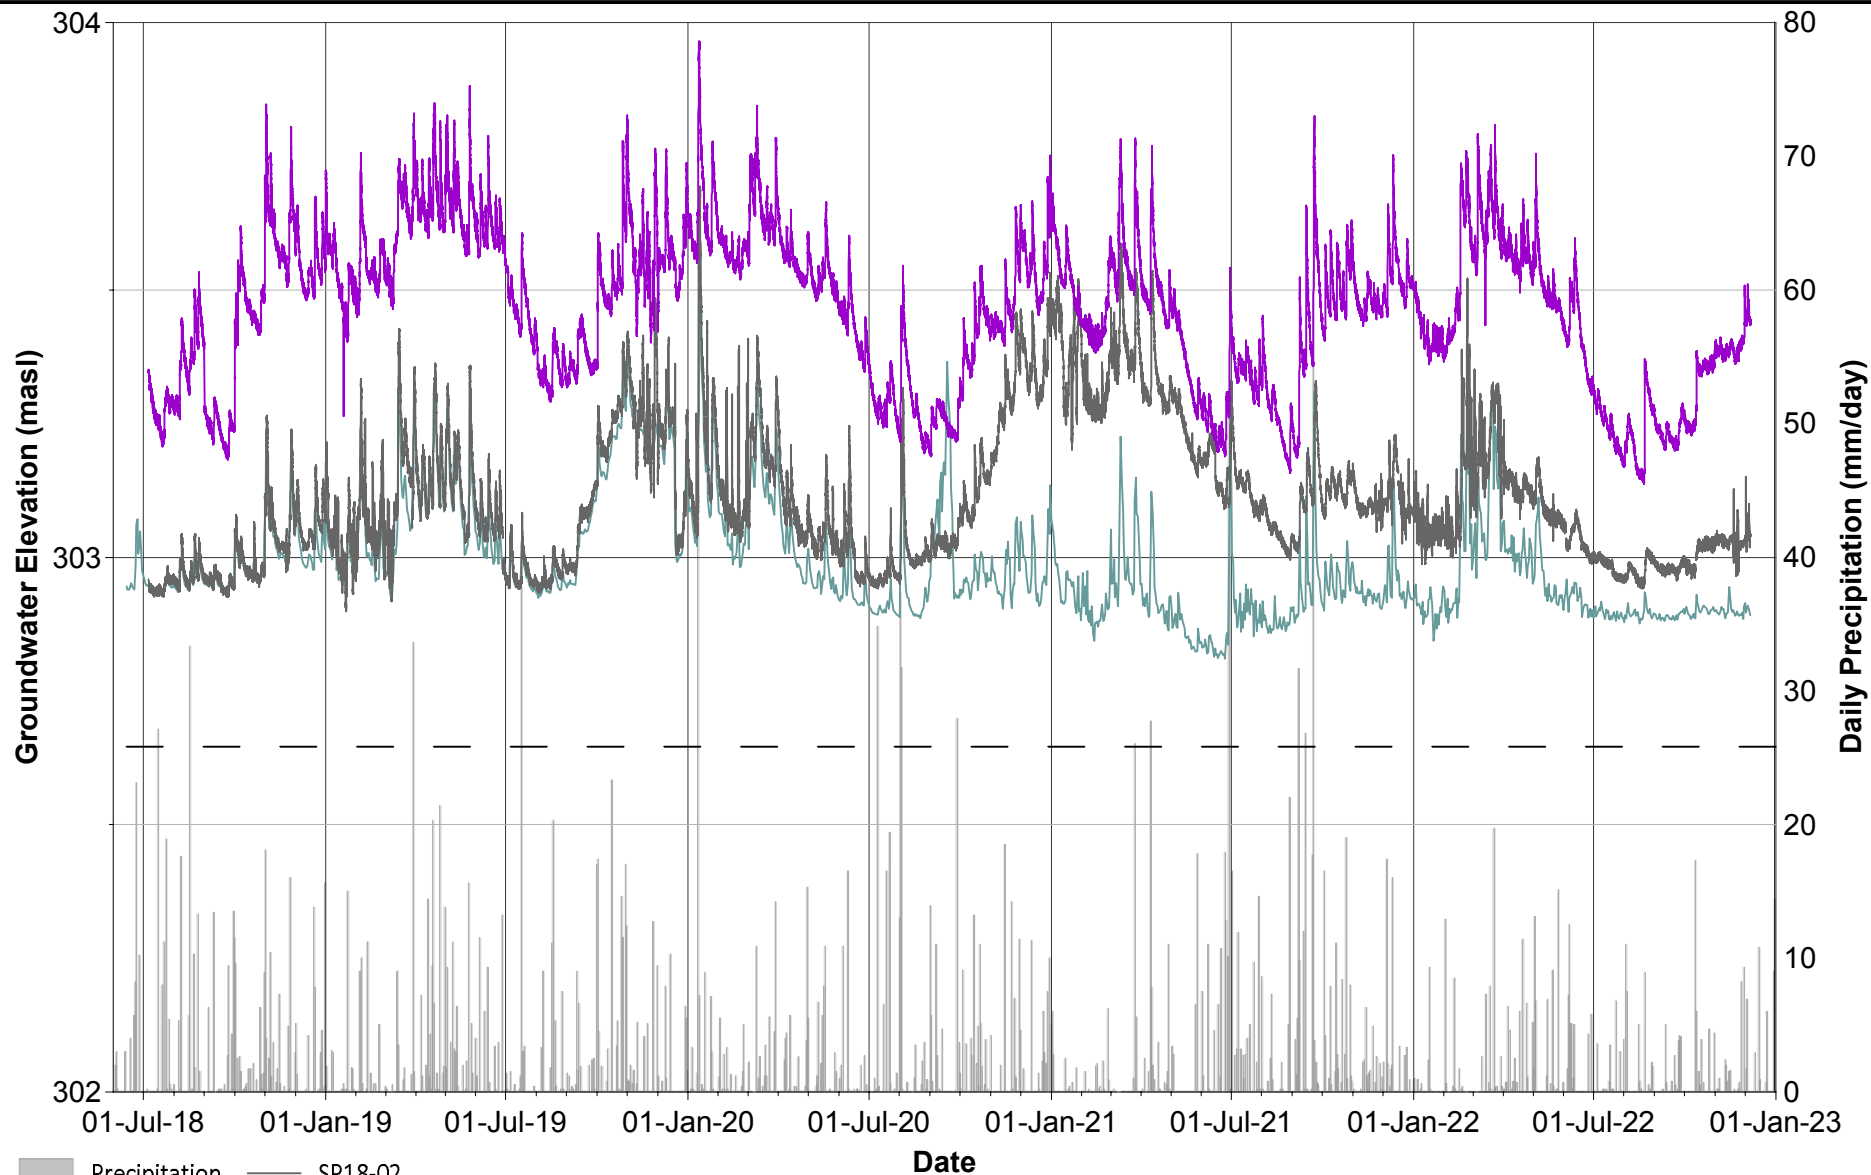
FIGURE
F.2.

Precipitation — SP18-02
SW-2 — MW18-04
Streambed

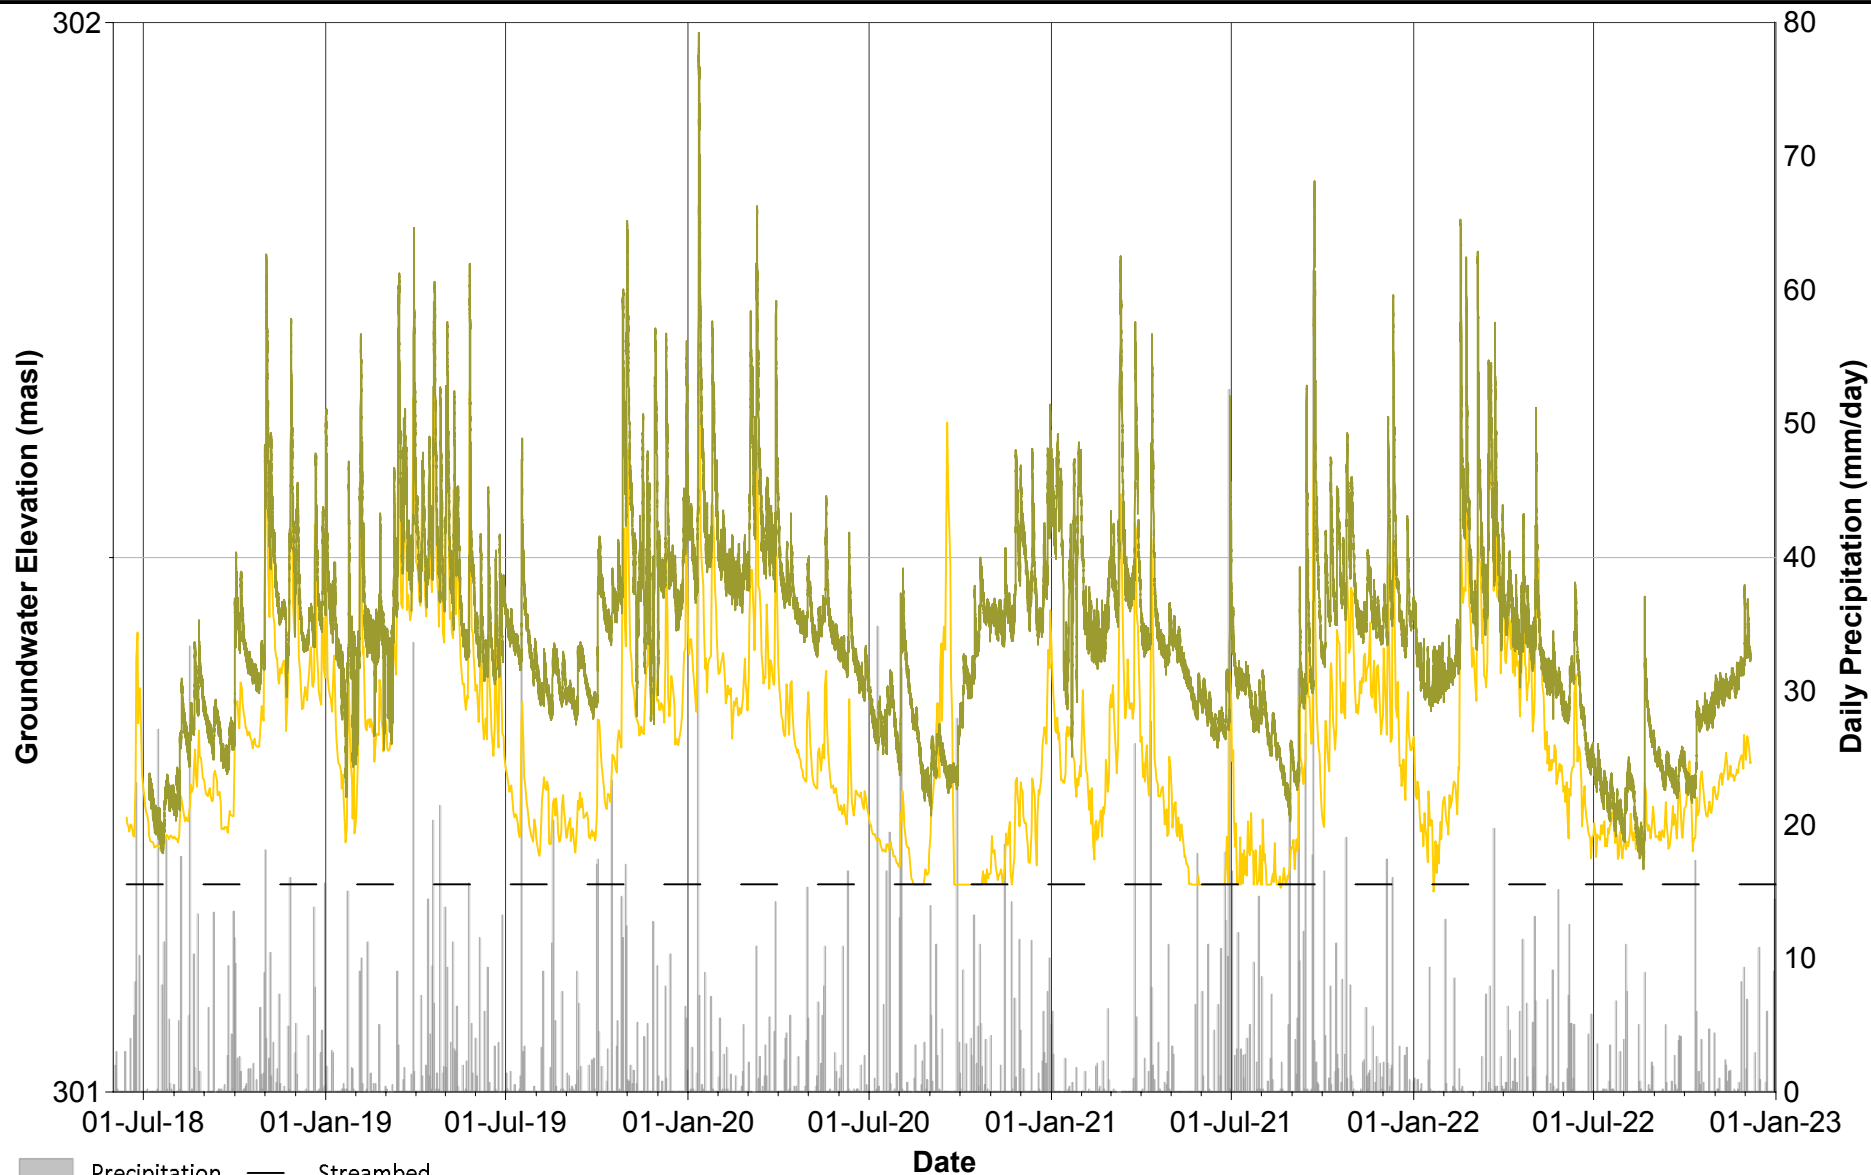
F.4.

Precipitation — Streambed
SW-4 SP18-04

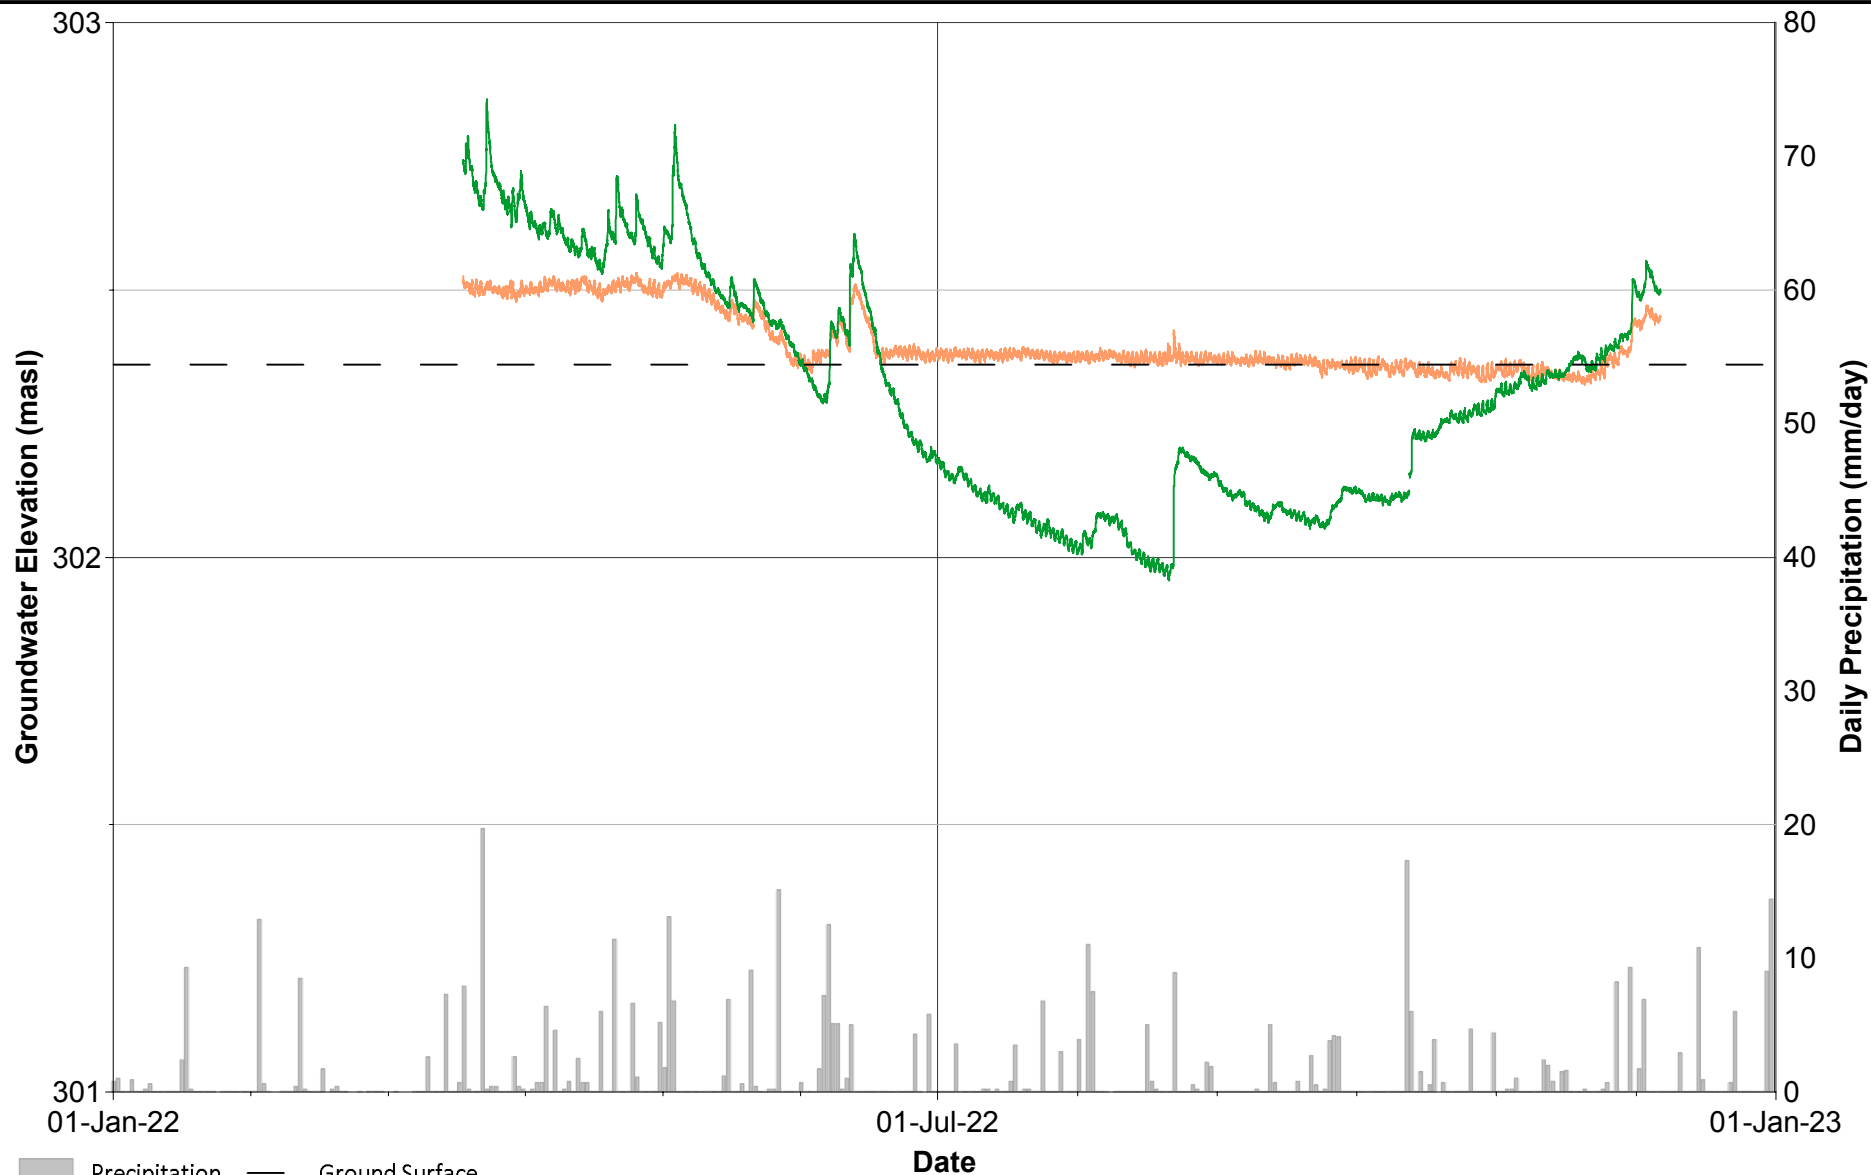
FIGURE
 F.5.

■ Precipitation — Ground Surface
 — SW-5 — SP22-01

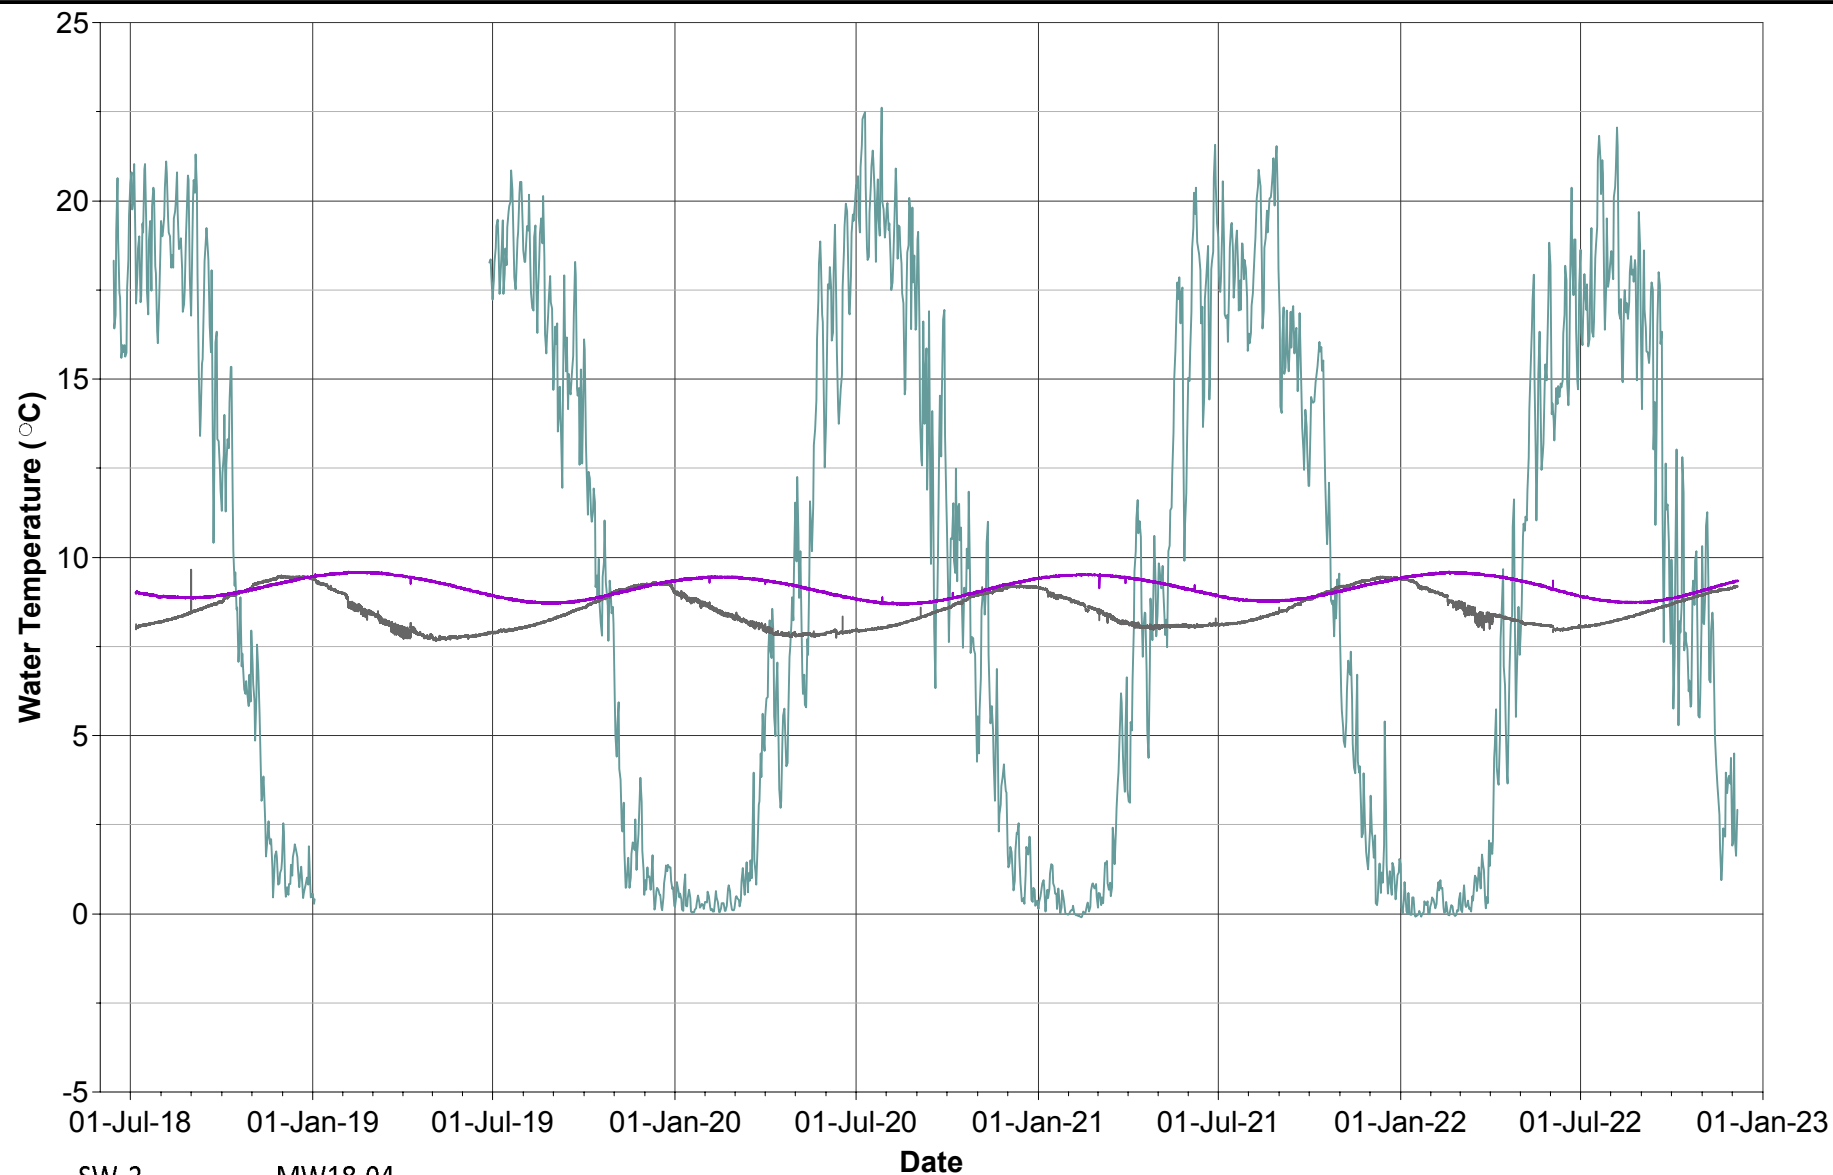
FIGURE
 F.8.

— SW-2 — MW18-04
 — SP18-02

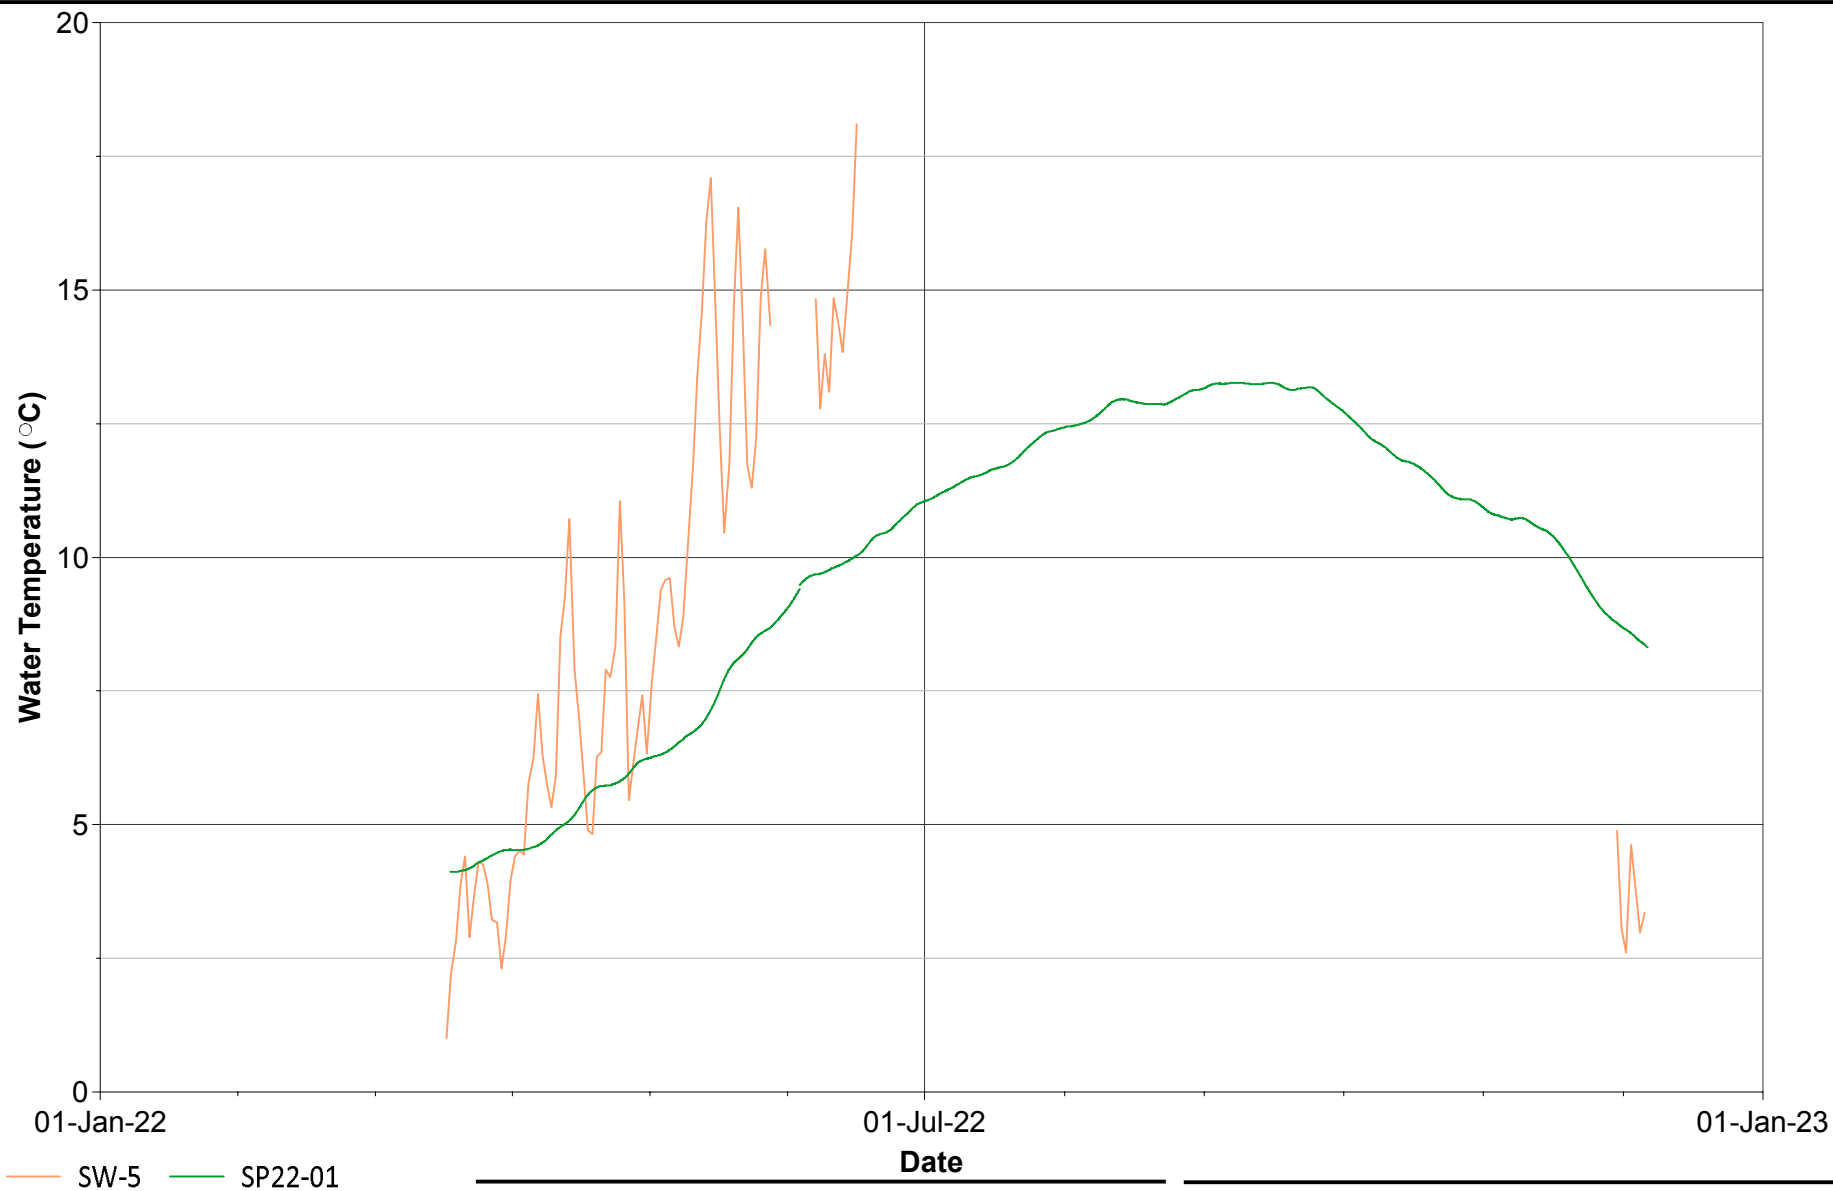
FIGURE
F.11.

1. To be read in conjunction with accompanying report.
2. Surface water temperature reported as a daily average when surface water levels are greater than 3cm at the logger.

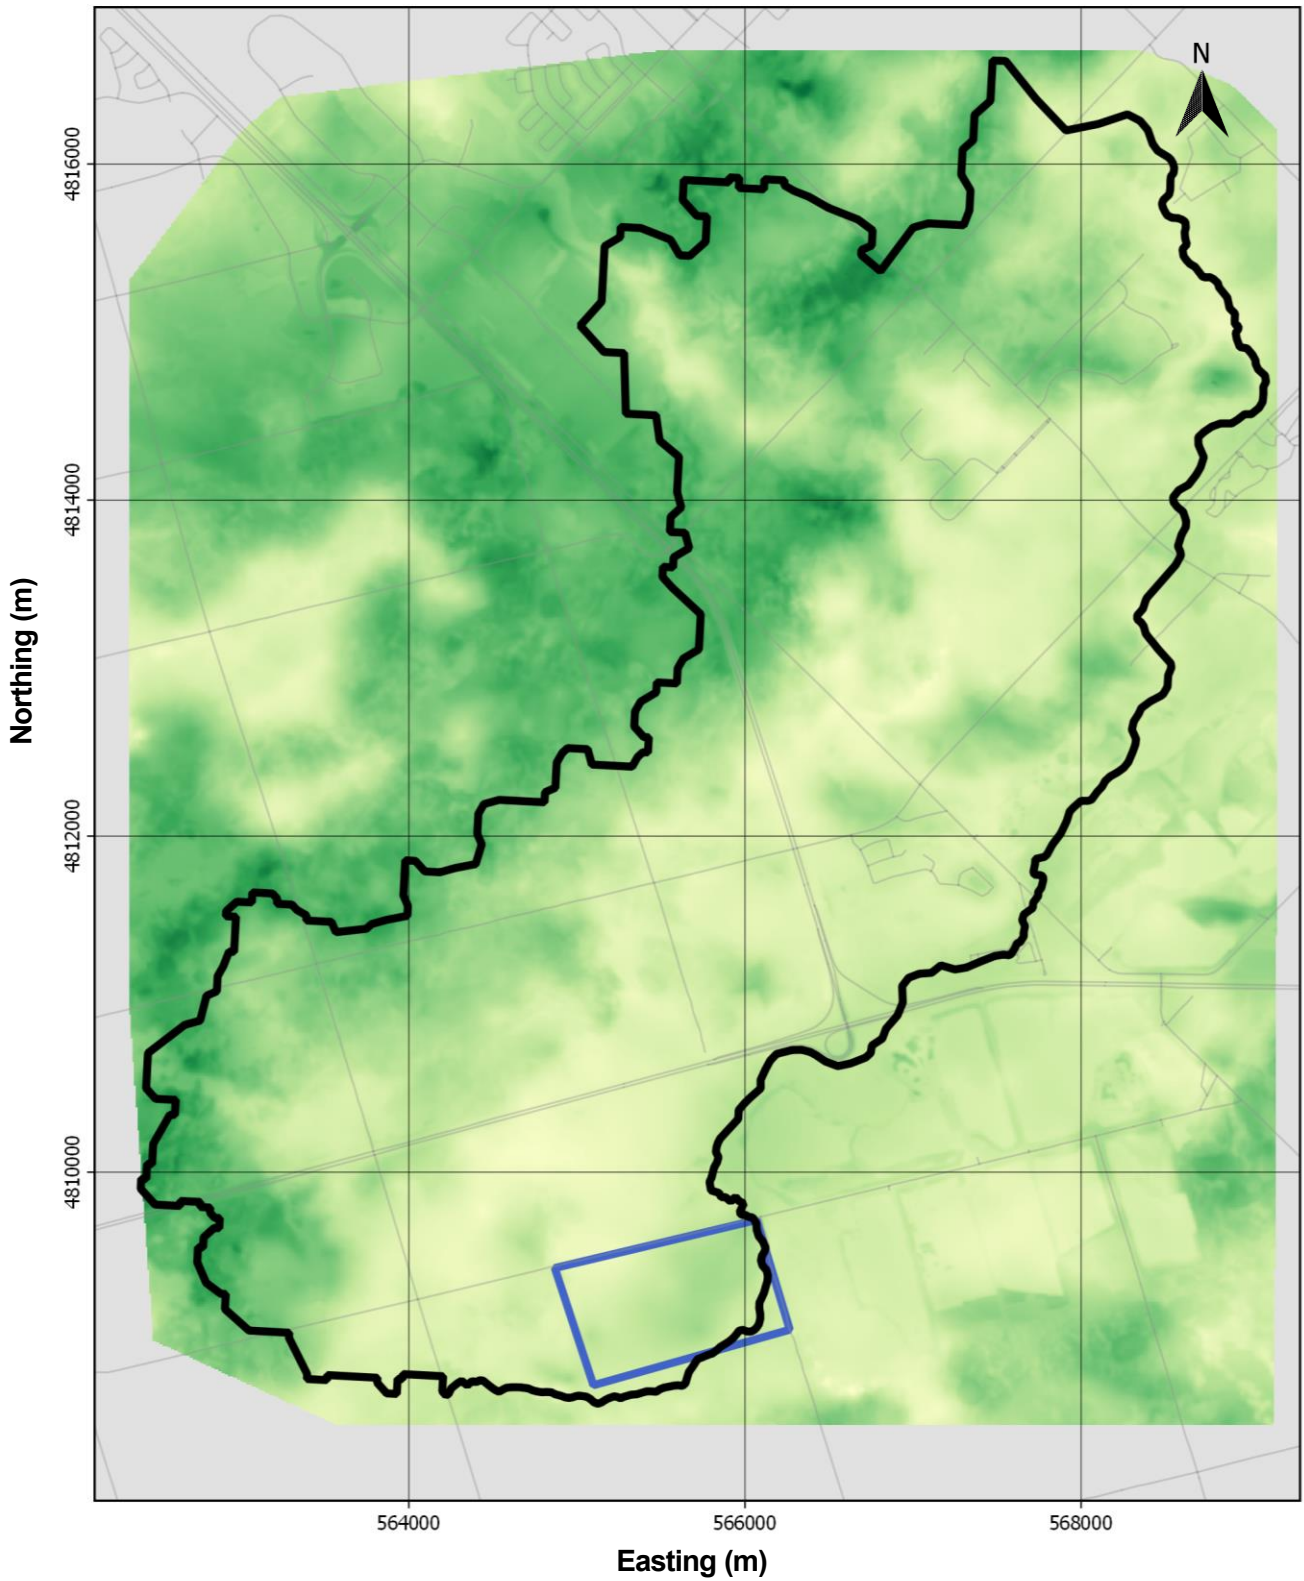
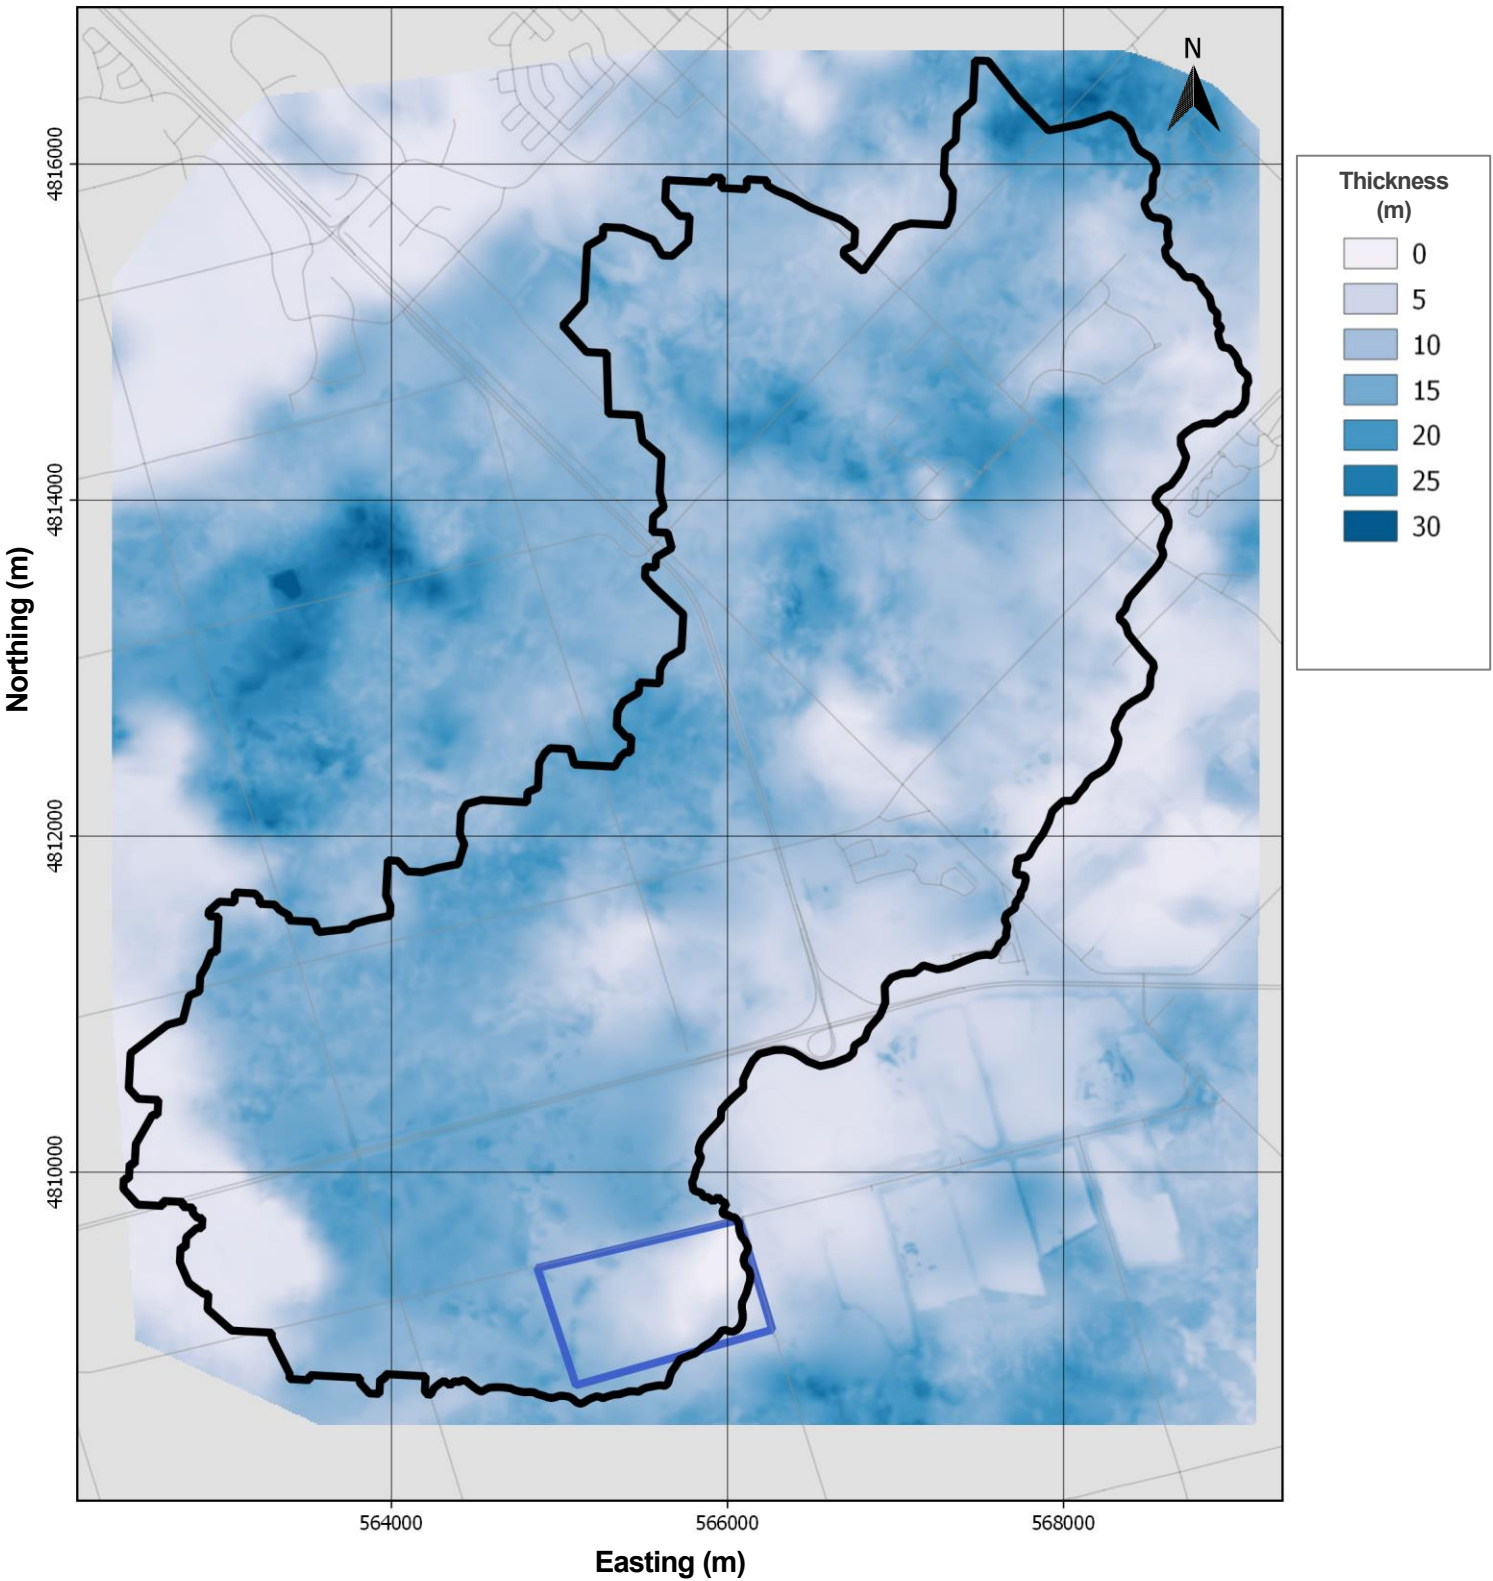
FIG.
5

Overburden Unit A

Overburden Unit B

Relative thicknesses of the two overburden layers were assigned based on the ratio of unit thicknesses applied in the Tier Three model (Matrix Solutions, 2017). Within the local property boundary, the overburden thicknesses were updated to incorporate data collected on-property. The thicknesses of the two overburden units are shown on Figure 5.
