Water Report Level 1/2

Aberfoyle South Pit Expansion

WSP Canada Inc.

November 2023

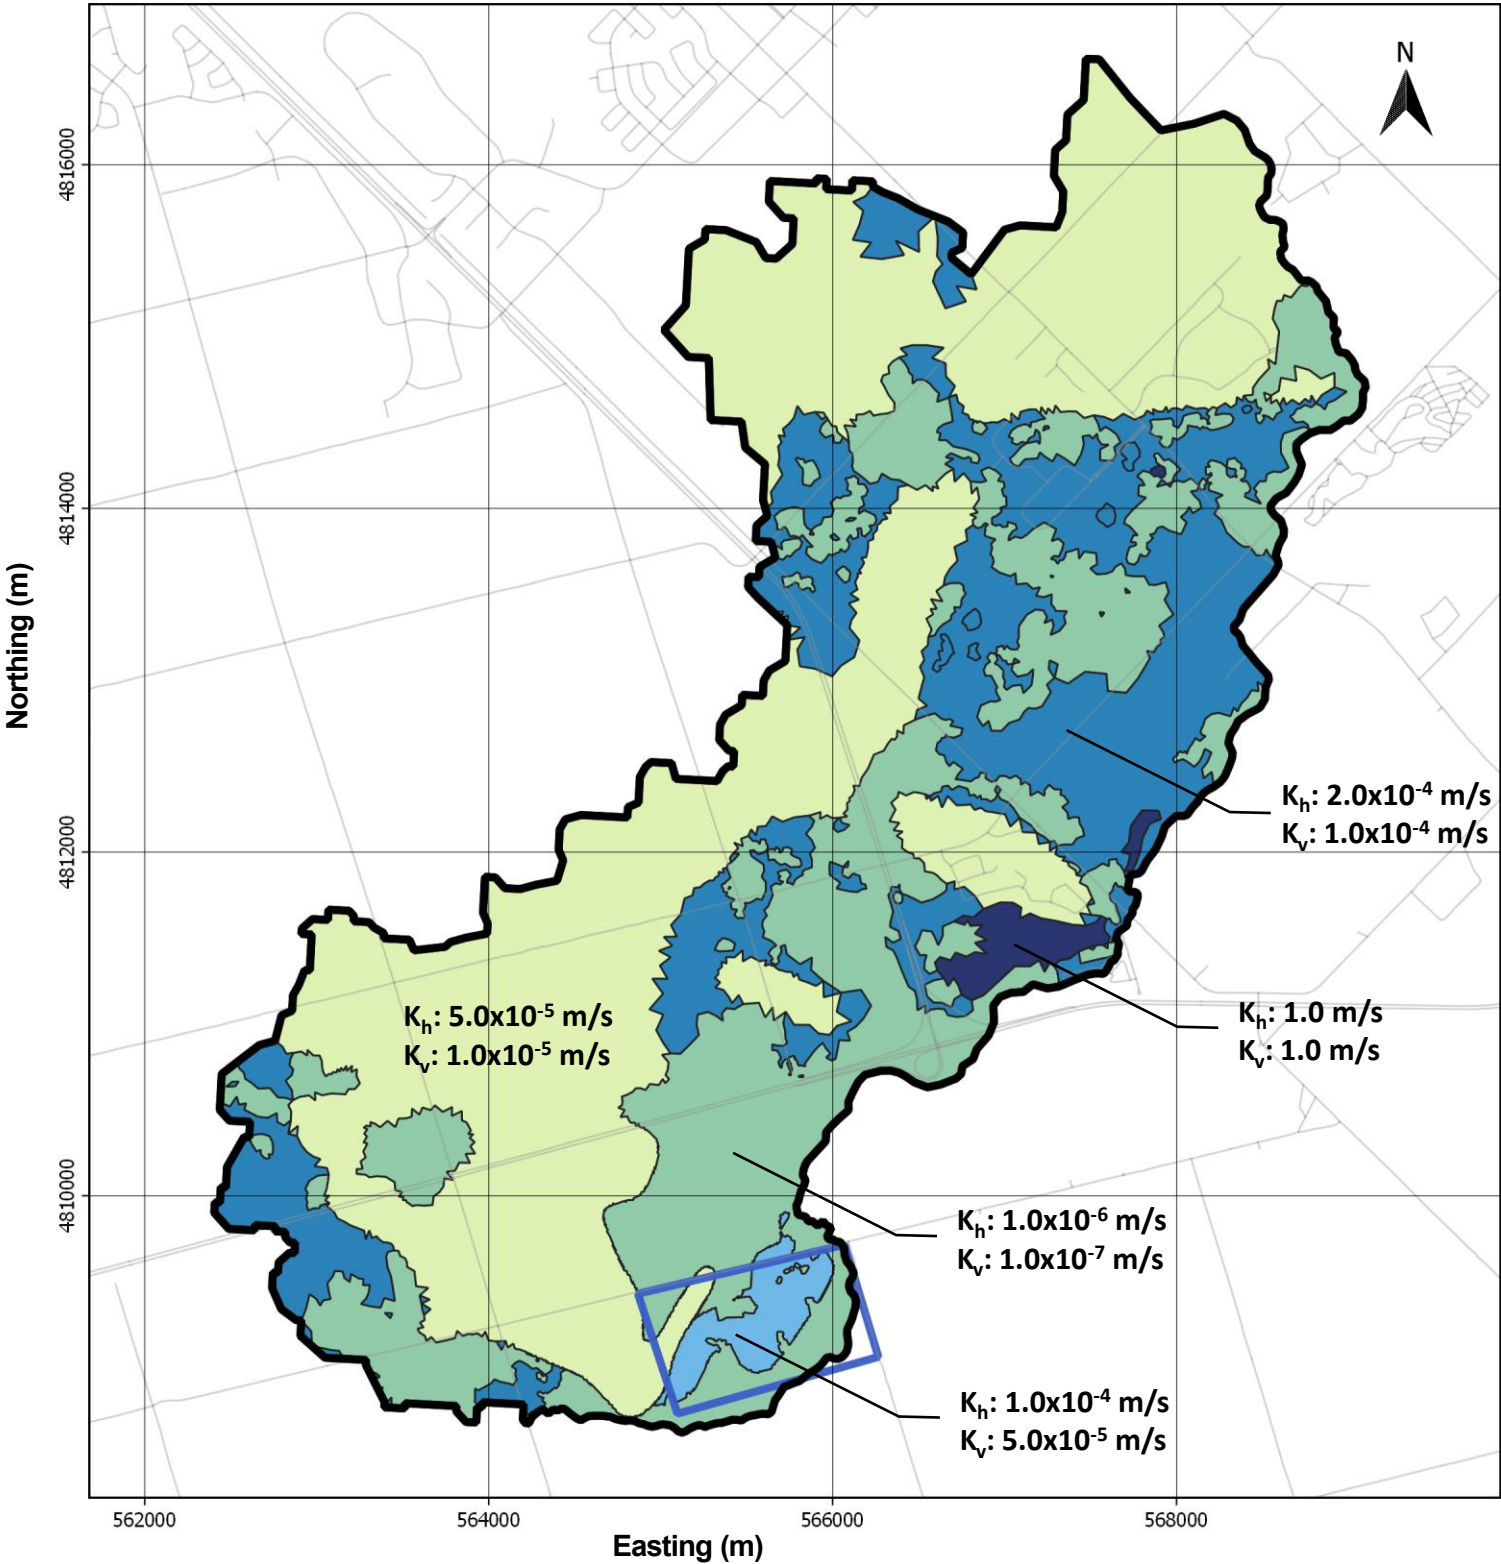
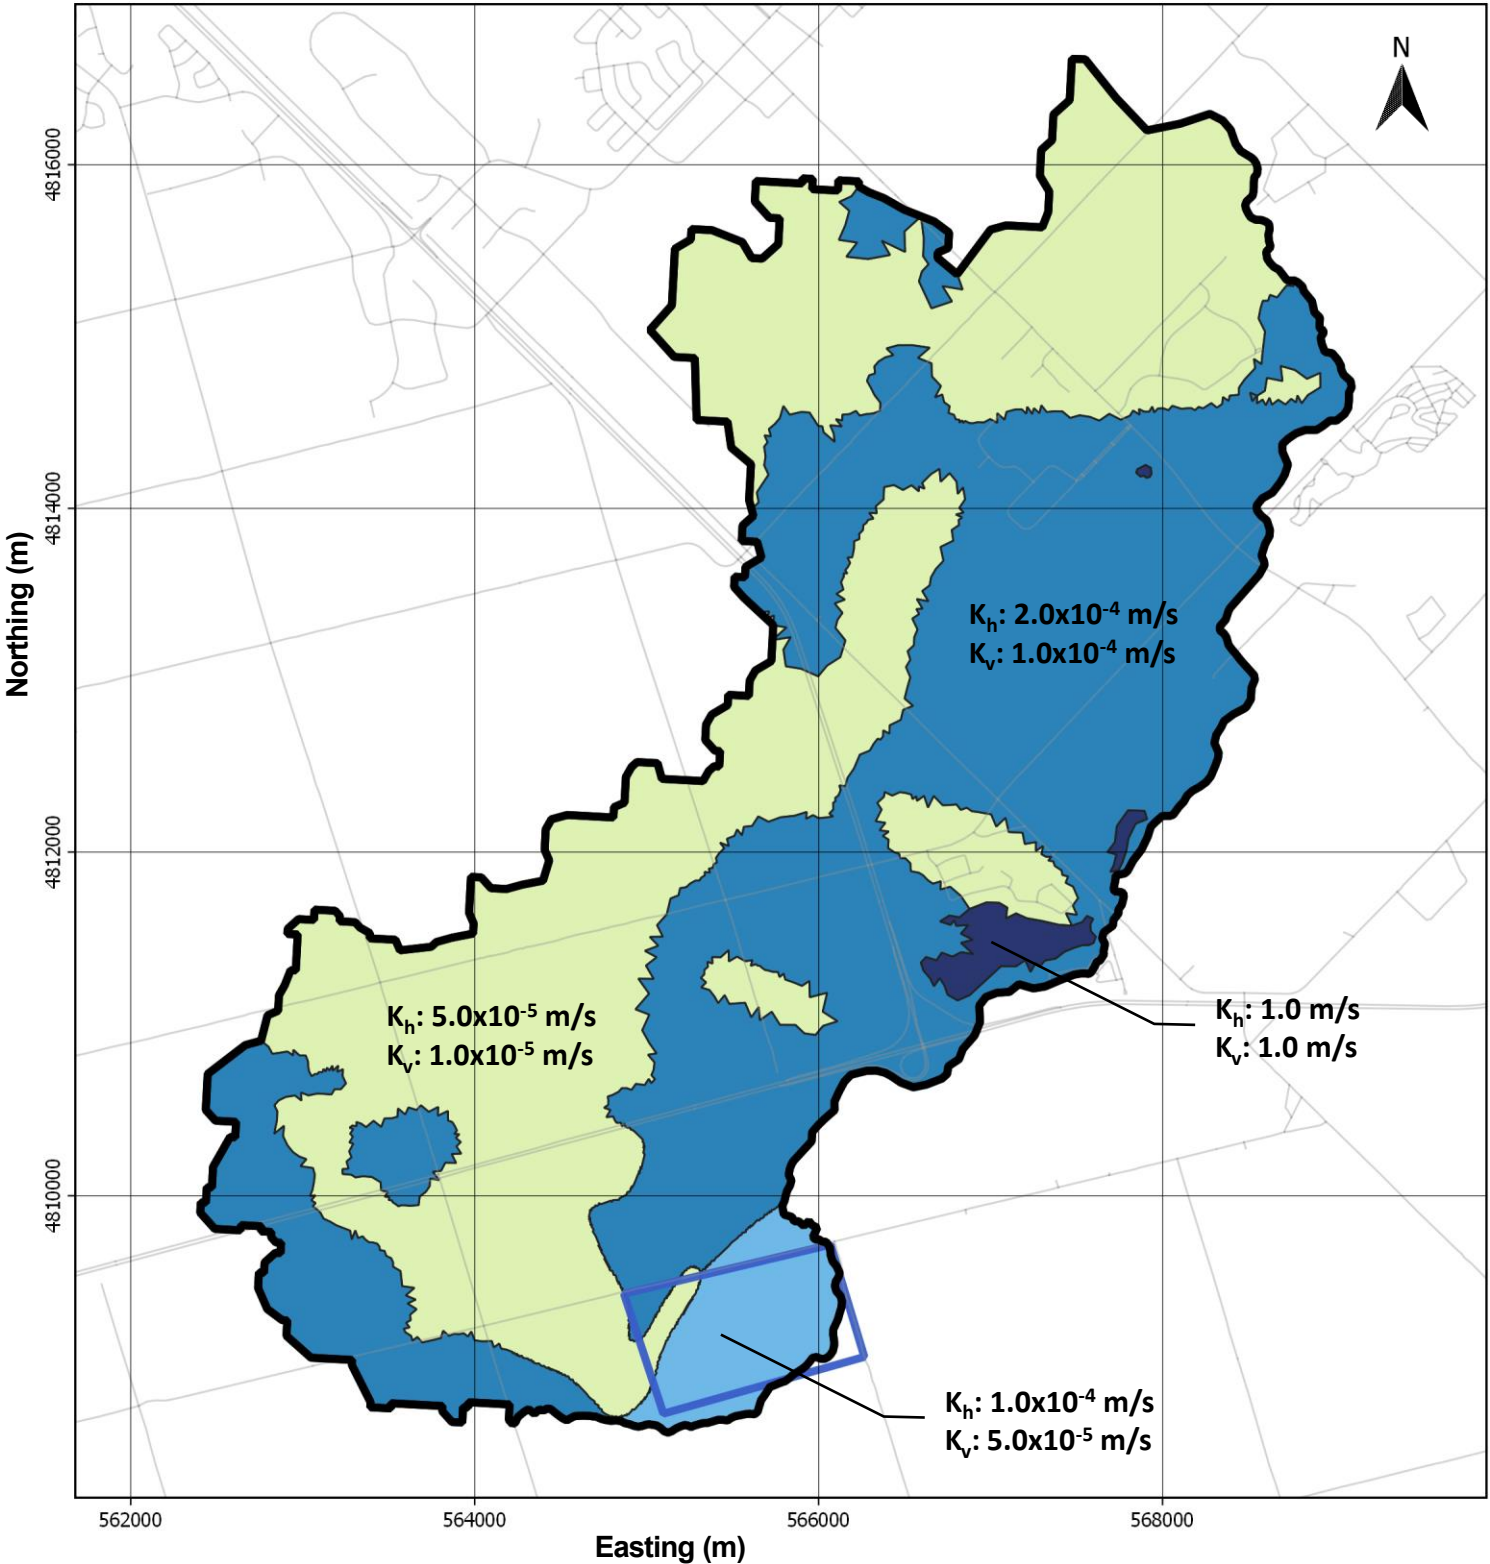
FIG.
6a

Surficial Deposits

Overburden A

- Model Boundary
- Roads
- Property Boundary
- Organic Deposits
- Sand and Gravel Outwash
- Local Sand and Gravel
- Weathered Wentworth Till
- Flooded Pits

assessment. Wetland areas are assumed to have accumulated detritus and are also designated as organic deposits. Where organic material is not present, the material properties from the underlying Overburden A layer were applied. A summary of the numerical model hydrostratigraphy is illustrated on Figures 6a and 6b.

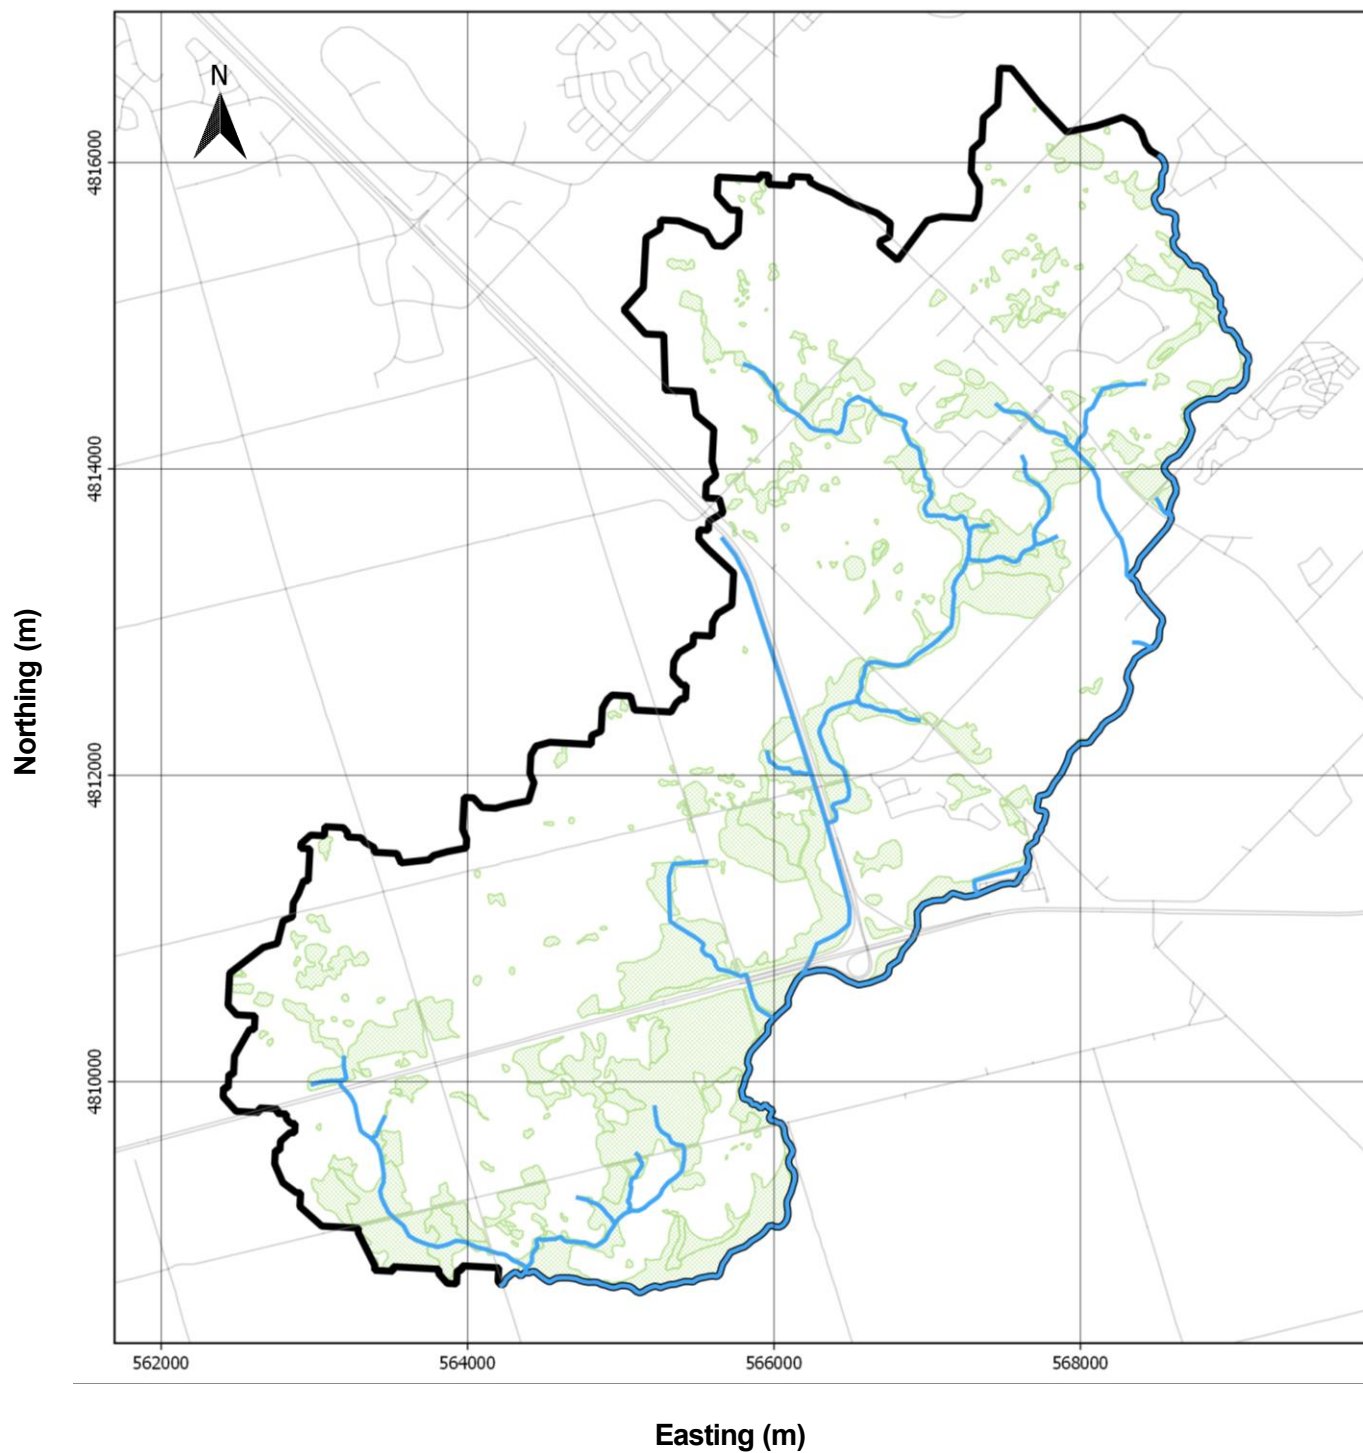
FIG.
8

- Rivers / Streams
- Roads
- Model Boundary
- Wetlands

The perimeter of the model domain was assigned as a no-flow boundary condition, except where surface water features are present. Within the surface layer, tributaries, ditches, and wetlands are set as type 1 (Dirichlet) constrained flow boundary conditions (Figure 8).

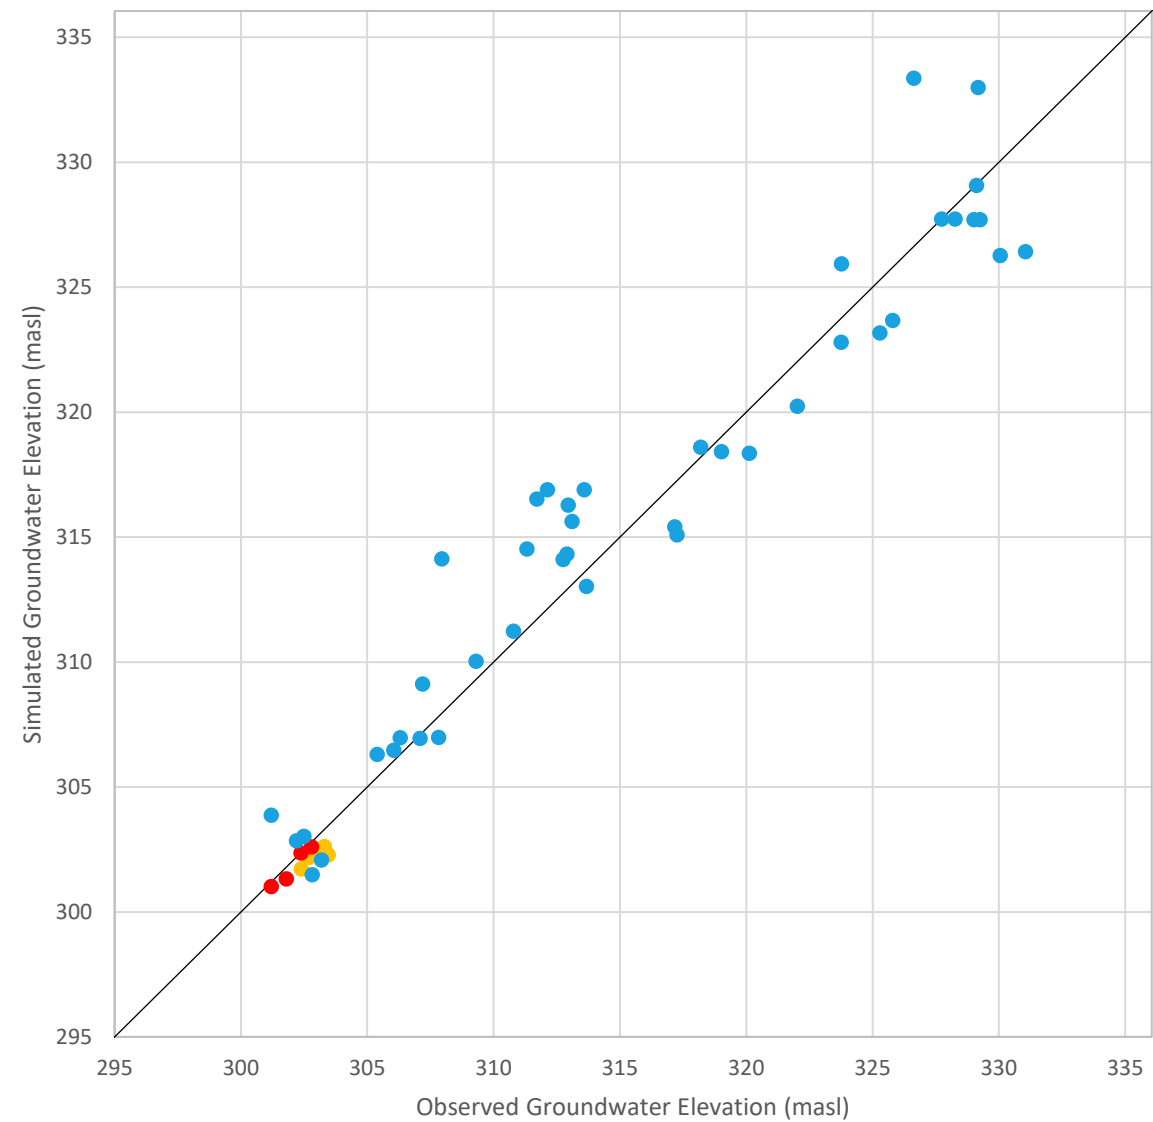
Mean Residual Error	-0.38	[m]
Mean Absolute Error	1.70	[m]
Median Residual	-0.13	[m]
Minimum Residual	-4.63	[m]
Maximum Residual	6.73	[m]
Root Mean Square Error	2.33	
Normalized RMS	7.8%

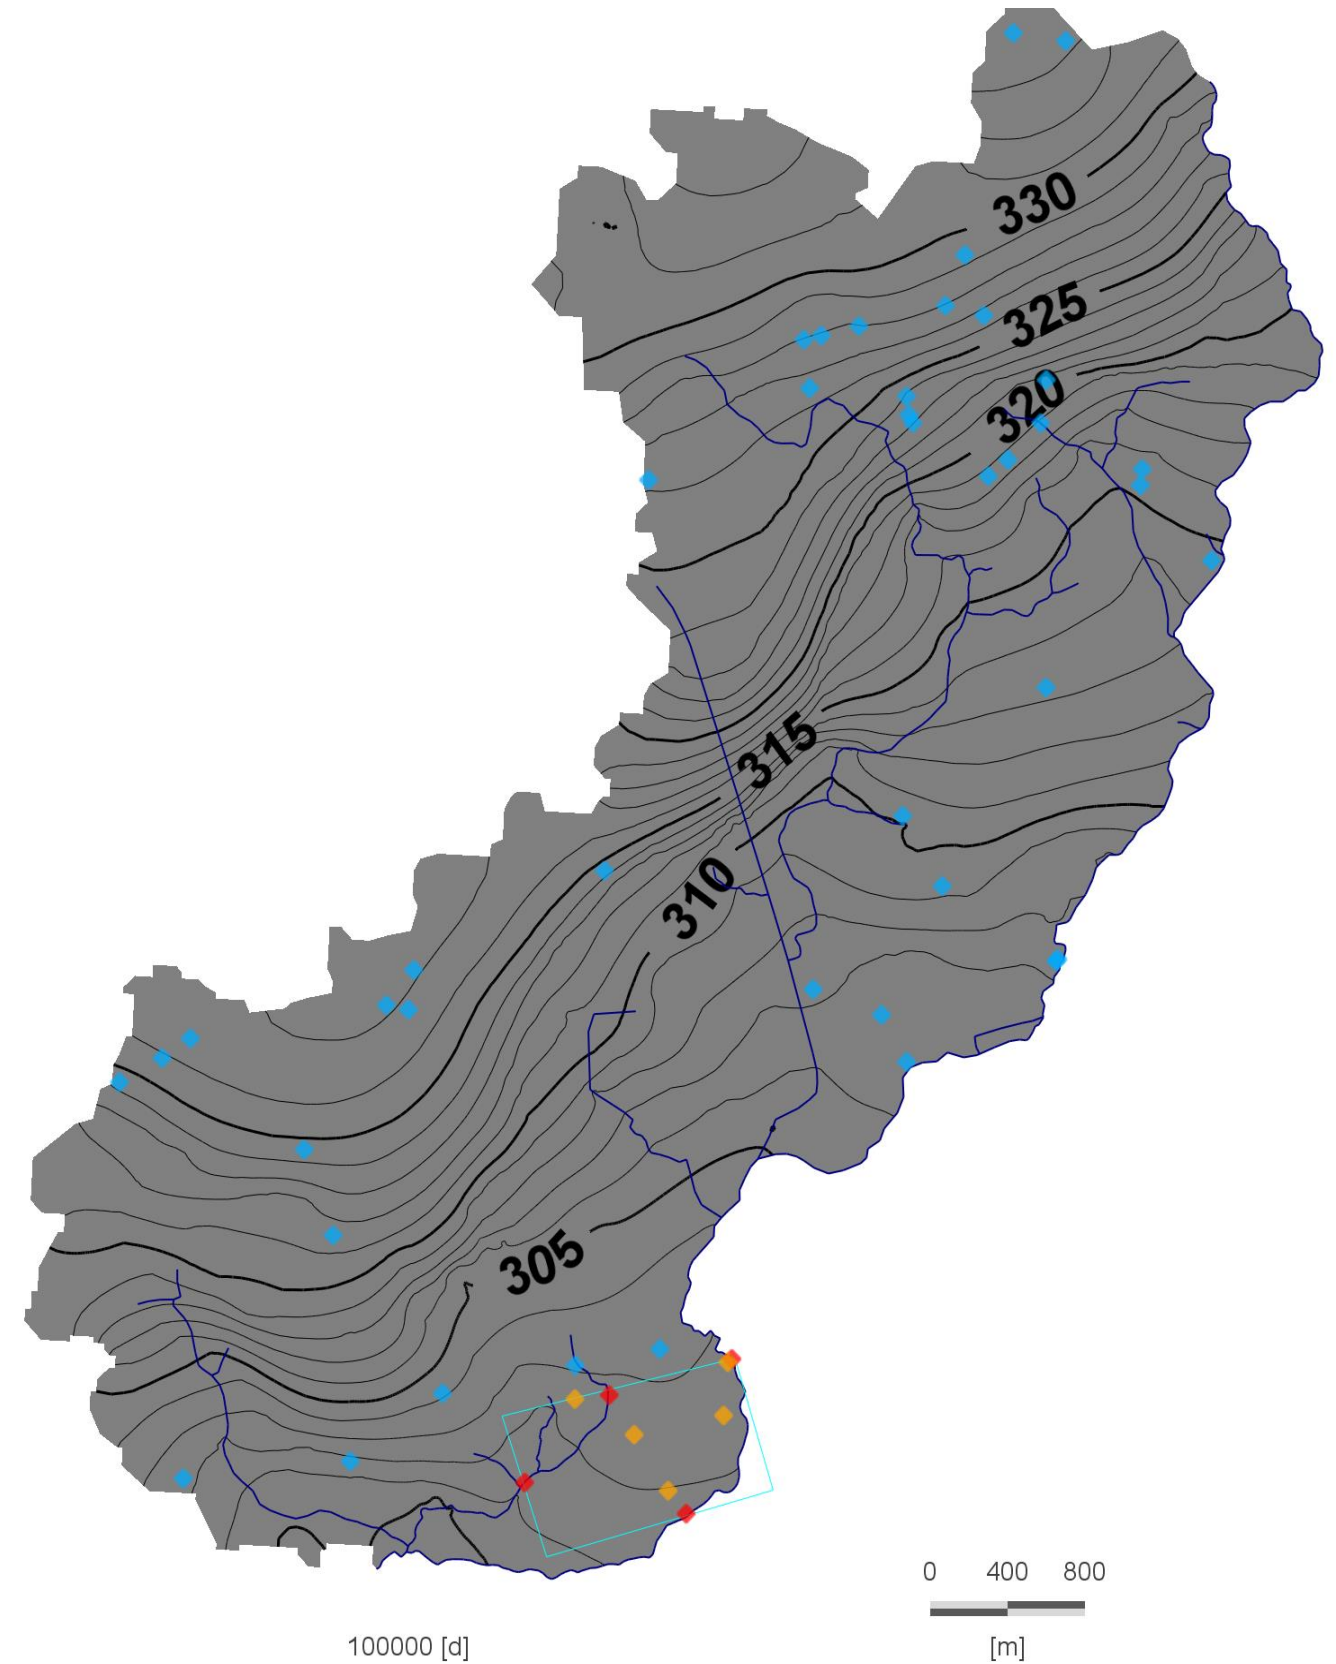
FIG.
10

- Golder MWs
- Golder SPs
- MECP
- Property Boundary
- Rivers / Streams
- Inferred Direction of Groundwater Flow

The final calibration statistics and a comparison of simulated vs observed groundwater elevations (i.e., 45-degree plot) are shown on Figure 10. The calibration error is generally distributed both above and below the 45-degree line with no strong bias towards over- or under-estimation of water levels. A mean residual error of -0.38 m and a normalized root mean square error of 7.8% suggest that the model is able to simulate the observed conditions within a reasonable margin of error.

The simulated hydraulic heads presented on Figure 10 illustrate a general flow direction from northwest to southeast, with groundwater near the property flowing from the north to the southwest. The simulated groundwater head directions are consistent with observed groundwater elevations on the property, the Site geology and hydrostratigraphy, and the results of the Tier Three study.

The simulated heads from the rehabilitated condition are presented on Figure 14a. When compared to the pre-pond condition (Figure 10), the final pond configuration flattens the water table over the majority of the property with a pond elevation of approximately 302 masl. Groundwater gradients towards and downstream of the pit pond are steeper than those simulated for Pre-pit conditions and inferred directions of groundwater flow under rehabilitated conditions are consistent with those without the pit pond. Groundwater flows from the northwest towards Tributary 3, from the north onto the Site, and from the Site to the southwest towards Tributary 3 and Mill Creek, while small changes in groundwater flow direction can be seen downstream of the pond with groundwater flow deflecting south and southwest towards Mill Creek and west towards Tributary 3.

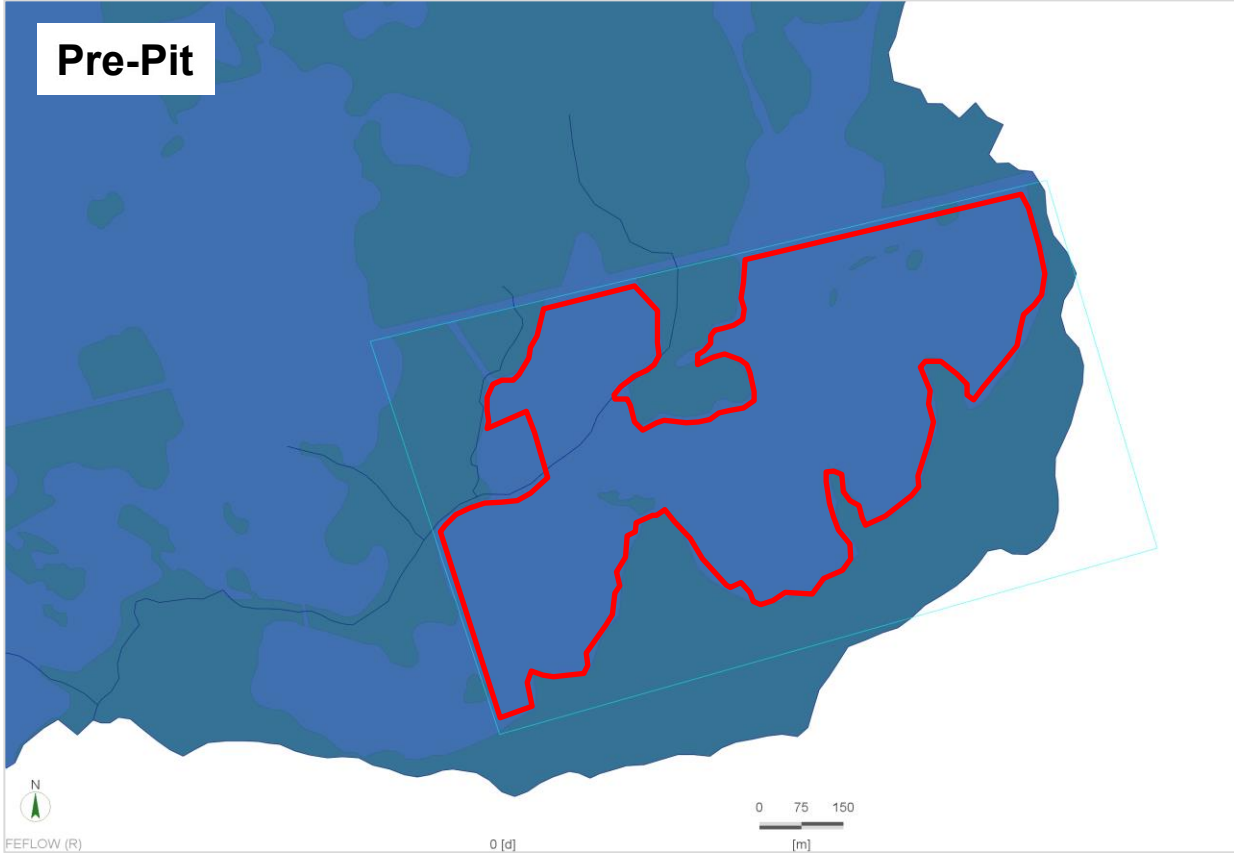
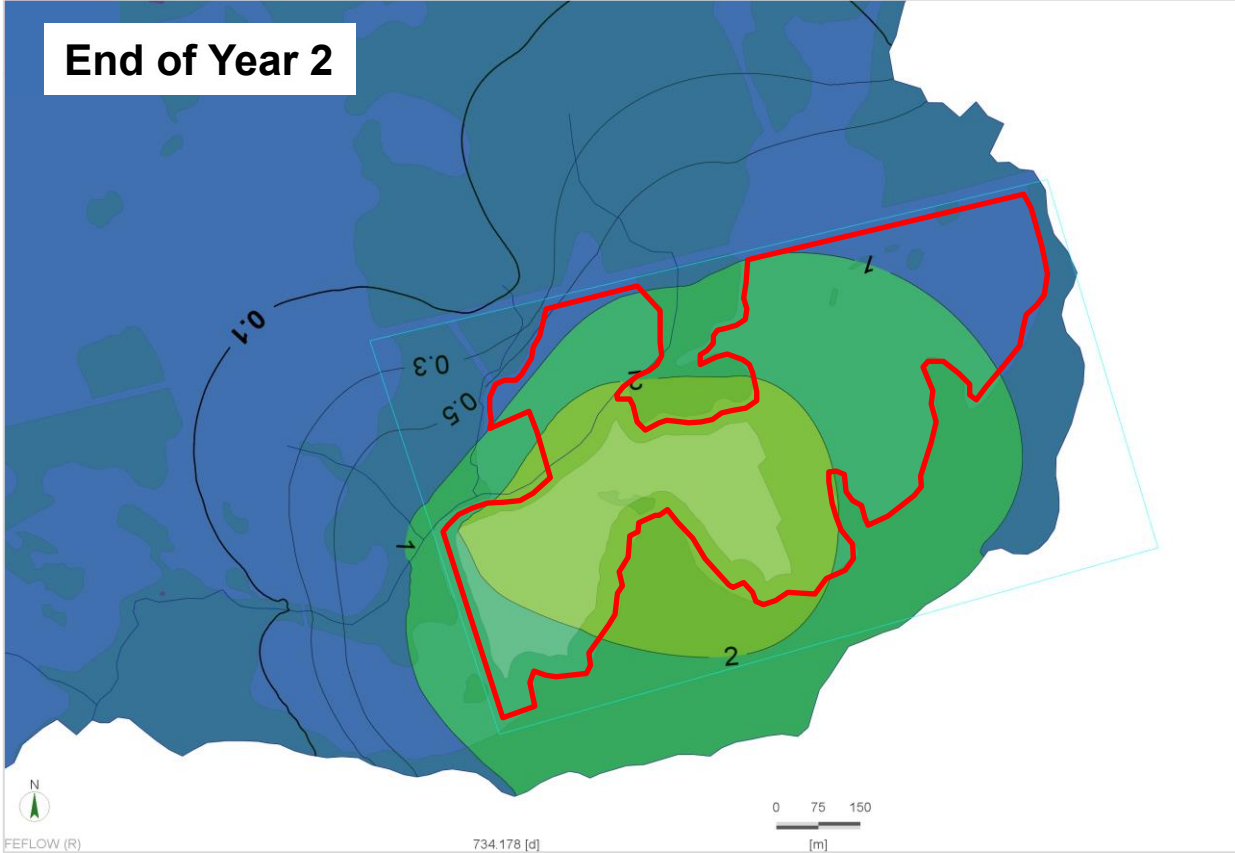
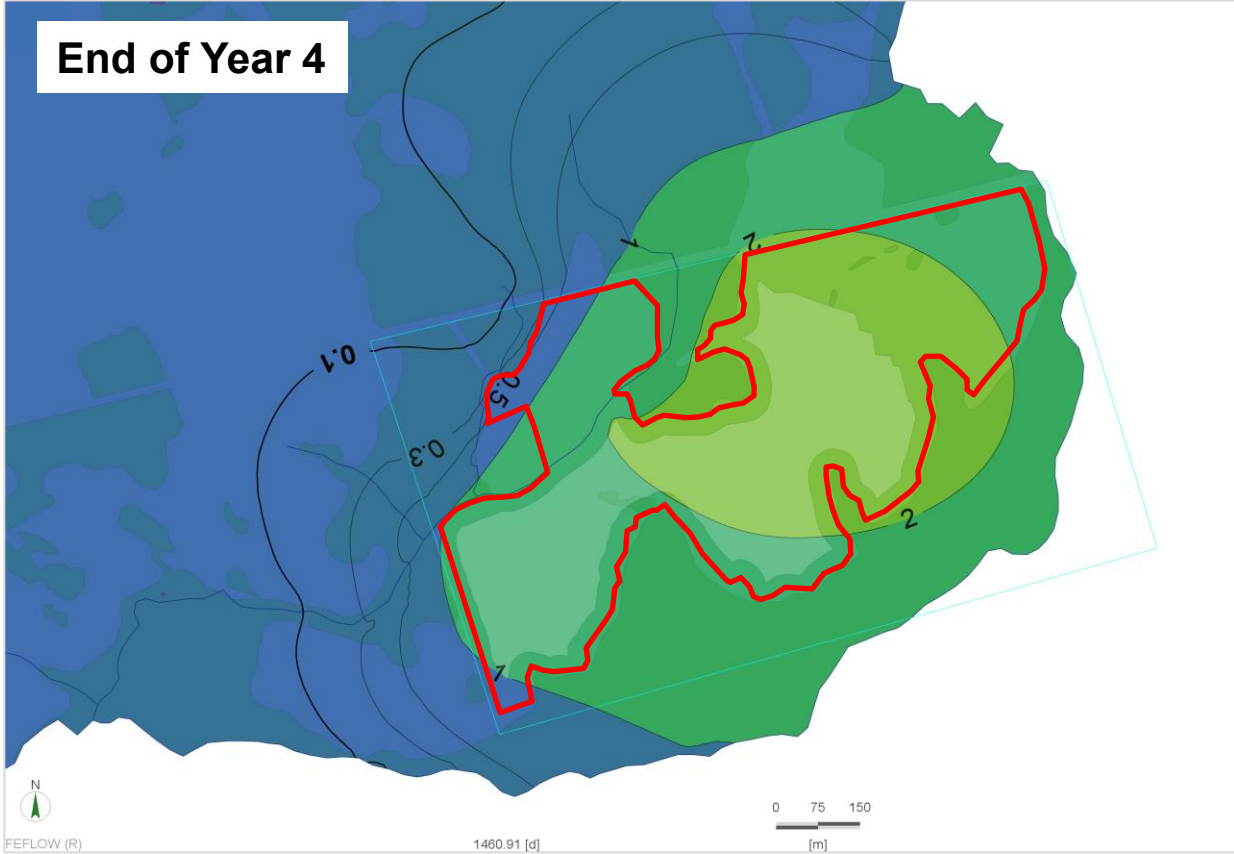
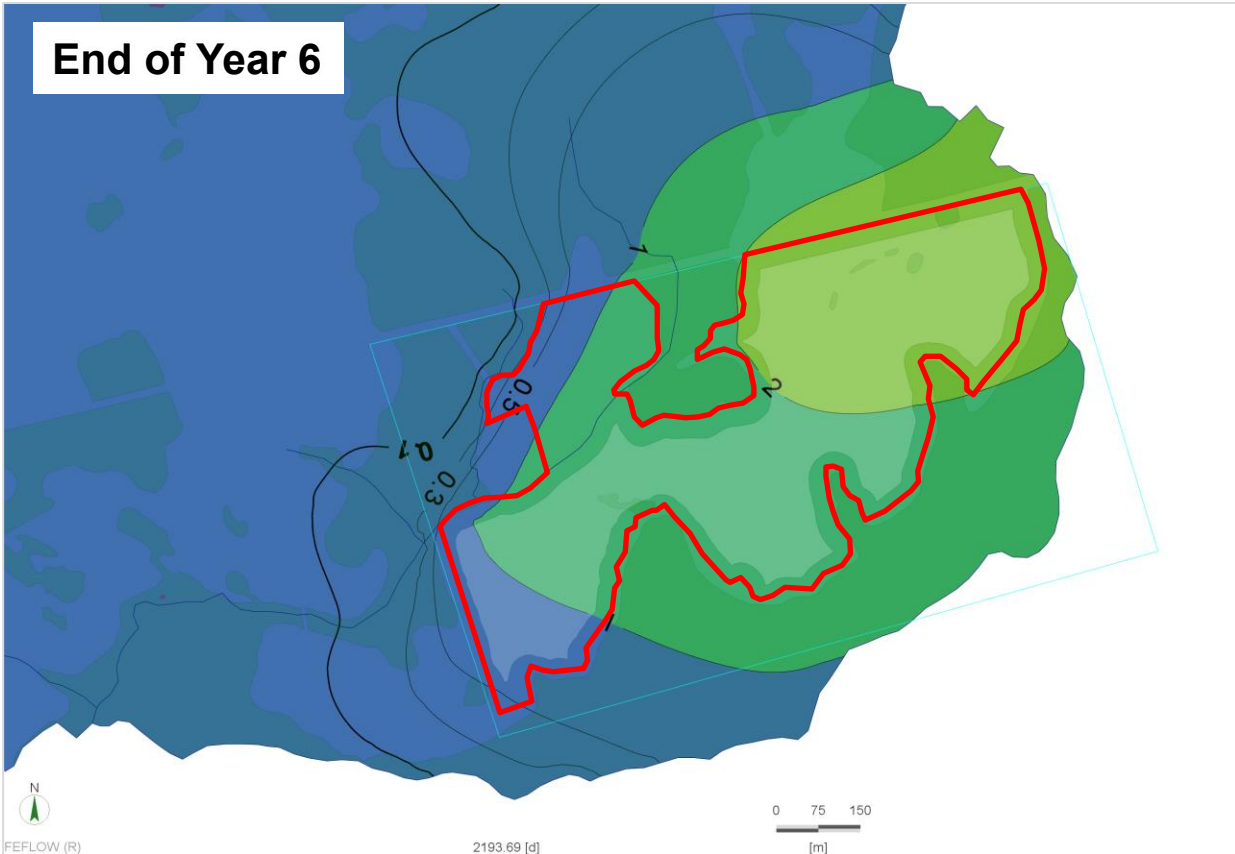
FIG.
12b

- NOTES**
1. End of Year 2 = End of operations in year two.
 2. End of operations is reached in year 6, assuming an extraction rate of 1,000,000 tons per year.

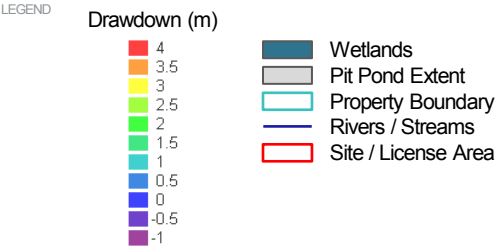
FIG.
12a

[Figure 12a](#) presents the simulated water table at various stages of pond development (Pre-pit, End of Years 2, 4, and 6). The initial pre-pit condition shows a general flow pattern of groundwater moving from the northwest towards Tributary 3, and groundwater from the northeast entering the site and flowing west towards the lower reaches of Tributary 3 and Mill Creek.

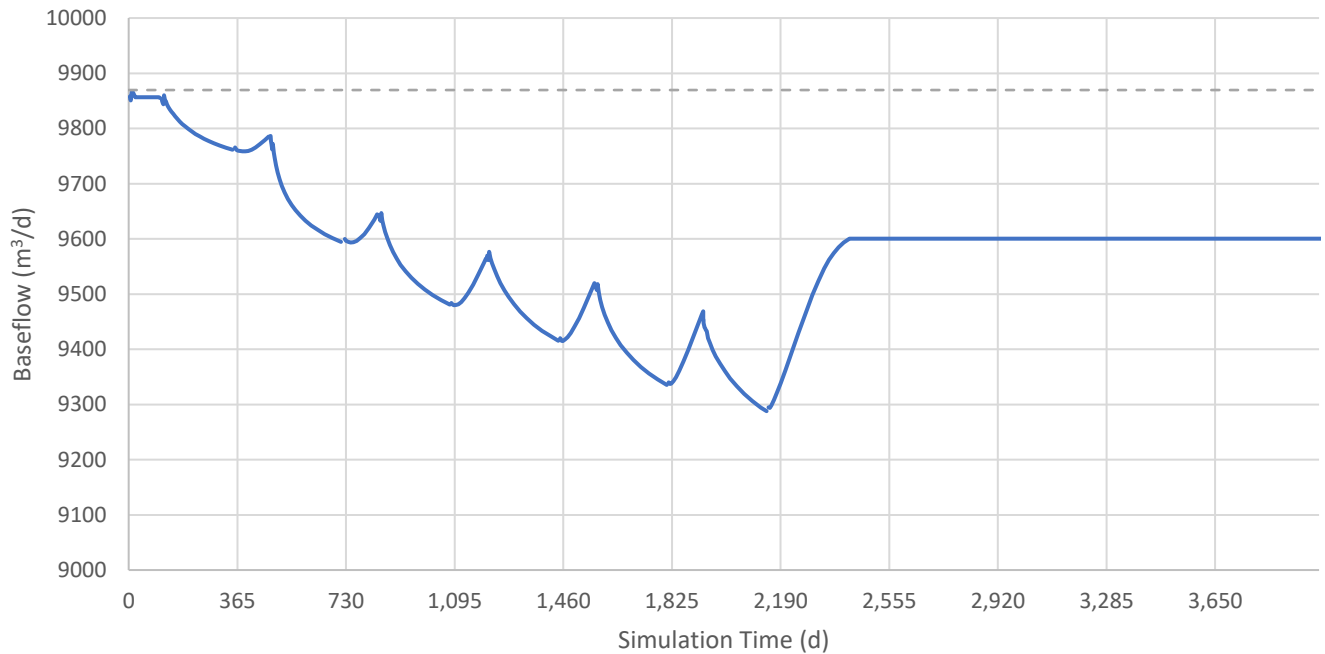
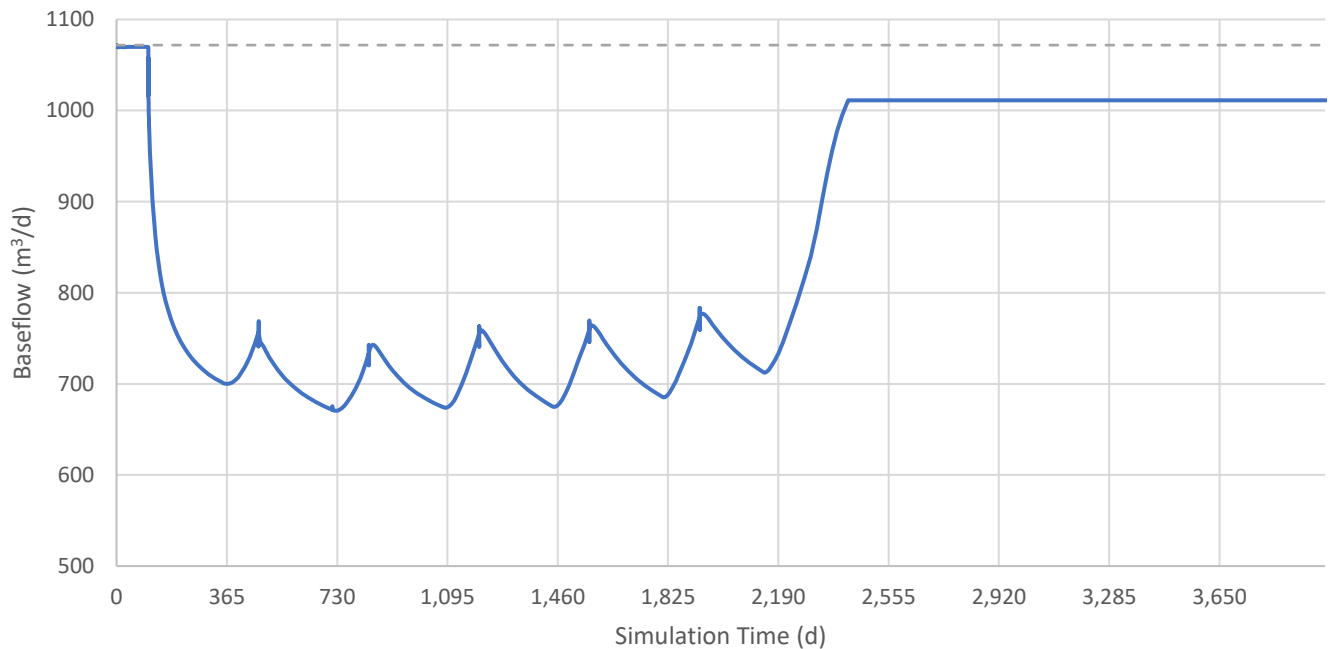
13

Mill Creek Simulated Baseflow at SW3

Tributary 3 Simulated Baseflow at SW4

- Simulated Operations Baseflow
- - - Simulated Pre-pit Baseflow
